**State of Louisiana  
Coastal Protection and Restoration  
Authority**

**2026 Annual Inspection Report**

**Penchant Basin Natural Resource  
Plan, Increment No. 1 (TE-34)**

January 23, 2026  
Terrebonne Parish

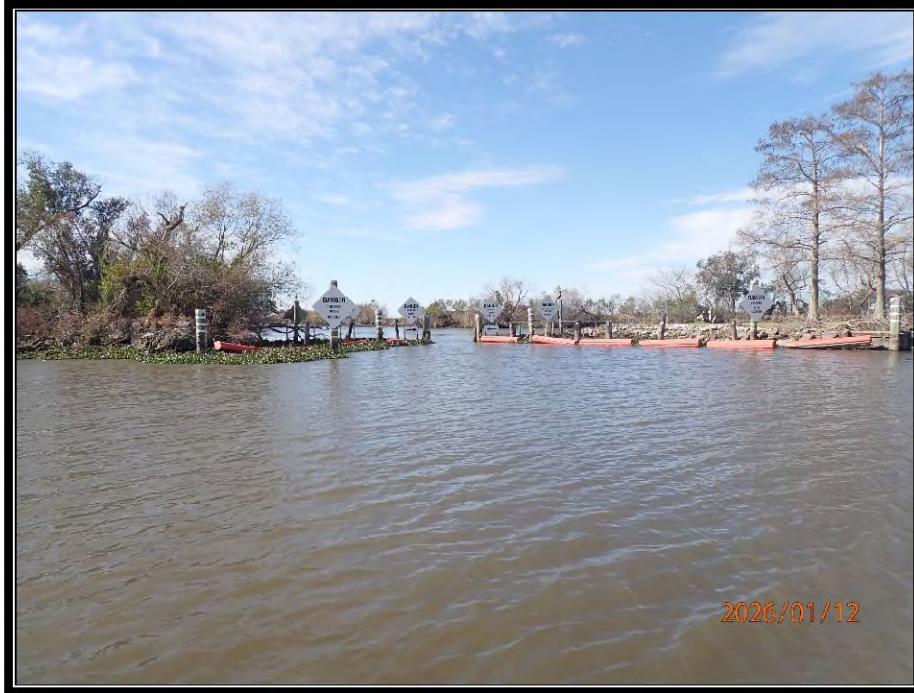
The fixed crest weir with a boat bay and flap-gates at the intersection of Brady Canal and Bayou Penchant was in good condition with no structural defects. The earthen bank tie-ins

Photo No.1 – view of the fixed crest weir at the intersection of Brady Canal and Bayou Penchant.

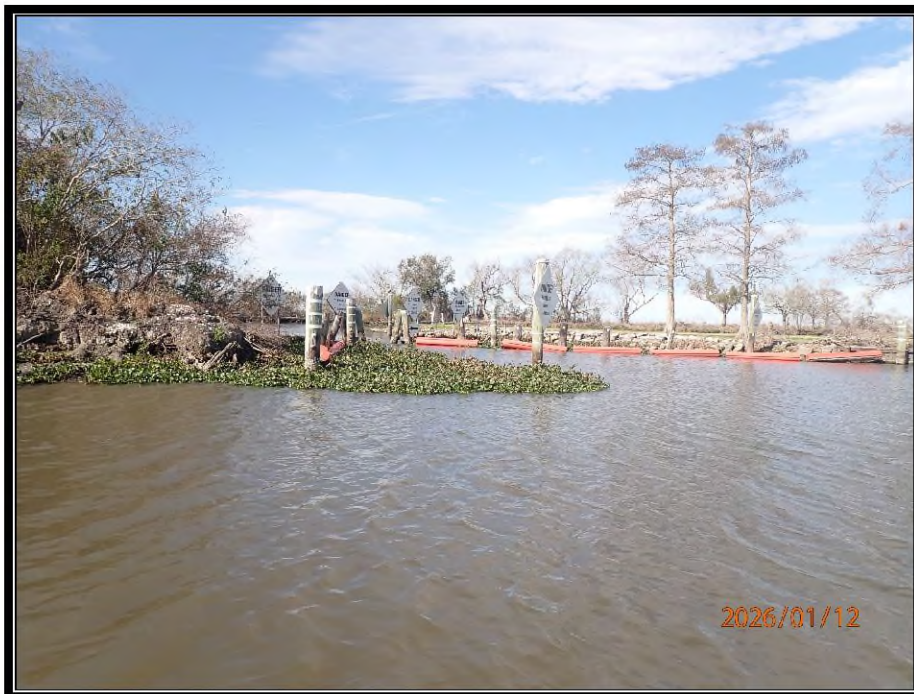
were stable with no signs of erosion. The floating debris barrier installed to prevent build-up of vegetation against the structure was also in good condition. There was a minor build-up of water hyacinth behind the floating barrier on the south side of the structure. The floating debris barrier is functioning as designed. The warning signs and supports were in good condition as well. No maintenance will be required at this time.

Photo No.2 – view of timber signage and floating debris barrier at Brady Canal Structure.

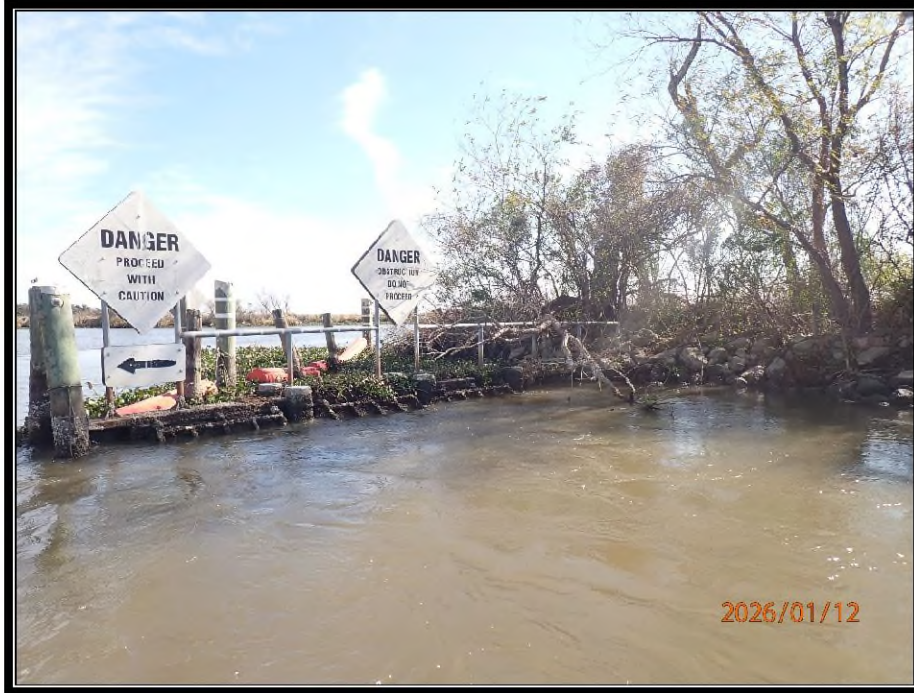
Photo No.3 – view of vegetative debris trapped between bulkhead and debris barrier at the Brady Canal Structure.

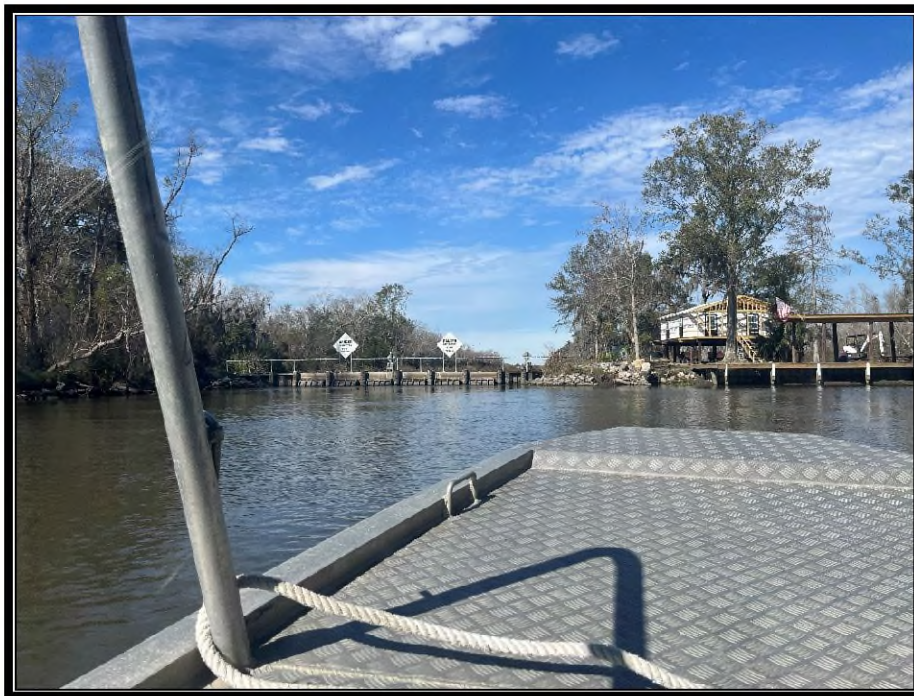
The fixed crest weir with flap-gates across Superior Canal was in good condition with no obvious structural defects or damage. The galvanized steel components, channel cap and sign supports all appeared to be in good condition. The rock armored bank tie-ins to the earthen bank were also in good condition. The floating debris barrier installed on the north side of the structure was in fair condition and working well. A large portion of the channel was clogged with marsh material and water hyacinth north of the floating barrier. The floating marsh mats and hyacinth may require spraying in the near future to kill vegetation and open the channel. The warning signs on both sides of the structure were in good condition with no visible damage.

Photo No.4 – view of water control weir along Superior Canal from Bayou Penchant.

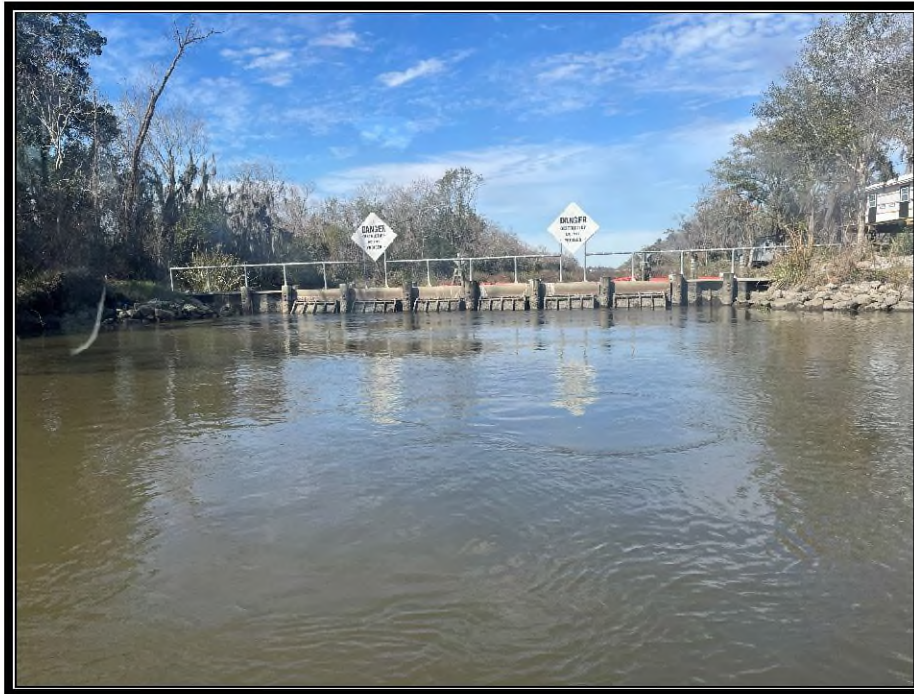
Photo No.5 – view of weir flap gates on the structure along Superior Canal.

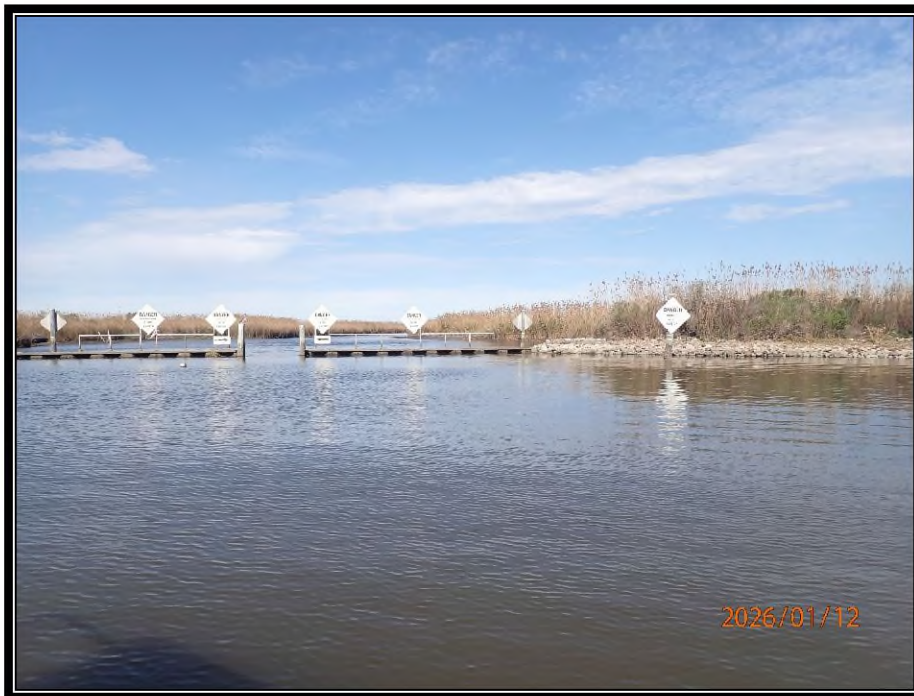
Photo No.6 – view of weir structure at Site 4 along Bayou Decade near Lost Lake and rock tie-in to steel sheet pile on the south side of the structure.

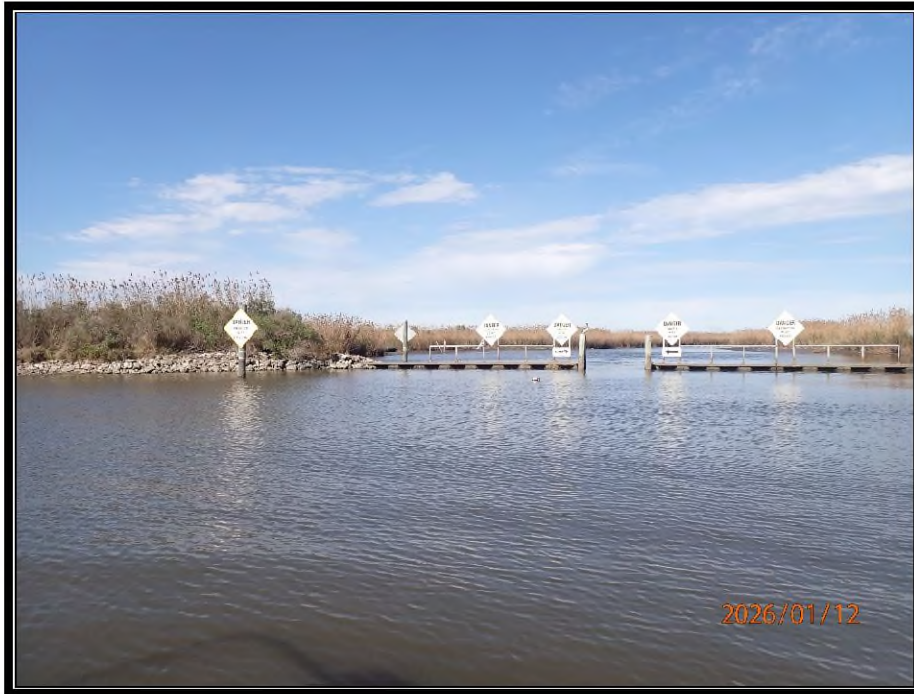
Structure No. 4 appeared to be in good condition with no visible structural damage or excessive corrosion of the steel components. The rock revetment bank tie-ins were also in good condition with no signs of bank erosion. The signs and supports were also in good condition. No maintenance will be required at this site at this time.

Photo No.7 – Rock dike tie-in to the steel bulkhead of Site No.4 and signage.

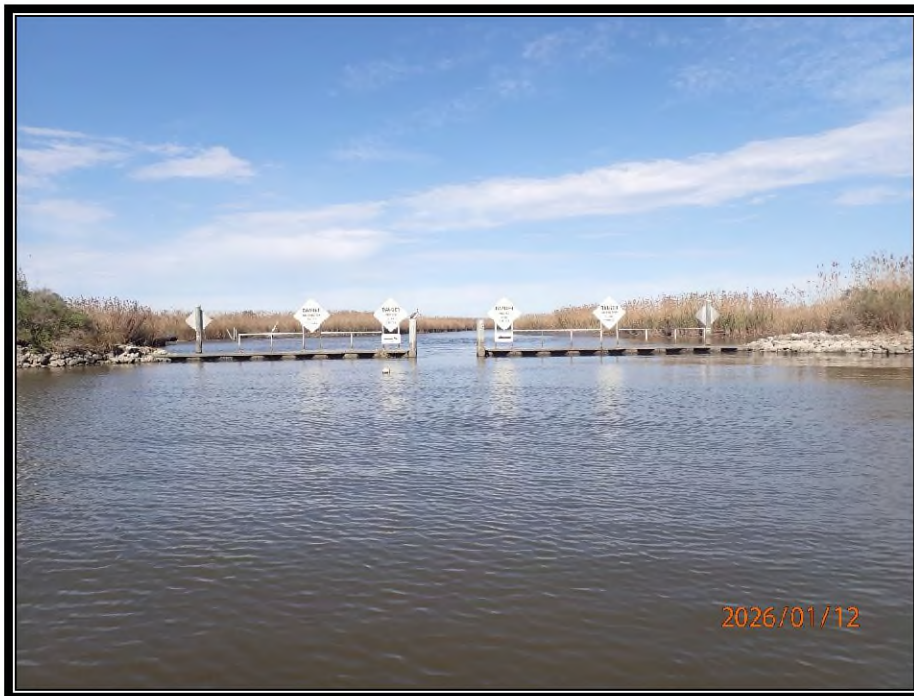
Photo No.8 – overall view of the weir structure and signage with at Site No.4.

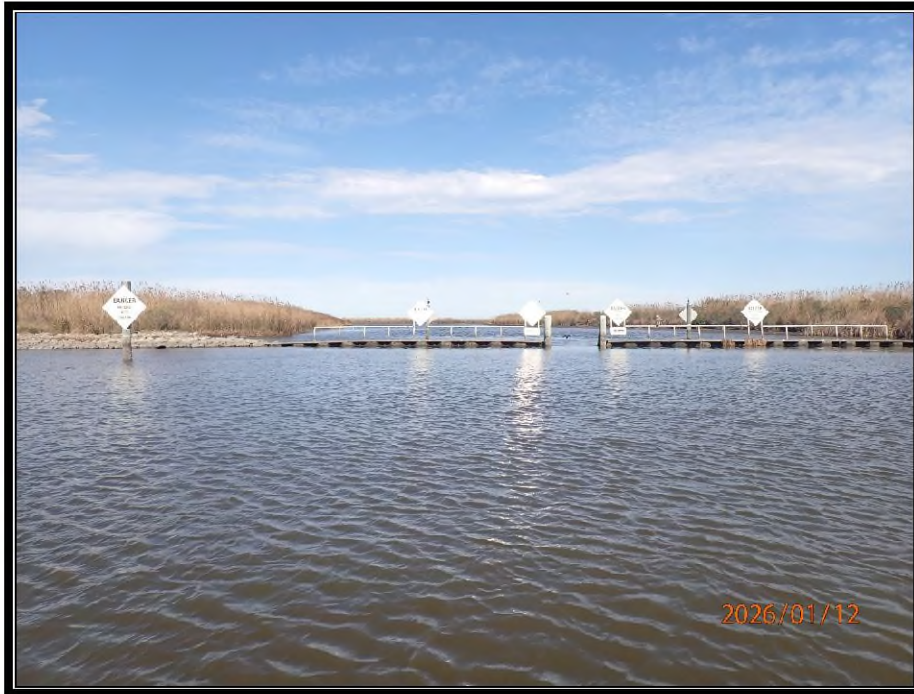
The fixed crest weir with boat bay closest to Lost Lake along the north bank of Bayou Decade appeared to be in good condition at the time of the inspection. The steel sheet piling and other components of the structure were in good condition with no major corrosion or structural damage. The rock revetment tie-ins to the structure were in good condition with slight settlement of the rock dike on the south side of the structure. There doesn't appear to be any breaching at this time. The warning signs and supports were also in good condition. No maintenance will be required at this time other than monitoring of the south side rock tie-in.

Photo No.9 – view of weir structure at Site No.5 along Bayou Decade near Lost Lake south of Site No.4 and rock dike tie in on the south side of the structure.

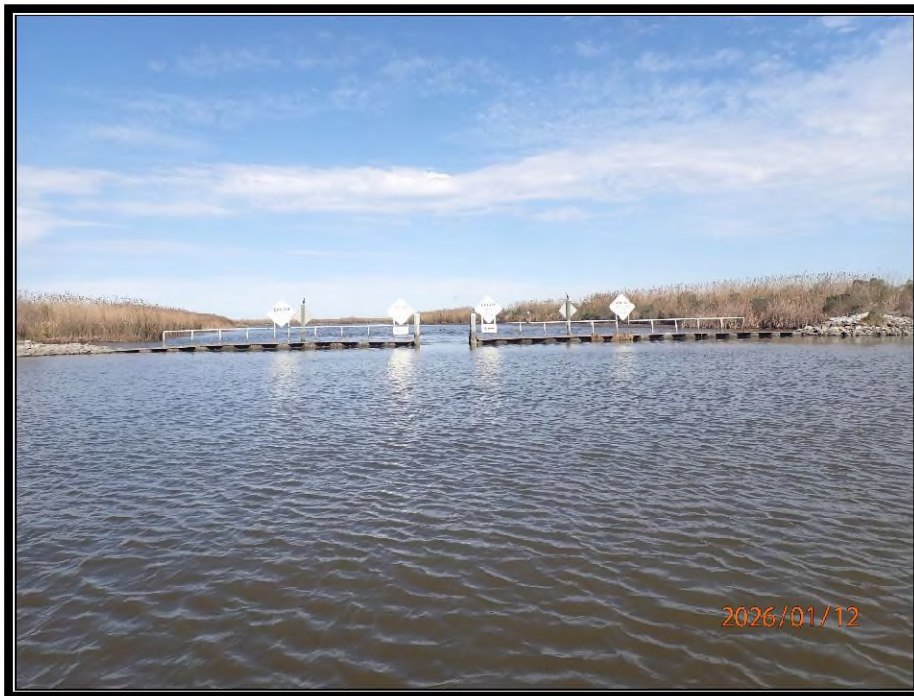
Photo No.10 – overall view of weir structure and signage at Site No.5.

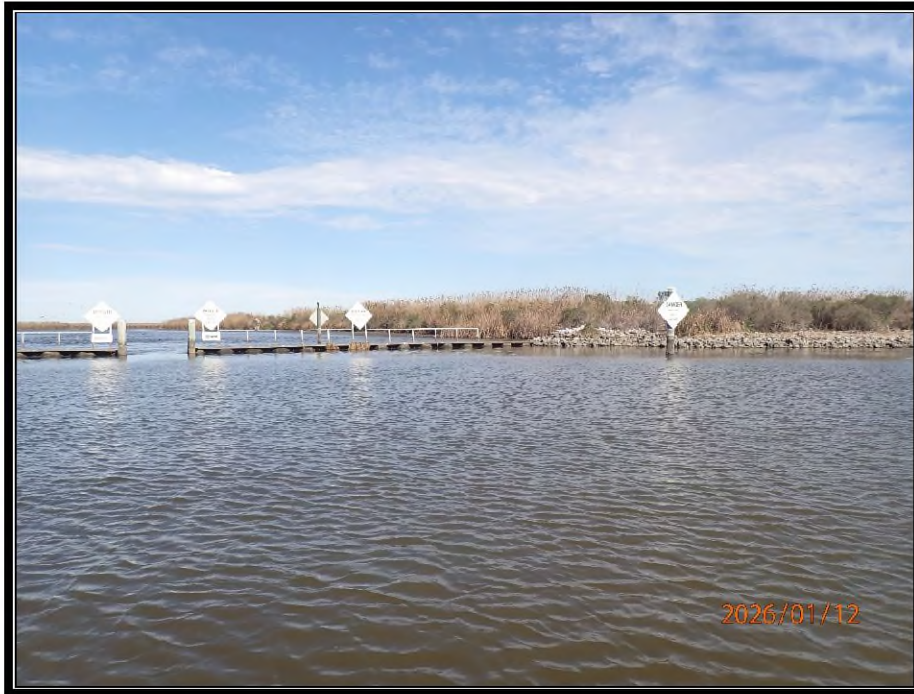
Photo No.11 – Rock dike tie-in to the steel bulkhead weir on the north side of the structure at Site No.5.

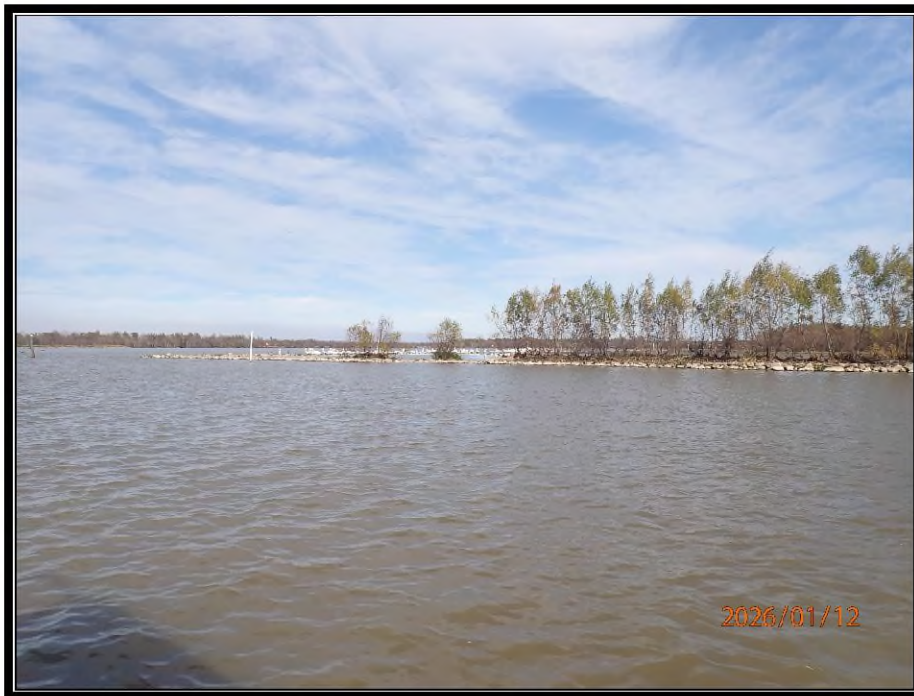
During normal water elevations, the rock dike is barely visible due to the structure settlement over the years. This particular day, the water levels in Bayou Chene were extremely low and the entire rock dike was visible, as well as the marsh creation areas behind the dike. The rock dike stone appeared to be displaced in some areas with vegetation and other debris covering the structure. The west marsh creation area was covered in woody vegetation and trees as well as vegetative debris. The east marsh creation area was more of a marsh grass with visible marsh flats and birds loafing on the flats. There are no plans to refurbish the east or west rock dike sections or nourish the existing marsh since there doesn't appear to be any erosion of the protected marsh behind the structure or major changes since construction was completed.

Photo No.12 – rock dike and marsh creation area along Bayou Chene and Bayou Penchant.

The rock dike containment and fill areas at the intersection of Bayou Penchant and Bayou Chene were in fair condition with minor to moderate settlement of the rock dike and uniform settlement of the both marsh platforms. This area is subject to seasonal high river stages which at times can cover the structures with several feet of water for extended periods of time. The impact of several feet of water over the disposal areas may have accelerated the consolidation of the marsh platform since construction was completed. At this time, we are not recommending an action to add additional material to the marsh creation areas since these areas will likely be underwater for periods of time resulting in constructability issues, as well as increased consolidation of any new material placed in these locations. Although the rock containment dike has settled since construction, it is still providing protection to the marsh creation areas. The project team will continue to monitor the condition of the dike and fill areas and make appropriate recommendation for maintenance as needed. Further discussions with NRCS will be required prior to pursuing action on marsh re-nourishment or dike restoration.

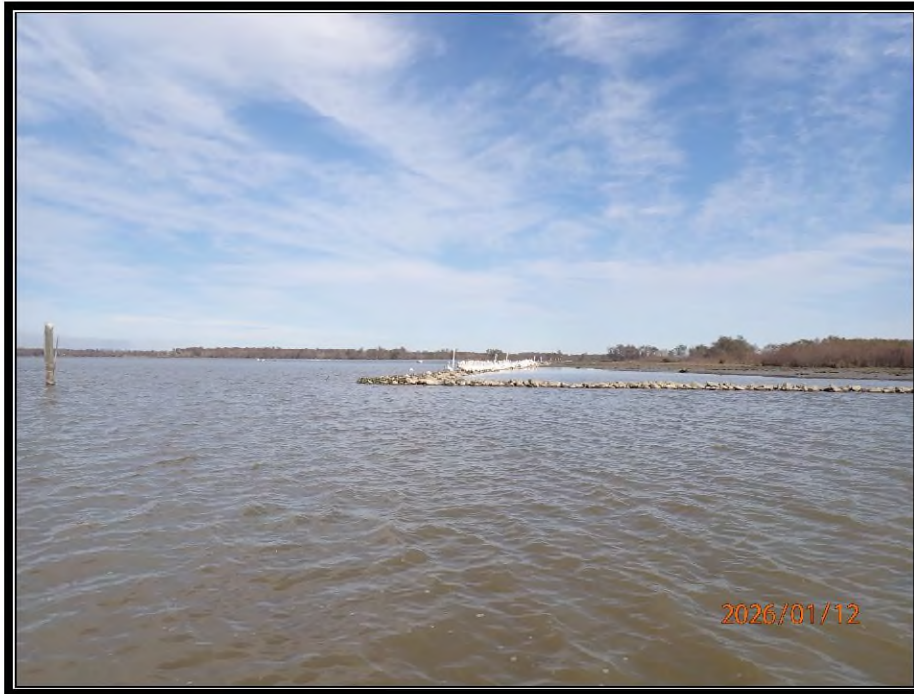
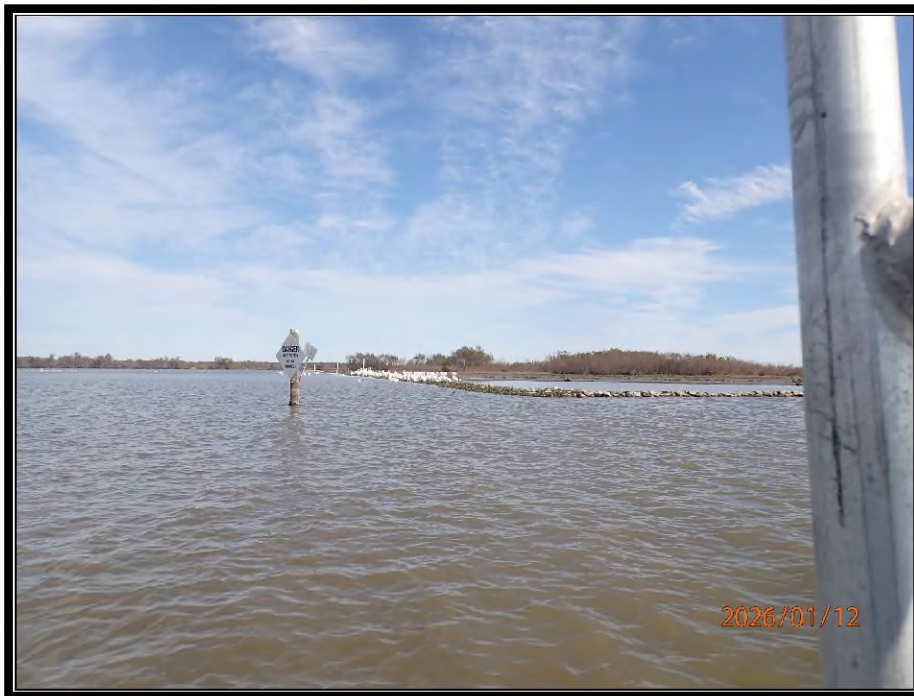
Photo No.13 - rock dike and marsh creation area along Bayou Chene on east side of Bayou Penchant.

Photo No.14 - rock dike and marsh creation area along Bayou Chene on east side of Bayou Penchant.

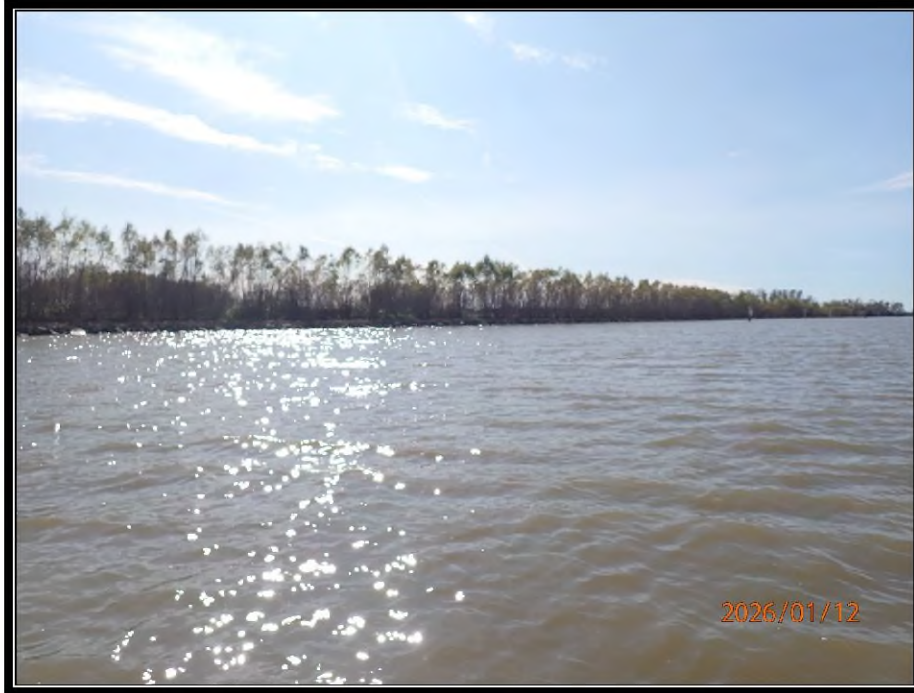
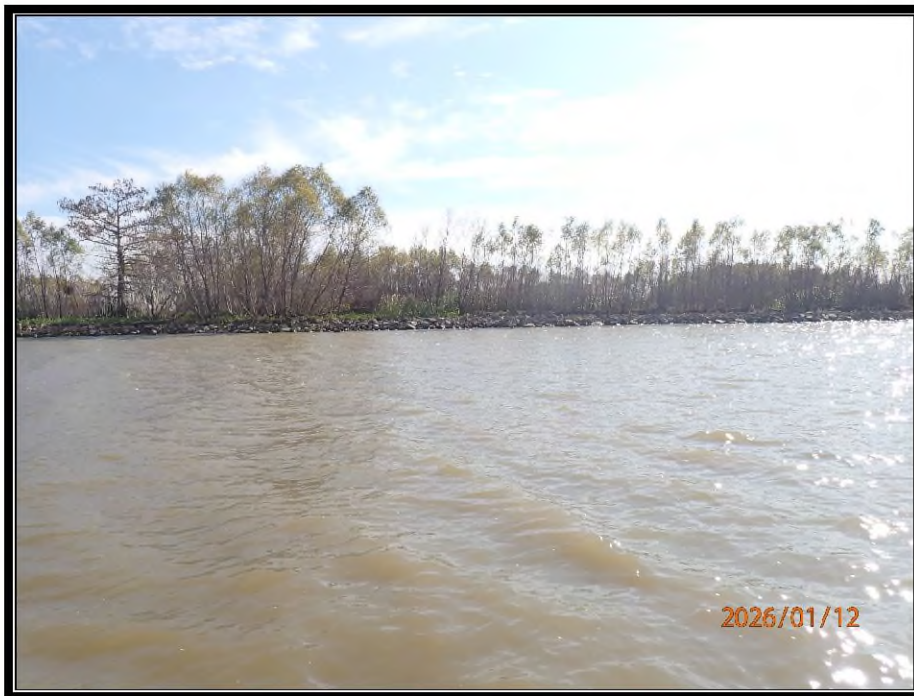
Photo No.15 - rock dike and marsh creation area along Bayou Chene on west side of Bayou Penchant.

Photo No.16 - rock dike and marsh creation area along Bayou Chene on west side of Bayou Penchant.
