## **2014 Operations, Maintenance, and Monitoring Report**

### **Boston Canal/Vermilion Bay Shoreline Stabilization Project (TV-09)**

State Project Number TV-09  
Priority Project List 2

June 2014  
Vermilion Parish

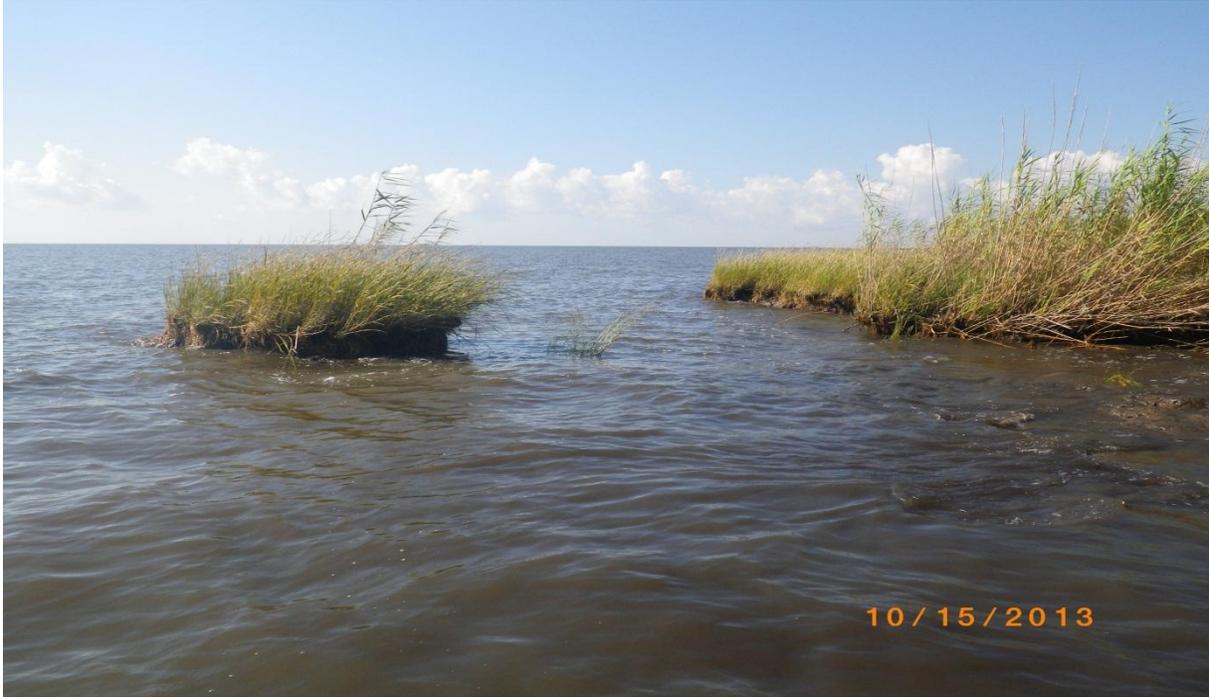
**Figure 12.** During the DGPS shoreline survey this broken and detached portion of the *Spartina alterniflora* hedgerow in the center of the project shoreline was noted.

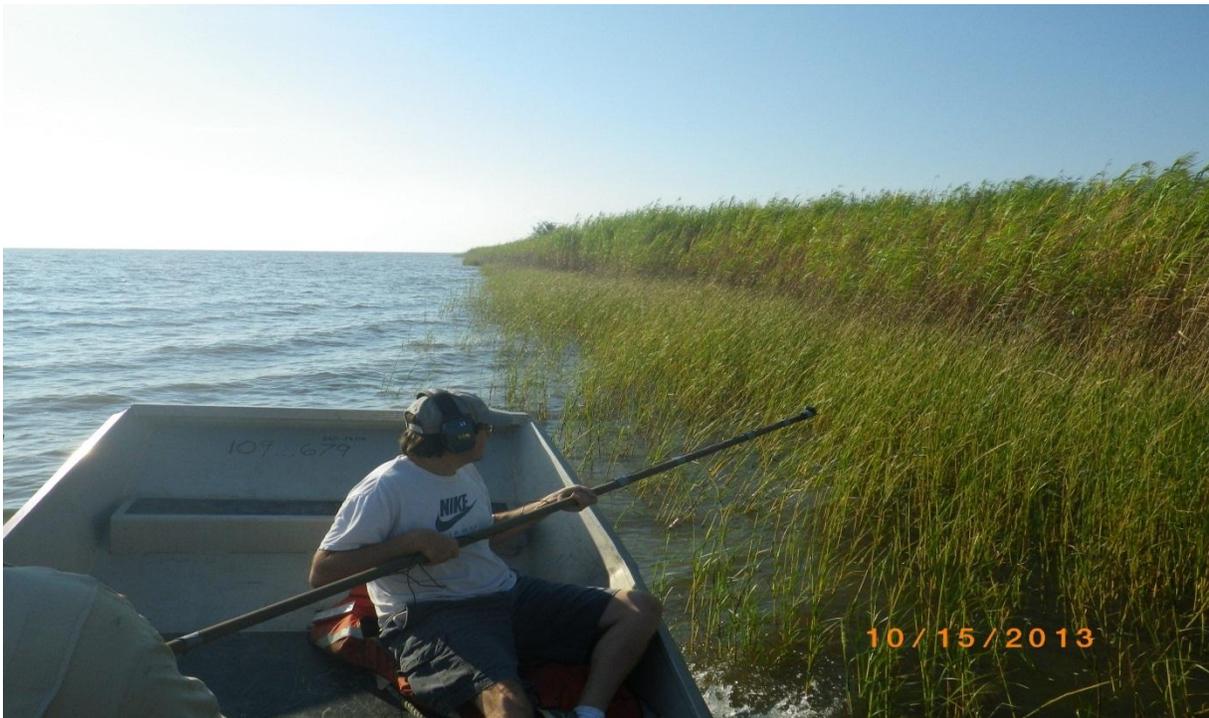
**Figure 13.** During the DGPS shoreline survey this very intact portion of the planting area on the north south oriented shoreline was noted.

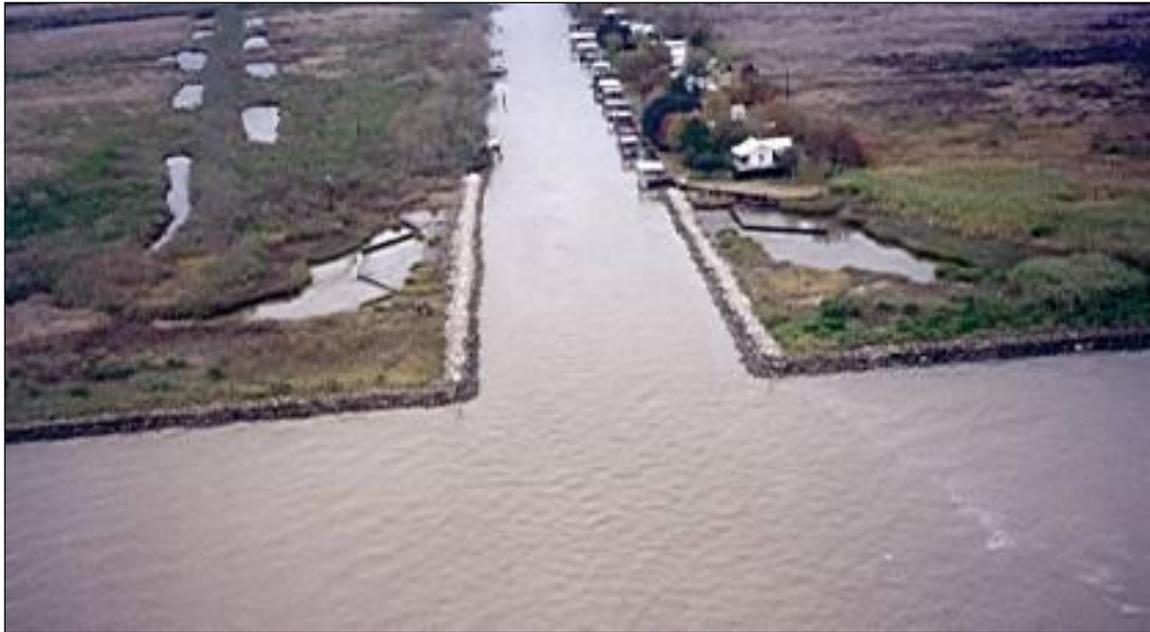
**Figure 19.** Boston Canal/Vermilion Bay Shoreline Stabilization (TV-09) rock dike and sediment fences at the mouth of Boston Canal (January 2001).

Sediment fences inhibited even distribution of sediment behind the rock breakwaters. After the geocloth-covered wire on the sediment fencing was removed by NRCS personnel it allowed the sediment to be more evenly distributed into the open water areas behind the rock dike. The use of sediment fences is not necessary behind rock breakwaters.

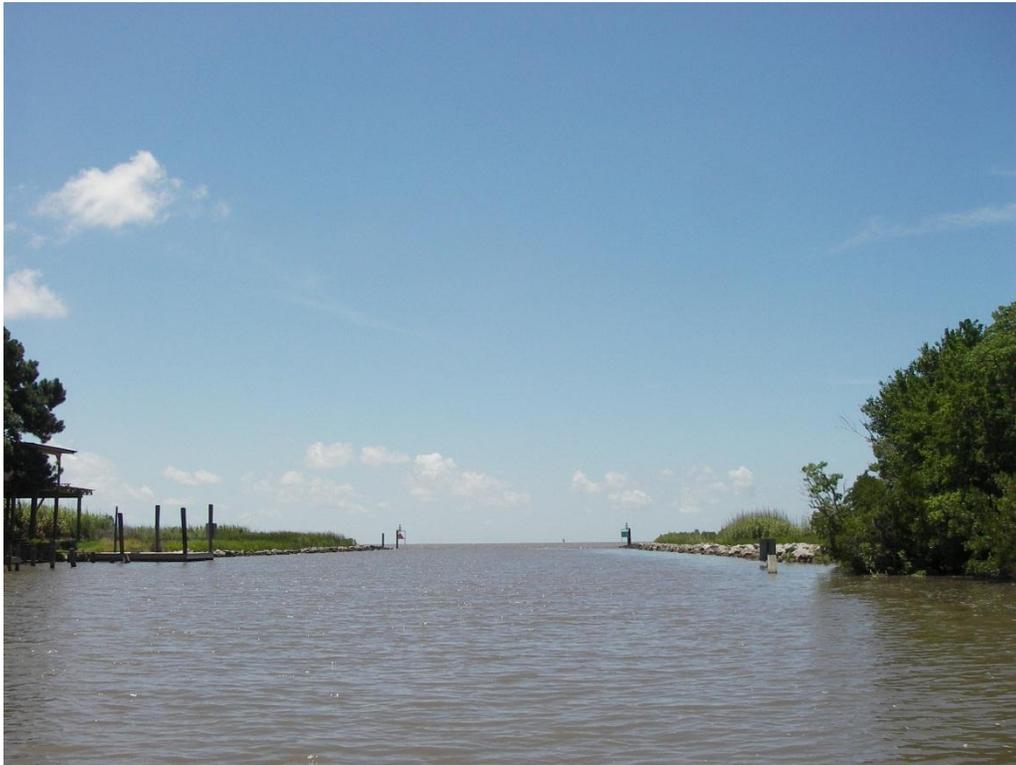
The rock dikes are in excellent condition. The Vermilion Bay shoreline erosion to the west and east of the rock dike tie-ins continue at average annual rates but have not worsened. Sediment accretion behind the rock dikes continues and approximately 90% of the open water area between the dikes and existing shoreline have filled-in and become emergent marsh. It was noted during previous inspections that a small gap left on the western tie-in during the original construction has increased in size and substantially separated from the existing shoreline. The eastern tie-in has also moderately separated from the existing shoreline due to ongoing shoreline recession. NRCS and CPRA agree that a maintenance event be performed to extend the rock dike on both the western and eastern sides of Boston Canal prior to the end of life of this project in October 2015. The west and east day markers installed as part of the TV-09 project are missing; however, the pilings remain. Additional day/night markers have been installed by others. (Photos: Appendix A, Photos 1 - 5)

**Photo No. 1, View of Boston Canal Looking South into Canal**

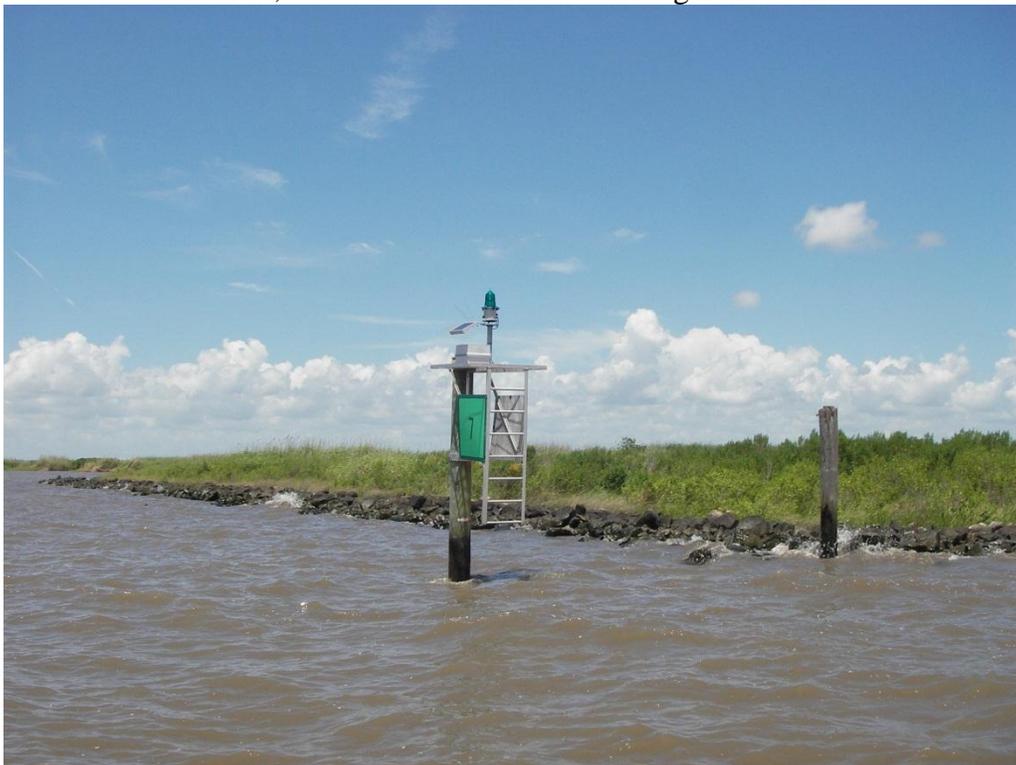
The shoreline plantings were not inspected on this trip. The vegetation in the area adjacent to the mouth of the Boston Canal, including the vegetation behind the rock dikes, is in good condition. (Photos: Appendix A, Photo 2-6)

**Photo No. 2, Rock Dike along the Bay Shore Looking West, Vegetation behind Rock**

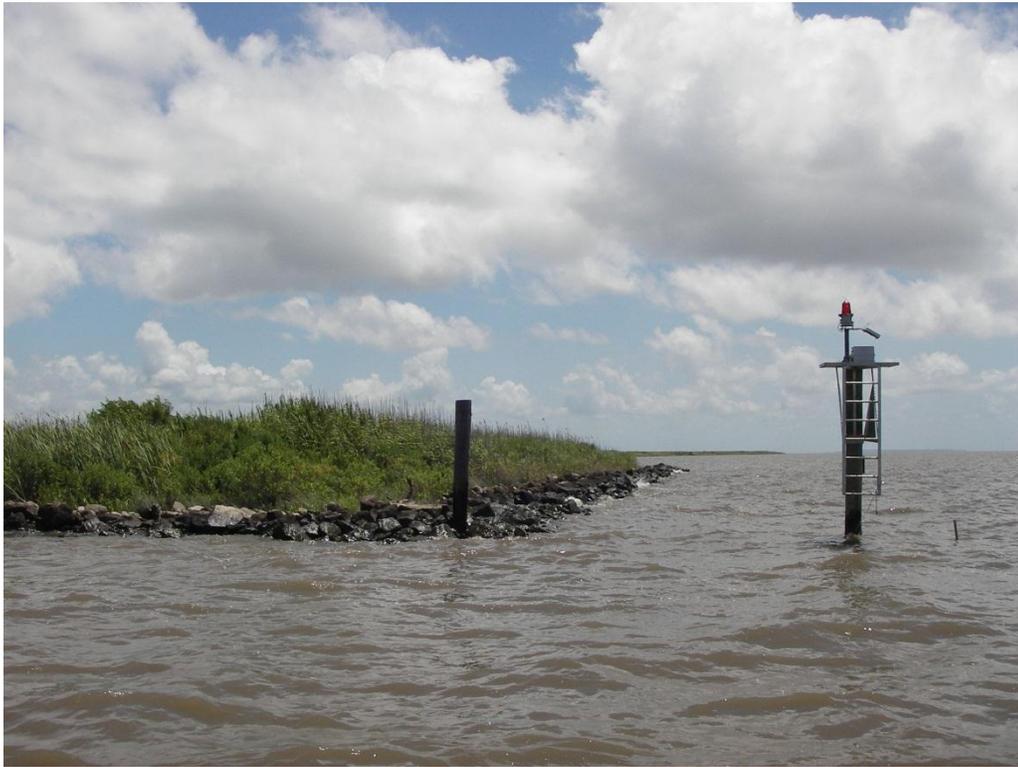
**Photo No. 3, View of East Rock Dike, Vegetation, and Signs**

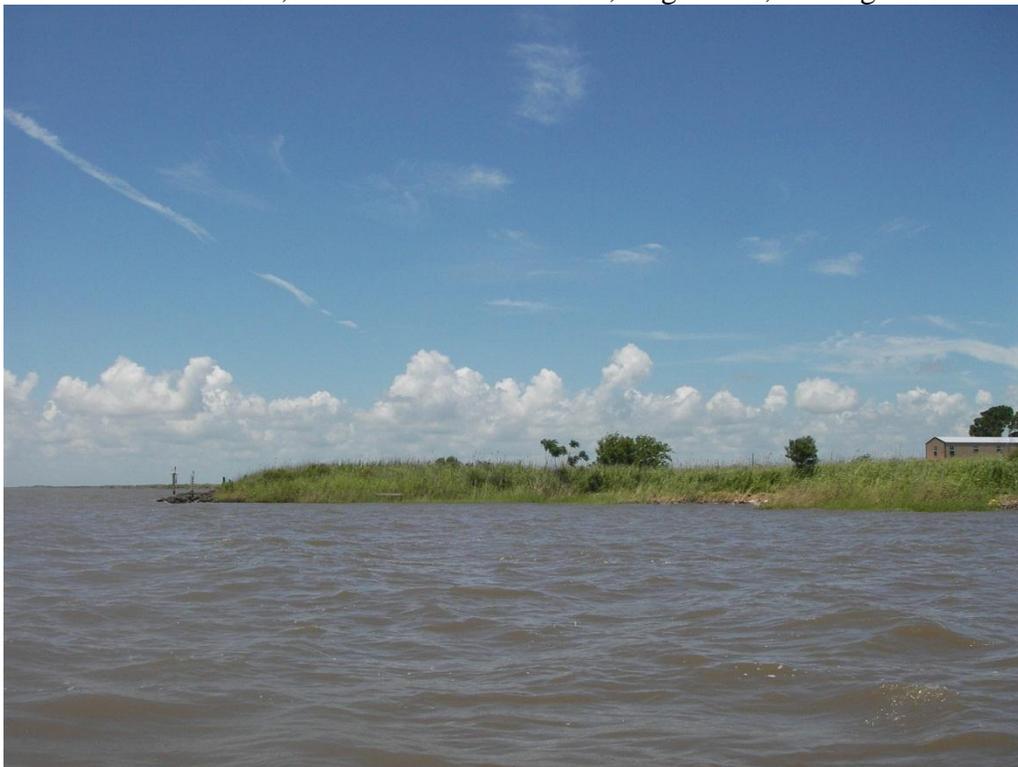
**Photo No. 4, Proposed East Tie In at Shoreline**

- Survey the western and eastern sides of Boston Canal to design a rock dike extension (765 linear feet total) to tie into the existing marsh shorelines.
- Prepare a funding request for the Fall CWPPRA Technical Committee meeting.

Extend the rock foreshore dike on both the western and eastern sides of Boston Canal prior to the end of life of this project in October 2015.

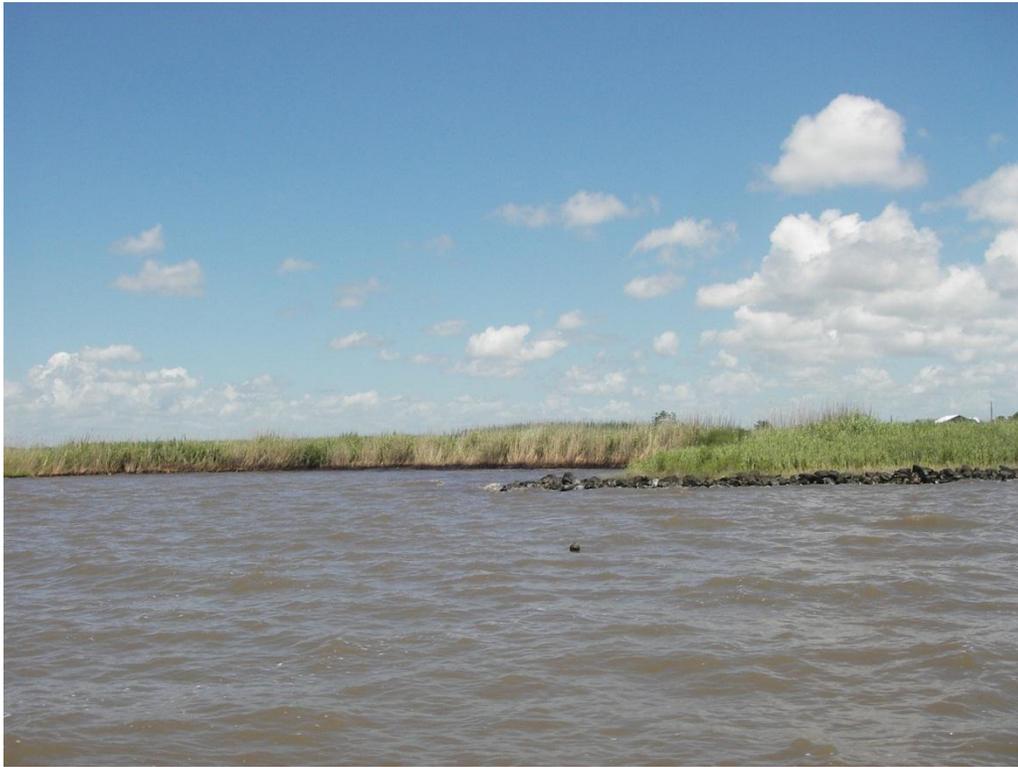
**Photo No. 5, Proposed West Tie In at Shoreline**

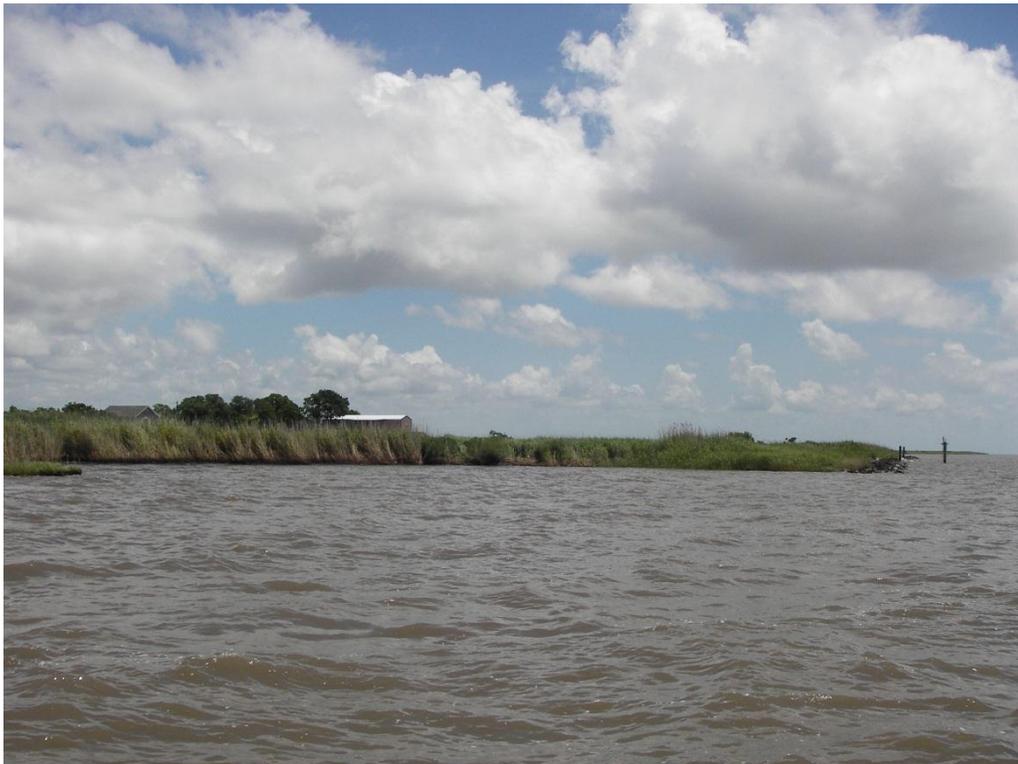
The sediment fencing was removed in 2002 as stated in Section II.d above. Vegetation has established between the rock dikes and previously existing shoreline. (Photos: Appendix A, Photos 1 - 6)

**Photo No. 6 Vegetation Behind Rock Dike, West Side**
