2016 Operations, Maintenance, and Monitoring Report

Little Vermilion Bay Sediment Trapping

State Project Number TV-12
Priority Project List 5

June 2016
Vermilion Parish

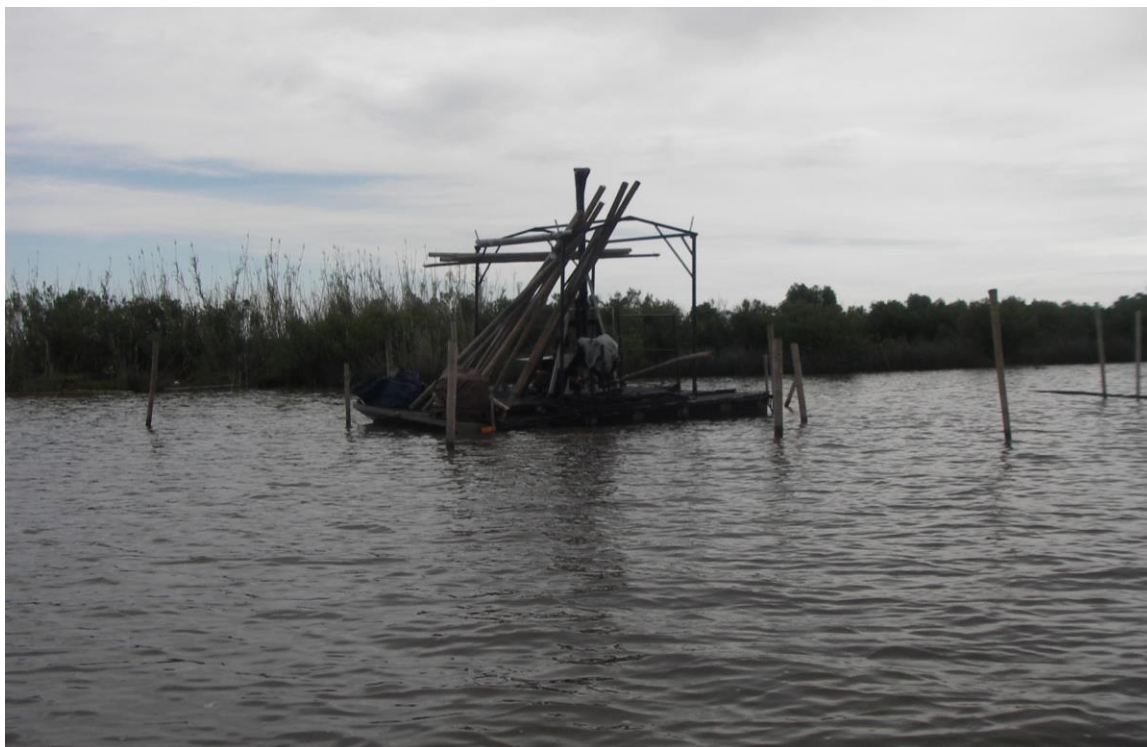
Photo No. 1—Bayou Backer installation equipment (2016)

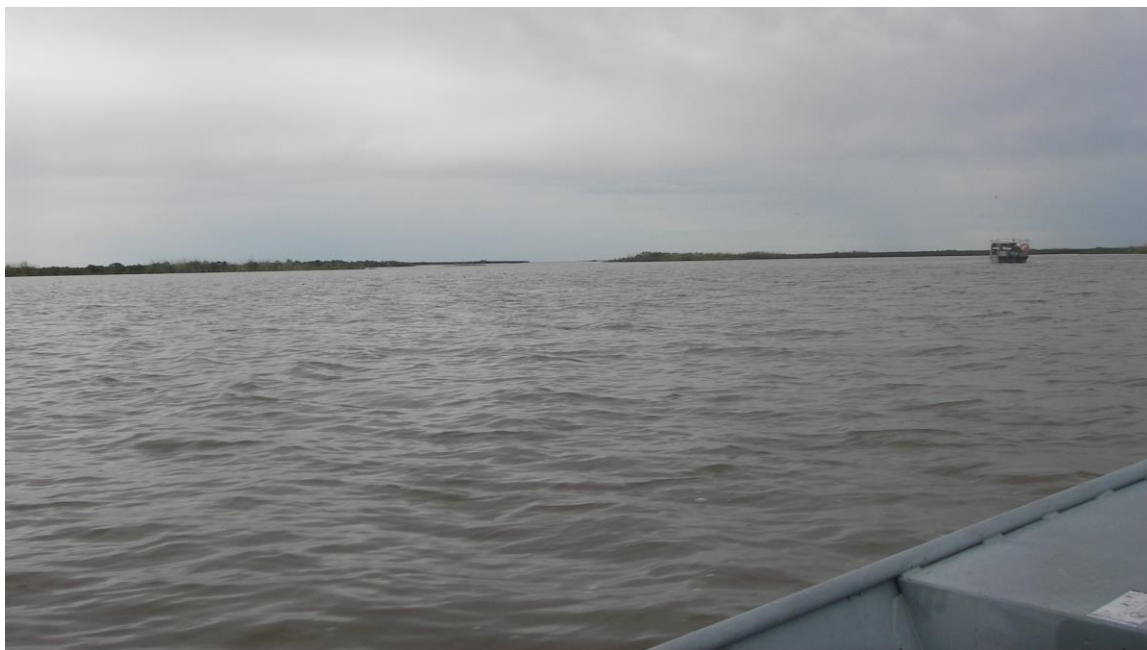
The terraces appear to be in excellent condition. The opening to the terrace field at the intersection of Little Vermilion Bay and Freshwater Bayou continues to widen. The erosion of terraces nearest Freshwater Bayou, however, has not gotten significantly worse. Bayou Backer Erosion Control has begun installing their product around the inside points of the two terraces closest to Freshwater Bayou, but installation is moving very slowly. Protected terraces continue to provide protection from waves allowing sediment delivered through the channels to continue to accrete. Planting of bullwhips performed by others in the areas between the terraces continues to expand. Submerged and emergent vegetation is evident throughout the project area. Narrowing the opening to Freshwater Bayou should still be considered as a way to protect this developing marsh. (Photos: Appendix A, Photos 1-5)

Photo No. 2—terrace field view from opening at Freshwater Bayou (2016)

The opening at Freshwater Bayou continues to expand. Limiting the widening of Freshwater Bayou into the terrace field should be considered.

The armoring of the southernmost terraces in the project area and reducing the opening at Freshwater Bayou Canal would likely lead to an extended functional project life and enhanced project performance over the life of the project. Sacrificial terraces built at the perimeter of a terrace field when exposed to wind and wave energy are designed to fail, but once this has occurred the next group of non-sacrificial terraces is subjected to these forces and will also fail. By armoring the outer terraces the project features are allowed to function as designed unaffected by the exterior wave energies.

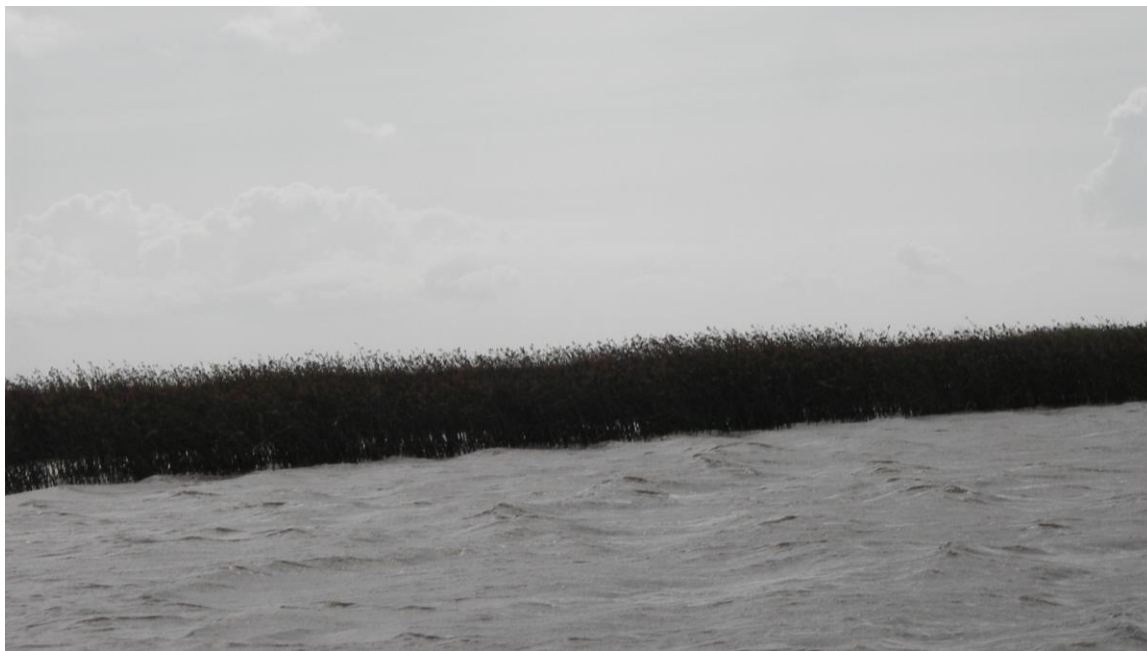
Vegetation continues to expand from the original plantings and appears strong. Native emergent vegetation between the terraces has become established and should continue to expand with the additional protection provided by the plants mentioned above.

Photo No. 3—bullwhip plantings between terraces (2014)

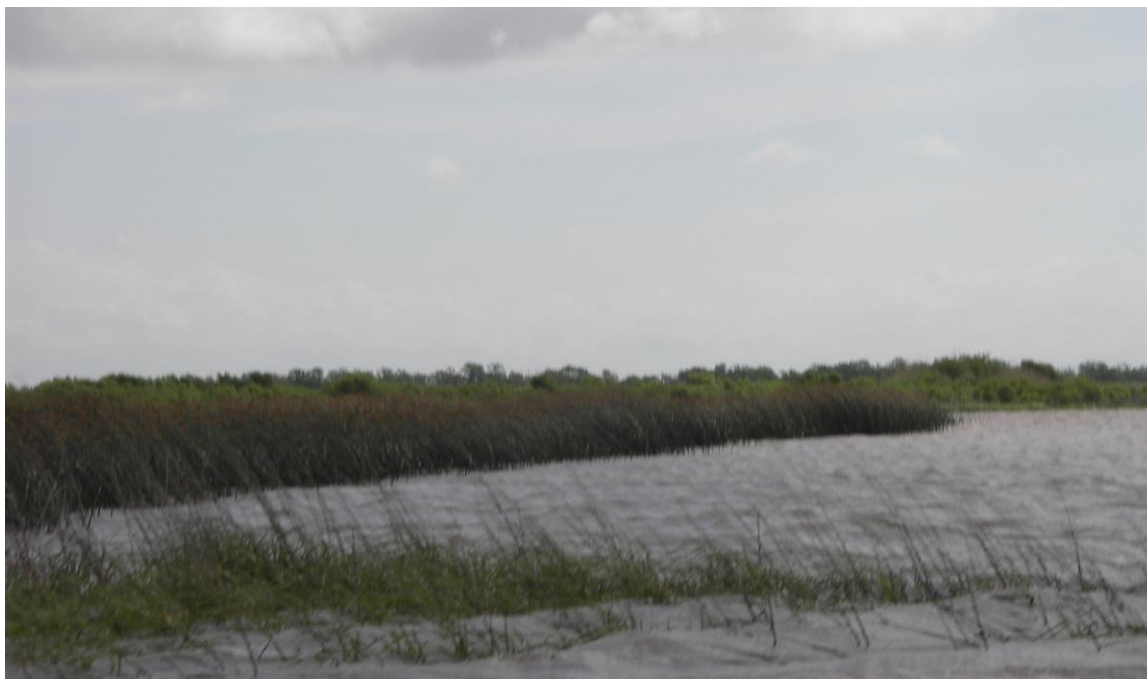
Photo No. 4—Emergent vegetation (2014)

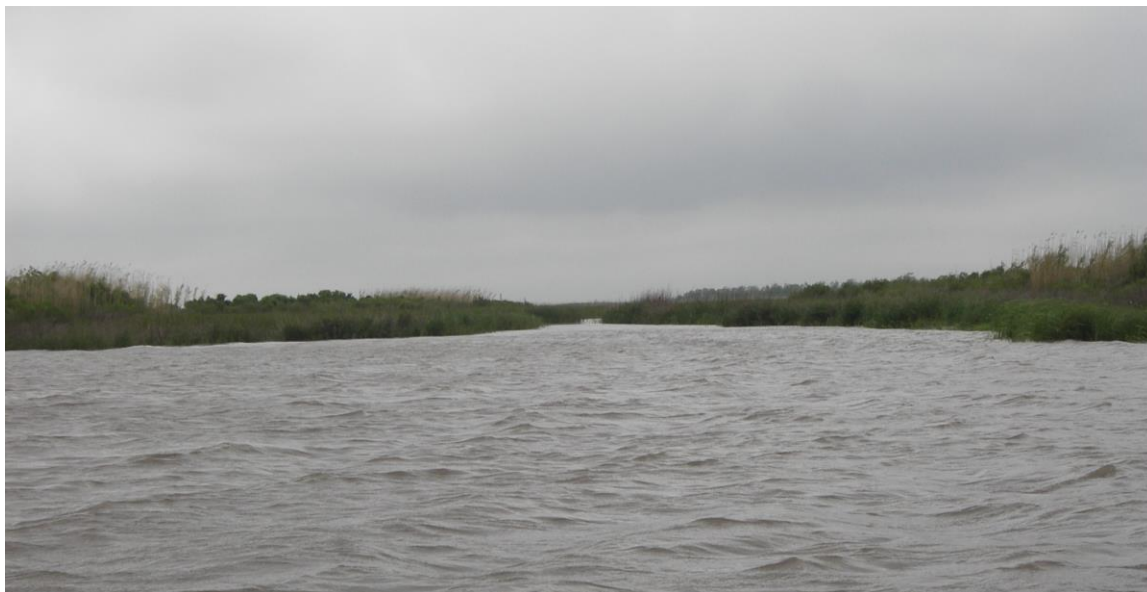
Photo No. 5—vegetation growing between terraces (2013)
