**2014/2015 Annual Inspection
Report**

**MARSH ISLAND HYDROLOGIC
RESTORATION PROJECT
(TV-14)**

State Project Number TV-14
Priority Project List 6

June 25, 2015
Iberia Parish

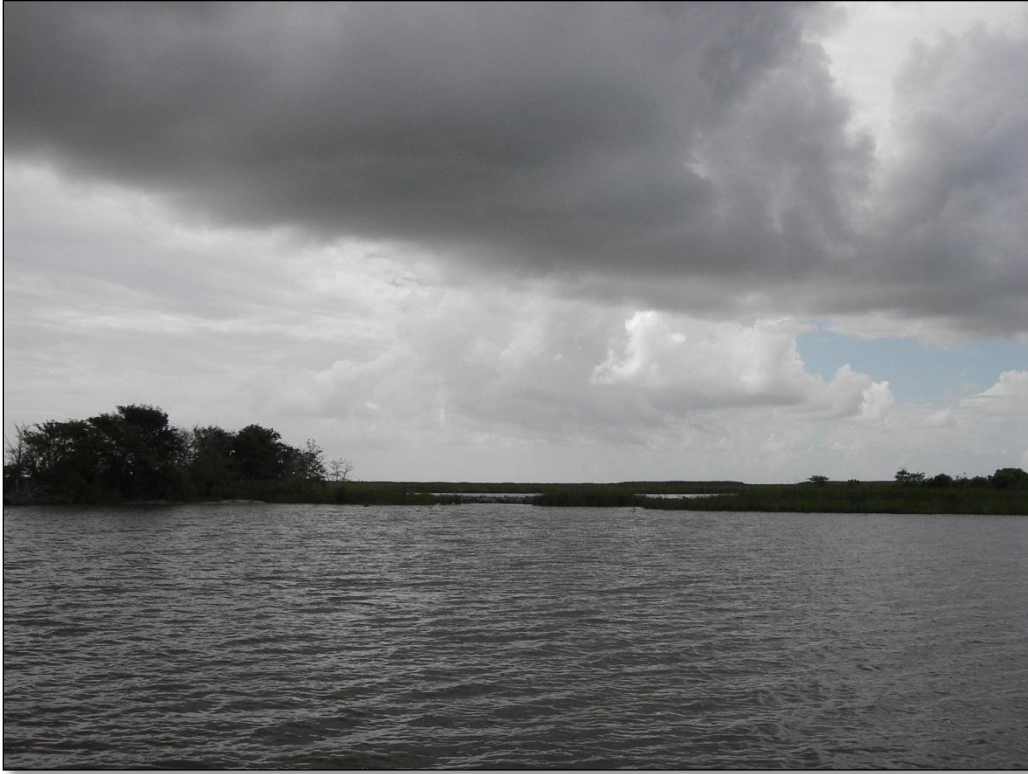
Photo No. 1, Closure No. 1

The erosion problems and Hurricane Rita damages have been repaired through the recent maintenance project that was completed in February 2009. The dike was capped and bank paving installed on both ends of the closure. This site is in good condition since this work was performed. (Photos: Appendix B, Photo 1).

Item	Condition	Physical Damage	Corrosion	Photo #	Observations and Remarks
Steel Bulkhead / Caps	N/A				
Steel Grating	N/A				
Stop Logs	N/A				
Hardware	N/A				
Timber Piles	N/A				
Timber Wales	N/A				
Galv. Pile Caps	N/A				
Cables	N/A				
Signage / Supports	N/A				
Rip Rap (fill)	Good			1	The site is in good condition.
Earthen Embankment	N/A

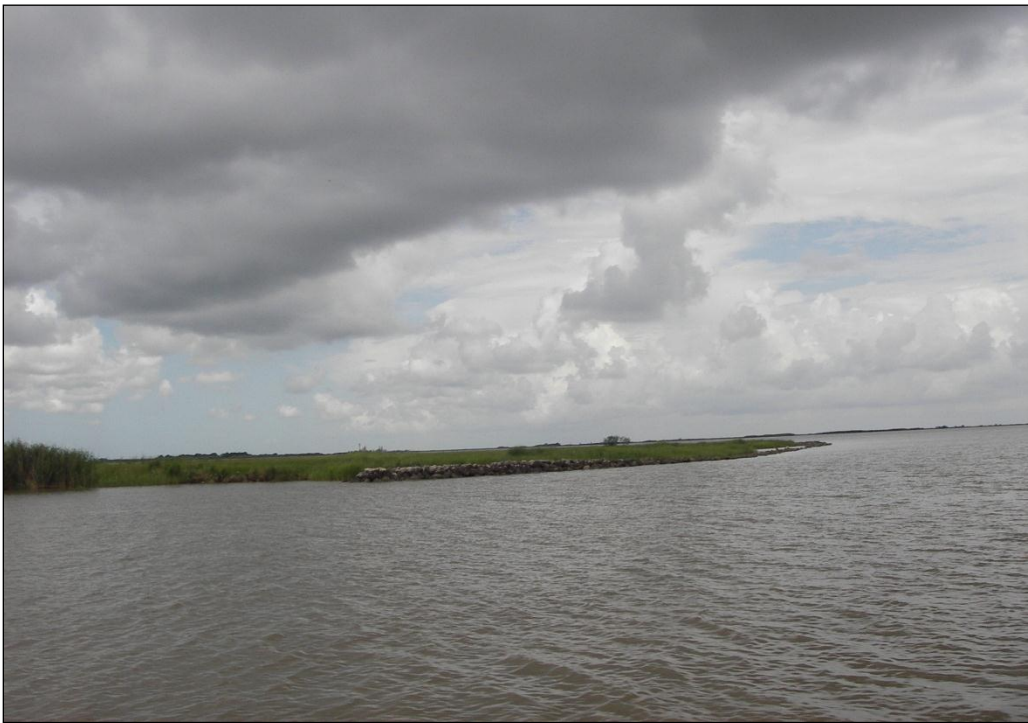
Photo No. 2, Closure No. 7

This closure site is in good condition and spoil material from the dredging of the north-south canal in 2008 was placed along the eastern end of the rock dike in an effort to stabilize this section of shore. In addition dredge spoil material was pumped behind the rock dike as part of this same access dredging and a small area of marsh creation was formed which is now starting to vegetate. There is some settlement along two (2) 150 foot lengths of the rock dike. (Photos: Appendix B, Photo 2).

Item	Condition	Physical Damage	Corrosion	Photo #	Observations and Remarks
Steel Bulkhead / Caps	N/A				
Steel Grating	N/A				
Stop Logs	N/A				
Hardware	N/A				
Timber Piles	N/A				
Timber Wales	N/A				
Galv. Pile Caps	N/A				
Cables	N/A				
Signage / Supports	N/A				
Rock Dike	Good			2	The site is in good condition.
Earthen Embankment	N/A

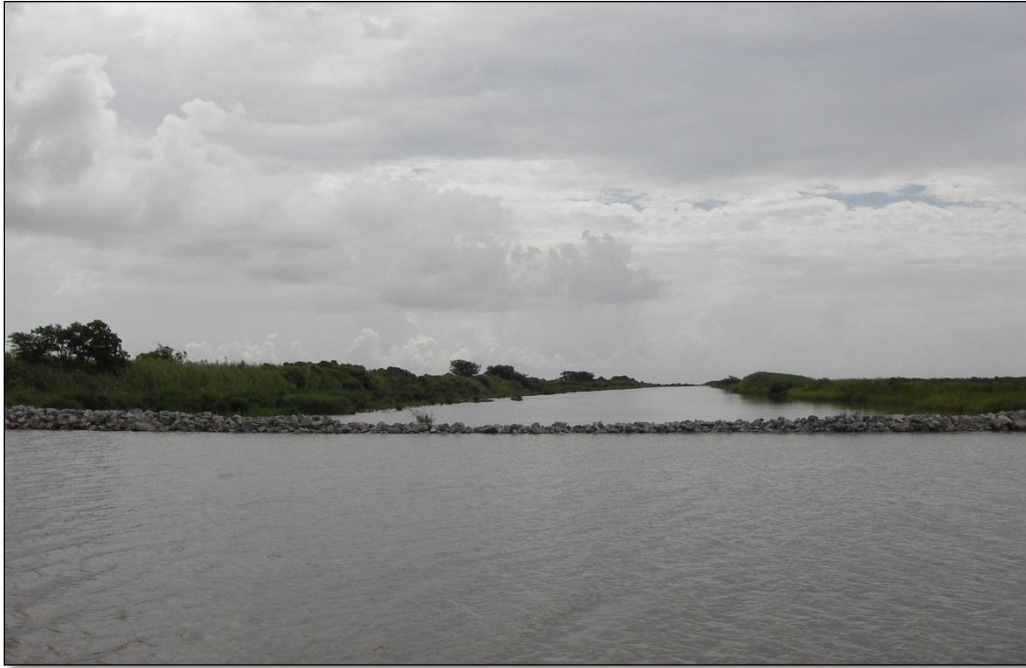
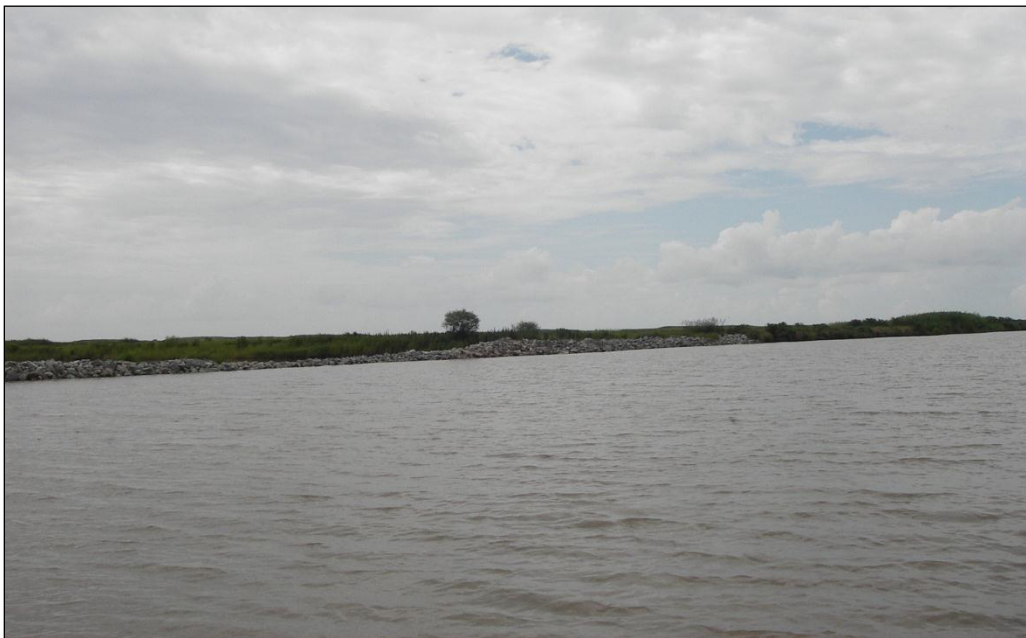
A maintenance event on the adjacent TV-21 project required the closure to be removed for access. At the conclusion of the TV-21 maintenance event, the contractor replaced the closure and added additional rock to repair the breach. There has been some settlement at the canal opening. (Photos: Appendix B, Photos 3 & 4).

Item	Condition	Physical Damage	Corrosion	Photo #	Observations and Remarks
Steel Bulkhead / Caps	N/A				
Steel Grating	N/A				
Stop Logs	N/A				
Hardware	N/A				
Timber Piles	N/A				
Timber Wales	N/A				
Galv. Pile Caps	N/A				
Cables	N/A				
Signage / Supports	N/A				
Rock Plug	Good			3,4	Breach on southern end of closure was repaired in conjunction with TV-21 maintenance event.
Earthen Embankment	N/A

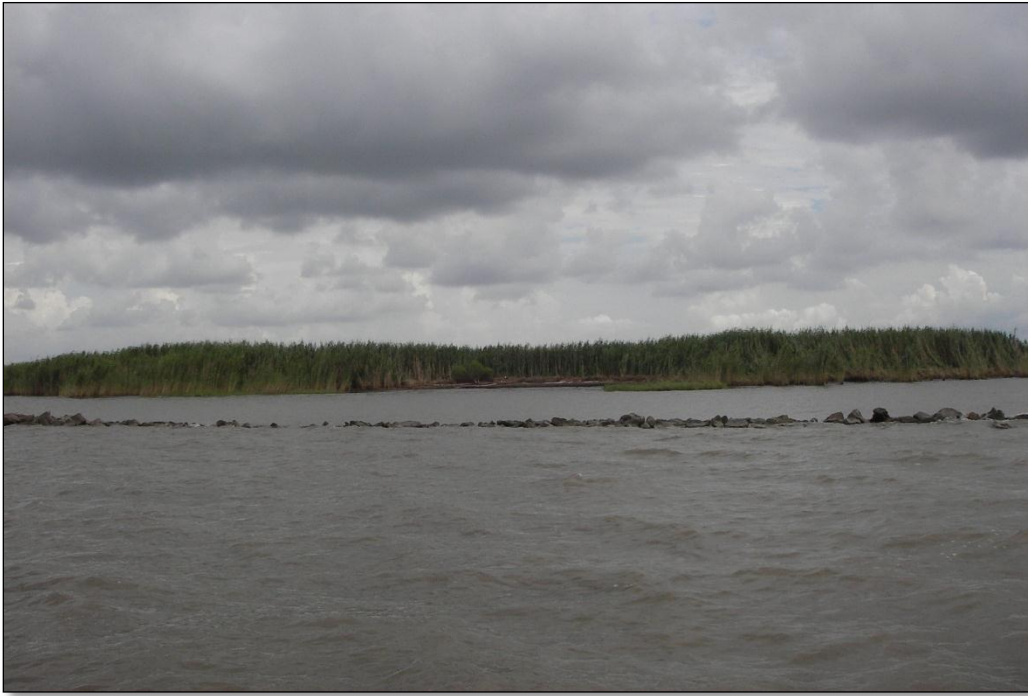
Photo No. 5, Closure No. 9

The rock riprap shoreline protection dike constructed on the south shoreline of Marsh Island was noted to now sit out further into the waters of the Gulf as discussed in the last inspection. Conditions were such that the feature was functioning well and that sediment had accreted and a growth of marsh vegetation had extended over the new fill. This rock shoreline feature will still function as a breakwater and extend the life of the earthen pipeline closure to the north. The recent construction of the TV-21 East Marsh Island Marsh Creation project has helped to reinforce the breach that had occurred on the southeast corner of the pipeline canal since the last inspection. The pipeline canal north of the rock breakwater was filled in with sediment from the marsh creation project and construction of containment dikes have now closed off the breach at the shoreline. No maintenance will be necessary at closure No. 9 as a result of the work performed through the TV-21 project. (Photos: Appendix B, Photo 5).

Item	Condition	Physical Damage	Corrosion	Photo #	Observations and Remarks
Steel Bulkhead / Caps	N/A				
Steel Grating	N/A				
Stop Logs	N/A				
Hardware	N/A				
Timber Piles	N/A				
Timber Wales	N/A				
Galv. Pile Caps	N/A				
Cables	N/A				
Signage / Supports	N/A				
Rock Dike	Fair			5	Dike is settling in some areas. Breach is closed and shoreline looks good since the TV-21 project.
Earthen Embankment	N/A
