## **2014 Operations, Maintenance, and Monitoring Report**

### **Marsh Island Hydrologic Restoration**

State Project Number TV-14  
Priority Project List 6

June 2014  
Iberia Parish

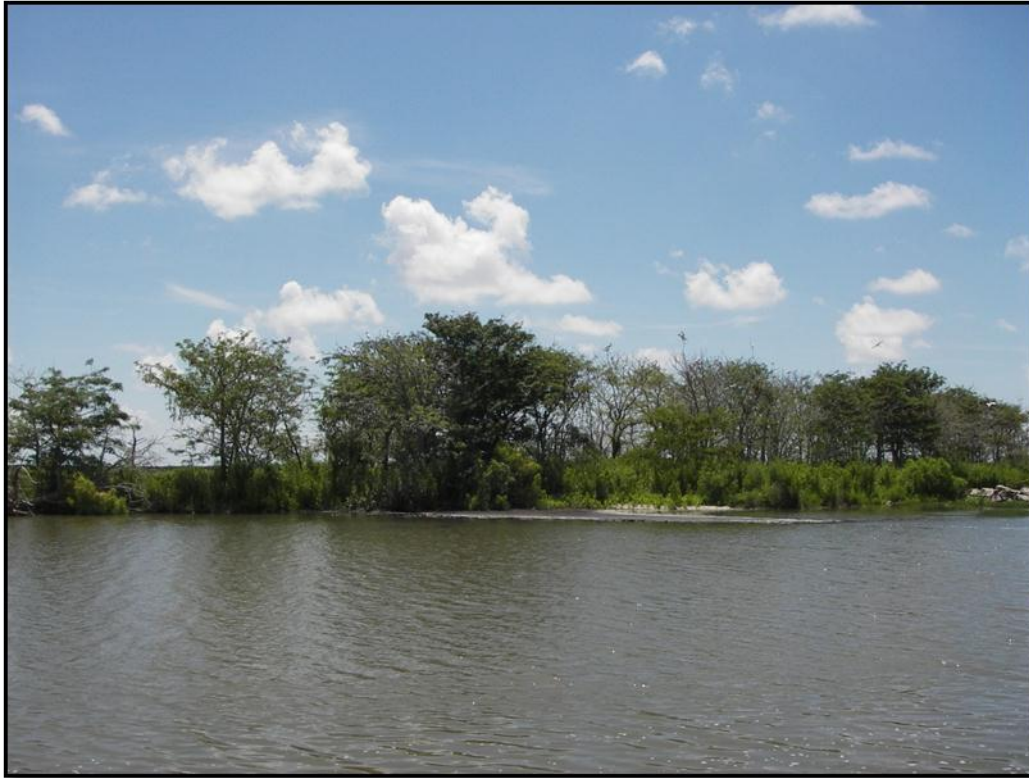
The erosion problems and Hurricane Rita damages have been repaired through the recent maintenance project that was completed in February 2009. The dike was capped and bank paving installed on both ends of the closure. This site is in good condition since this work was performed. (Photos: Appendix A, Photo 1 & 2).

**Photo No. 1**, Eastern End of Closure No. 1

Item	Condition	Physical Damage	Corrosion	Photo #	Observations and Remarks
Steel Bulkhead / Caps	N/A				
Steel Grating	N/A				
Stop Logs	N/A				
Hardware	N/A				
Timber Piles	N/A				
Timber Wales	N/A				
Galv. Pile Caps	N/A				
Cables	N/A				
Signage / Supports	N/A				
Rip Rap (fill)	Good			1,2	The site is in good condition.
Earthen Embankment	N/A

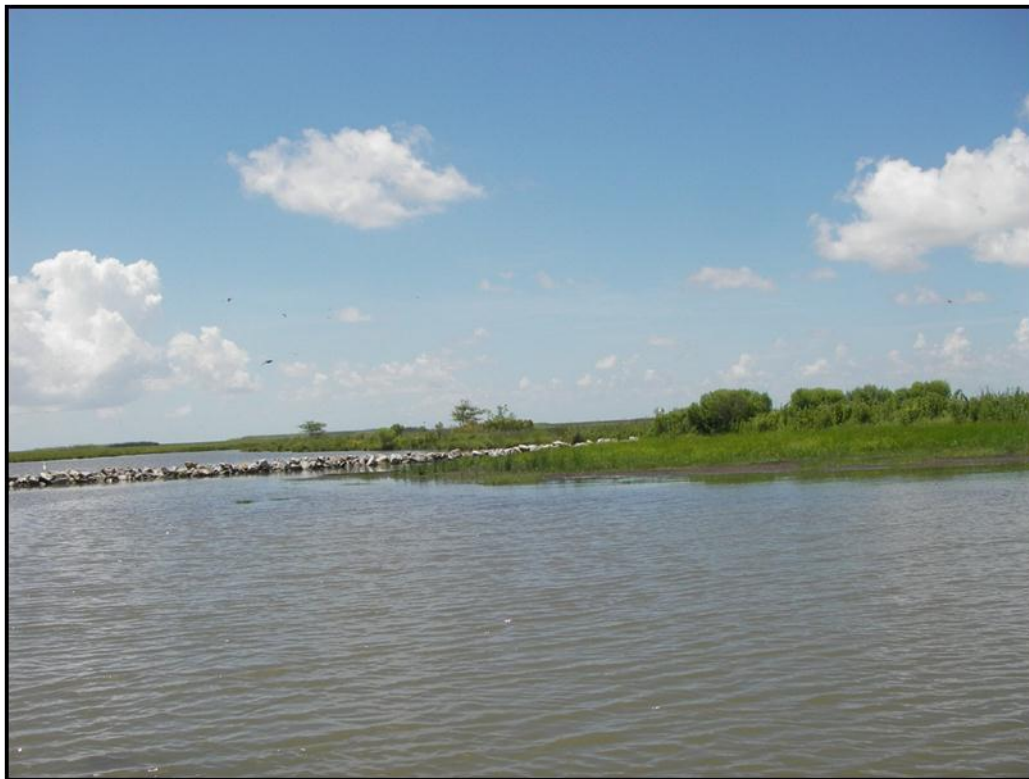
**Photo No. 2**, Western End of Closure No. 1

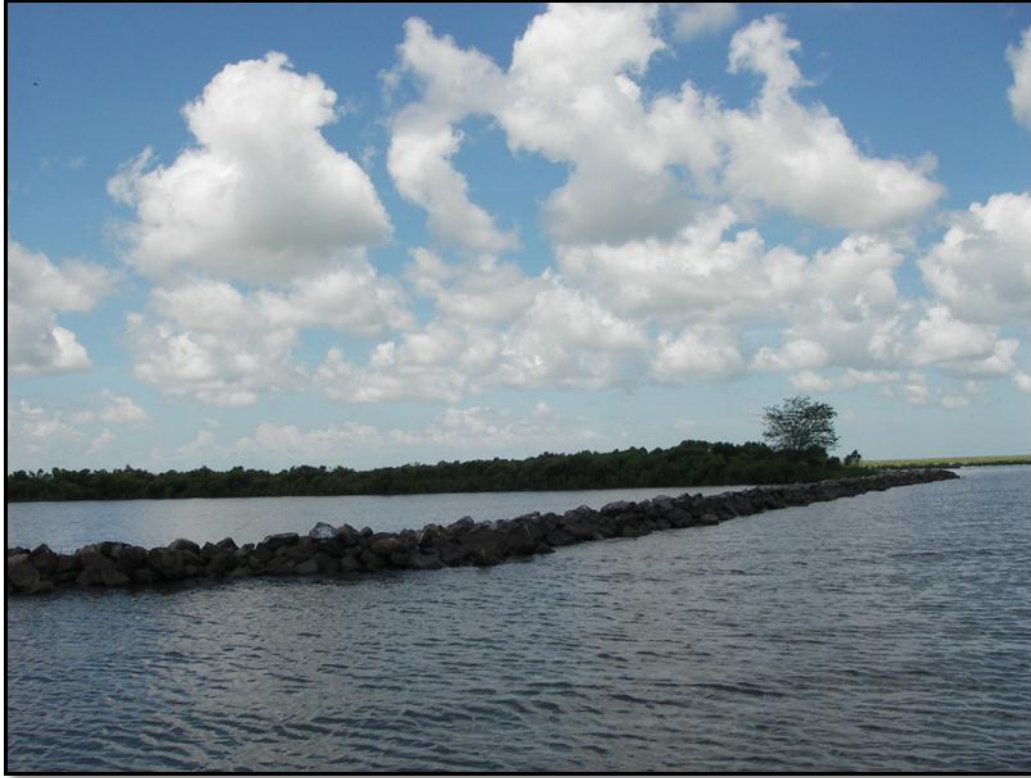
The dike was capped and bank paving installed as noted above and is in good condition since the work was performed. (Photos: Appendix A, Photo 3).

**Photo No. 3, Closure No. 2**

Item	Condition	Physical Damage	Corrosion	Photo #	Observations and Remarks
Steel Bulkhead / Caps	N/A				
Steel Grating	N/A				
Stop Logs	N/A				
Hardware	N/A				
Timber Piles	N/A				
Timber Wales	N/A				
Galv. Pile Caps	N/A				
Cables	N/A				
Signage / Supports	N/A				
Rip Rap (fill)	Good			3	The site is in good condition.
Earthen Embankment	N/A

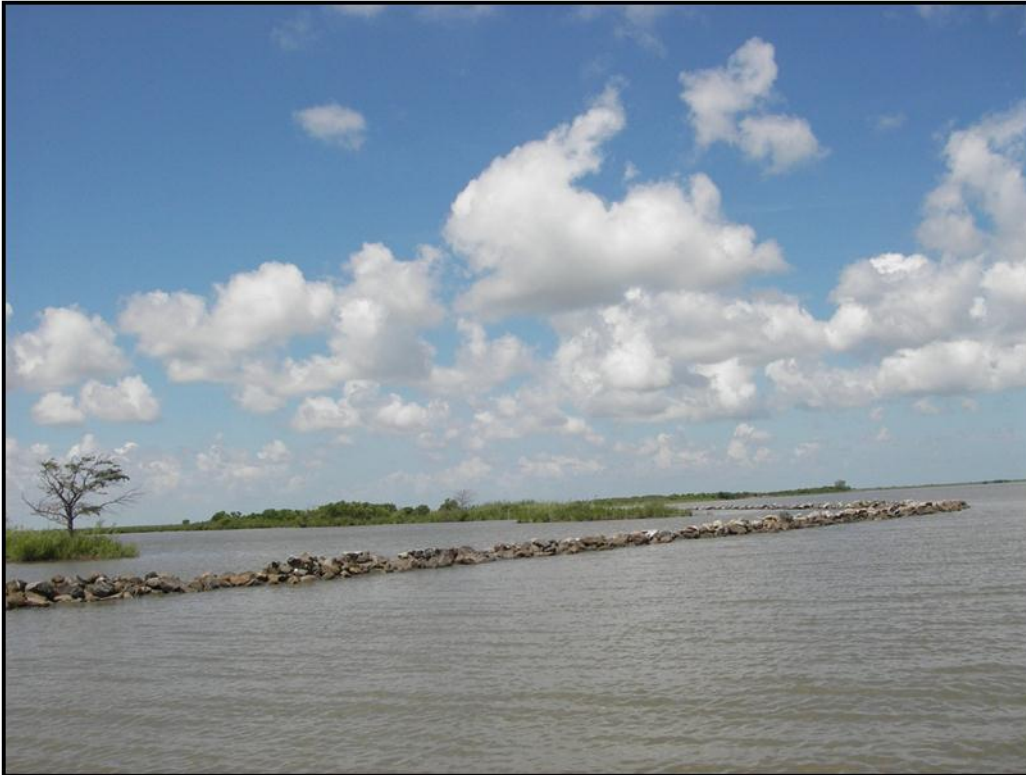
The rock closure dike appears in good condition and was extended on the western end along with installing bank paving during the recent maintenance event. Also, it was observed (and confirmed with aerial photography post Hurricane RITA) that a large open water area has developed within the marsh near the western terminus of Closure No. 3 and that the bankline between that point and the eastern end of Closure No. 2 has eroded very severely and such that the “landbridge” between Vermilion Bay on the north of Marsh Island and the northwestern portion of Lake Sand proper is now narrow and may become subject to breaching thus allowing an undesirable water connection between the two bodies of water. CPRA and COE agree that this area is in poor condition and should be considered for maintenance. It is recommended that an additional reach of shoreline protection dike be constructed, an estimated 1,500 to 1,800 linear feet, to connect the western end of Closure No. 3 to the eastern end of Closure No. 2. The estimated cost for rock dike and flotation is approximately \$1,250,000. (Photos: Appendix A, Photos 4 & 5).

**Photo No. 4, Closure No. 3**

Item	Condition	Physical Damage	Corrosion	Photo #	Observations and Remarks
Steel Bulkhead / Caps	N/A				
Steel Grating	N/A				
Stop Logs	N/A				
Hardware	N/A				
Timber Piles	N/A				
Timber Wales	N/A				
Galv. Pile Caps	N/A				
Cables	N/A				
Signage / Supports	N/A				
Rip Rap (fill)	Good			4,5	Thin strip of land on the eastern side of the closure is cause for concern.
Earthen Embankment	N/A

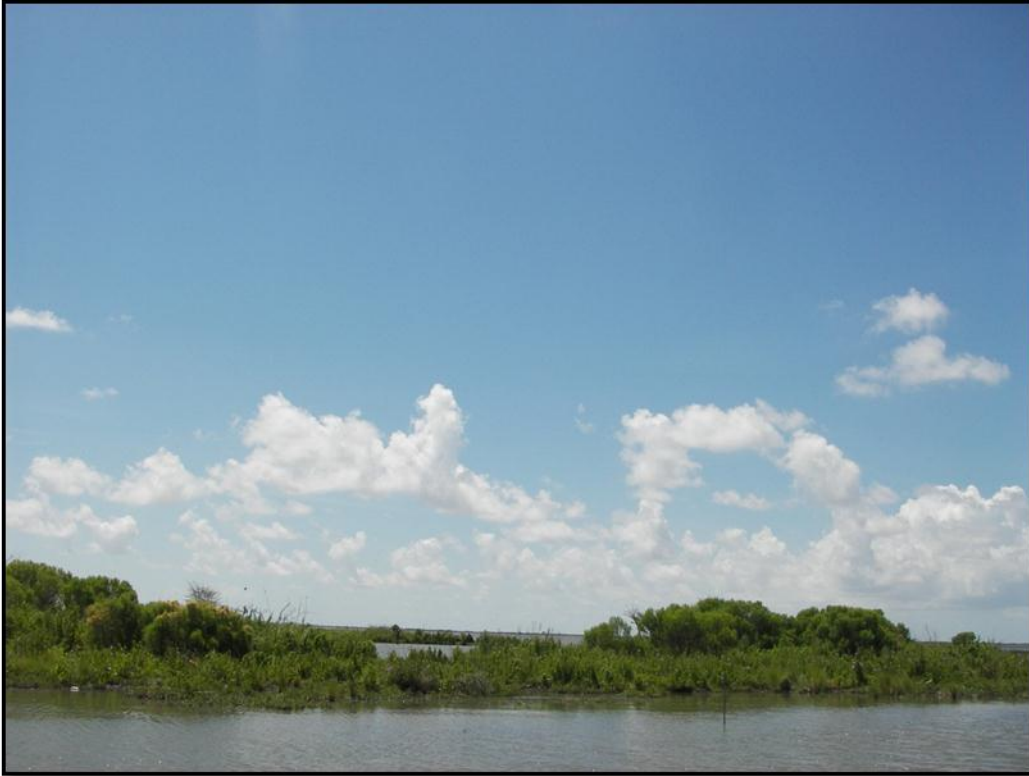
- A large open water area has developed within the marsh near the western terminus of Closure No. 3 and that the bankline between that point and the eastern end of Closure No. 2 has

eroded very severely and such that the “landbridge” between Vermilion Bay on the north of Marsh Island and the northwestern portion of Lake Sand proper is now narrow and may become subject to breaching thus allowing an undesirable water connection between the two bodies of water. It is recommended that an additional reach of shoreline protection dike be constructed, an estimated 1,500 to 1,800 linear feet, to connect the western end of Closure No. 3 to the eastern end of Closure No.2.

**Photo No. 5, Thin strip of land between Closures 2 & 3**

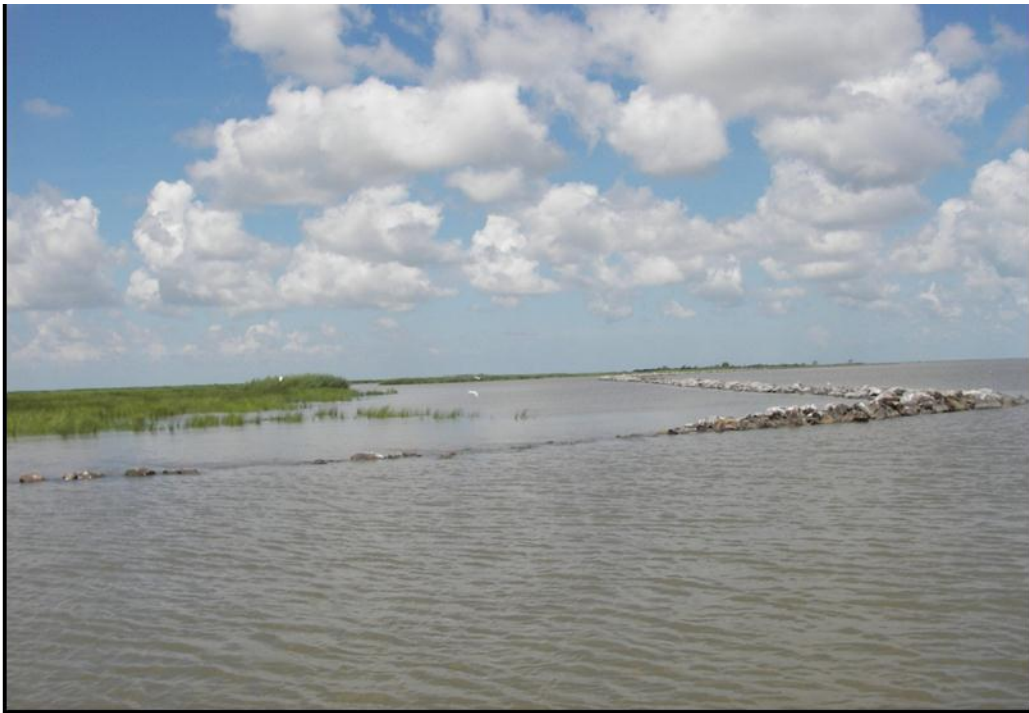
The Lake Sand Dike closure as originally constructed and recently repaired for Hurricane Rita damages, appears in good condition. The dike was capped in those areas where it was below elevation +3.0 as well as extended on the eastern end with bank paving. Dike has maintained elevation in capped areas. There is some settlement on the eastern end of the dike. (Photos: Appendix A, Photo 6).

**Photo No. 6, Closure No. 4**

Item	Condition	Physical Damage	Corrosion	Photo #	Observations and Remarks
Steel Bulkhead / Caps	N/A				
Steel Grating	N/A				
Stop Logs	N/A				
Hardware	N/A				
Timber Piles	N/A				
Timber Wales	N/A				
Galv. Pile Caps	N/A				
Cables	N/A				
Signage / Supports	N/A				
Rip Rap (fill)	Good			6	Settlement on eastern end of the dike.
Earthen Embankment	N/A

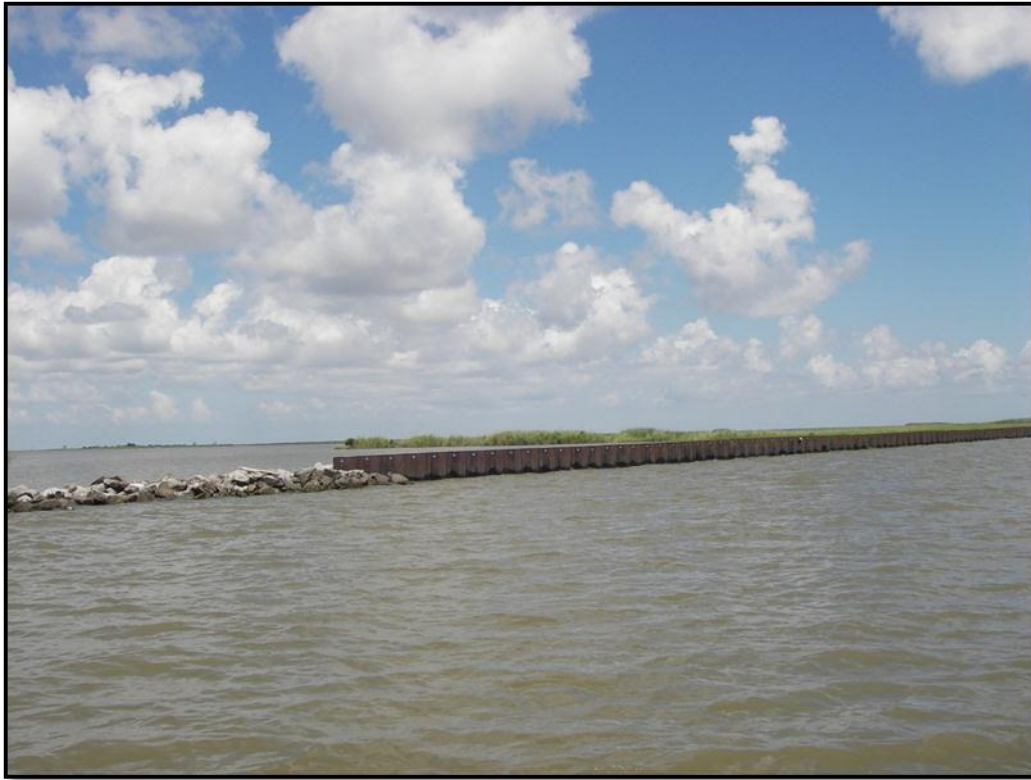
The steel sheet pile, rock riprap wingwalls, and stone bank/marsh paving placed as part of the Hurricane LILI repair project is in good condition and were apparently very effective in preventing additional damage by the erosive action of Hurricane RITA. The staff gage was re-set as part of the recent maintenance event. The overbank marsh areas paved to make same “hard” and paid for with O & M funding needs to be continually evaluated for its effectiveness. There is a breach on the southern end of the bank paving where water is passing through. Additionally, a small area of broken land/marsh exists between closures 5 and 6. If left unattended, an undesirable water connection between Vermilion Bay and Lake Sand will occur. It is recommended that an additional reach of shoreline protection dike be constructed, an estimated 1,500 to 1,800 linear feet, to connect the southern end of Closure No. 5 to the northern end of Closure No. 6. The estimated cost for rock dike and flotation is approximately \$1,250,000. (Photos: Appendix A, Photos 7-9).

**Photo No. 7, Closure No. 5**

Item	Condition	Physical Damage	Corrosion	Photo #	Observations and Remarks
Steel Bulkhead / Caps	Good			7	
Steel Grating	N/A				
Stop Logs	N/A				
Hardware	N/A				
Timber Piles	N/A				
Timber Wales	N/A				
Galv. Pile Caps	N/A				
Cables	N/A				
Signage / Supports	N/A				
Rip Rap (fill)	Good			8,9	There is a small area of broken land/marsh in between closures 5 & 6.
Earthen Embankment	N/A

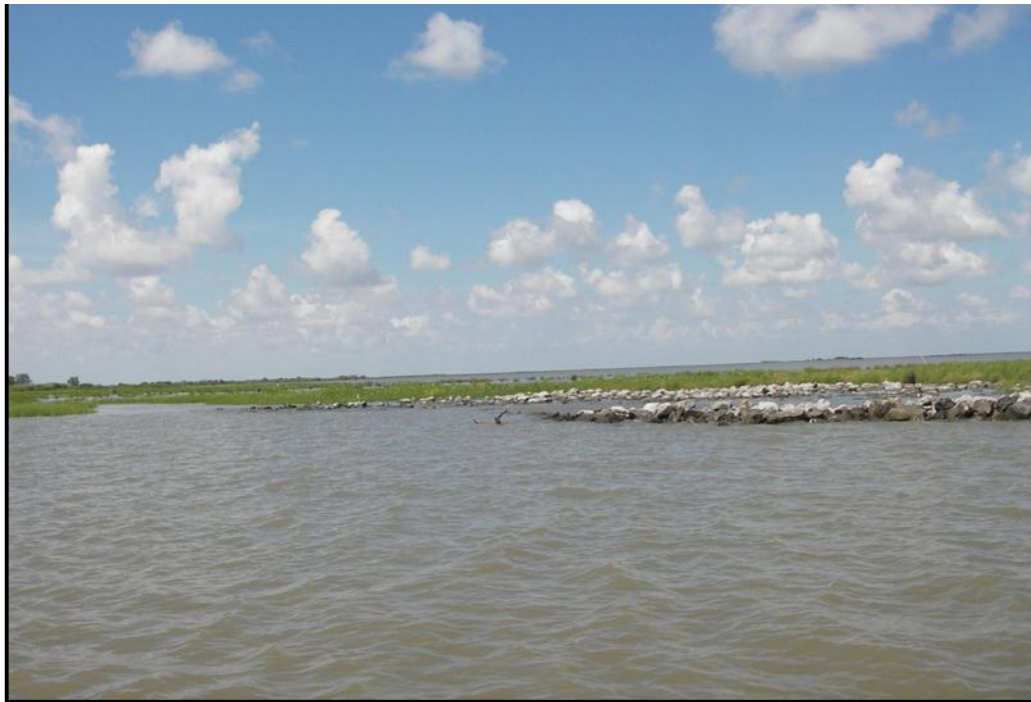
**Photo No. 8, Southern End of Closure No. 5**

- There is a breach on the southern end of the bank paving at Closure No. 5 as well as a section of broken marsh between Closures No. 5 and No. 6 which is allowing exchange to occur between Vermilion Bay and Lake Sand. It is recommended that an additional reach of shoreline protection dike be constructed, an estimated 1,500 to 1,800 linear feet, to connect the southern end of Closure No. 5 to the northern end of Closure No. 6.
- There is a breach on the southern end of the rock plug at Closure No. 8 which will be addressed in conjunction with a maintenance event currently underway for TV-21.

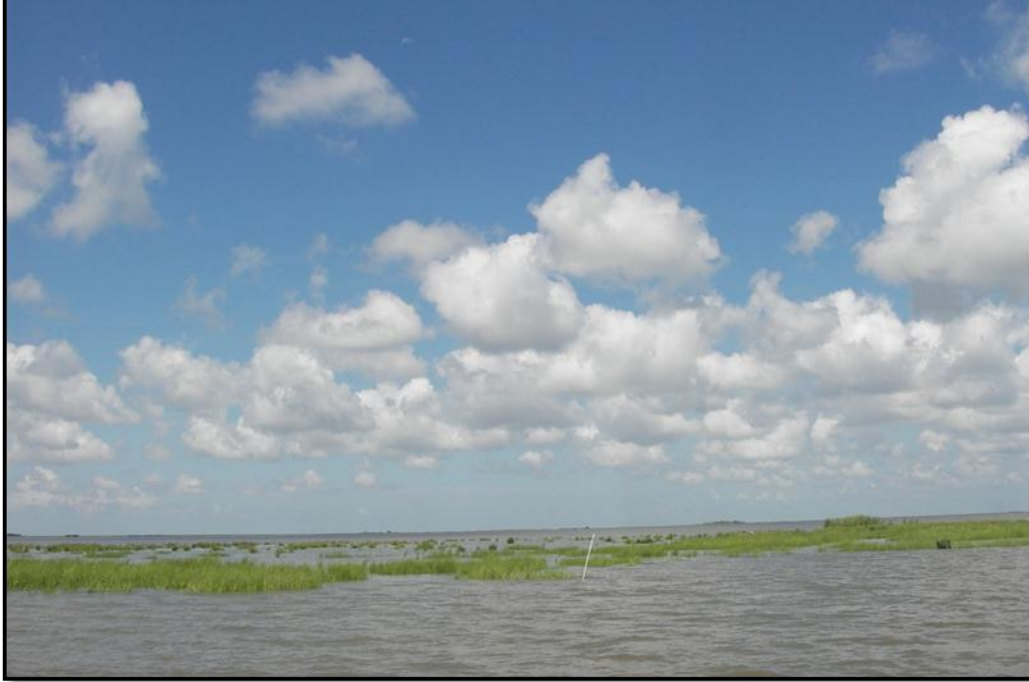
**Photo No. 9**, Broken land/marsh between Closures 5 & 6

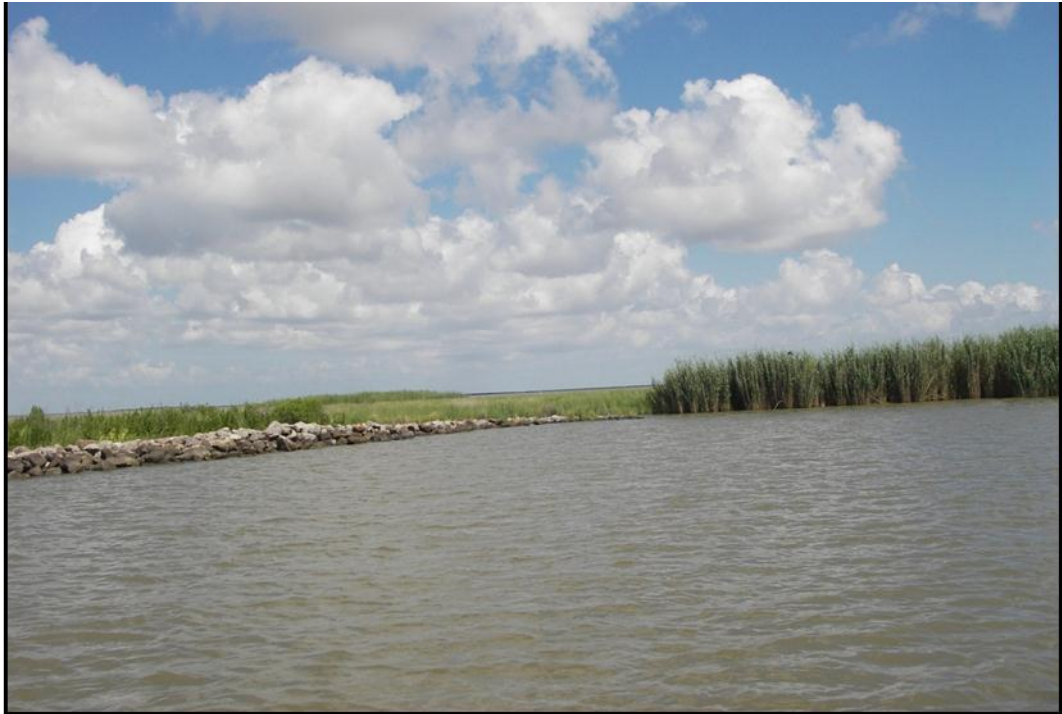
The breach on the southern end of the dike that had occurred prior to Hurricane Rita and subsequently worsened as a result of the tidal surge has been repaired as part of the recent maintenance event. The dike was extended on the northern end and bank paving was installed on both ends of the closure. With high tides, water is migrating around the southern end of the closure where bank paving was introduced to mitigate this problem in the past. A trenasse has formed and could lead to further damage to the marsh. (Photos: Appendix A, Photos 10 & 11).

**Photo No. 10**, Northern End of Closure No. 6

Item	Condition	Physical Damage	Corrosion	Photo #	Observations and Remarks
Steel Bulkhead / Caps	N/A				
Steel Grating	N/A				
Stop Logs	N/A				
Hardware	N/A				
Timber Piles	N/A				
Timber Wales	N/A				
Galv. Pile Caps	N/A				
Cables	N/A				
Signage / Supports	N/A				
Rock Dike	Good			10,11	Water is cutting around southern end of structure.
Earthen Embankment	N/A

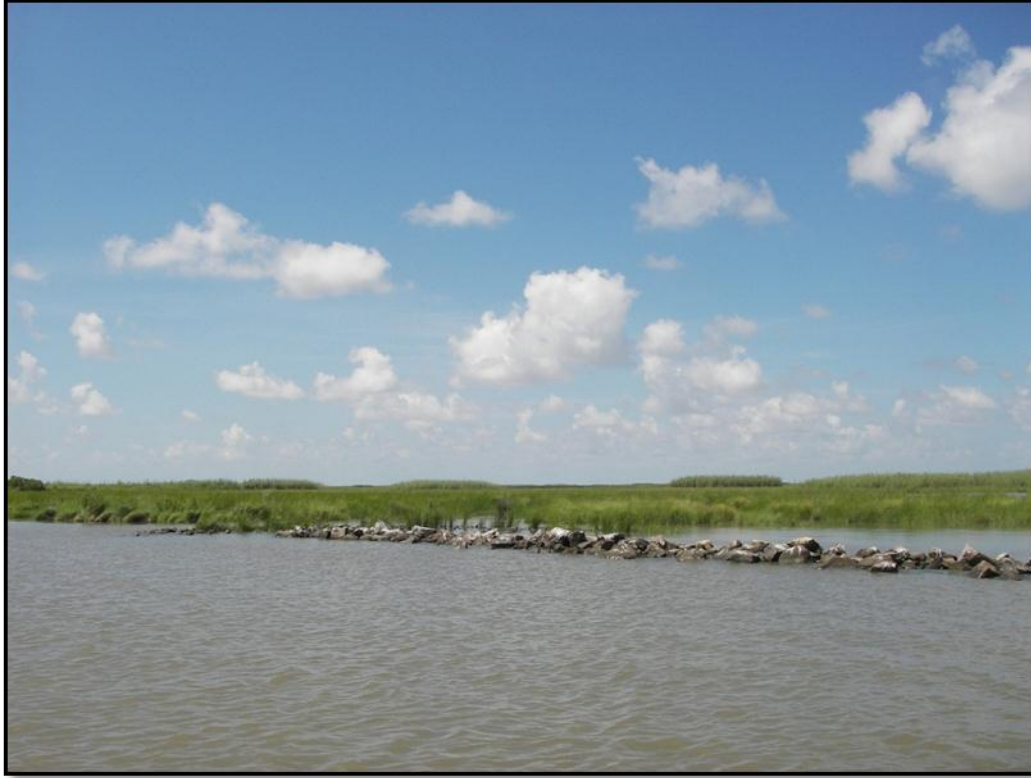
**Photo No. 11,** Southern End of Closure No. 6

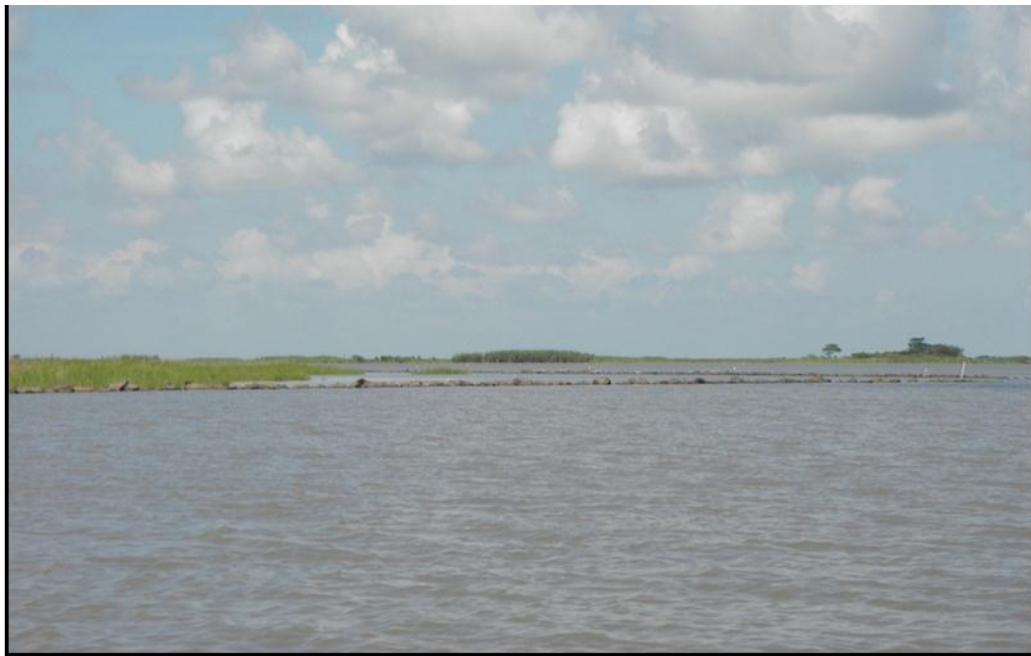
This closure site is in good condition and spoil material from the dredging of the north-south canal in 2008 was placed along the eastern end of the rock dike in an effort to stabilize this section of shore. In addition dredge spoil material was pumped behind the rock dike as part of this same access dredging and a small area of marsh creation was formed which is now starting to vegetate. There is some settlement along two (2) 150 foot lengths of the rock dike. (Photos: Appendix A, Photo 12).

**Photo No. 12,** Closure No. 7

Item	Condition	Physical Damage	Corrosion	Photo #	Observations and Remarks
Steel Bulkhead / Caps	N/A				
Steel Grating	N/A				
Stop Logs	N/A				
Hardware	N/A				
Timber Piles	N/A				
Timber Wales	N/A				
Galv. Pile Caps	N/A				
Cables	N/A				
Signage /Supports	N/A				
Rock Dike	Good			12	The site is in good condition.
Earthen Embankment	N/A

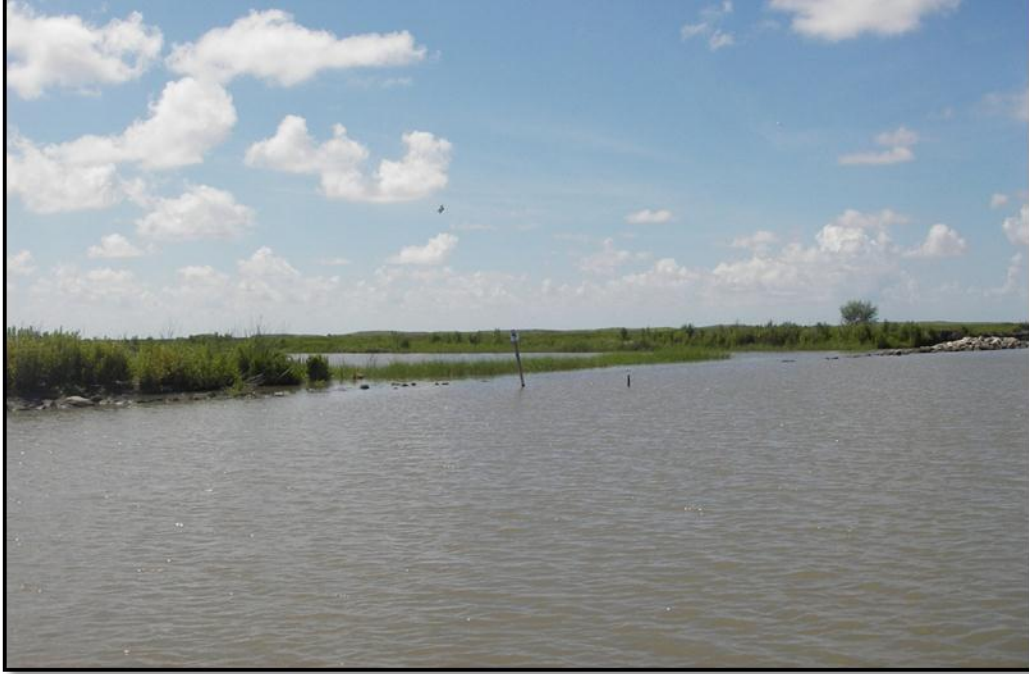
There is a breach on the southern end of the closure. A maintenance event on the adjacent TV-21 project will require the closure to be partially removed for access. At the conclusion of the TV-21 maintenance event, the contractor will replace the closure and add additional rock to repair the breach. (Photos: Appendix A, Photos 13 & 14).

**Photo No. 13, Closure No. 8**

Item	Condition	Physical Damage	Corrosion	Photo #	Observations and Remarks
Steel Bulkhead / Caps	N/A				
Steel Grating	N/A				
Stop Logs	N/A				
Hardware	N/A				
Timber Piles	N/A				
Timber Wales	N/A				
Galv. Pile Caps	N/A				
Cables	N/A				
Signage / Supports	N/A				
Rock Plug	Good			13,14	Breach on southern end of closure will be repaired in conjunction with TV-21 maintenance event.
Earthen Embankment	N/A

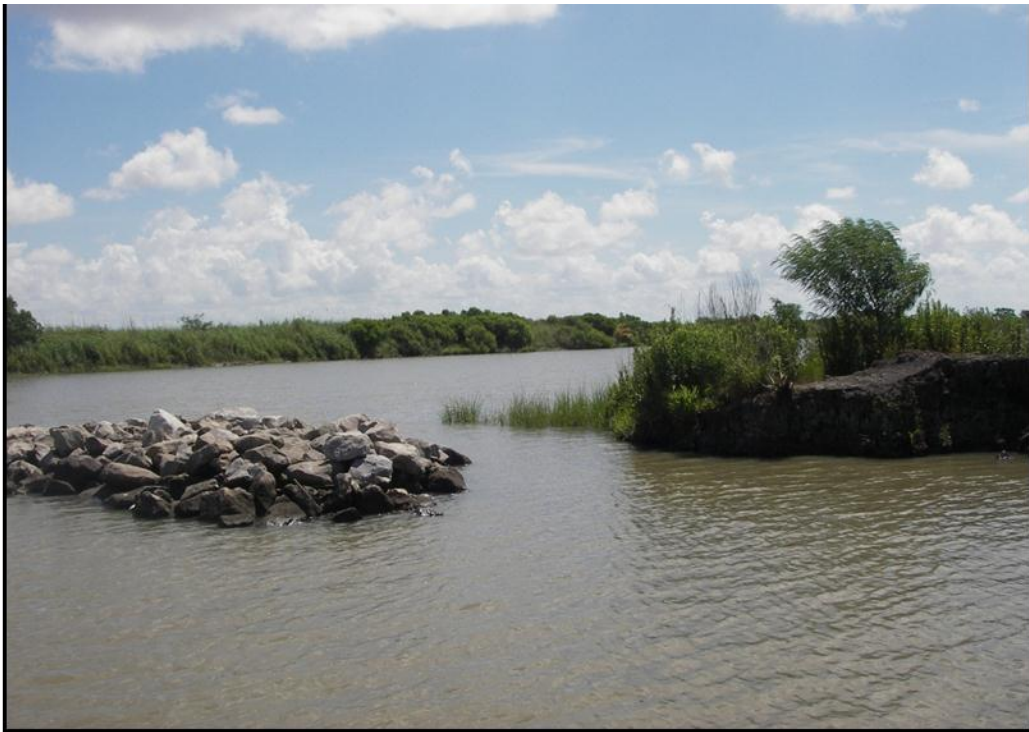
**Photo No. 14, Breach at Closure No. 8**

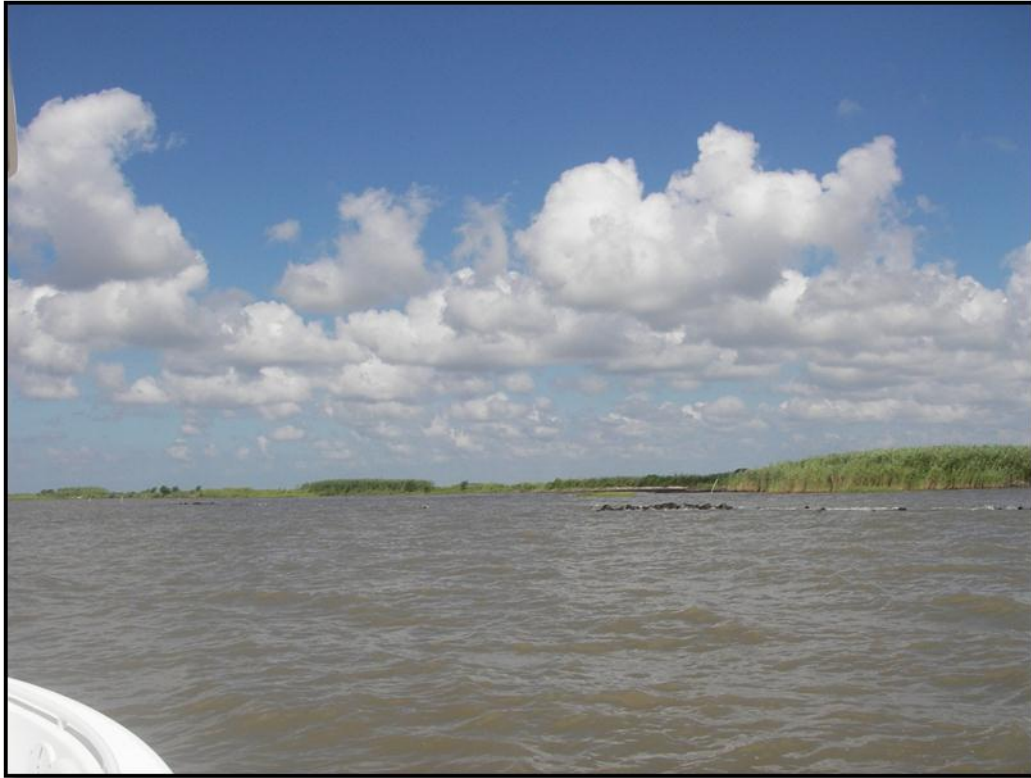
The rock riprap shoreline protection dike constructed on the south shoreline of Marsh Island was noted to now sit out further into the waters of the Gulf as discussed in the last inspection. Conditions were such that the feature was functioning well and that sediment had accreted and a growth of marsh vegetation had extended over the new fill. This rock shoreline feature will still function as a breakwater and extend the life of the earthen pipeline closure to the north. The recent construction of the TV-21 East Marsh Island Marsh Creation project has helped to reinforce the breach that had occurred on the southeast corner of the pipeline canal since the last inspection. The pipeline canal north of the rock breakwater was filled in with sediment from the marsh creation project and construction of containment dikes have now closed off the breach at the shoreline. No maintenance will be necessary at closure No. 9 as a result of the work performed through the TV-21 project. (Photos: Appendix A, Photo 15).

**Photo No. 15**, Closure No. 9

Item	Condition	Physical Damage	Corrosion	Photo #	Observations and Remarks
Steel Bulkhead / Caps	N/A				
Steel Grating	N/A				
Stop Logs	N/A				
Hardware	N/A				
Timber Piles	N/A				
Timber Wales	N/A				
Galv. Pile Caps	N/A				
Cables	N/A				
Signage / Supports	N/A				
Rock Dike	Fair			15	Dike is settling in some areas. Breach is closed and shoreline looks good since the TV-21 project.
Earthen Embankment	N/A
