**Coastal Protection and Restoration
Authority (CPRA)**

2018 Operations, Maintenance, and Monitoring Report

Marsh Island Hydrologic Restoration

State Project Number TV-14
Priority Project List 6

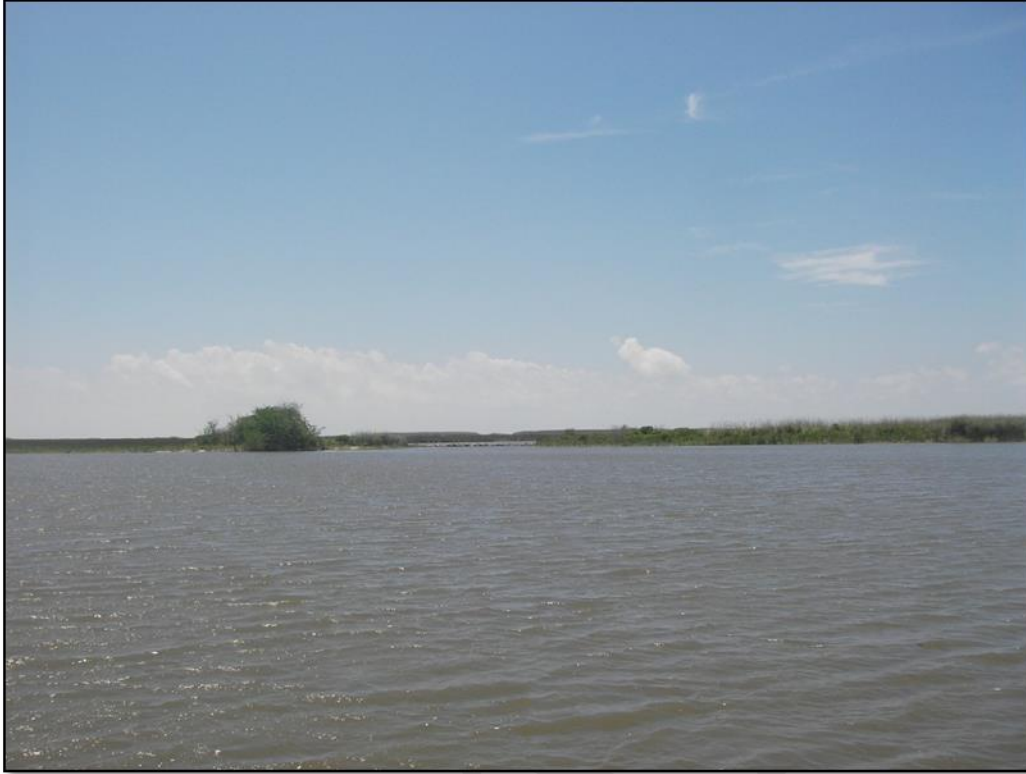
Photo No. 1, Closure No. 1

Erosion problems and Hurricane Rita damages were repaired through a maintenance project that was completed in February 2009. The dike was capped and bank paving installed on both ends of the closure. This site is in good condition since this work was performed. (Photos: Appendix A, Photo 1).

Item	Condition	Physical Damage	Corrosion	Photo #	Observations and Remarks
Steel Bulkhead / Caps	N/A				
Steel Grating	N/A				
Stop Logs	N/A				
Hardware	N/A				
Timber Piles	N/A				
Timber Wales	N/A				
Galv. Pile Caps	N/A				
Cables	N/A				
Signage / Supports	N/A				
Rip Rap (fill)	Good			1	The site is in good condition.
Earthen Embankment	N/A

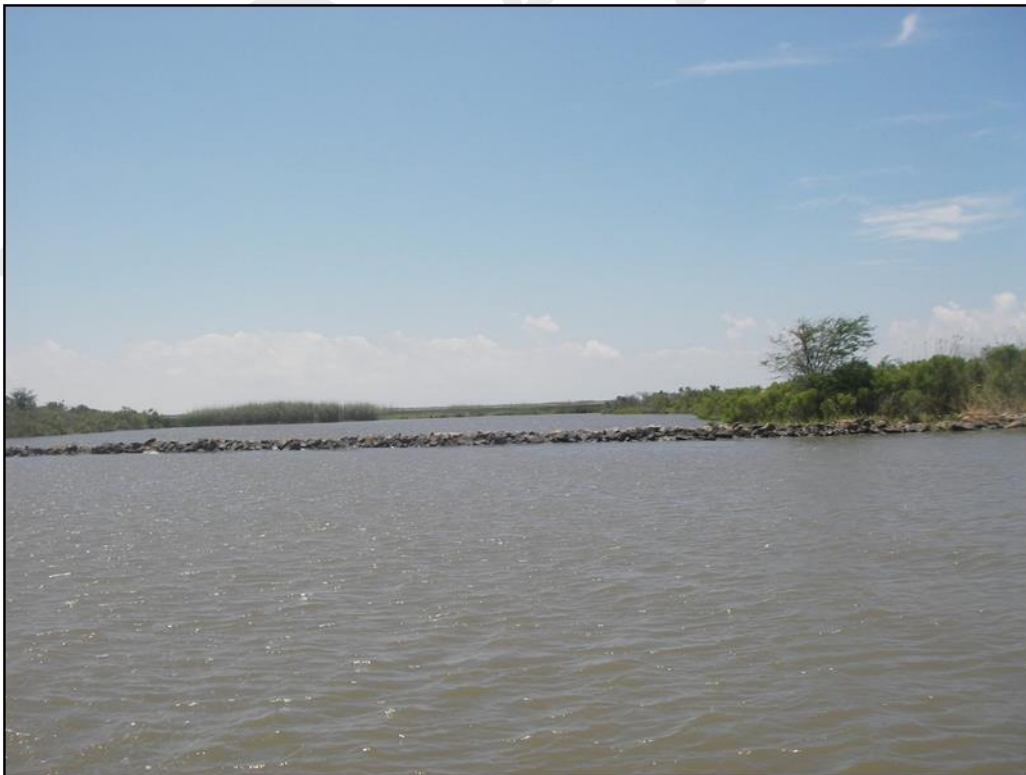
Photo No. 2, Closure No. 2

This structure is in good condition. (Photos: Appendix A, Photo 2)

Item	Condition	Physical Damage	Corrosion	Photo #	Observations and Remarks
Steel Bulkhead / Caps	N/A				
Steel Grating	N/A				
Stop Logs	N/A				
Hardware	N/A				
Timber Piles	N/A				
Timber Wales	N/A				
Galv. Pile Caps	N/A				
Cables	N/A				
Signage / Supports	N/A				
Rip Rap (fill)	Good			2	The site is in good condition.
Earthen Embankment	N/A

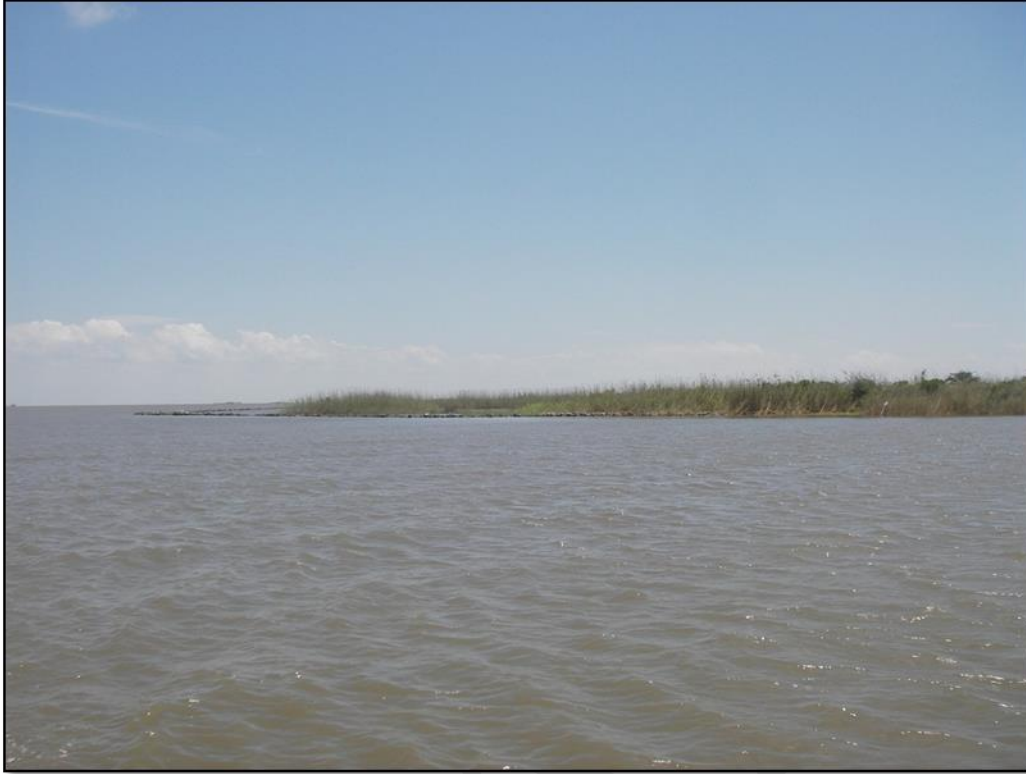
Photo No. 3, Closure No. 3

This structure is in good condition. (Photos: Appendix A, Photo 3)

Item	Condition	Physical Damage	Corrosion	Photo #	Observations and Remarks
Steel Bulkhead / Caps	N/A				
Steel Grating	N/A				
Stop Logs	N/A				
Hardware	N/A				
Timber Piles	N/A				
Timber Wales	N/A				
Galv. Pile Caps	N/A				
Cables	N/A				
Signage / Supports	N/A				
Rip Rap (fill)	Good			3	This site is in good condition.
Earthen Embankment	N/A

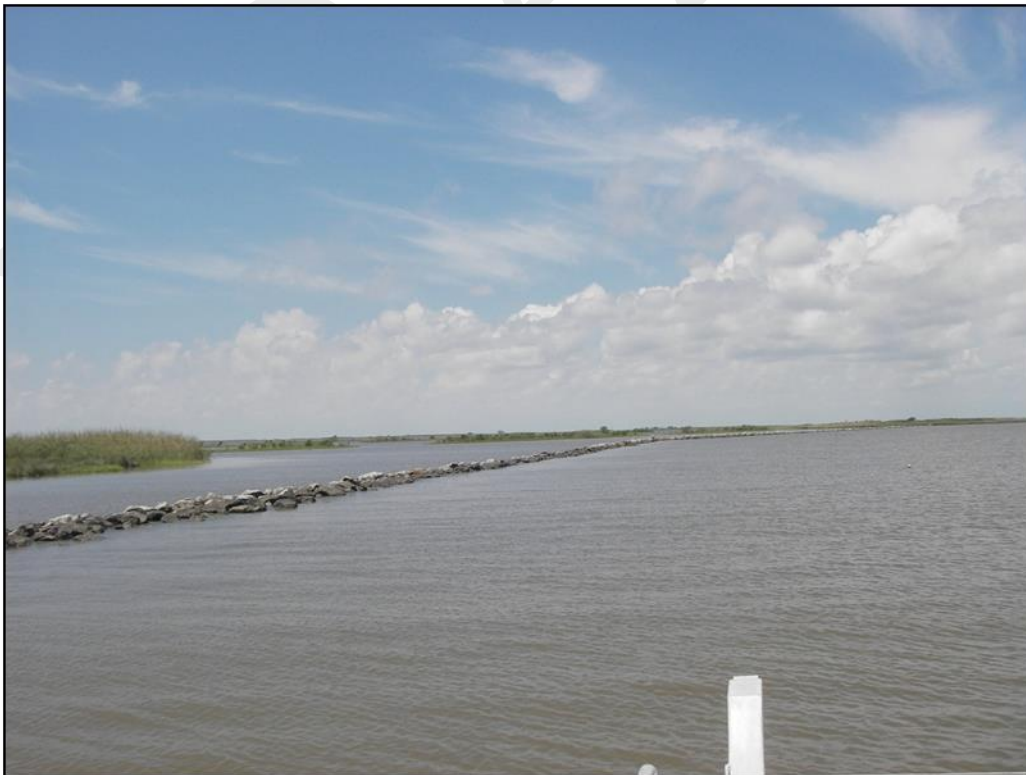
Photo No. 4, Closure No. 4

This structure is in good condition. (Photos: Appendix A, Photo 4)

Item	Condition	Physical Damage	Corrosion	Photo #	Observations and Remarks
Steel Bulkhead / Caps	N/A				
Steel Grating	N/A				
Stop Logs	N/A				
Hardware	N/A				
Timber Piles	N/A				
Timber Wales	N/A				
Galv. Pile Caps	N/A				
Cables	N/A				
Signage / Supports	N/A				
Rip Rap (fill)	Good			4	This site is in good condition.
Earthen Embankment	N/A

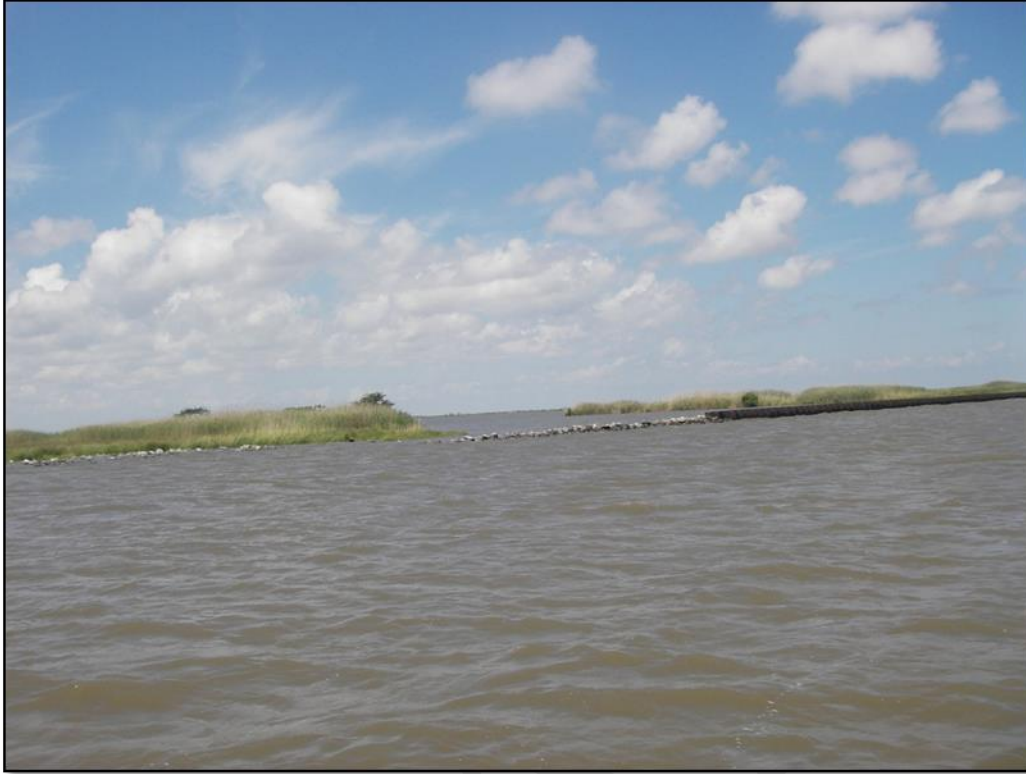
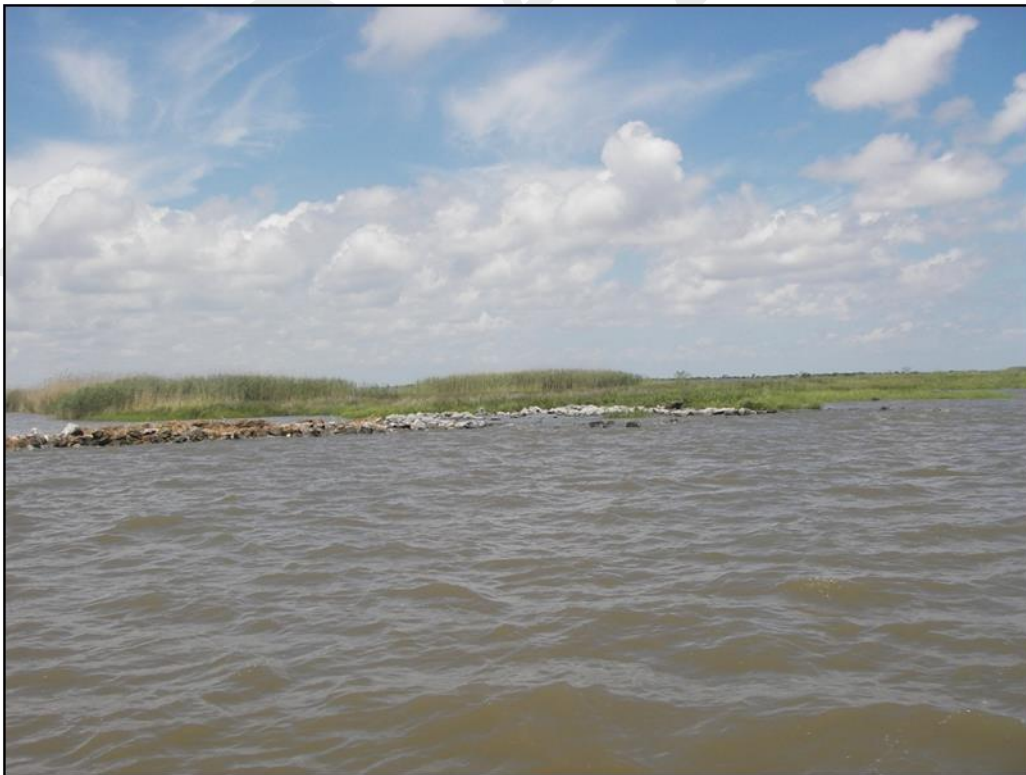
Water is migrating around the structure on both ends. (Photos: Appendix A, Photos 5 & 6)

Item	Condition	Physical Damage	Corrosion	Photo #	Observations and Remarks
Steel Bulkhead / Caps	Good			5	Good
Steel Grating	N/A				
Stop Logs	N/A				
Hardware	N/A				
Timber Piles	N/A				
Timber Wales	N/A				
Galv. Pile Caps	N/A				
Cables	N/A				
Signage / Supports	N/A				
Rip Rap (fill)	Good			5 & 6	Water migrating around structure on both ends.
Earthen Embankment	N/A

- There is a breach on the southern end of the bank paving at Closure No. 5 as well as a section of broken marsh between Closures No. 5 and No. 6, which is allowing exchange to occur between Vermilion Bay and Lake Sand. It is recommended that an additional reach of shoreline protection dike be constructed, an estimated 1,500 to 1,800 linear feet, to connect the southern end of Closure No. 5 to the northern end of Closure No. 6. NRCS proposed a new rock project to protect the shoreline between closure Nos. 5 & 6. The project was rejected. CPRA and USACE do not plan to pursue the matter further.

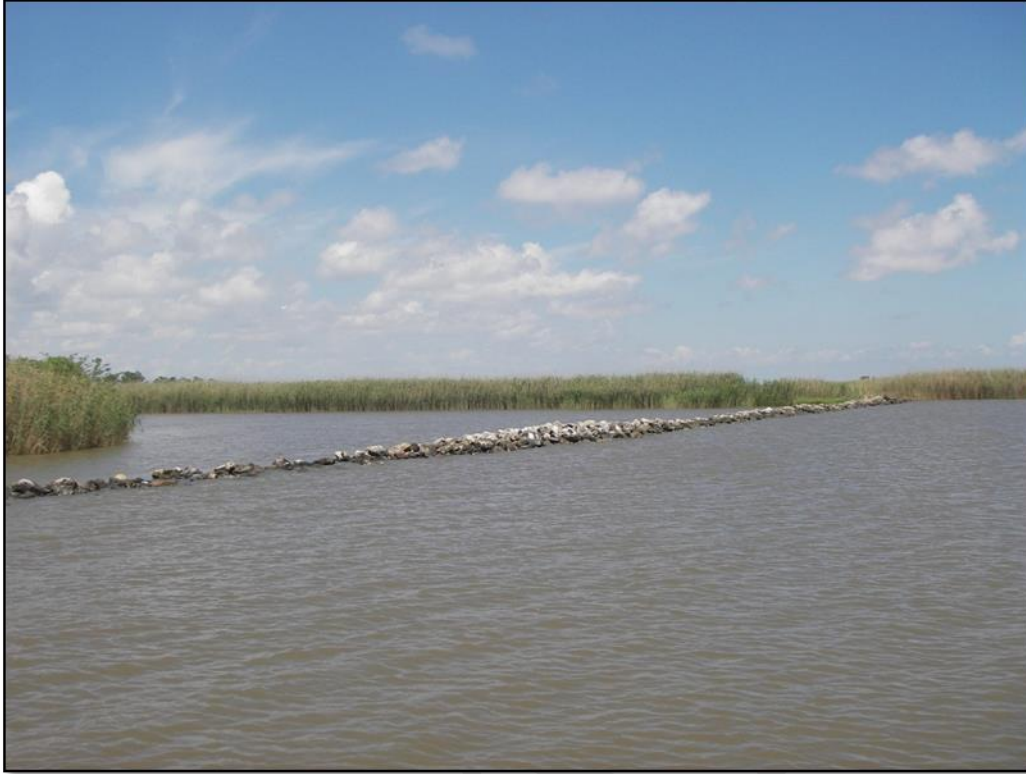
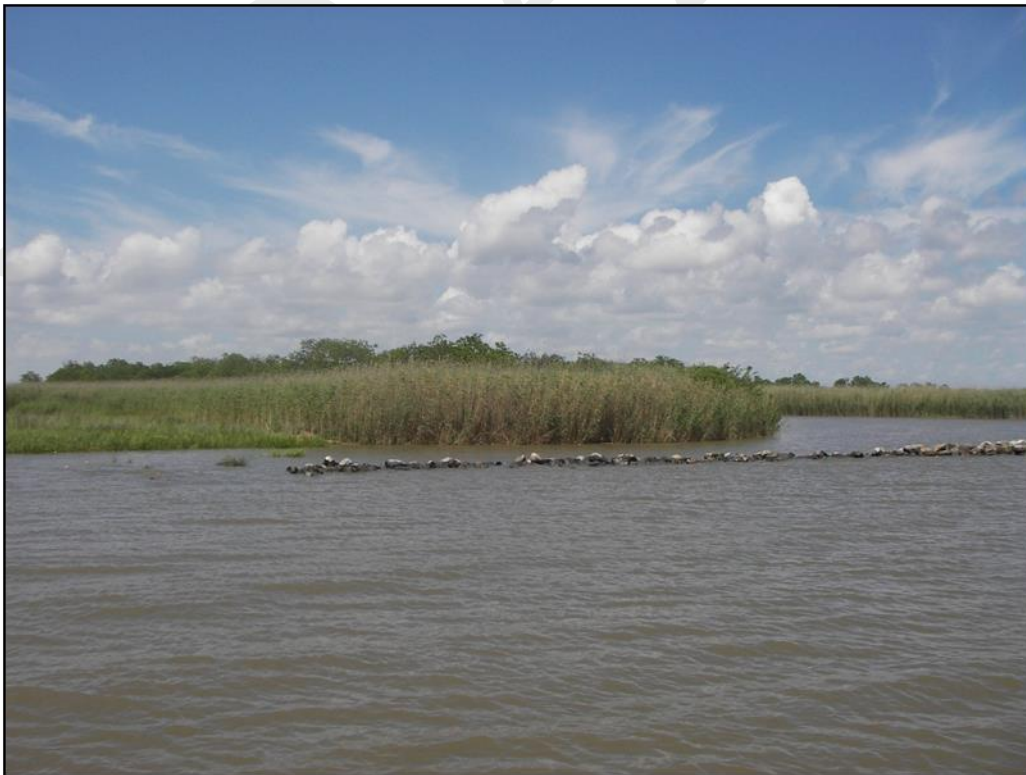
Water is migrating around the southern end of the structure. (Photos: Appendix A, Photos 7 & 8)

Item	Condition	Physical Damage	Corrosion	Photo #	Observations and Remarks
Steel Bulkhead / Caps	N/A				
Steel Grating	N/A				
Stop Logs	N/A				
Hardware	N/A				
Timber Piles	N/A				
Timber Wales	N/A				
Galv. Pile Caps	N/A				
Cables	N/A				
Signage / Supports	N/A				
Rock Dike	Good			7 & 8	Water migrating around southern end of structure.
Earthen Embankment	N/A

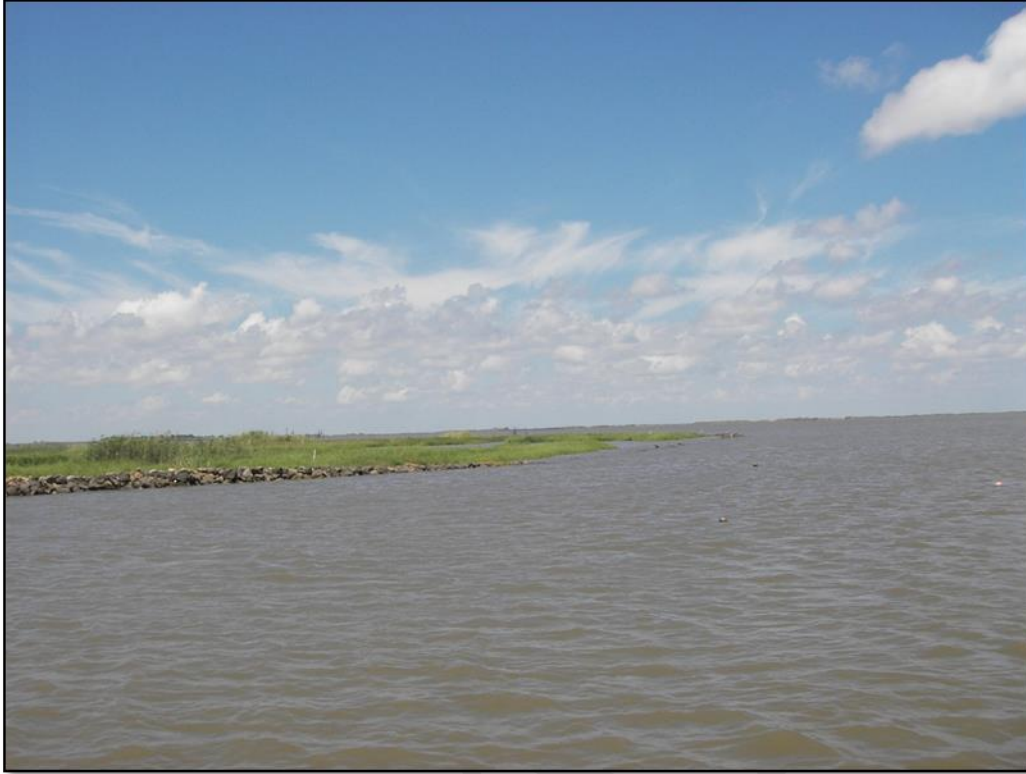
Photo No. 9, Closure No. 7

This structure is in good condition. (Photos: Appendix A, Photo 9).

Item	Condition	Physical Damage	Corrosion	Photo #	Observations and Remarks
Steel Bulkhead / Caps	N/A				
Steel Grating	N/A				
Stop Logs	N/A				
Hardware	N/A				
Timber Piles	N/A				
Timber Wales	N/A				
Galv. Pile Caps	N/A				
Cables	N/A				
Signage / Supports	N/A				
Rock Dike	Good			9	The site is in good condition.
Earthen Embankment	N/A

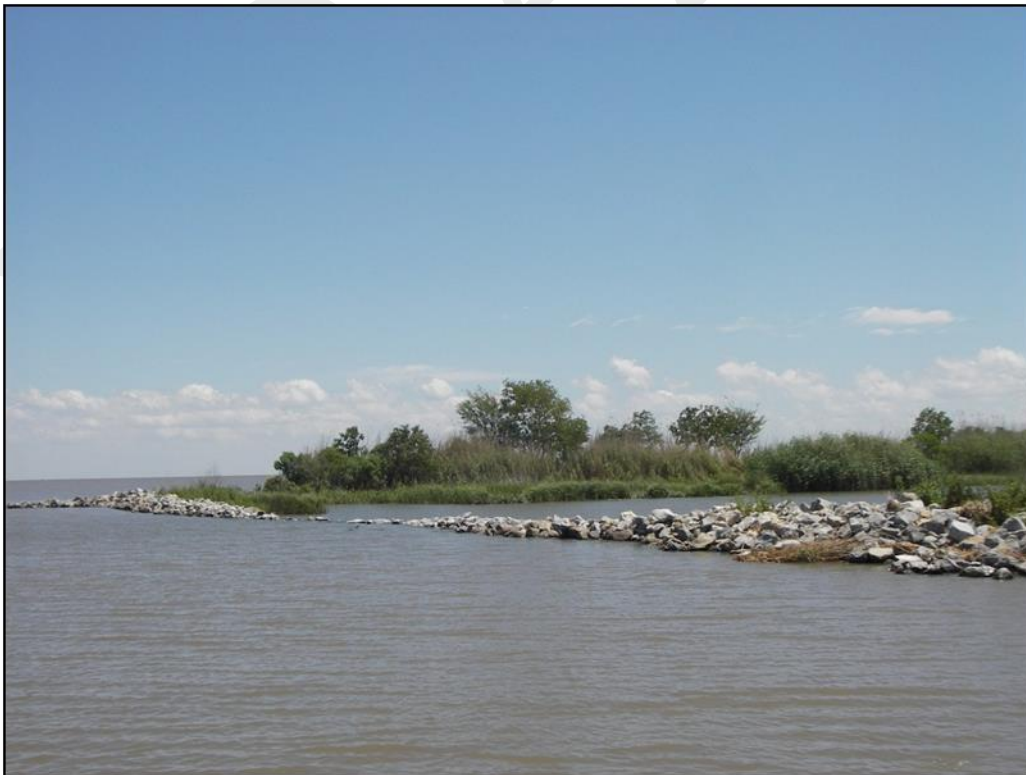
Photo No. 10, Closure No. 8

A maintenance event on the adjacent TV-21 project required the closure to be removed for access. At the conclusion of the TV-21 maintenance event, the contractor replaced the closure and added additional rock to repair the breach. There has been some settlement at the canal opening. (Photos: Appendix A, Photo 10).

Item	Condition	Physical Damage	Corrosion	Photo #	Observations and Remarks
Steel Bulkhead / Caps	N/A				
Steel Grating	N/A				
Stop Logs	N/A				
Hardware	N/A				
Timber Piles	N/A				
Timber Wales	N/A				
Galv. Pile Caps	N/A				
Cables	N/A				
Signage / Supports	N/A				
Rock Plug	Good			10	Breach on southern end of closure was repaired in conjunction with TV-21 maintenance event. Some settlement of canal plug.
Earthen Embankment	N/A

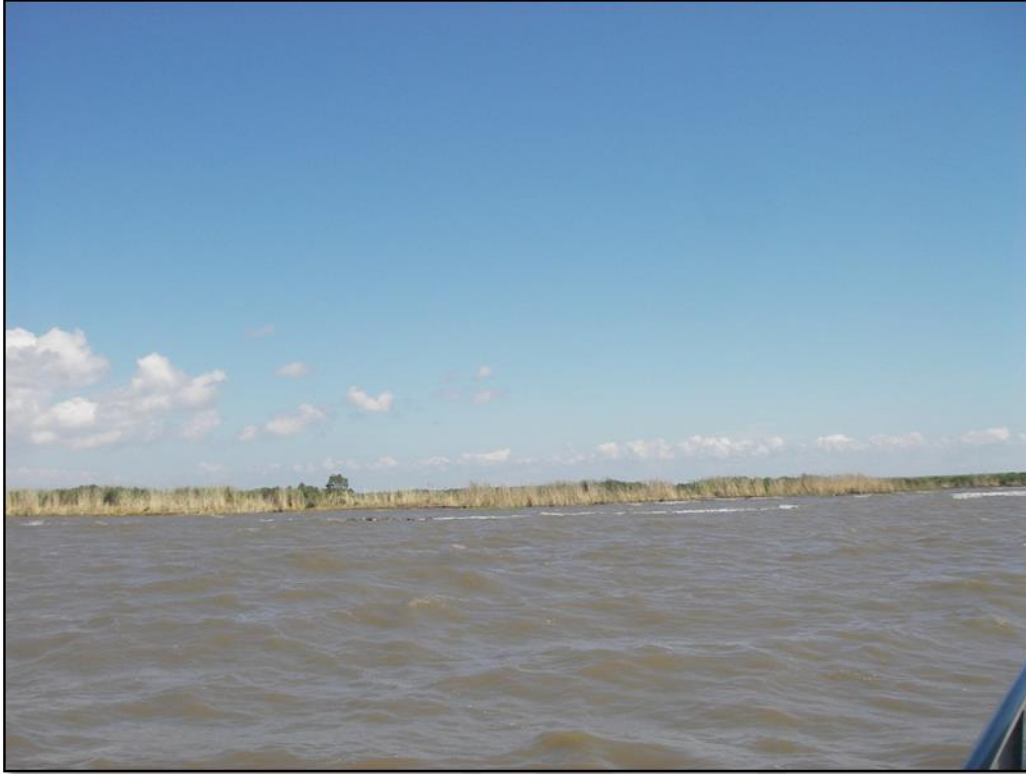
Photo No. 11, Closure No. 9

This rock shoreline feature functions as a breakwater protecting the earthen pipeline closure to the north. The recent construction of the TV-21 East Marsh Island Marsh Creation project has helped to reinforce the breach that had occurred on the southeast corner of the pipeline canal. (Photos: Appendix A, Photo 11)

Item	Condition	Physical Damage	Corrosion	Photo #	Observations and Remarks
Steel Bulkhead / Caps	N/A				
Steel Grating	N/A				
Stop Logs	N/A				
Hardware	N/A				
Timber Piles	N/A				
Timber Wales	N/A				
Galv. Pile Caps	N/A				
Cables	N/A				
Signage / Supports	N/A				
Rock Dike	Fair			11	Dike is settling in some areas. Breach is closed and shoreline looks good since the TV-21 project.
Earthen Embankment	N/A
