**2015/2016 Annual Inspection
Report**

**SEDIMENT TRAPPING AT THE
JAWS PROJECT (TV-15)**

State Project Number TV-15
Priority Project List 6

May 5, 2016
St. Mary Parish

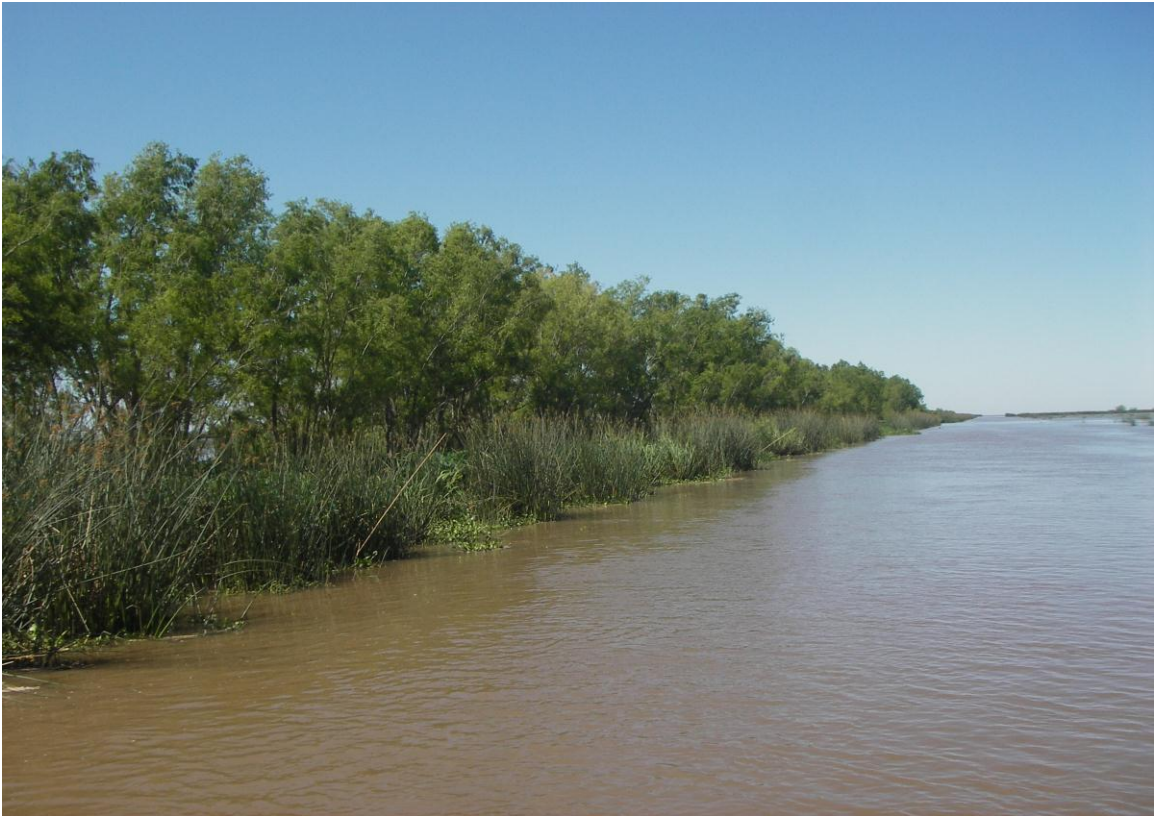
Photo No. 1--typical terrace

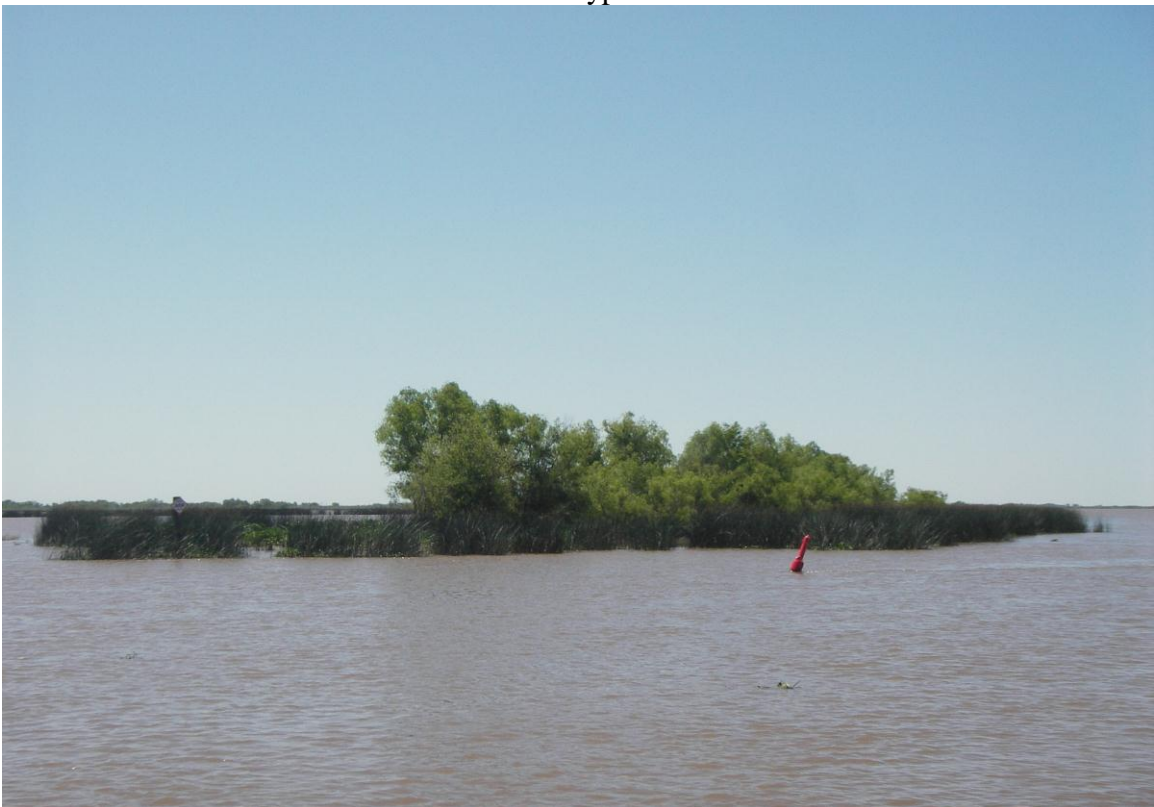
Photo No. 2--typical terrace and warning sign

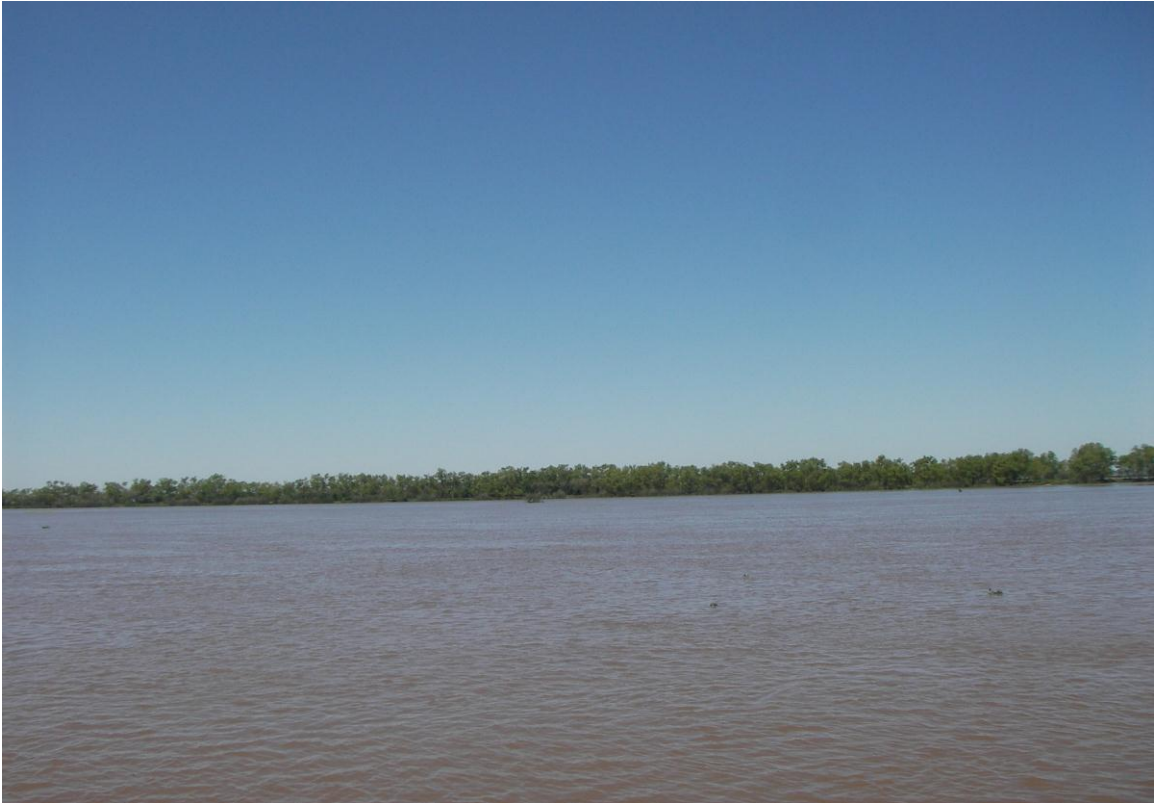
Photo No. 3--typical terrace

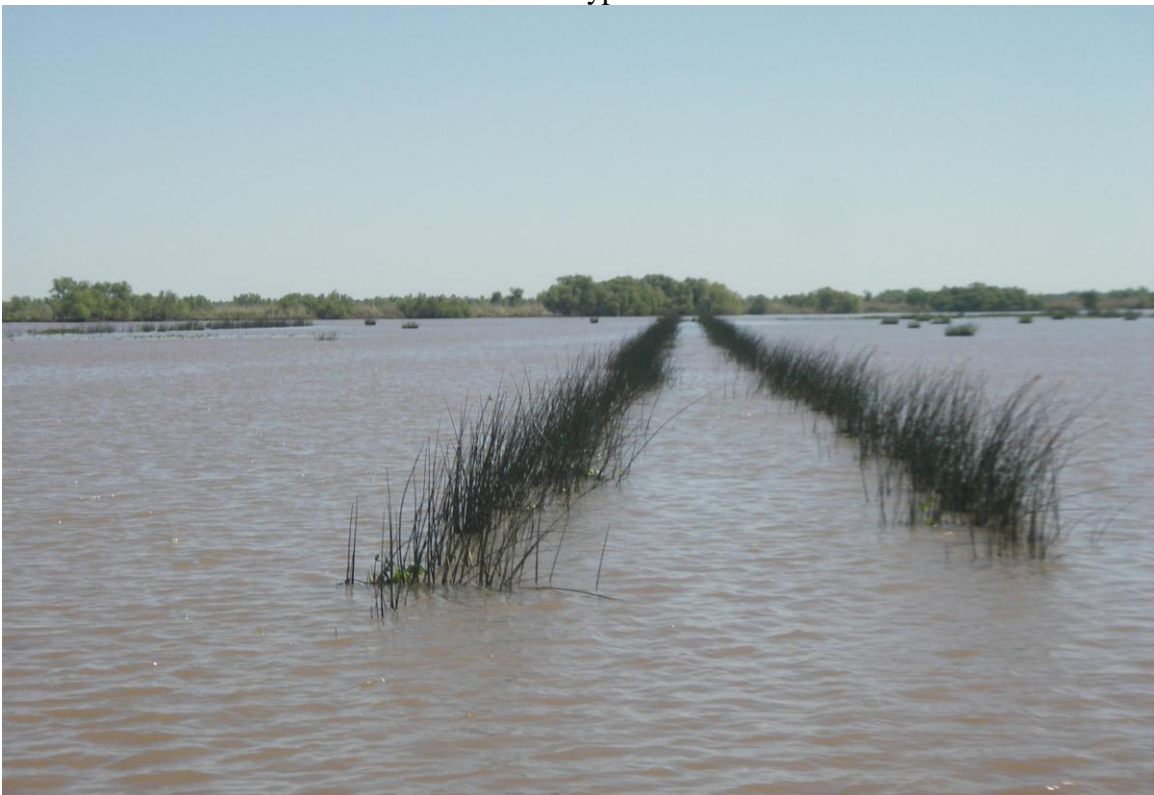
Photo No. 4—plantings and new vegetation between terraces
