**2014/2015 Annual Inspection
Report**

**LAKE PORTAGE LAND
BRIDGE PROJECT
(TV-17)**

State Project Number TV-17
Priority Project List 8

August 20, 2015
Vermilion Parish

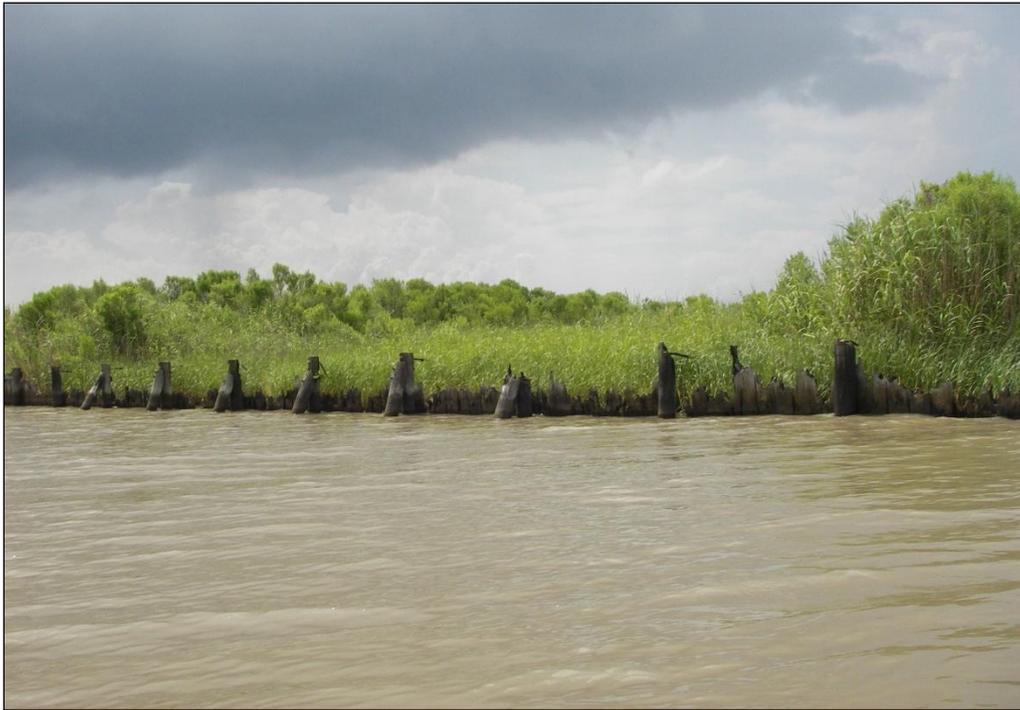
Area 1 is in good condition and vegetation has continued to expand from the containment banks moving towards the center of the channel and is 100 per cent vegetated. As a result of the inspection of Area 1, CPRA and NRCS agree that no corrective actions will be required this year. (Photos: Appendix B, Photo 1).

Photo 1, Area 1, Timber bulkhead.

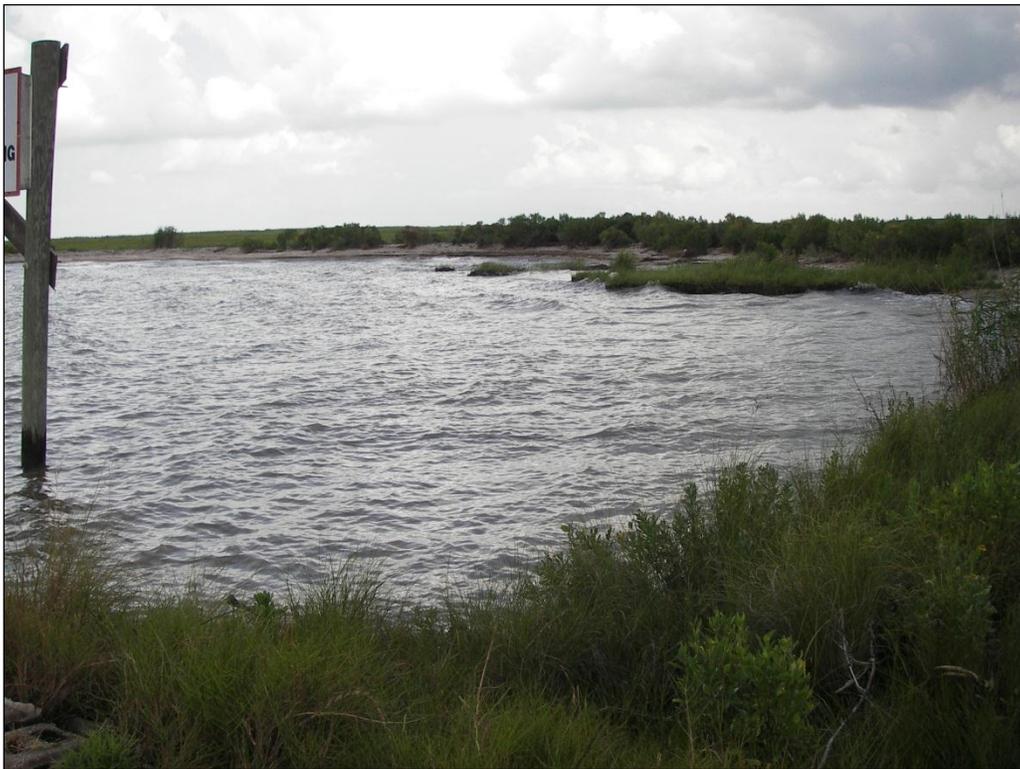
Area 2 is also in good condition and is fully vegetated, such that this reach was preexisting with additional dredge material added through this project to fill in any trenasses. Some erosion at the ends of the concrete mats along the Gulf shoreline has occurred over time and part of the mat system is showing signs of failure. Although the concrete mat system is not a feature to be maintained as part of this project, this area is experiencing erosion that may threaten the integrity of the overall project. Therefore, CPRA and NRCS agree that maintenance may be required at some time in the future. (Photos: Appendix B, Photos 2, 3, & 4).

Photo 2, Area 2, West side of concrete mats.

Overall, the Lake Portage Land Bridge Project is in good condition and functioning as designed. However, the erosion problem occurring at the Gulf shoreline will need to be addressed. Preliminary survey work to develop an accurate estimate of costs was performed in 2008 and a subsequent request made to CWPPRA for additional funds. The Task Force decided that monitoring of the shoreline should continue and opted not to take any action at this time.

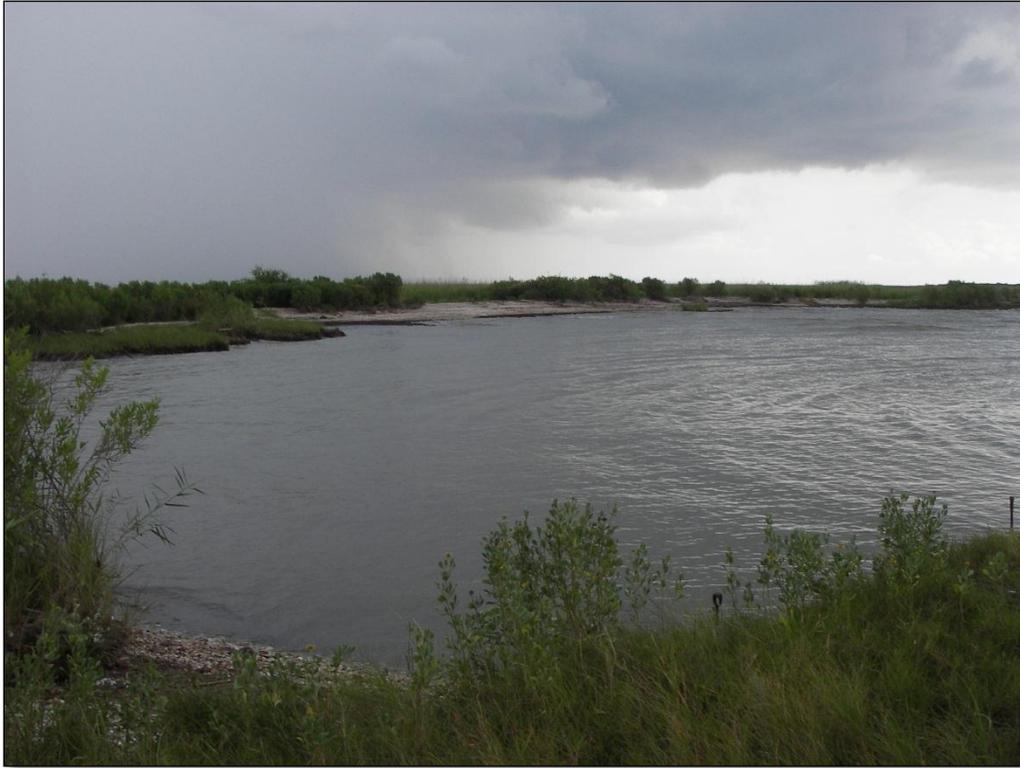
Photo 3, Area 2, Erosion on east side of concrete mats.

Item	Condition	Physical Damage	Corrosion	Photo #	Observations and Remarks
Timber Bulkhead / Caps	Good				
Steel Grating	N/A				
Salinity Readings					
Concrete Mats	Good			2, 3, 4	Some erosion each side of concrete mats along Gulf shoreline.
Timber Piles	Good				
Timber Wales	N/A				
Galv. Pile Caps	N/A				
Vegetation	Good			1	Area 1 has solid vegetation.
Signage / Supports	Good				
Rip Rap (fill)	N/A				
Earthen Embankment	Good				
Dredge Spoil	Good				
What are the conditions of the existing levees?				Good	
Are there any noticeable breaches?				No	
Settlement of rock plugs and rock weirs?				N/A	
Position of stoplogs at the time of the inspection?				N/A	
Are there any signs of vandalism?				No

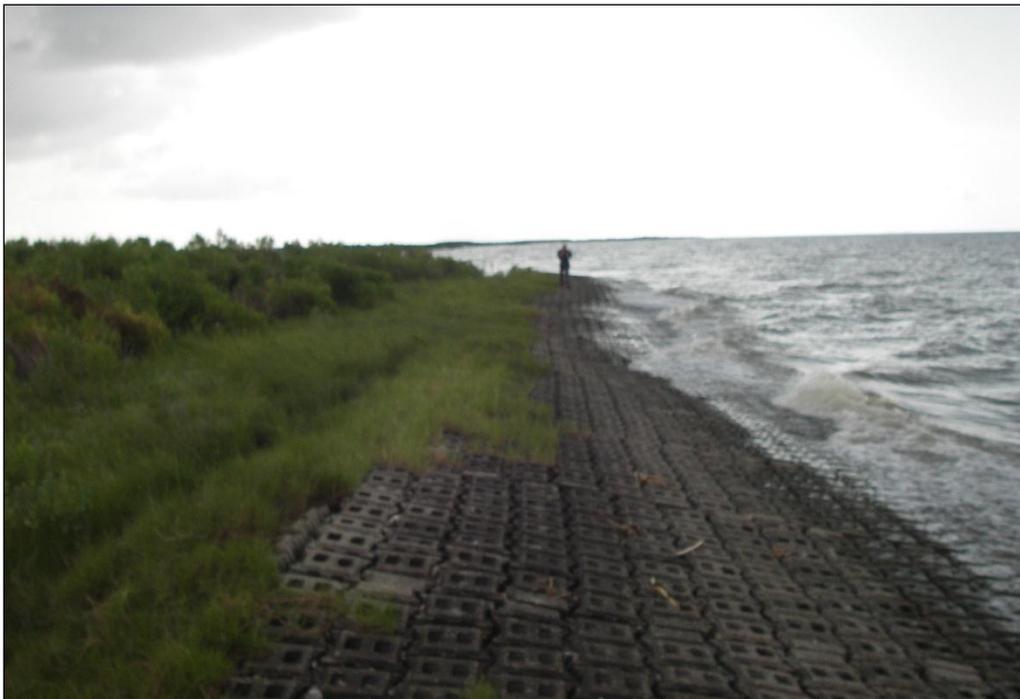
Photo 4, Area 2, East side of concrete mats.
