## **2019 Operations, Maintenance, and Monitoring Report**

### **LAKE PORTAGE LAND BRIDGE PROJECT (TV-0017)**

State Project Number TV-17  
Priority Project List 8

November 2019  
Vermilion Parish

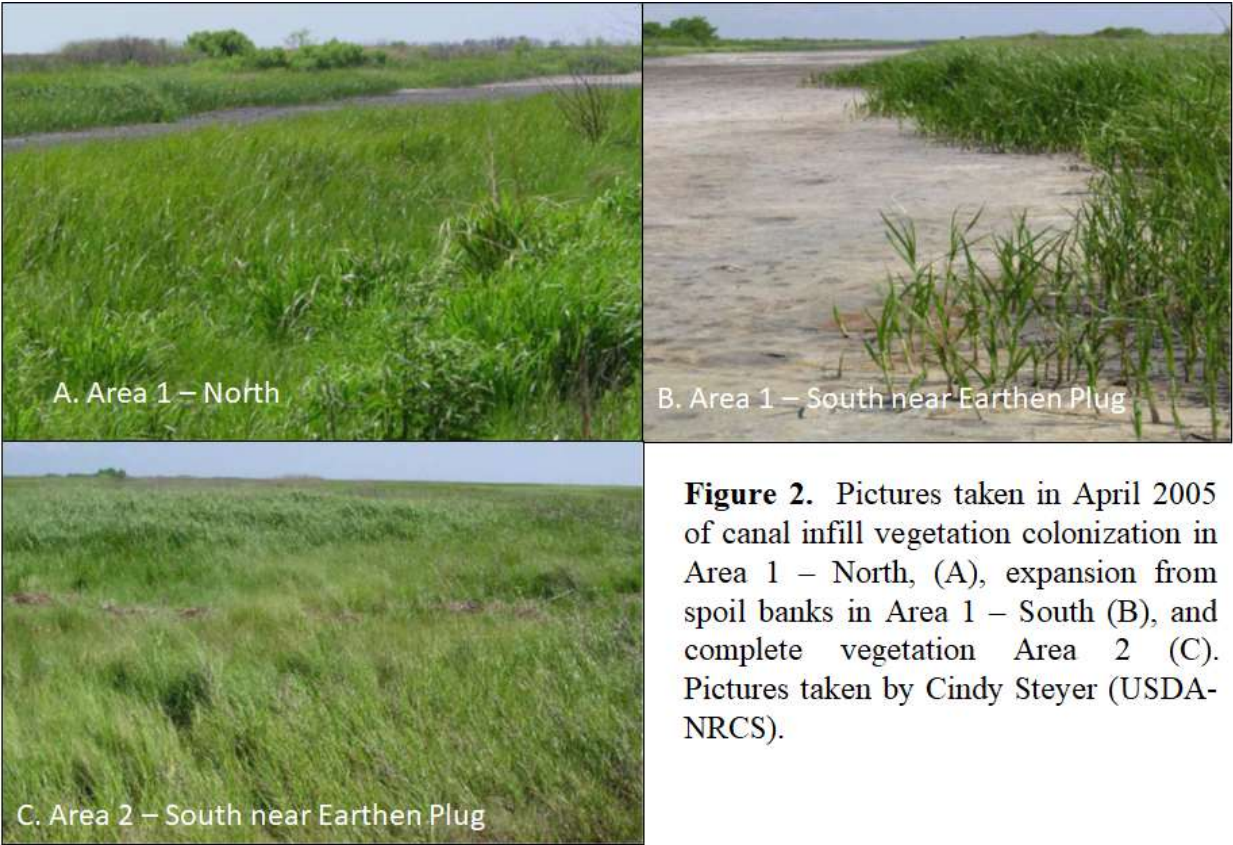
From an April 2005 vegetation survey (pers. comm. Cindy Steyer, USDA-NRCS), the northern portion of Area 1 was colonized predominantly by leafy three-square bulrush with trace *Calystegia sepium* (hedge bindweed) (Fig.2). The middle section of Area 1 was further along in succession and was slightly more diverse with leafy three-square bulrush sharing dominance with marshhay cordgrass and smooth cordgrass; saltgrass, morning glory, *Iva frutescens* (big leaf sumpweed), salt bush, and *Amaranthus* sp. also occurred in small to trace amounts. The higher portion of Area 1 approaching the earthen plug was slower to colonize (Fig. 2B). By April 2008, about 4 years after dredge placement, the Area 1 canal infill was 100 % vegetated as plants expanded naturally from the containment levees towards the center of the former pipeline canal (Fig. 3) (Pontiff 2008). Vegetation has remained intact as of 2018 (Fig. 2C).

**Figure 2.** Pictures taken in April 2005 of canal infill vegetation colonization in Area 1 – North, (A), expansion from spoil banks in Area 1 – South (B), and complete vegetation Area 2 (C). Pictures taken by Cindy Steyer (USDA-NRCS).

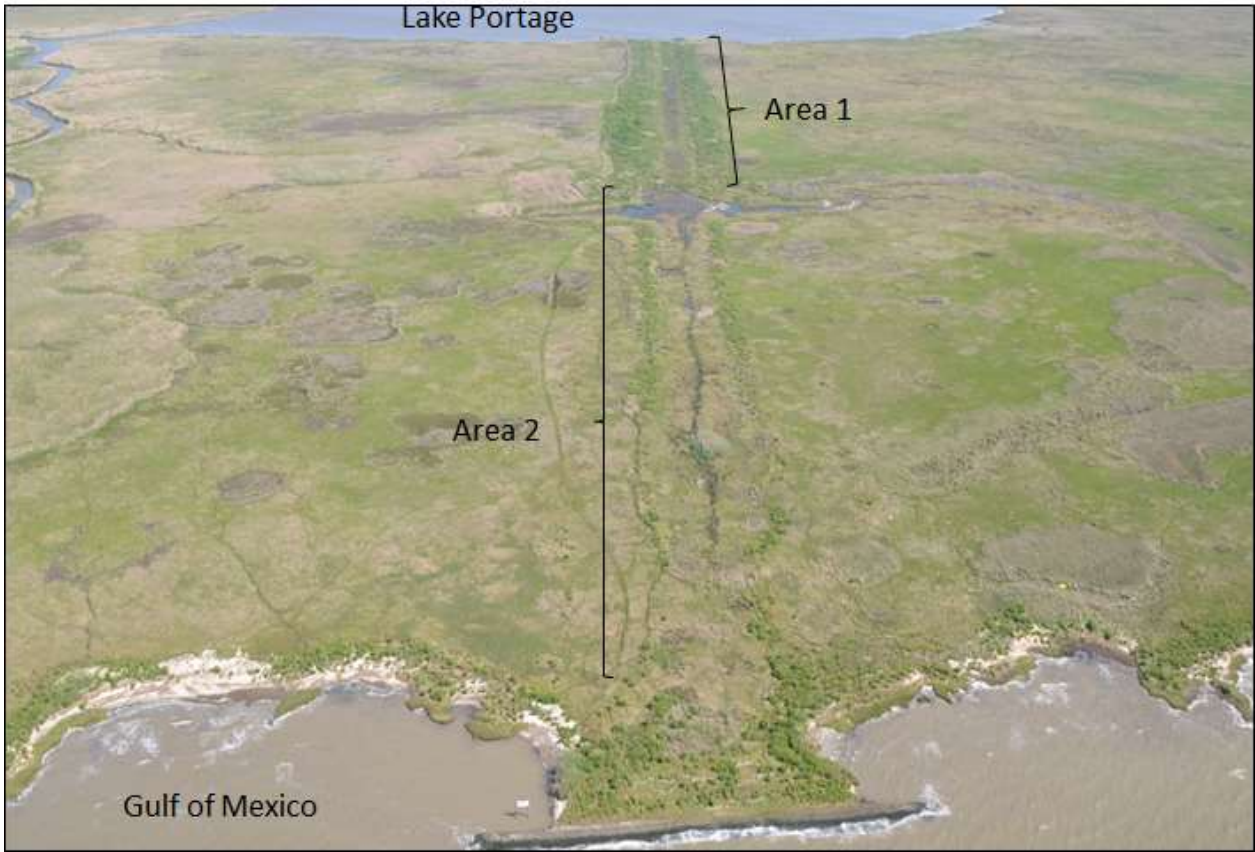
Area 2 was almost completely vegetated by April 2005, with leafy three-square and smooth cordgrass found to be the dominant species, with marshhay cordgrass and big cordgrass co-dominant. *Phragmites australis* (Roseau cane) and salt bush were also present in small amounts. Some isolated ponding near the earthen plug separating Areas 1 and 2 was apparent in 2013 (Fig. 4) and was mostly vegetated by 2018 (Fig. 2C).

**Figure 4.** Oblique aerial photograph of Areas 1 and 2 in 2013. The picture is oriented with north at the top. Photograph courtesy of Louisiana Department of Wildlife and Fisheries.

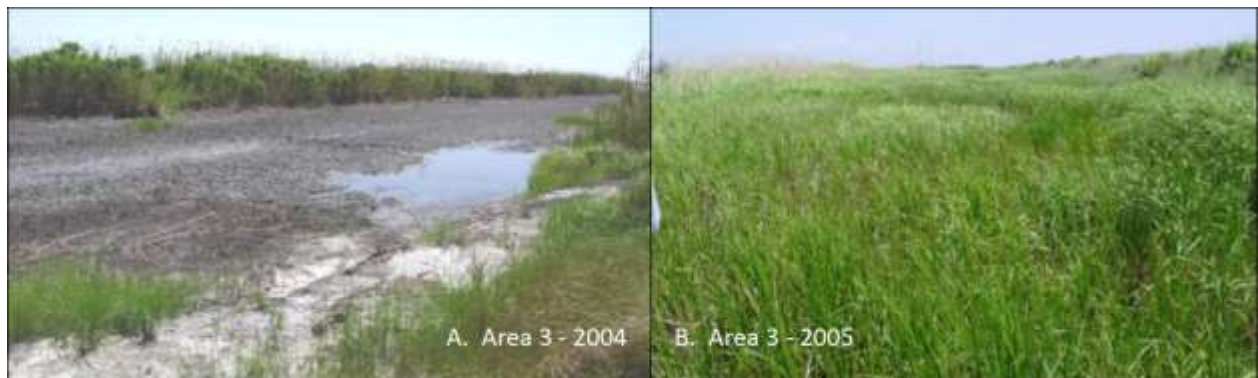
By April 2005, Area 3 had vegetated (Fig. 5) with very a robust community of smooth cordgrass, leafy three-square, and Roseau cane (Fig. 6). The northern portion of the Area 3 closer to the Hell Hole, which overtopped a pre-existing earthen plug and was higher vegetation, still had a bare patch by 2005 that completely vegetated by 2007 (Fig. 5). By 2013, Area 3 was completely vegetated aside from a small trennase connected to Lake Portage (Figs. 5 and 7).

**Figure 6.** Pictures taken of Area 3, one (A) and two (B) years after infilling.

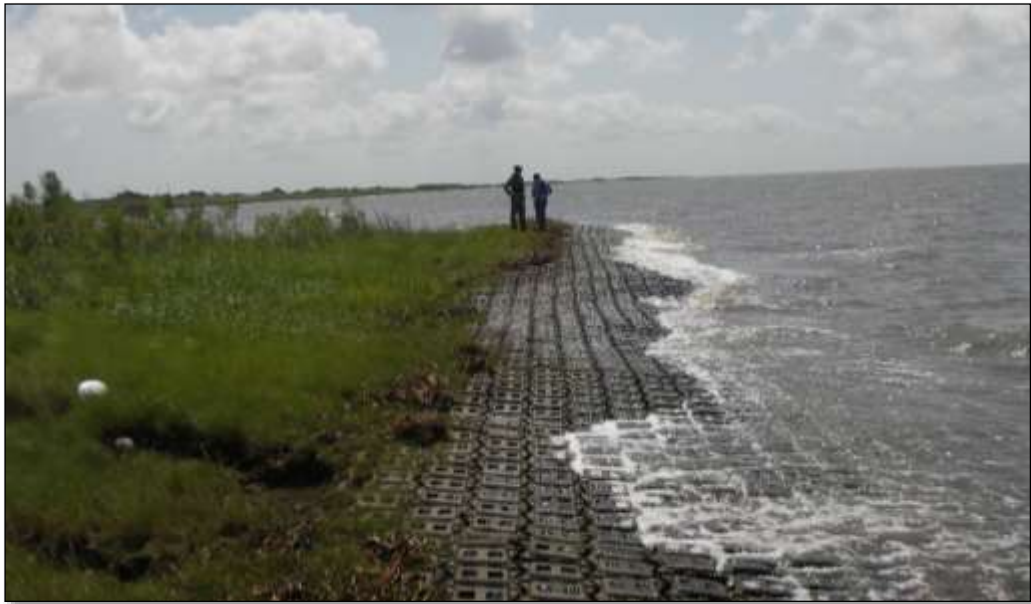
Area 2 is also in good condition and is fully vegetated. Some erosion at the ends of the concrete mats along the Gulf shoreline has occurred over time and part of the mat system is showing signs of failure. Although the concrete mat system is not a feature to be maintained as part of this project, this area is experiencing erosion that may threaten the integrity of the overall project. Therefore, CPRA and NRCS agree that maintenance may be required at some time in the future. With that said, there are no remaining funds in the O&M budget, and the CWPPRA Task Force decided that monitoring of the shoreline should continue but opted not to take any action to address the erosion. (Photos: Appendix A, Photos 2 & 3).

Photo 2- East side –Revetment of Gulf Shoreline

Item	Condition	Physical Damage	Corrosion	Photo #	Observations and Remarks
Timber Bulkhead / Caps	Good				
Steel Grating	N/A				
Salinity Readings					
Concrete Mats	Good			2 & 3	Some erosion each side of concrete mats along Gulf shoreline.
Timber Piles	Good				
Timber Wales	N/A				
Galv. Pile Caps	N/A				
Vegetation	Good			1	Area 1 has solid vegetation.
Signage / Supports	Good				
Rip Rap (fill)	N/A				
Earthen Embankment	Good				
Dredge Spoil	Good

Although the concrete gobi-mat system at the southern end of the project along the Gulf of Mexico is not a project feature, this area is experiencing erosion that may threaten the integrity of the overall project and may need to be addressed. Preliminary survey work to develop an accurate estimate of costs was performed in 2008 and a subsequent request was made to CWPPRA for additional funds. The CWPPRA Task Force decided that monitoring of the shoreline should continue, but opted not to take any action to address the erosion. The gobi-mat system is a pre-existing feature to TV-0017 and is the responsibility of the pipeline owner.

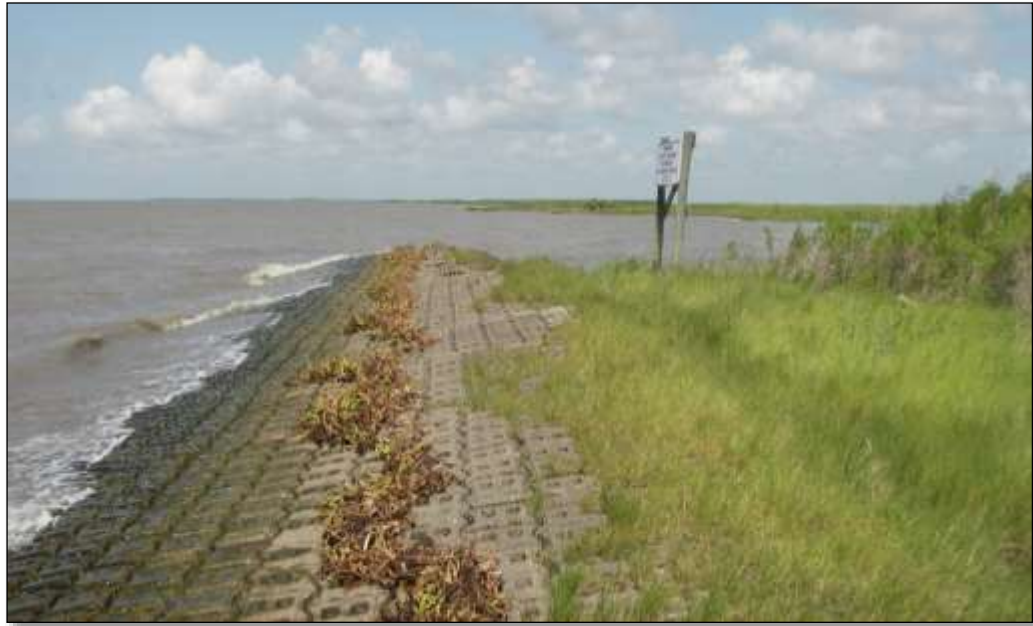
Photo 3—Area 2, Revetment on gulf shoreline

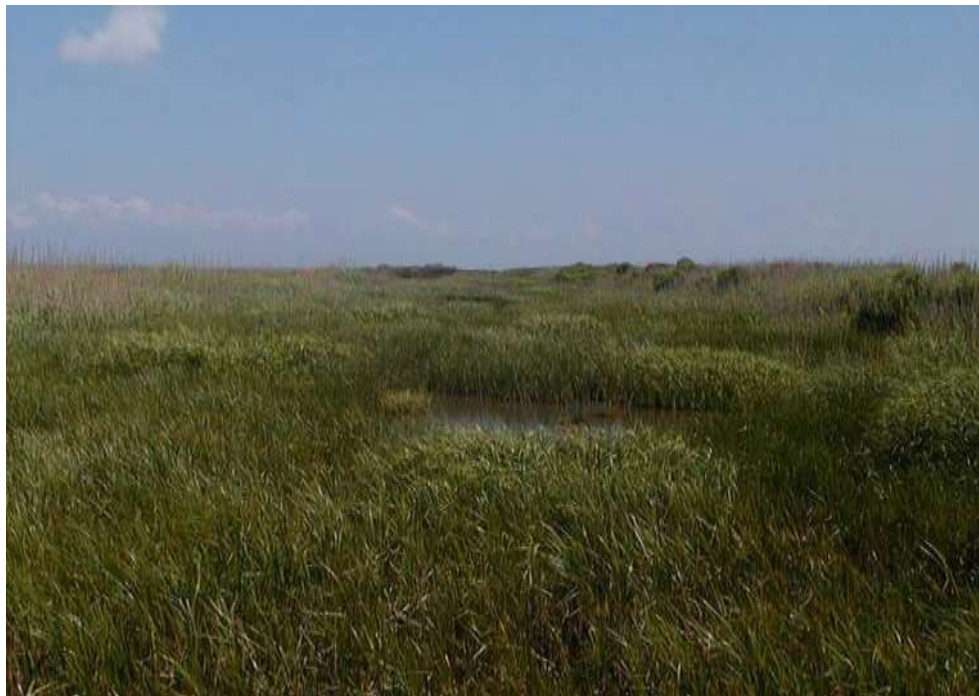
Photo 4—Area 3, vegetation on north canal (looking north)

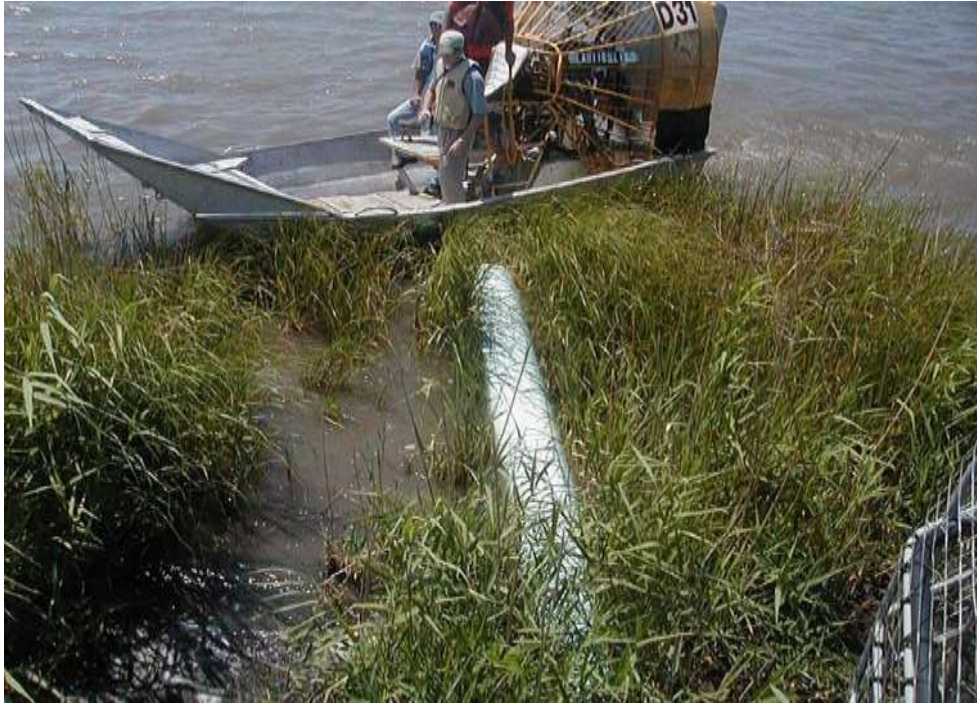
Photo 5—Area 3, 15-in. drain pipe on southern plug of north canal
