**2014/2015 Annual Inspection
Report**

**FOUR MILE CANAL TERRACING
AND SEDIMENT TRAPPING
PROJECT (TV-18)**

State Project Number TV-18
Priority Project List 9

June 24, 2015
Vermilion Parish

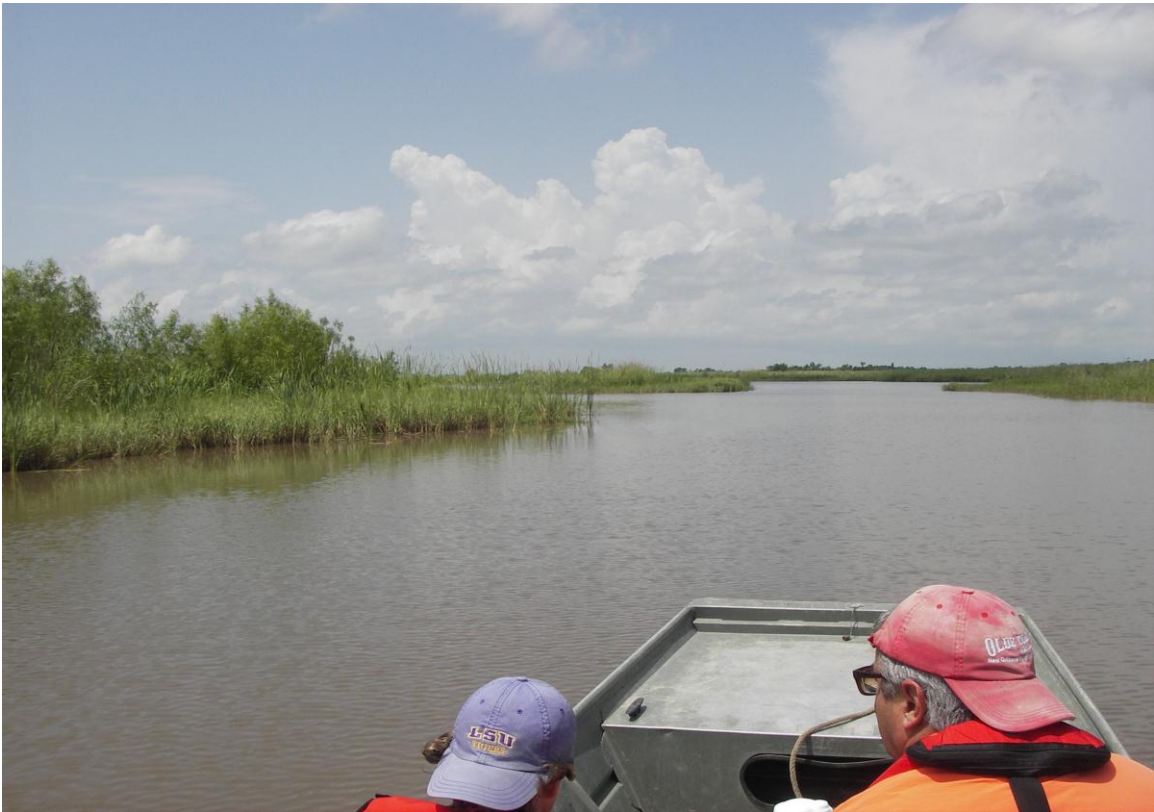
Water levels were approximately +1.0 NAVD. Water depths at the entrance to the terrace field in Little White Lake were very, very shallow. Erosion continues on the 3rd row of terraces with even fewer terraces visible. The 2nd row has begun to suffer effects of the waves. The 1st row remains in excellent condition. The eastern terraces adjacent to the Four Mile Canal continue to erode as well as the western most terraces. The boat wakes continue to damage these terraces. Interior terraces were inspected on this trip and found to be in excellent condition. (Photos: Appendix B, Photo 1-4)

Photo No. 1—Little White Lake terraces (interior row)

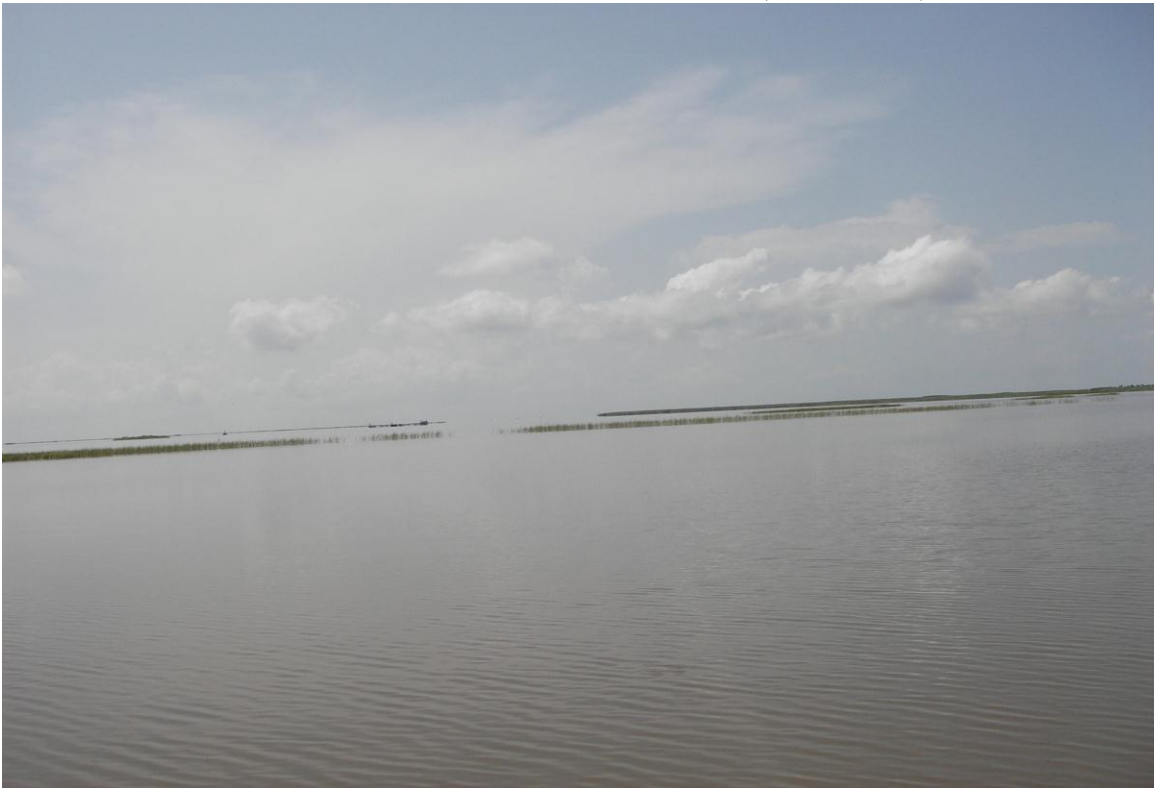
Photo No. 2—Little White Lake terraces (2nd and 3rd rows)

The Four Mile Canal Terracing and Sediment Trapping Project is still in fair condition and functioning as intended where terraces remain intact. Protection of the terraces along Four Mile Canal should still be considered.

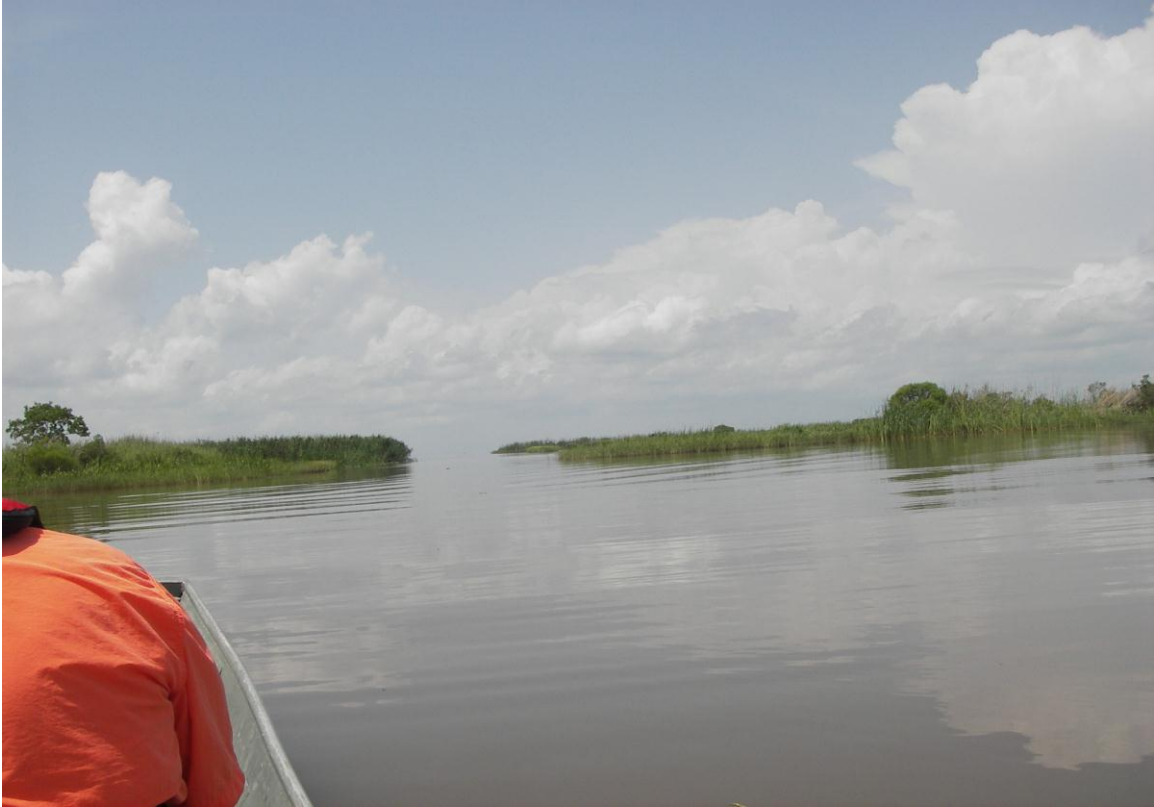
Photo 3—Four Mile Canal terraces

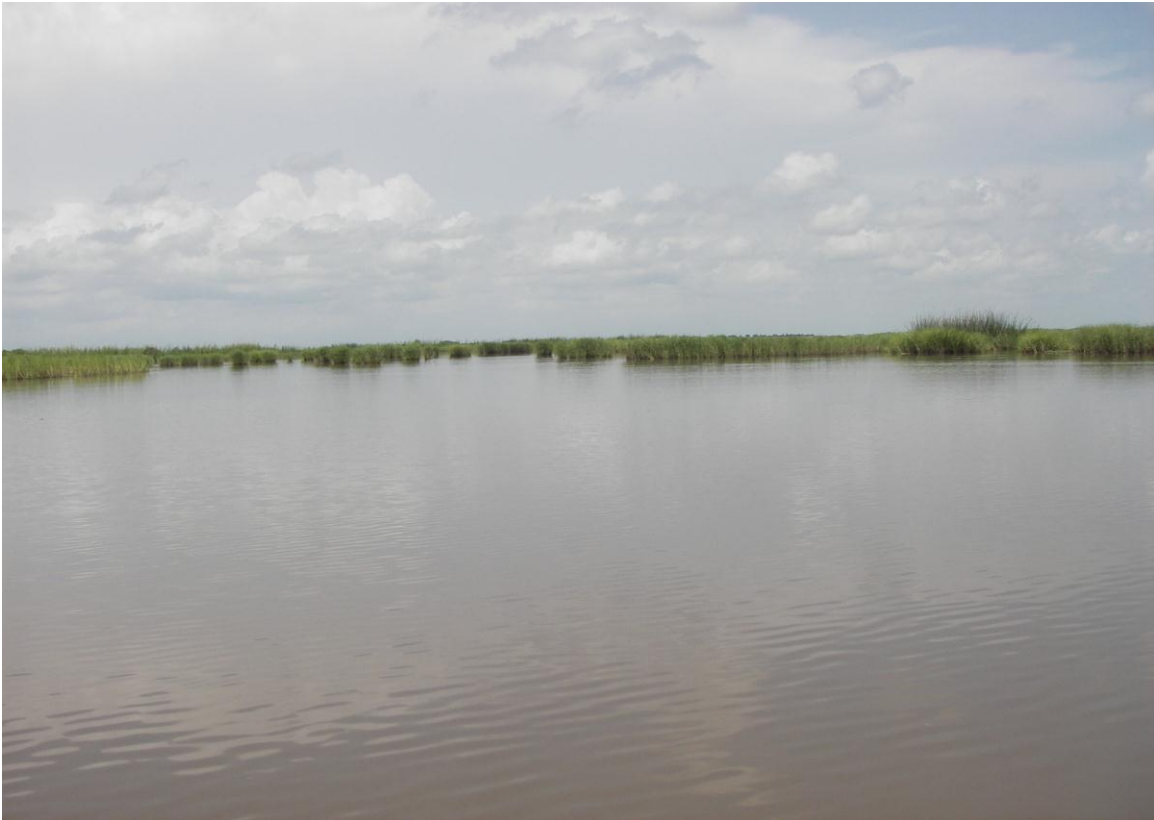
Vegetation on stable terraces in both areas continues to do extremely well. Emergent vegetation has become established and continues to expand. No maintenance with regard to the plantings is needed at this time.

Photo 4—emergent vegetation within Four Mile Canal terraces
