**2015/2016 Annual Inspection
Report**

**FOUR MILE CANAL TERRACING
AND SEDIMENT TRAPPING
PROJECT (TV-18)**

State Project Number TV-18
Priority Project List 9

April 21, 2016
Vermilion Parish

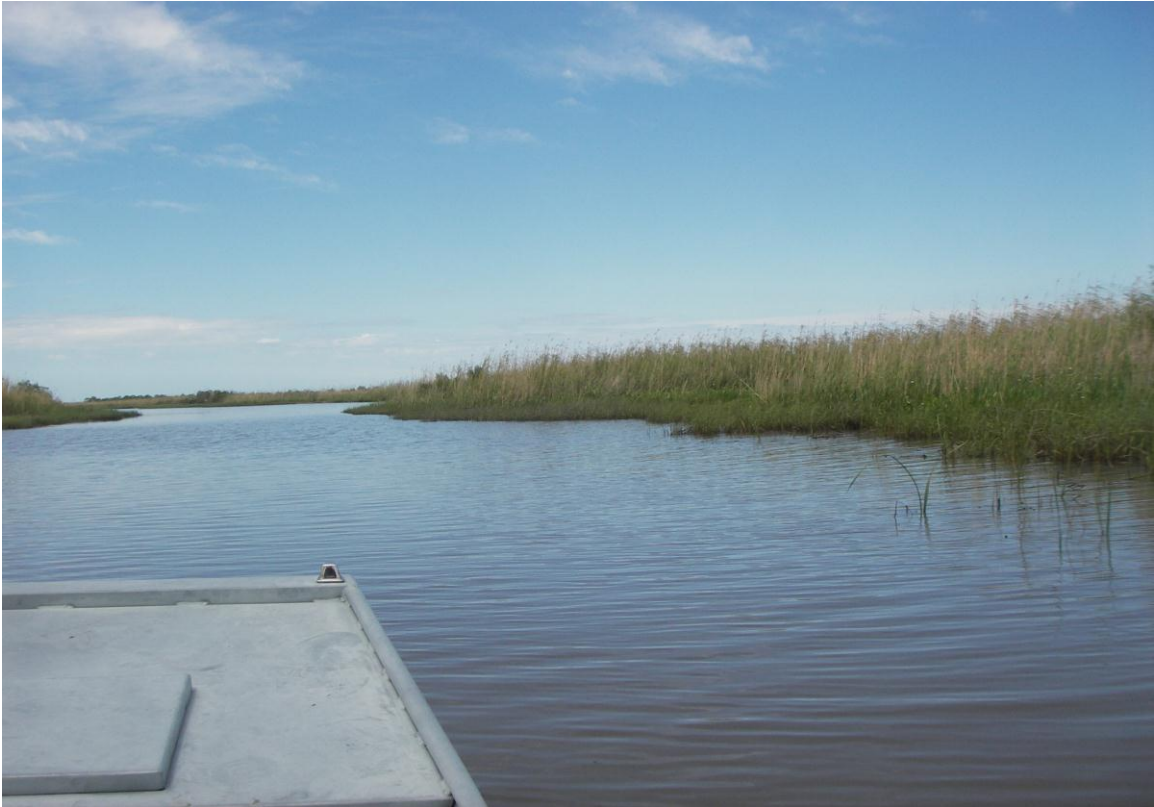
Water depths at the entrance to the terrace field in Little White Lake continue to shallow. The 3rd row of terraces has fewer terraces visible. The 2nd row continues to suffer effects of the waves. The 1st row remains in excellent condition. The eastern terraces adjacent to the Four Mile Canal continue to erode as well as the western most terraces. The boat wakes continue to damage these terraces. Interior terraces were inspected on this trip and found to be in excellent condition. Vegetation between the terraces in both fields is expanding. (Photos: Appendix B, Photo 1-4)

Photo No. 1—Little White Lake terraces (interior row)

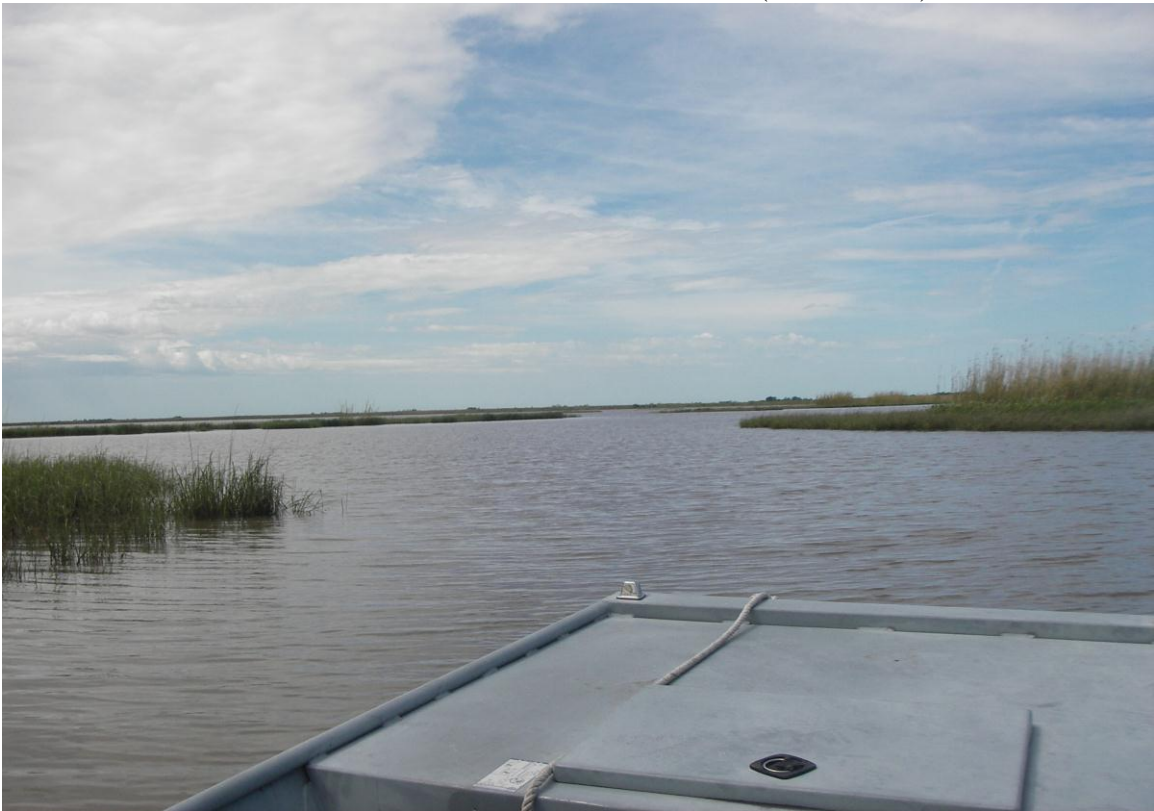
Photo No. 2—Little White Lake terraces (2nd row)

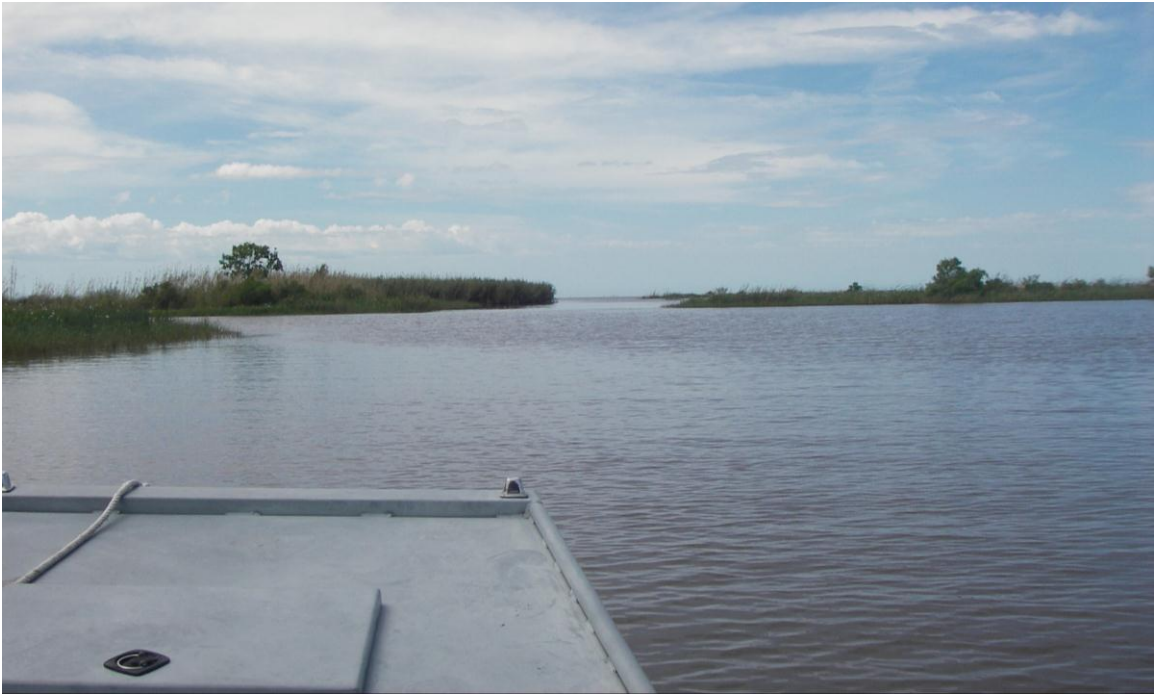
Photo 3—Four Mile Canal
terraces

The Four Mile Canal Terracing and Sediment Trapping Project is still in fair condition and functioning as intended where terraces remain intact. Protection of the terraces along Four Mile Canal should still be considered.

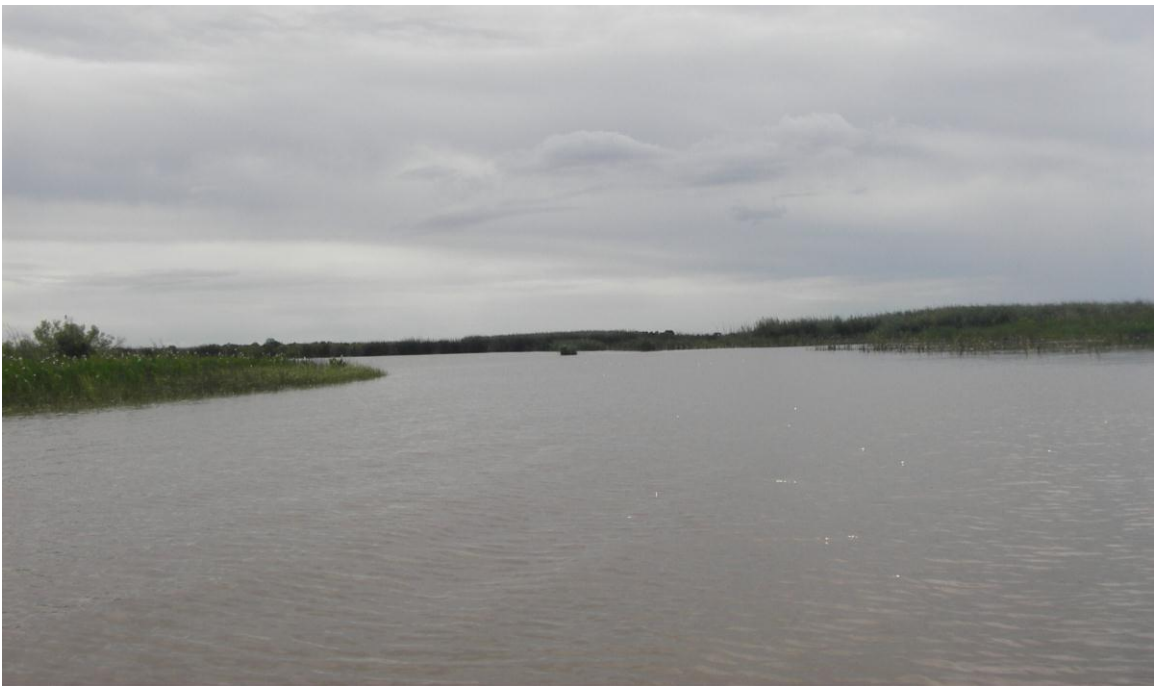
Vegetation on stable terraces in both areas continues to do extremely well. Emergent vegetation has become established and continues to expand. No maintenance with regard to the plantings is needed at this time.

Photo 4—emergent vegetation within Four Mile Canal terraces
