COLE'S BAYOU MARSH RESTORATION PROJECT (TV-63) PROJECT COMPLETION REPORT

Project: Cole's Bayou Marsh Restoration Project

State Project No.: TV-63

By: Sellers & Associates, Inc.

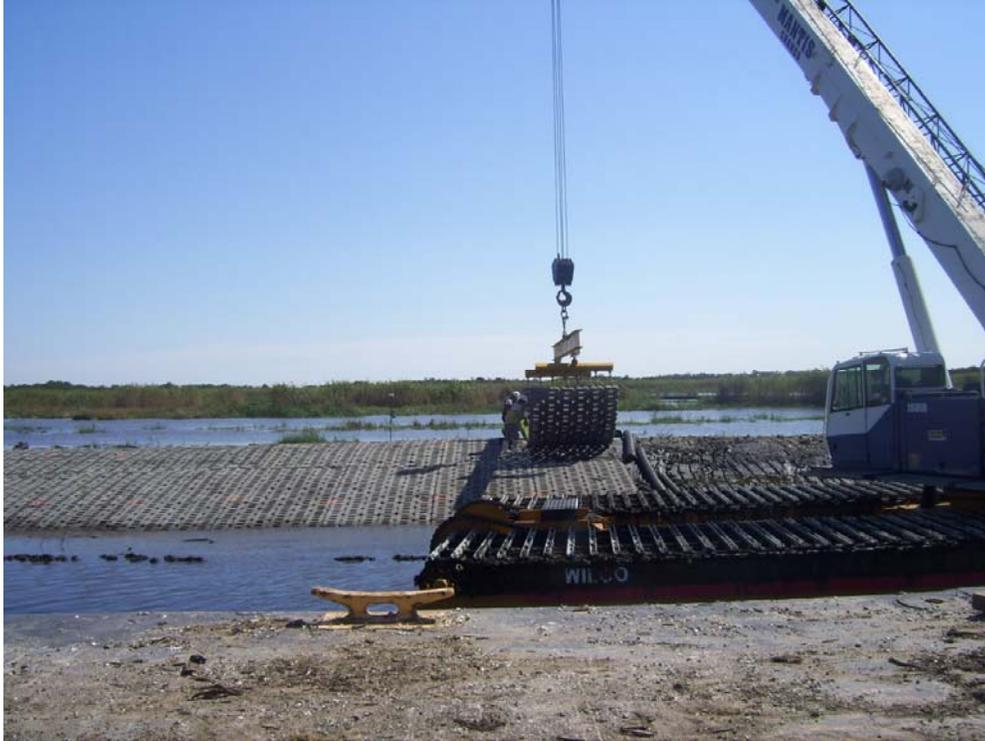
Upon completion of ECD 1, non-woven geotextile fabric and articulated concrete block mats were installed along Freshwater Bayou to protect the ECD from erosion and scour due to high vessel traffic in the project area, as shown in figure 2.

Figure 2: Articulated Concrete Block Mats placed along ECD 1

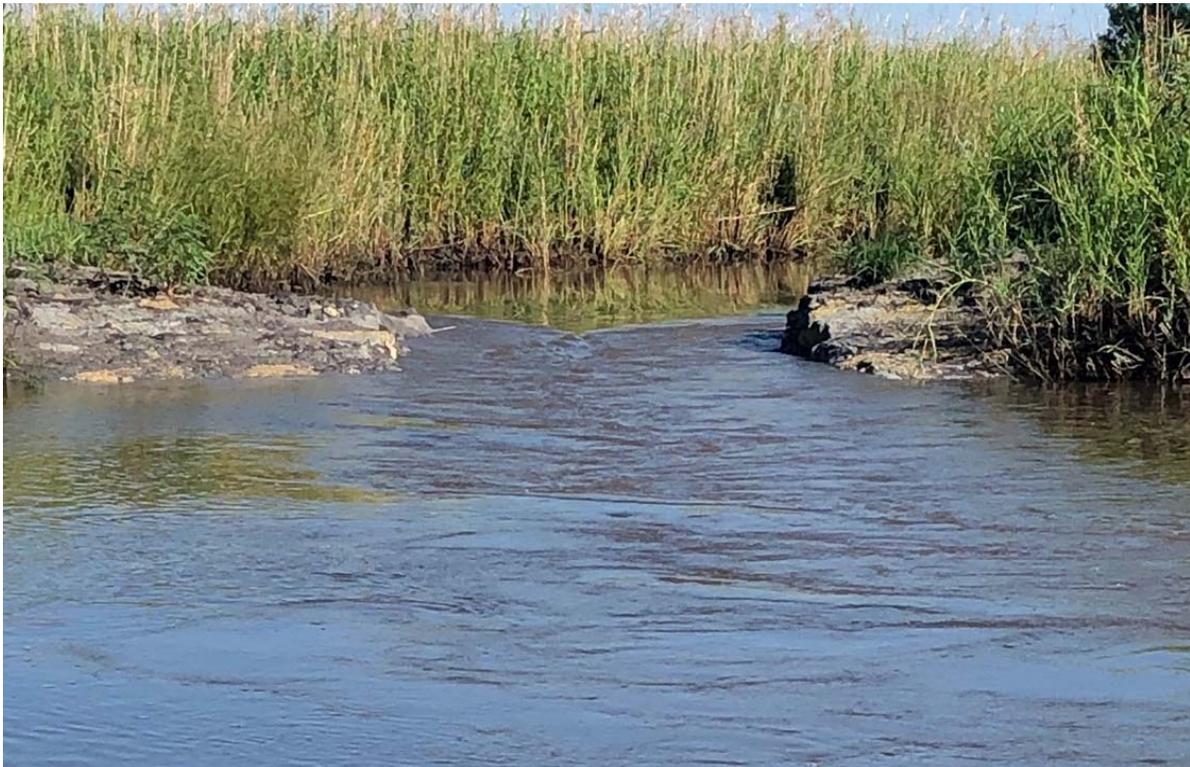
Figure 37: EP 6 (6/14/2019)

EP 6 presented various challenges, similar to EP 3. EP 6 continuously settled and degraded after initial construction was complete (degradation shown in Figure 37). Animals (alligators crossing), Hurricane Barry, boats crossing, water level fluctuation and tidal flushing contributed to the erosion and degradation of the plug. To ensure the structural stability of EP 6, it was rebuilt and protected with geotextile fabric and ACB mats through Change Order No. 4. The design target elevation of EP 6 was 2.5', while the as-built elevation varies from 2.5' – 3.3'. EP 6 was constructed using material excavated from the adjacent canal.

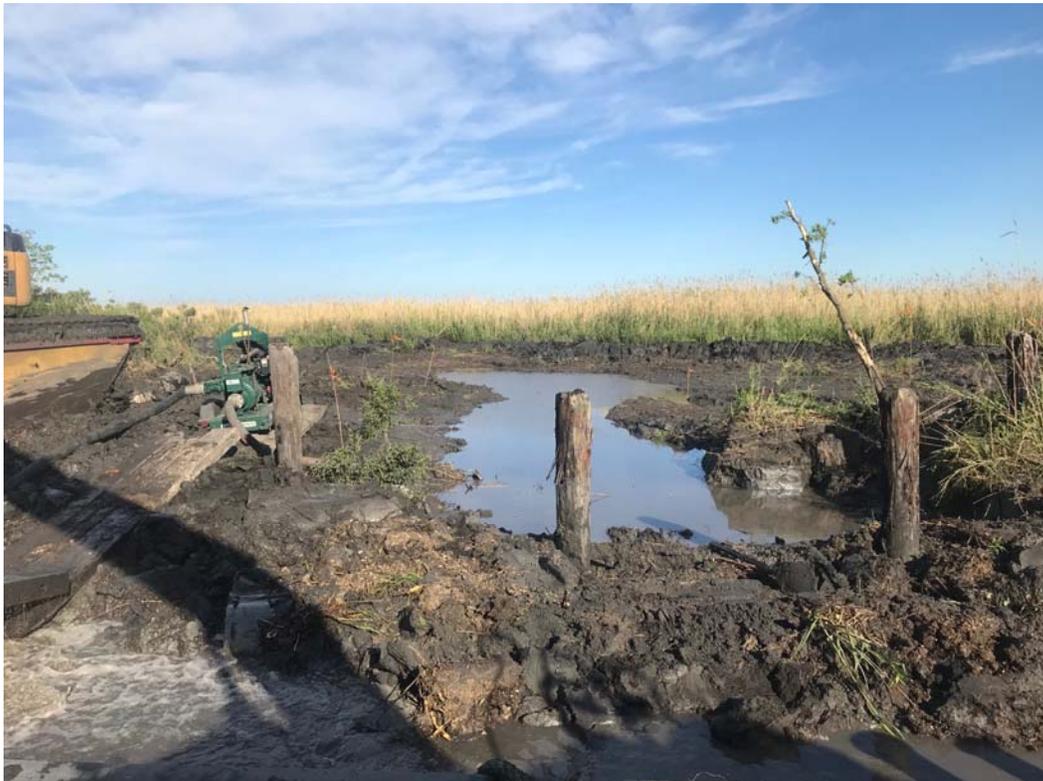
Figure 39: Existing Wooden Piles to be removed at WCS 6 (4/15/2019)

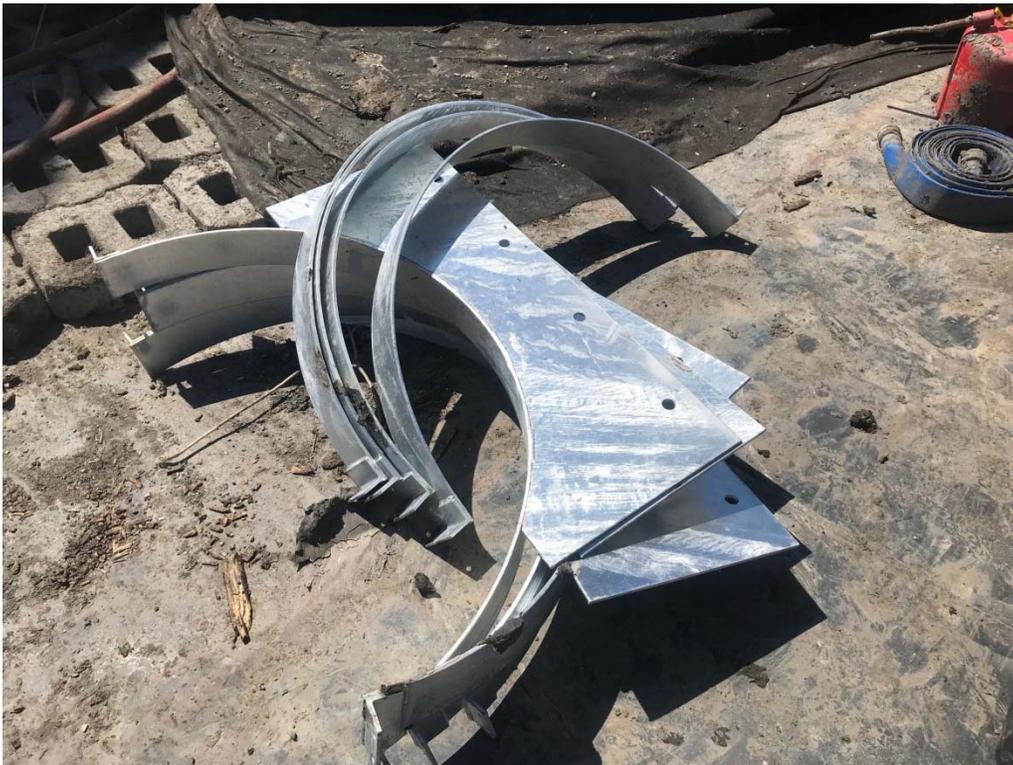
Water Control Structure 9 included the installation of three 42" corrugated metal pipes, each containing a Red Valve in-line check valve. WCS 9 was the first WCS constructed in the Cole's Bayou Marsh Restoration Project. During the construction of WCS 9, it was observed that the end of the CMPs without the check valve experienced an uplift causing the invert of the intake to be above the required elevation. It is suspected that the uplift was caused by inadequate bedding and support under the pipe, the weight of the earthen embankment and ACB mats on top of the pipe, and movement/pumping of earthen material below the pipe. To compensate for the uplifting forces a new bid item, "CMP Collars," was included in Change Order No. 3 to secure the ends of the CMPs to the timber joists. The CMP collars are shown in Figure 56. Prior to CMP collar fabrication, an alternative solution was required at WCS 9 to allow construction to proceed while preventing uplift in the culverts. A steel cable was used to secure the pipe to the timber joist below. This method was approved and utilized only at WCS 8 and 9.

Figure 56: CMP Collars

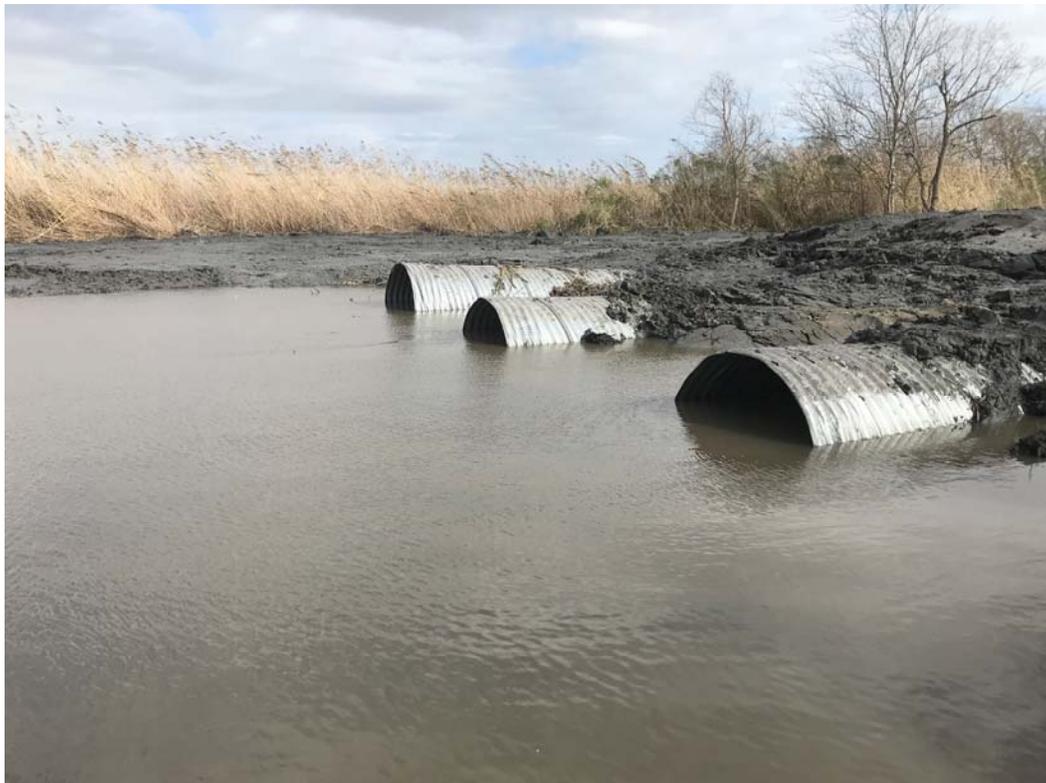
Figure 62: WCS 9 showing intake of "pipe A" a higher elevation than the other two (1/22/2019)
