**Coastal Protection and Restoration
Authority (CPRA)**

2017 Operations, Maintenance, and Monitoring Report

Cote Blanche Hydrologic Restoration

State Project Number TV-04
Priority Project List 3

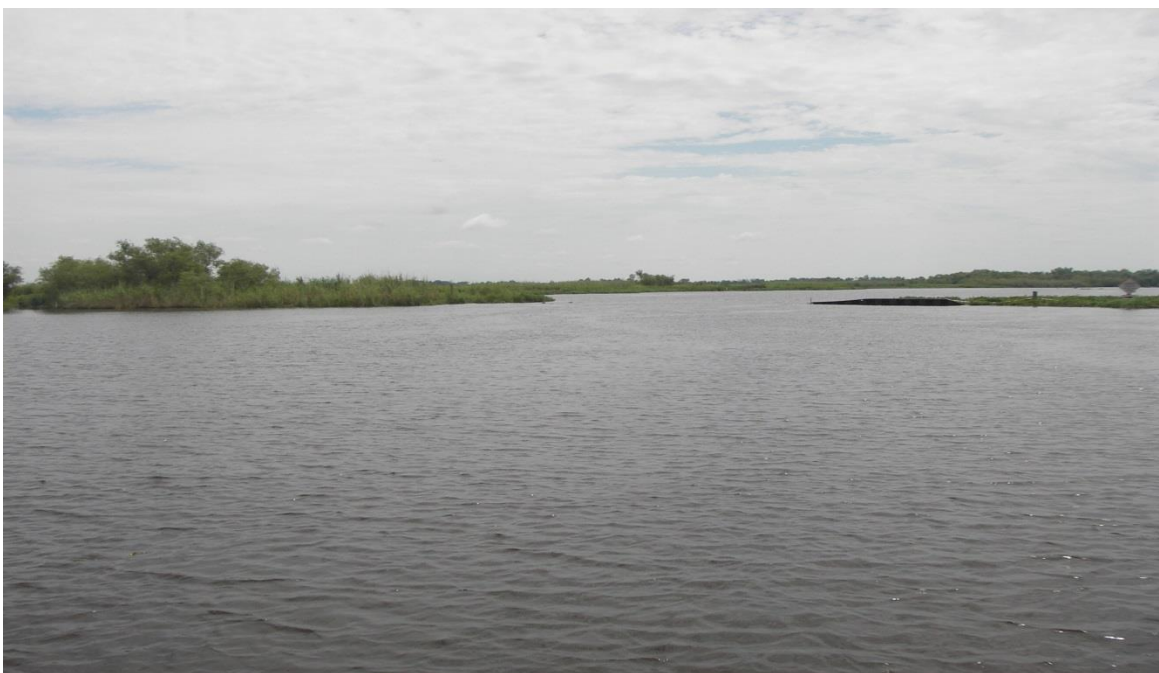
The Mud Bayou structure remains in fair shape. Rust on the sheet piles and the pile cap continues. The railings have been replaced with stainless steel cable and are holding up well. The north danger sign is missing and will not be replaced. Erosion of the bank on the south side of the structure is becoming apparent. Staff gauges are no longer functional. (Photos: Appendix A, Photo 1, 18)

Photo 1--Mud Bayou structure

Item	Condition	Physical Damage	Corrosion	Photo #	Observations and Remarks
Steel Bulkhead / Caps	good			1	Structure in good condition and functioning as intended. Rust continues to be monitored.
Steel Grating	N/A				Staff gauges need to be replaced.
Stop Logs	N/A				
Hardware	good				
Timber Piles	good				
Timber Wales	N/A				
Galv. Pile Caps	N/A				
Cables	Good			1	Railings have been replaced with stainless steel cables
Signage / Supports	good				The north danger sign is missing and will not be replaced.
Rip Rap (fill)	good				
Earthen Embankment	Fair			1	Erosion of the bank on the South side of the structure is becoming apparent.

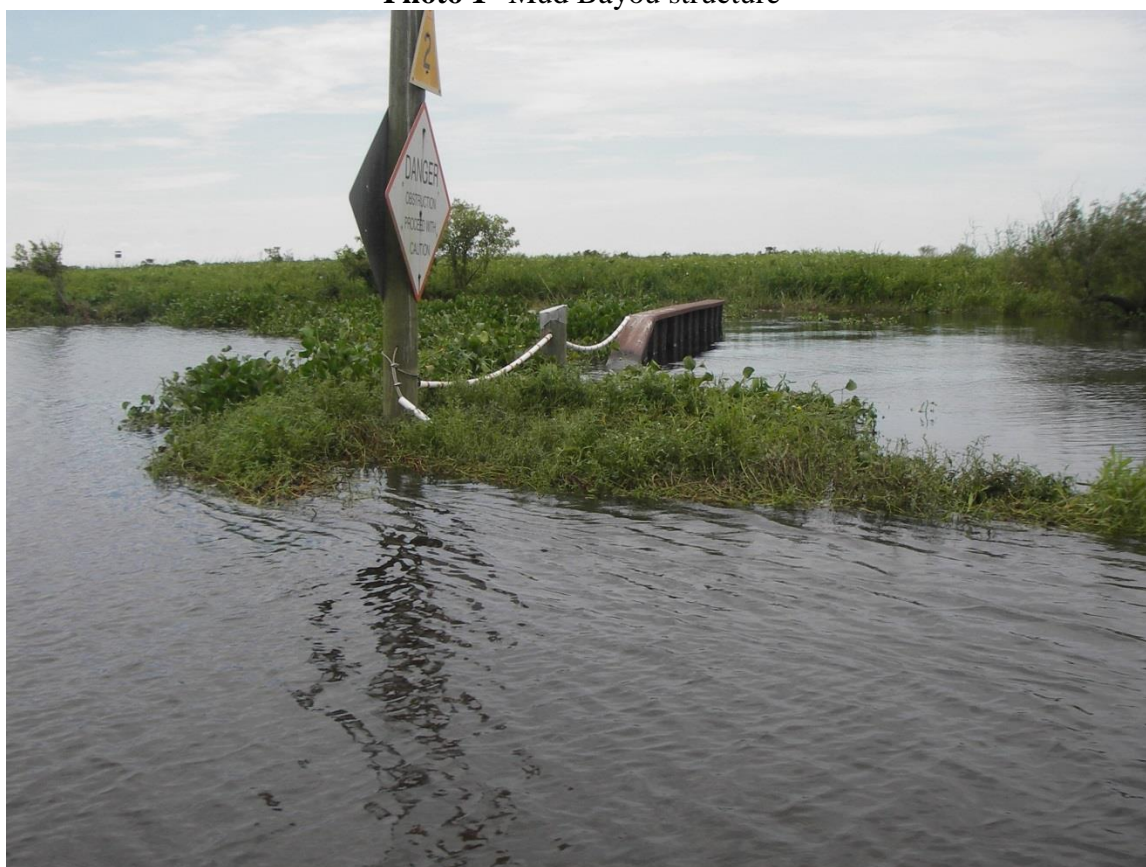
Both pilings and arrow signs replaced during the last maintenance event (north side) is missing, again. Stainless steel cables remain. Sheet piles and rocks on the end of the structure are stable and functioning as intended. Rust on the sheet piles will be monitored. The bayshore continues to erode in front of this structure to the point that the structure is near the bayshore. (Photos: Appendix A, Photo 2, 18)

Photo 2—Cable attached to broken pile and sign at Humble F Canal structure

Item	Condition	Physical Damage	Corrosion	Photo #	Observations and Remarks
Steel Bulkhead / Caps	good			2, 18	Structure in good condition. Some slight rusting of pile caps.
Steel Grating	N/A				
Stop Logs	N/A				
Hardware	good				
Timber Piles	good				
Timber Wales	N/A				
Galv. Pile Caps	N/A				
Cables	Good			2	Stainless Steel Cables are present and functioning.
Signage / Supports	good			2	The piling and arrow sign replaced during last maintenance on north side is missing.
Rip Rap (fill)	good				Rock on end of structure is stable and functioning as intended.
Earthen Embankment	N/A				The bay shore in front of the structure continues to erode such that the structure is now near the bayshore.

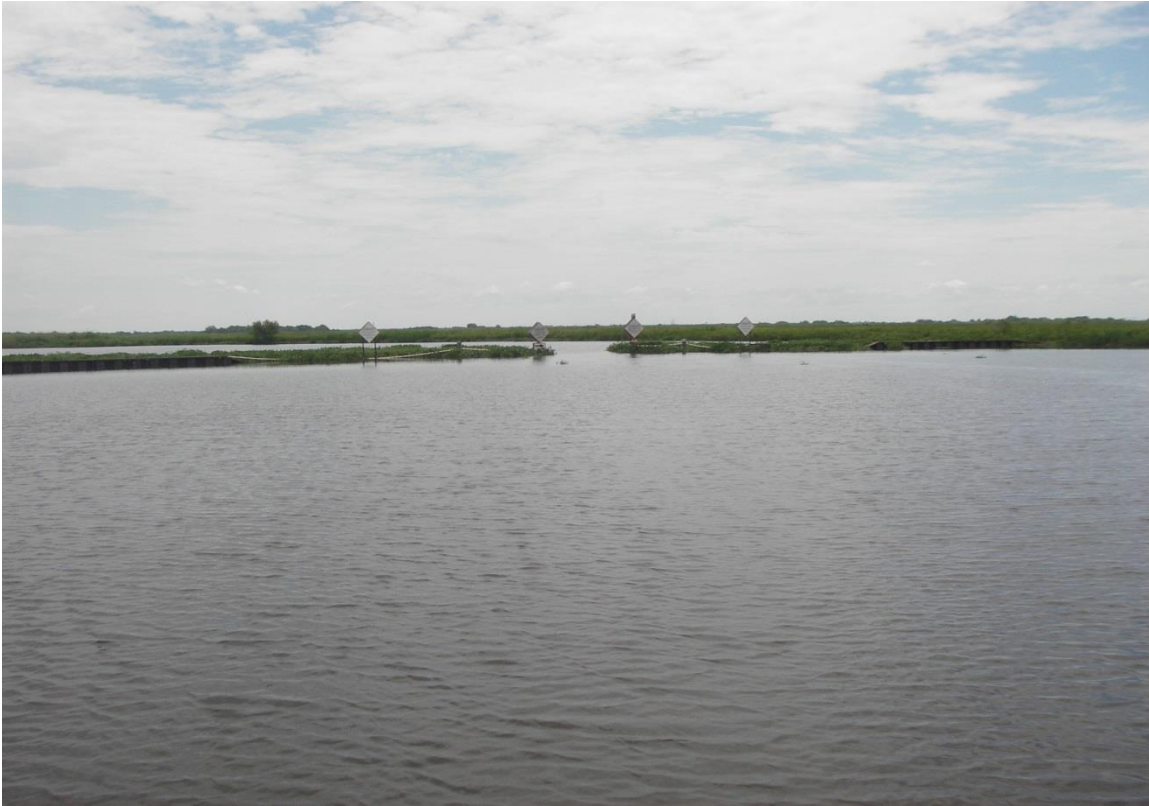
The structure is in fair to good post-maintenance condition. Rusting on the sheet piles has significantly worsened. (Photos: Appendix A, Photo 3, 18)

Photo 3—Bayou Long structure

Item	Condition	Physical Damage	Corrosion	Photo #	Observations and Remarks
Steel Bulkhead / Caps	good			3, 18	Rusting on steel sheet piles will continue to be monitored.
Steel Grating	N/A				
Stop Logs	N/A				
Hardware	good				
Timber Piles	good				
Timber Wales	N/A				
Galv. Pile Caps	N/A				
Cables	Good			3	The railings on the structure have been replaced with stainless steel cables.
Signage / Supports	good			3	Signage is in place
Rip Rap (fill)	good				
Earthen Embankment	N/A

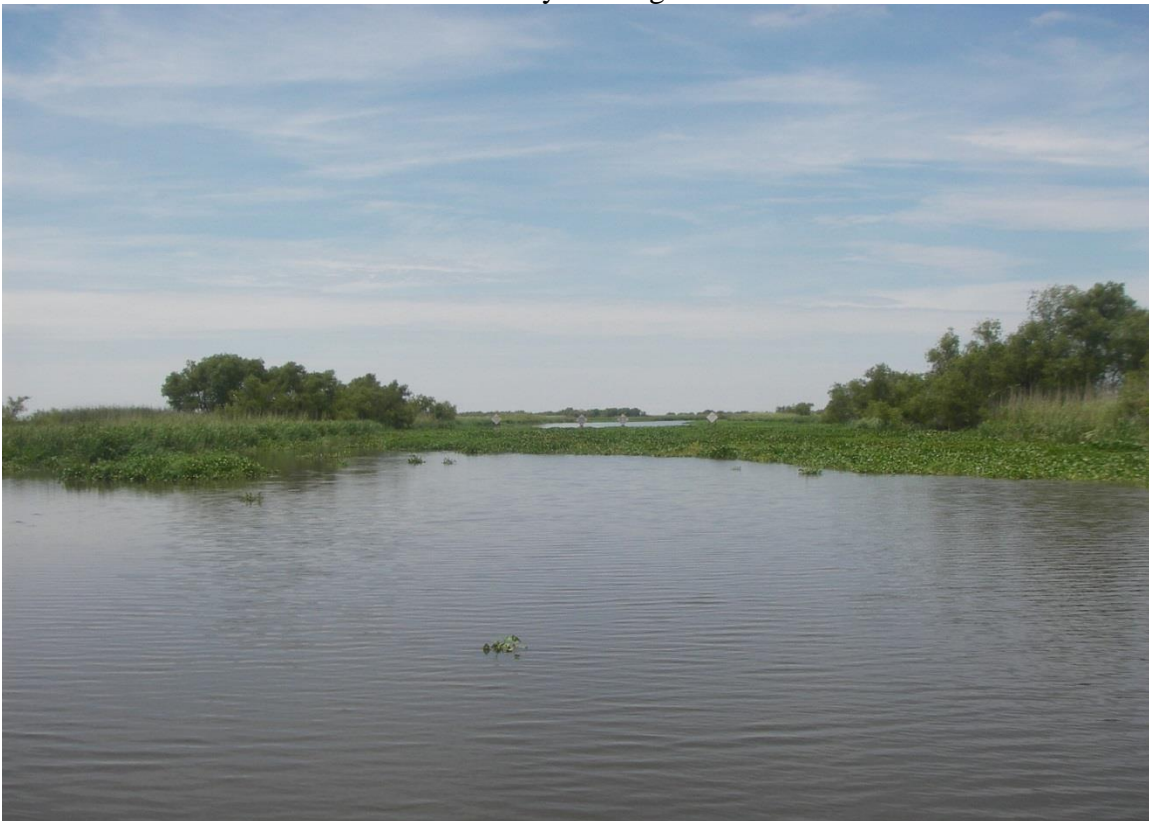
The structure is in fair to good post-maintenance condition. Pilings and stainless cables are all in place and functioning. Rusting on the sheet piles wasn't evaluated due to massive water hyacinth build-up. (Photos: Appendix A, Photo 5-7, 18)

Photo 4--Bayou Carlin Structure

Item	Condition	Physical Damage	Corrosion	Photo #	Observations and Remarks
Steel Bulkhead / Caps	good			4	Structure is in fair to good post-construction condition. Hyacinths prevented a close up inspection of the structure. Sheet piling and stainless steel cables were in place.
Steel Grating	N/A				
Stop Logs	N/A				
Hardware	good				
Timber Piles	good				
Timber Wales	N/A				
Galv. Pile Caps	N/A				
Cables	N/A				
Signage / Supports	good			4	present and functioning
Rip Rap (fill)	N/A				
Earthen Embankment	N/A

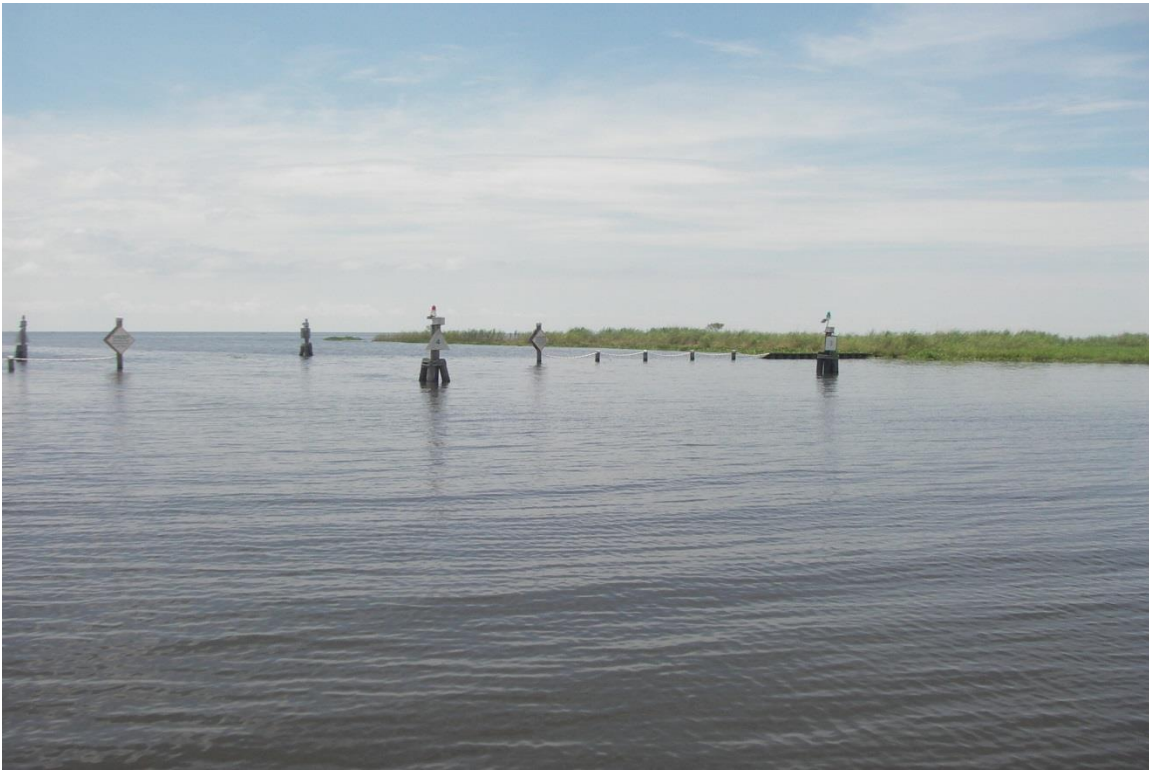
The pile cap on the eastern side of the structure is completely gone. The cables installed to replace the rails continue to function as intended except where it was attached to the pile cap on the eastern side. Rock that was placed to extend the keyway closure has settled but is in otherwise good shape. Signage/lighting is all stable. Rust continues to worsen. (Photos: Appendix A, Photos 5-7, 18)

Photo 5--Humble Canal structure

Item	Condition	Physical Damage	Corrosion	Photo #	Observations and Remarks
Steel Bulkhead / Caps	good			5-6, 18	Rust continues to worsen and will be monitored.
Cables	Good			5-6	Rusting on sheet pile will continue to be monitored. No immediate action needed.
Stop Logs	N/A				Railings have been replaced with stainless steel cables. The stainless steel cables are functioning except for the area which was connected to the pile cap.
Hardware	fair				
Timber Piles	N/A				
Timber Wales	N/A				
Galv. Pile Caps	Fair			6	Pile Cap on East Side is Missing
USCG Lights	good			5	Present and functioning
Signage / Supports	good			5	Present and functioning
Rip Rap (fill)	good			7	Some settlement but still in good condition
Earthen Embankment	N/A

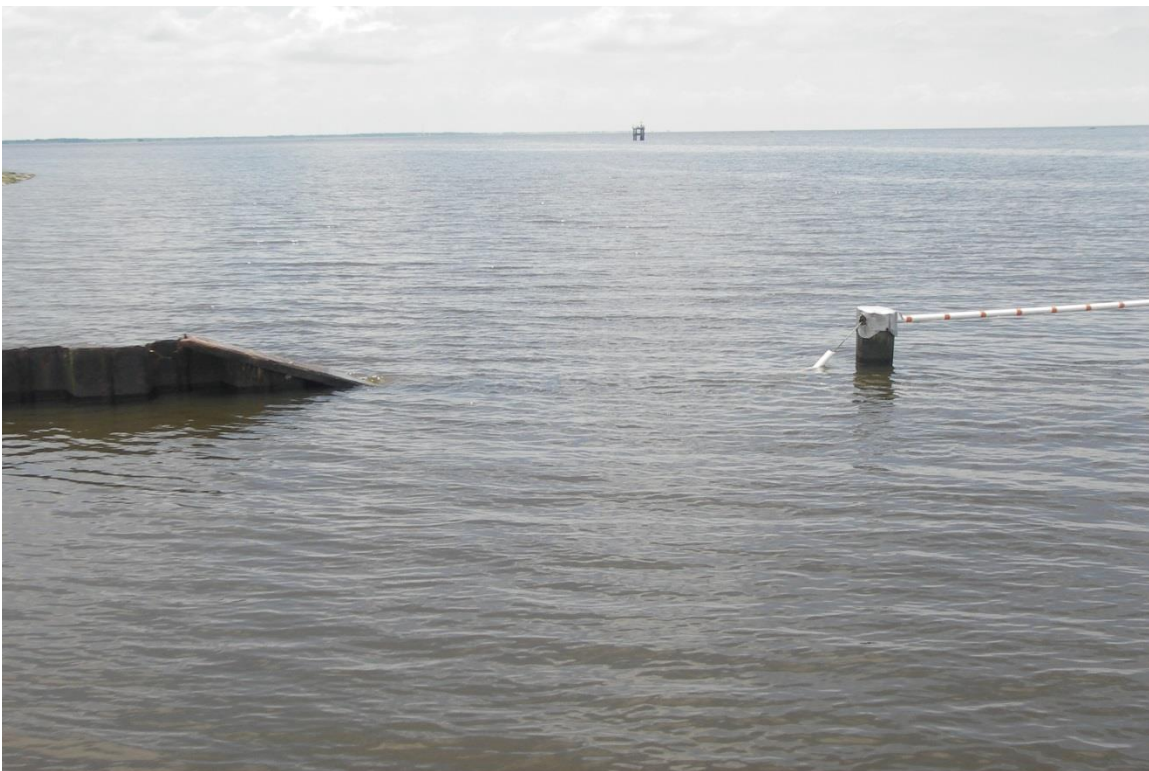
Photo 6—Humble Canal structure east side showing missing pile cap and disconnected cable

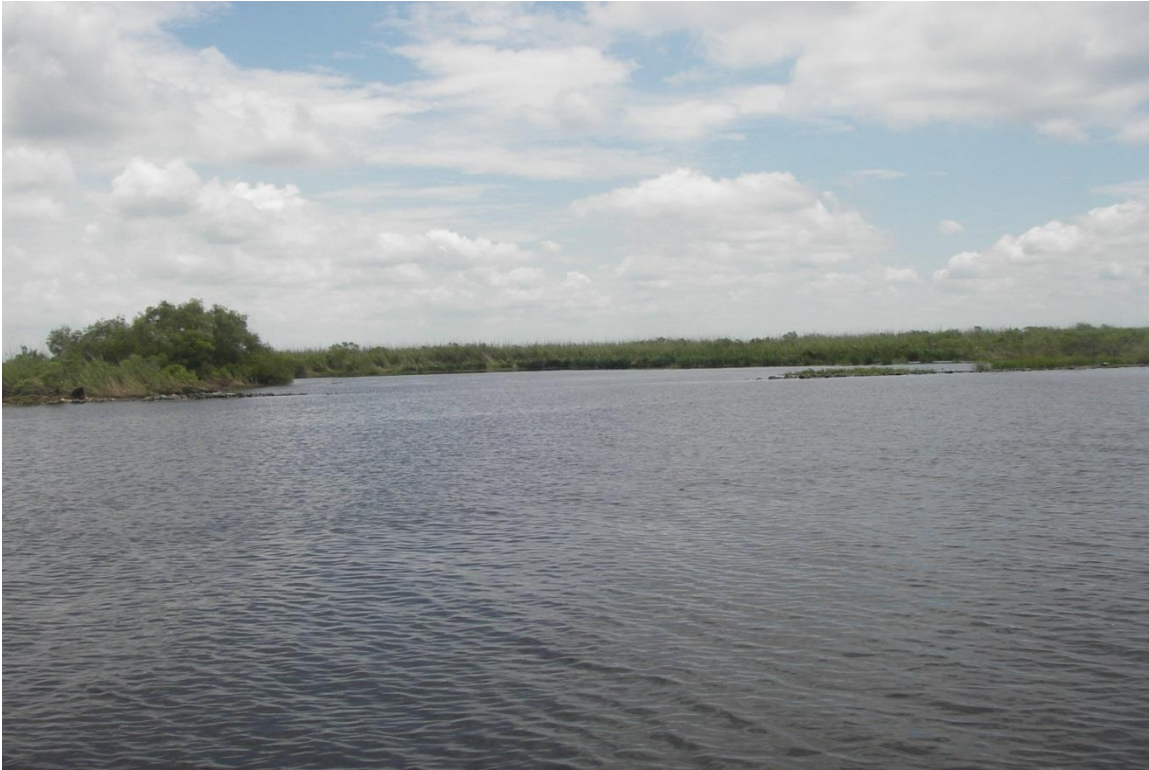
Photo 7--rock on east side of Humble Canal

Rock will be needed in the future to combat bankline erosion at the following features: Mud Bayou, Humble Canal, School Bus Bayou, and Jackson Bayou. Shoreline retreat near some of the structures may require alternative solutions.

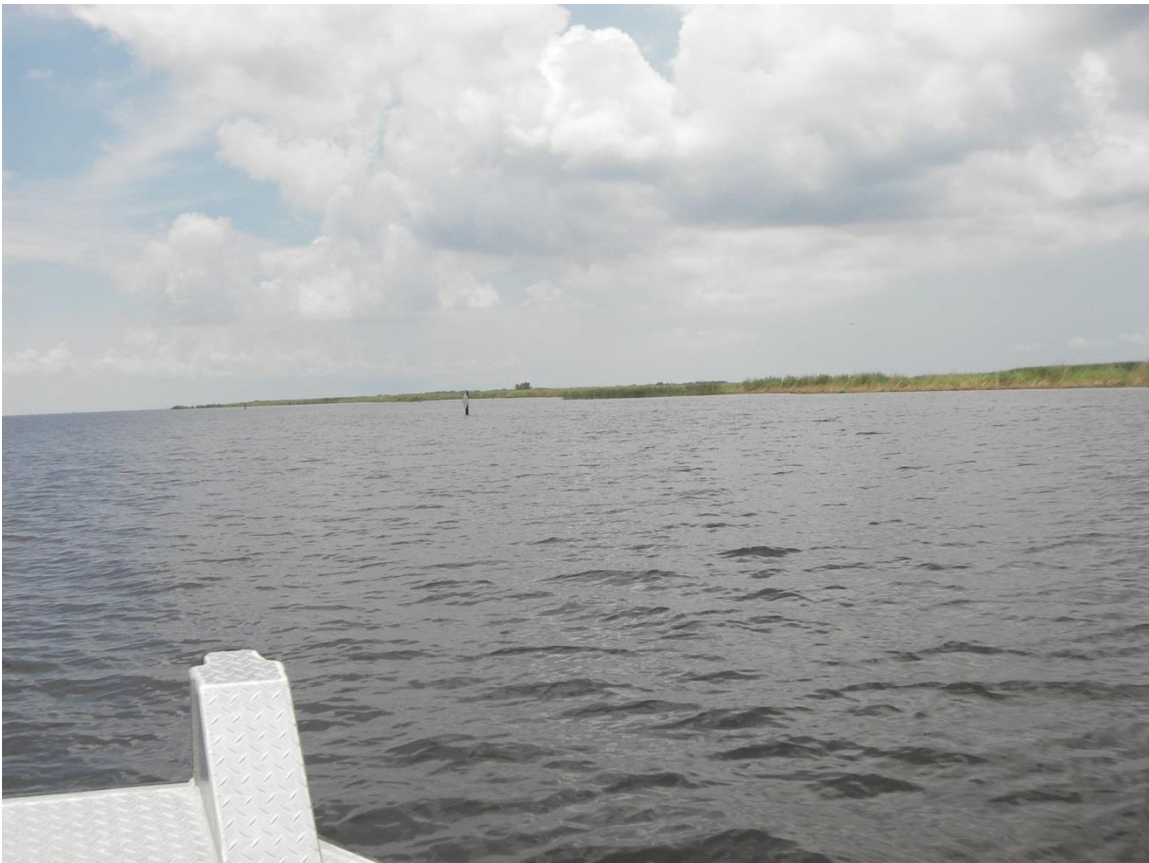
The dike was completely submerged due to high tides and was unable to be inspected. Signage along the bayshore is intact. Rock at the eastern intersection of School Bus Bayou and Humble Canal is in place and stable. No rock was found on the western side. Signage for the two weirs at the crossings is ok. (Photos: Appendix A, Photos 8-10)

Photo 8—area of submerged School Bus Bayou dike

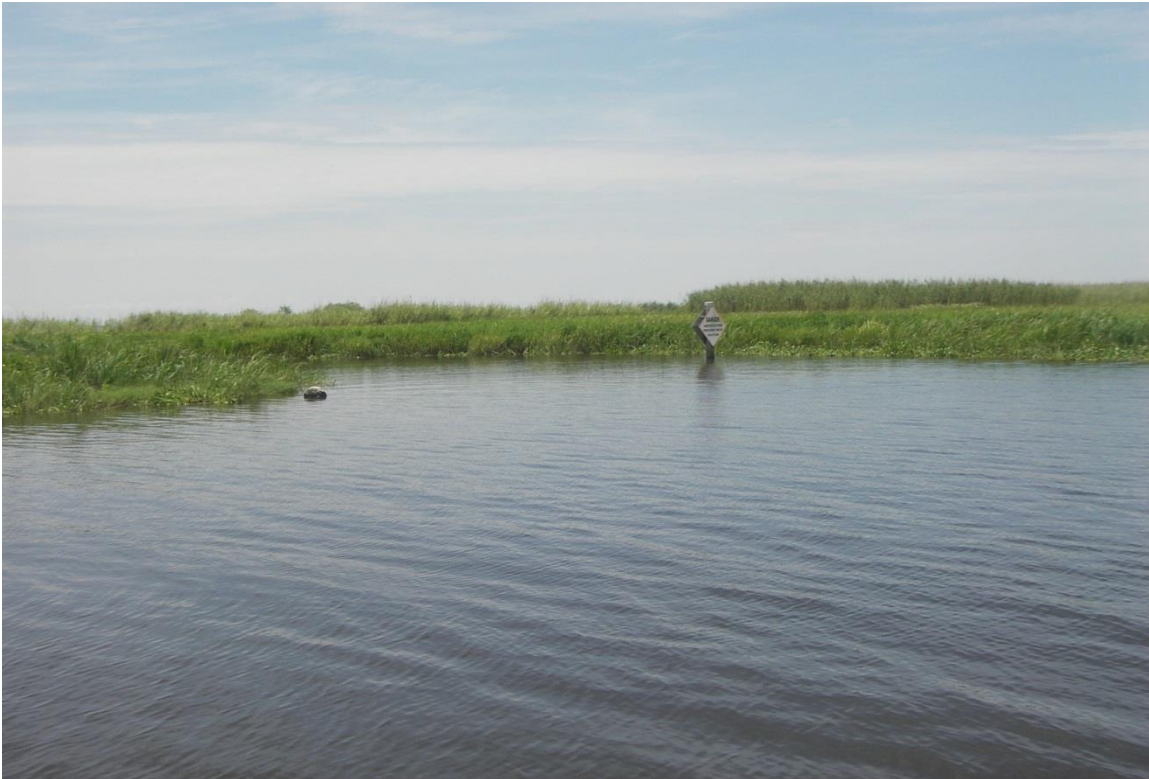
Photo 9—western weir at School Bus Bayou

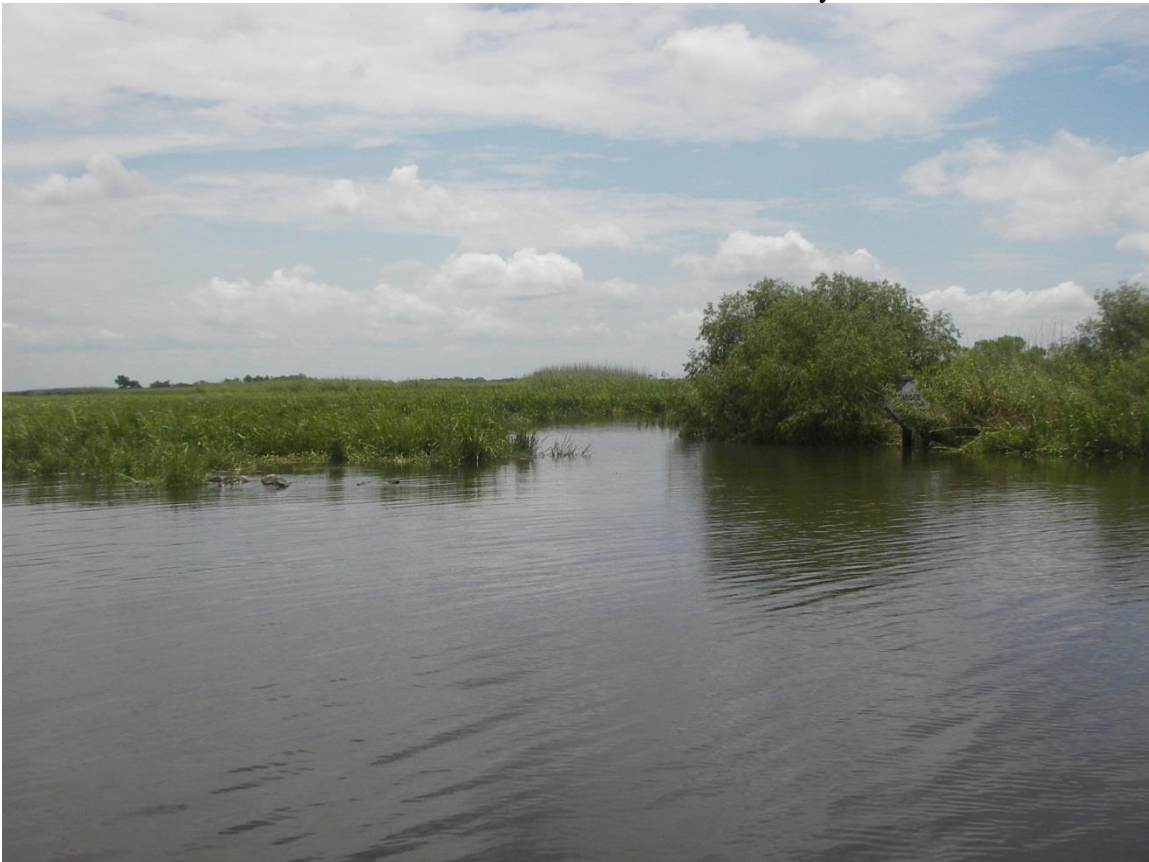
Photo 10—eastern weir at School Bus Bayou

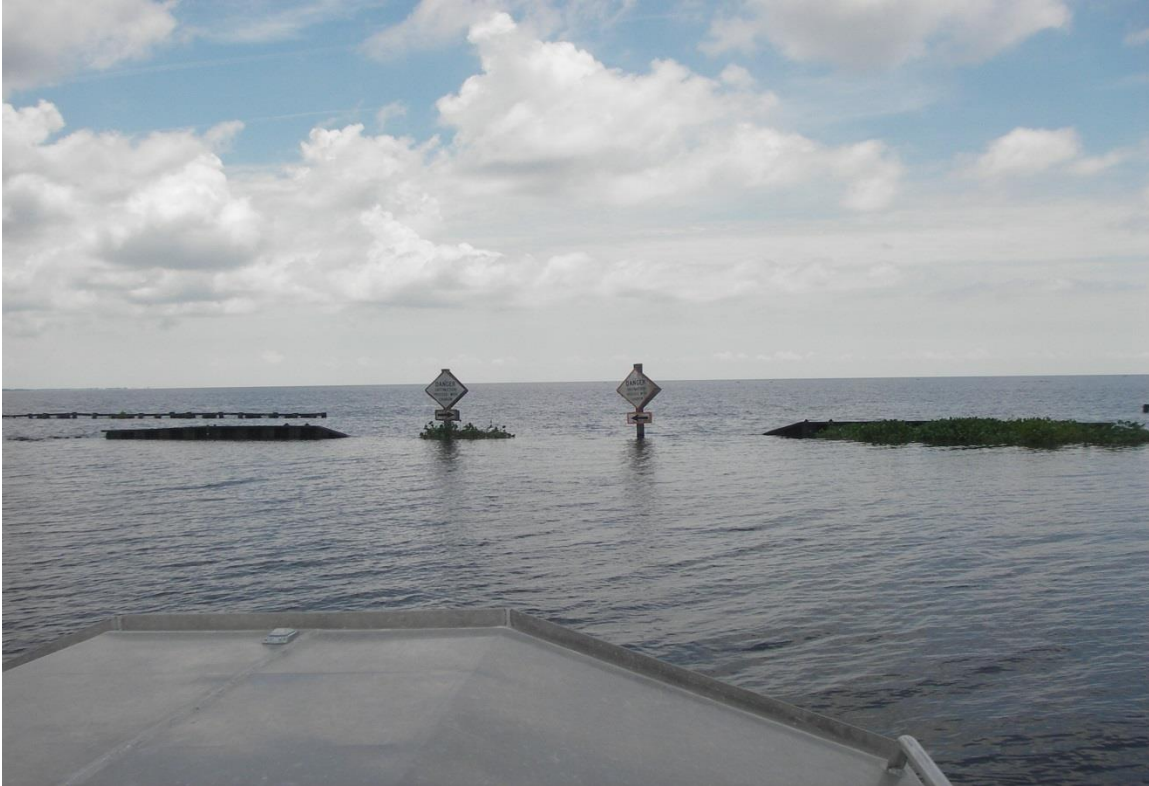
Rust continues at this site. Erosion, especially on the western side of the structure is worsening. The gap between the eastern end of the structure and the shoreline has been somewhat stabilized with rock that was placed between the structure and the shoreline during construction of the new PVC wall. This area could use some additional rock. Signage is stable. (Photos: Appendix A, Photos 11-12, 18)

Photo 11—Jackson Bayou structure (and piece of new PVC wall)

Item	Condition	Physical Damage	Corrosion	Photo #	Observations and Remarks
Steel Bulkhead / Caps	good			11, 18	Some slight rusting of pile caps.
Steel Grating	N/A				
Stop Logs	N/A				
Hardware	good				
Timber Piles					
Timber Wales	N/A				
Galv. Pile Caps	N/A				
Cables	N/A				
Signage / Supports	good			11	Present and functioning
Rip Rap (fill)	good			12	The rock from original construction at the end of the PVC wall was salvaged and moved to the eastern end of the Jackson Bayou structure to fill a gap forming around the structure. The stone hasn't fully closed the gap but improved the situation slightly. Additional stone would be needed to completely shore up this gap.
Earthen Embankment	N/A				The bankline has eroded past the structure wingwalls. Erosion particularly on the western side is worsening.

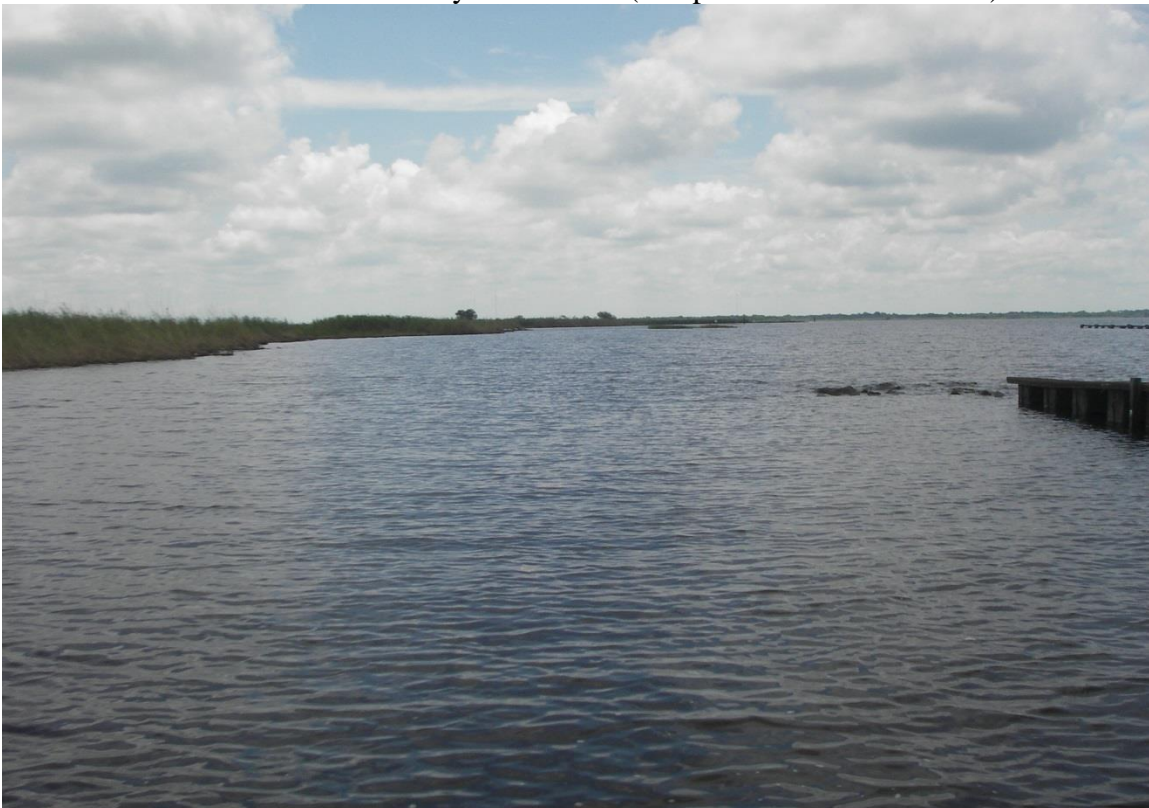
Photo 12—breach on eastern end of Jackson Bayou Structure

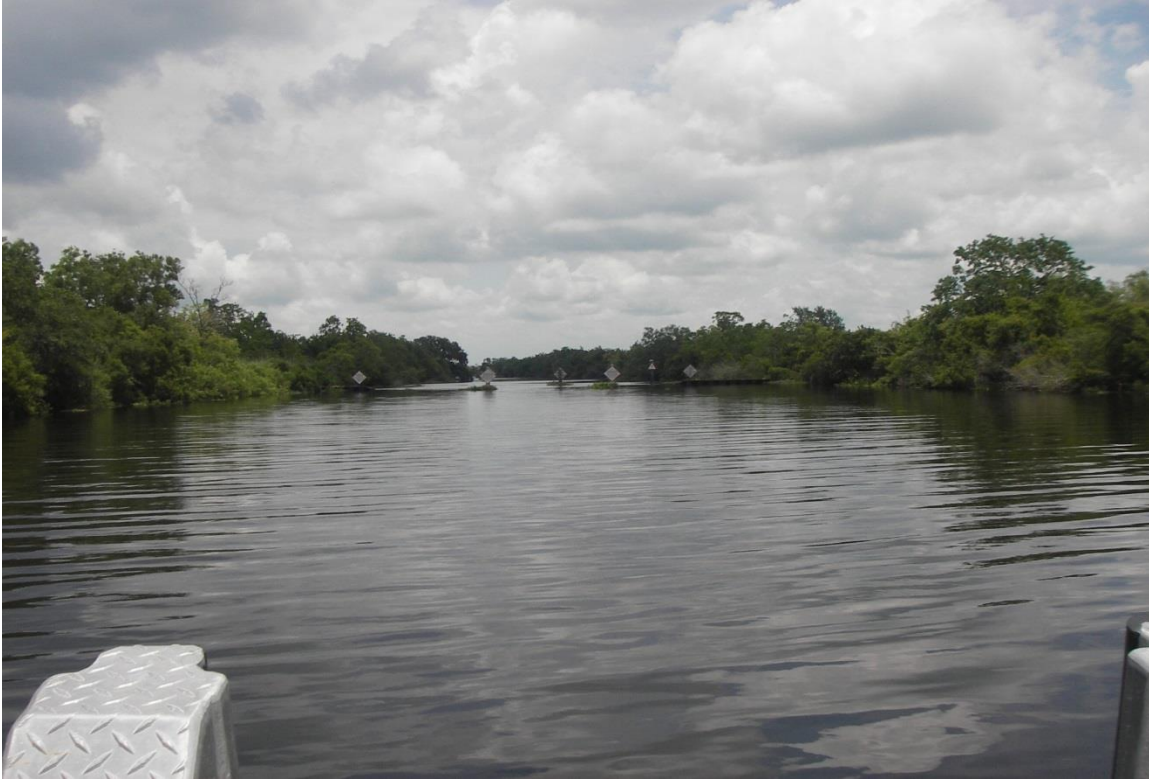
Rust on the sheet piles continues to worsen and will be monitored as well. The port side day marker and timber pile are gone. Rock along the shoreline between the structure and the PVC wall is also in excellent shape. (Photos: Appendix A, Photos 13-14, 18)

Photo 13—British American Canal Structure

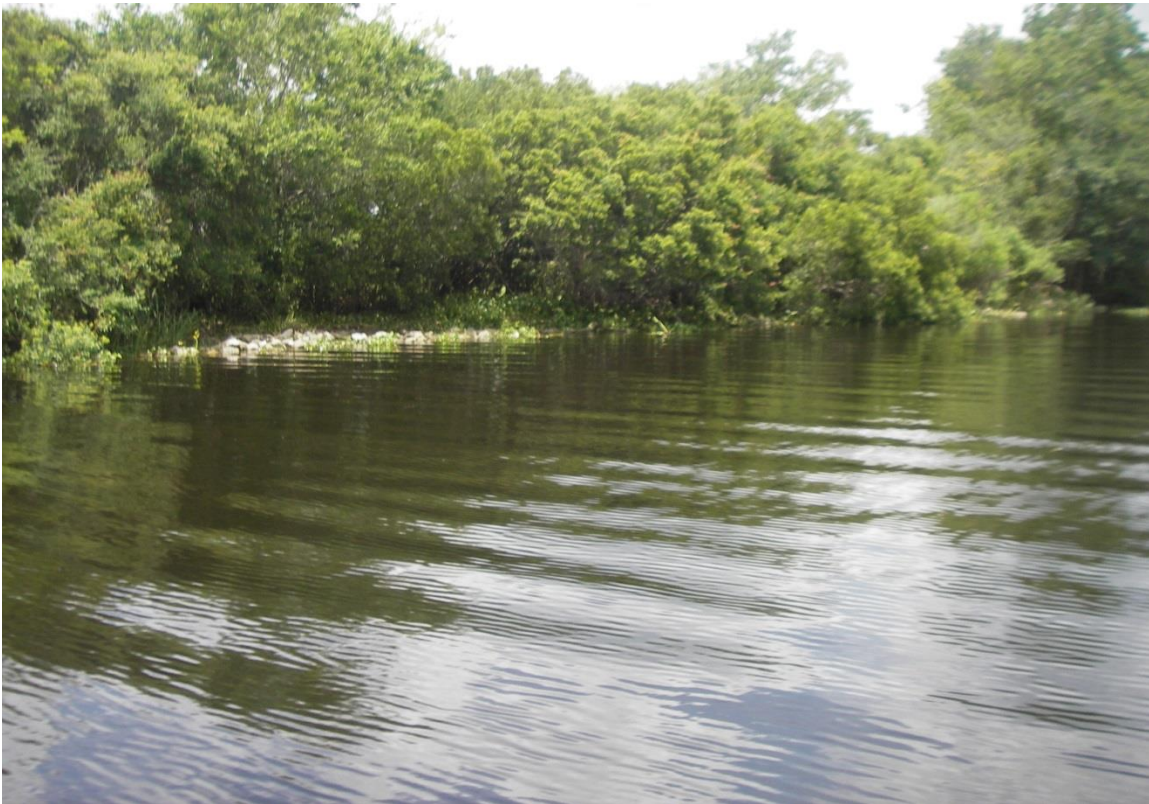
Photo 14—rock along British American Canal

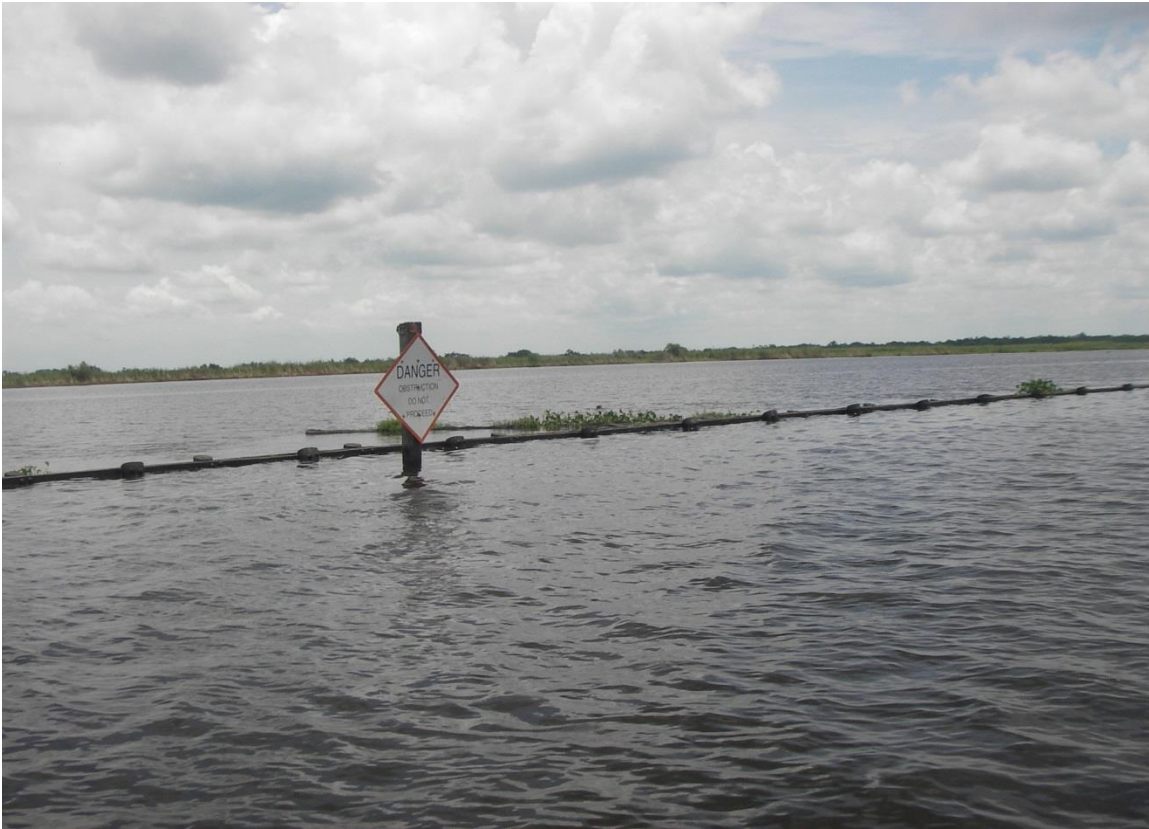
The original PVC shoreline protection wall continues to show signs of age and is in need of some repair. Several areas have either sheet pile or whalers missing or deteriorated. Hardware is rusting significantly. Some of the timber piles are also showing signs of decay. The wall, for the most part, is still functioning as intended. Signs are all in place and stable. The two new wall sections that were installed during the 2015 maintenance event have basically failed. Approximately 80% of the total length is damaged or missing. Timber piles are still in place and stable. Scour at the base, that was noticed during the final inspection is still evident but stable. However, rock should be placed at the base of this new wall when this wall is repaired/replaced. (Photos: Appendix A, Photo 15-17)

Photo 15—Typical section of old PVC wall

The PVC walls are in poor condition and are in need of repair. Pilings are still in place; however, sheet piles and whalers are missing or broken.

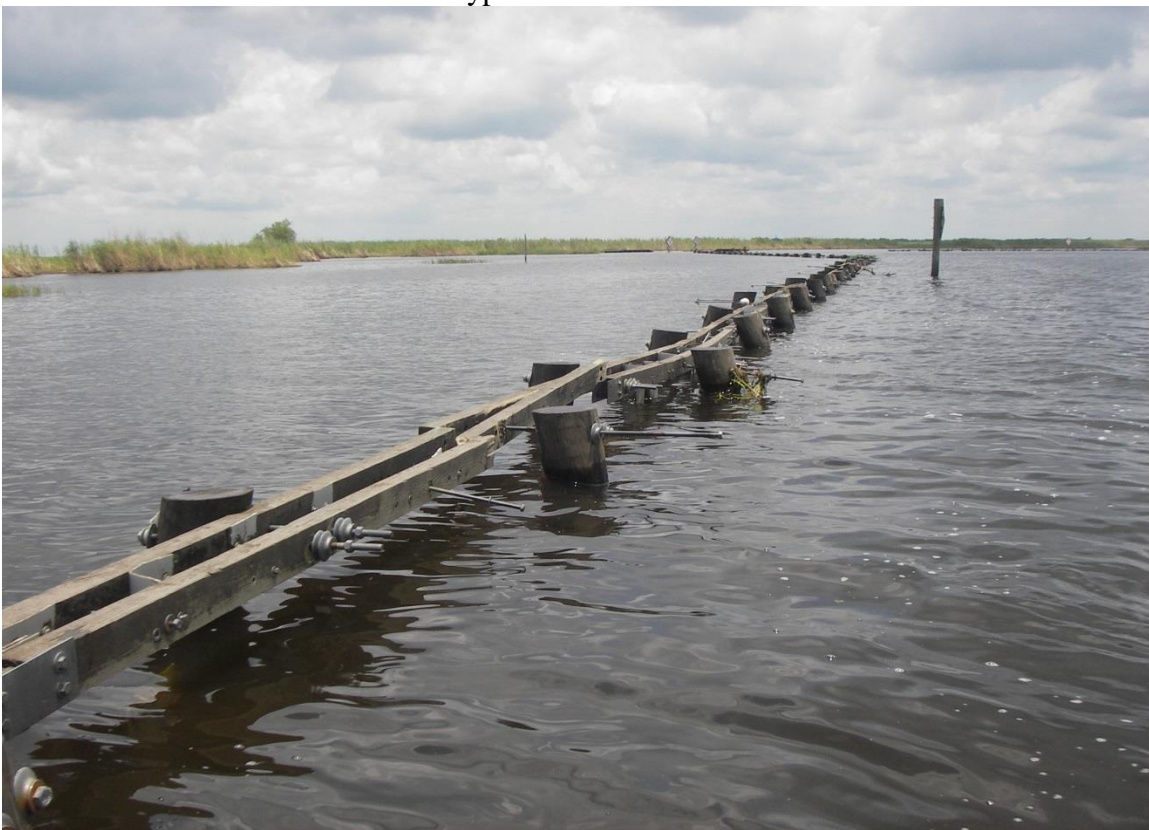
Photo 16—typical damage on new PVC wall

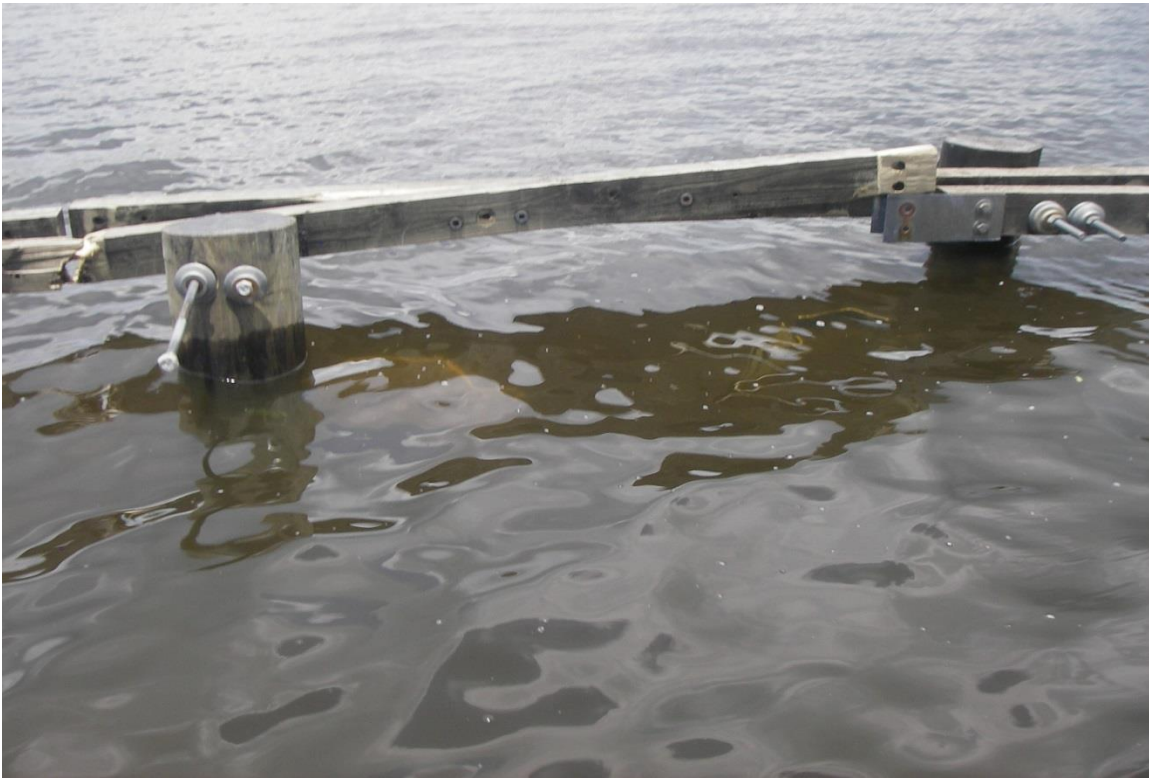
Photo 17—typical damage on new PVC wall

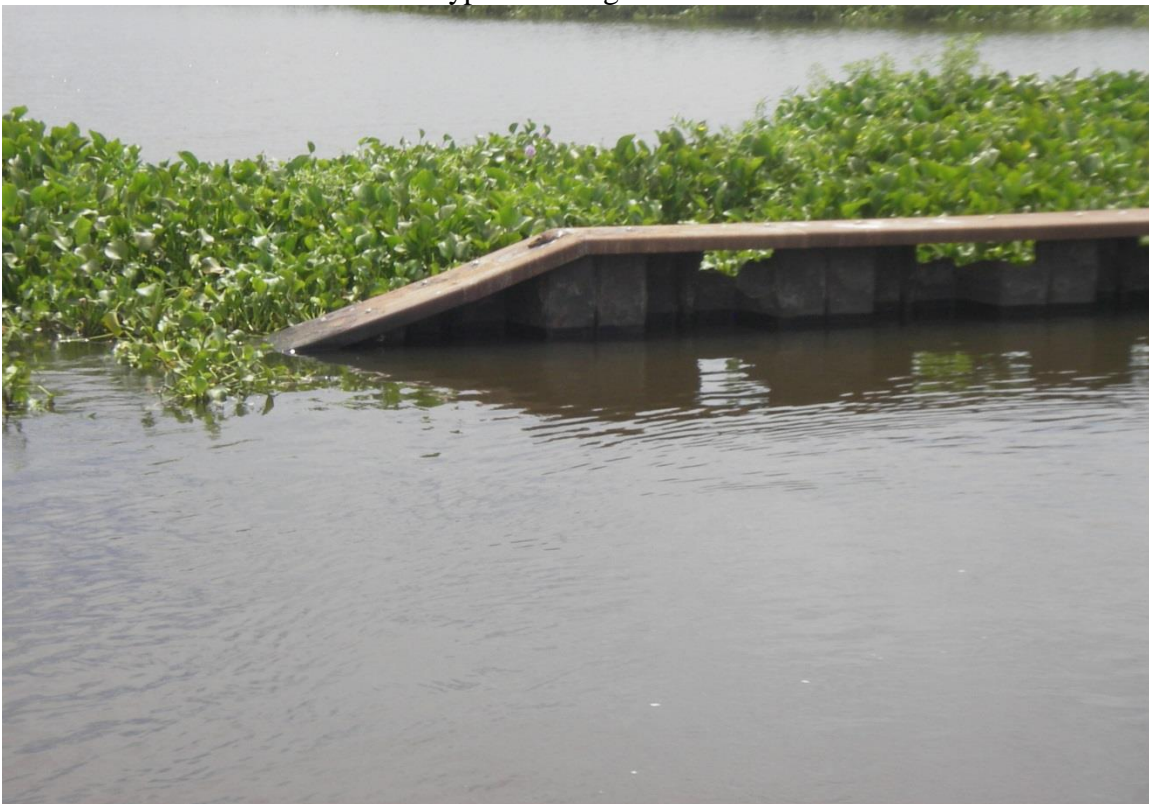
Photo 18—typical rust on sheet pile structures
