# **2020 Operations, Maintenance and Monitoring Report**

## **Oaks/Avery Canals Hydrologic Restoration**

State Project Number T/V-13a  
Priority Project List 6

August 2020  
Iberia/Vermilion Parishes

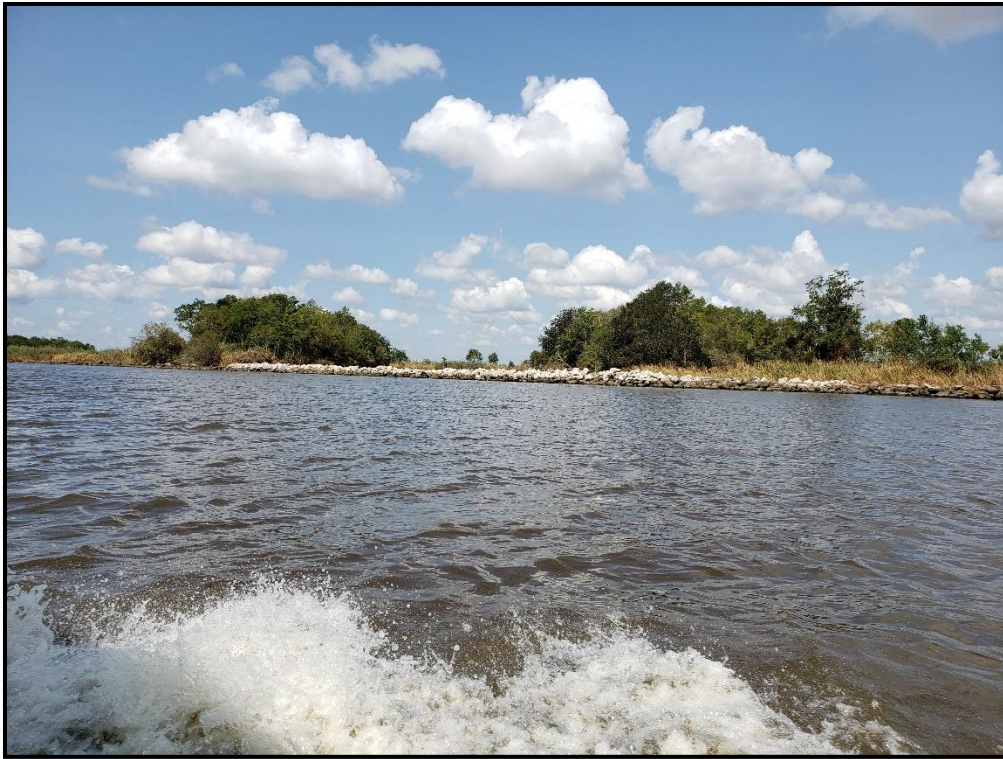
The dike is in excellent condition. The rock settlement at the old oilfield location at N 29° 49' 58.3" and W 91° 59' 25.9" has been lifted back to grade through a maintenance event completed in October 2019. The eastern rock tie-in, which was previously noted to be experiencing some minor erosion is now stable. The western tie-in remains stable, as well. (Appendix A; Photo 1)

**Photo No. 1,** Rock along north bank of GIWW showing capped dike

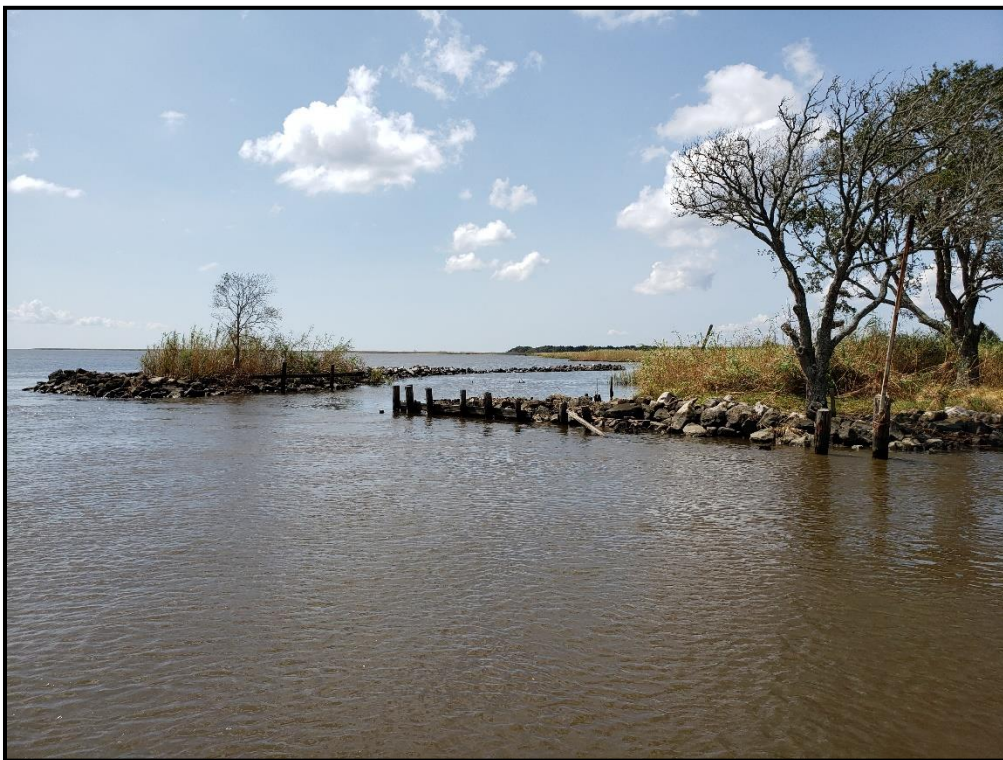
**Photo No. 2,** Rock revetment at Oaks Canal, west side

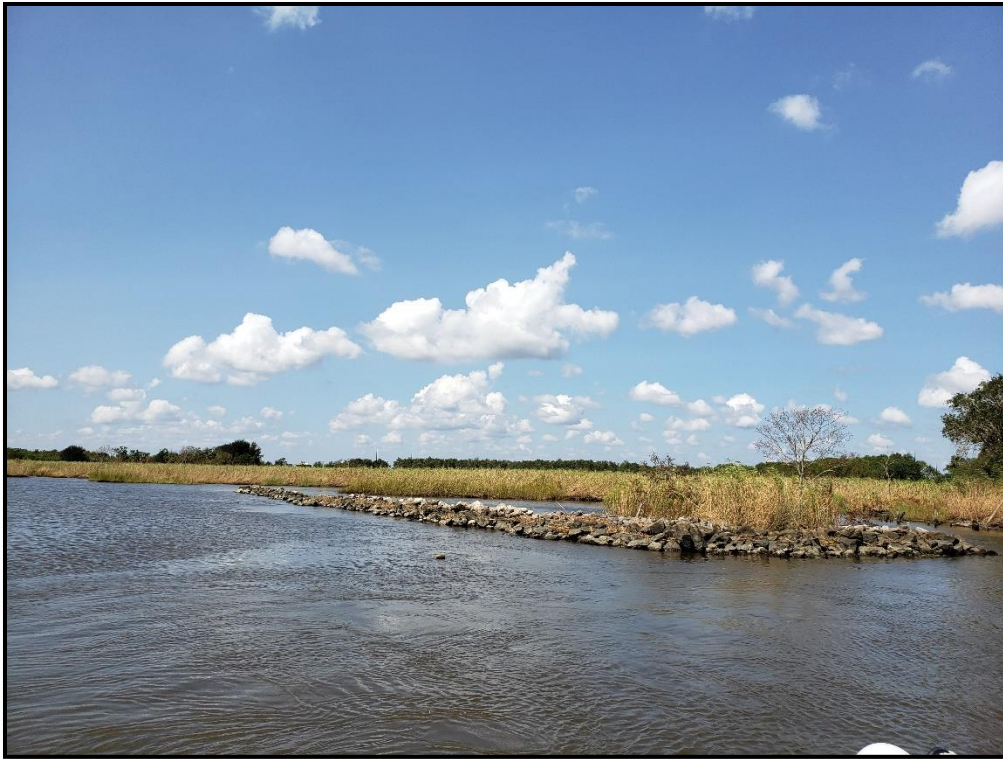
**Photo No. 3,** Rock dike extension at Oaks Canal, west side

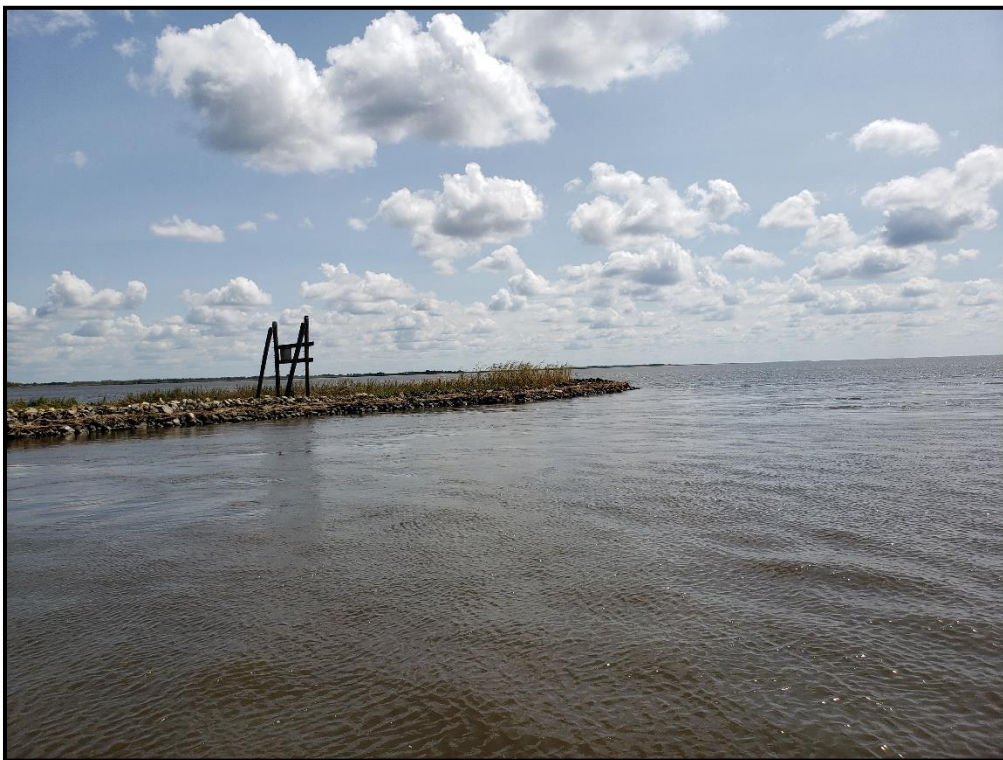
**Photo No. 4,** Rock revetment at Oaks Canal, East side

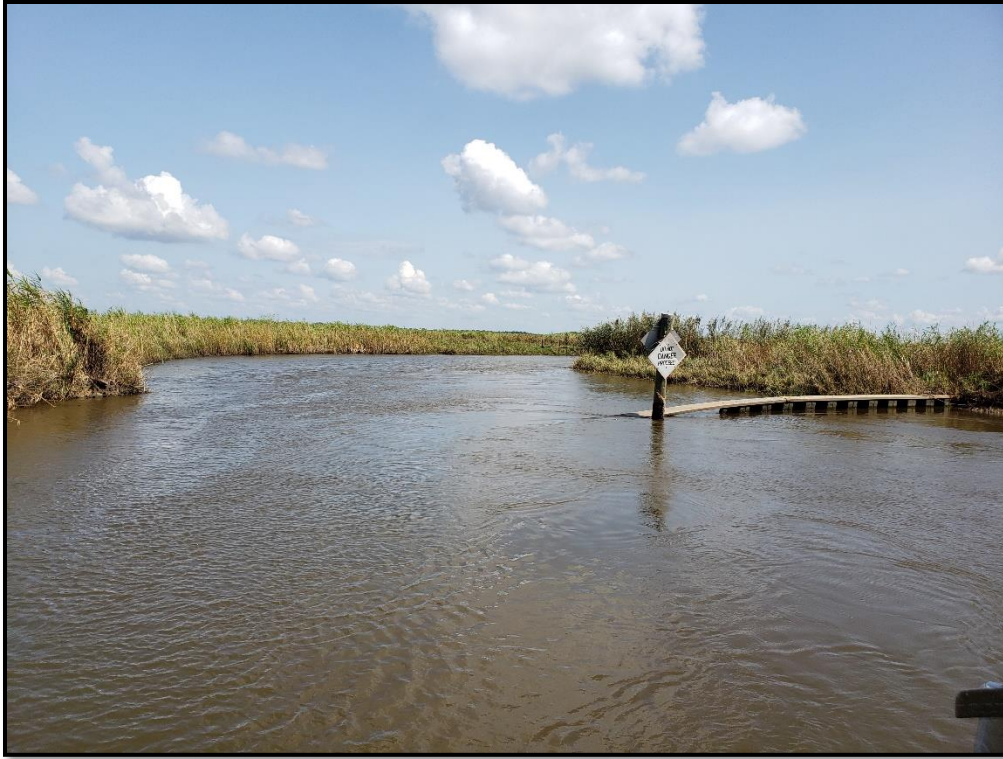
**Photo No. 5, Cow Path Structure**

The landowner notified CPRA on April 23, 2018 that the Cow Path weir had failed. CPRA and NRCS made a site visit to inspect the damage on June 13, 2018. The eastern portion of the sheet pile weir was still standing and the western portion was no longer embedded. There appeared to be no change to the condition of the structure at the time of the post storm damage assessments. (Appendix A; Photo 5)

Item	Condition	Physical Damage	Corrosion	Photo #	Observations and Remarks
Steel Bulkhead / Caps	Failed			5	West side of structure still seems to be attached to rest of structure, but no longer embedded. Could not be seen due to high water level.
Steel Grating	N/A				
Stop Logs	N/A				
Hardware	Failed				
Timber Piles	N/A				
Timber Wales	N/A				
Galv. Pile Caps	Failed				
Vegetation	N/A				
Signage /Supports	OK				
Rip Rap (fill)	N/A				
Eathern Embankment	Good				
What are the conditions of the existing levees?					
Are there any noticable breaches?					
Settlement of rock plugs and rock weirs?					
Position of stoplogs at the time of the inspection?					
Are there any signs of vandalism?

The Cow Path weir needs to be repaired to get the project back to good working order. CPRA and NRCS have requested more funding to remove the Cow Path weir and replace it with a low sill rock weir.

From an engineering standpoint, the Oaks/Avery Canals Hydrologic Restoration Project features are in good condition with the exception of the Cow Path weir. CPRA and NRCS have requested funding from CWPPRA to remove and replace the Cow Path weir. Funding was approved on November 13, 2020. Engineering and Design will be tasked at the beginning of 2021, with construction anticipated for 2022.

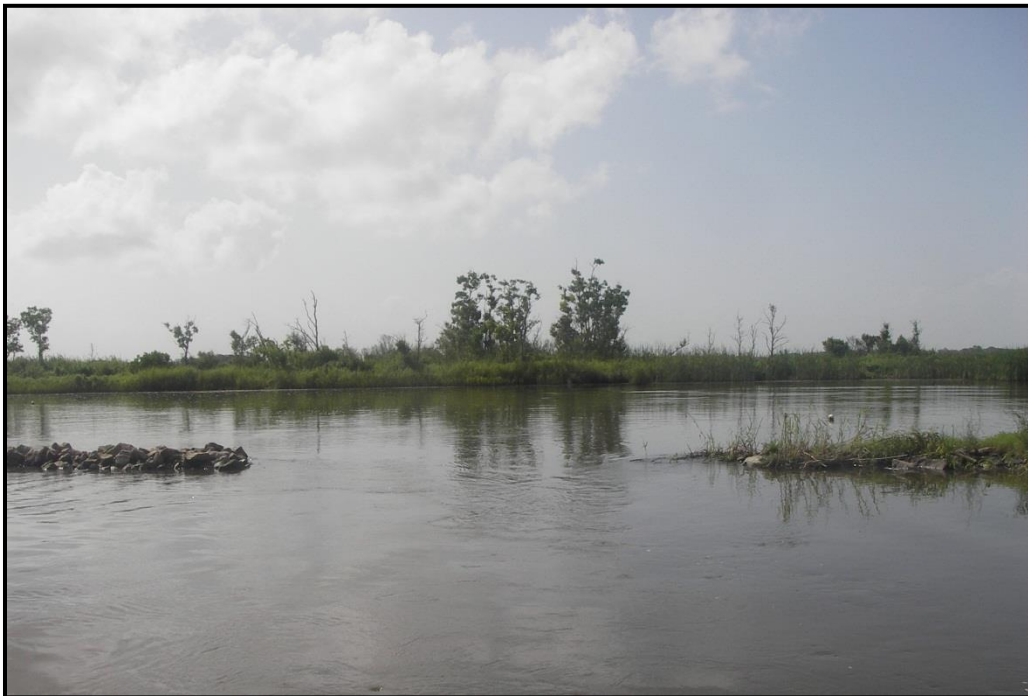
**Photo No. 6, Rock plug gapped as part of maintenance event. (photo taken 07/02/2012)**

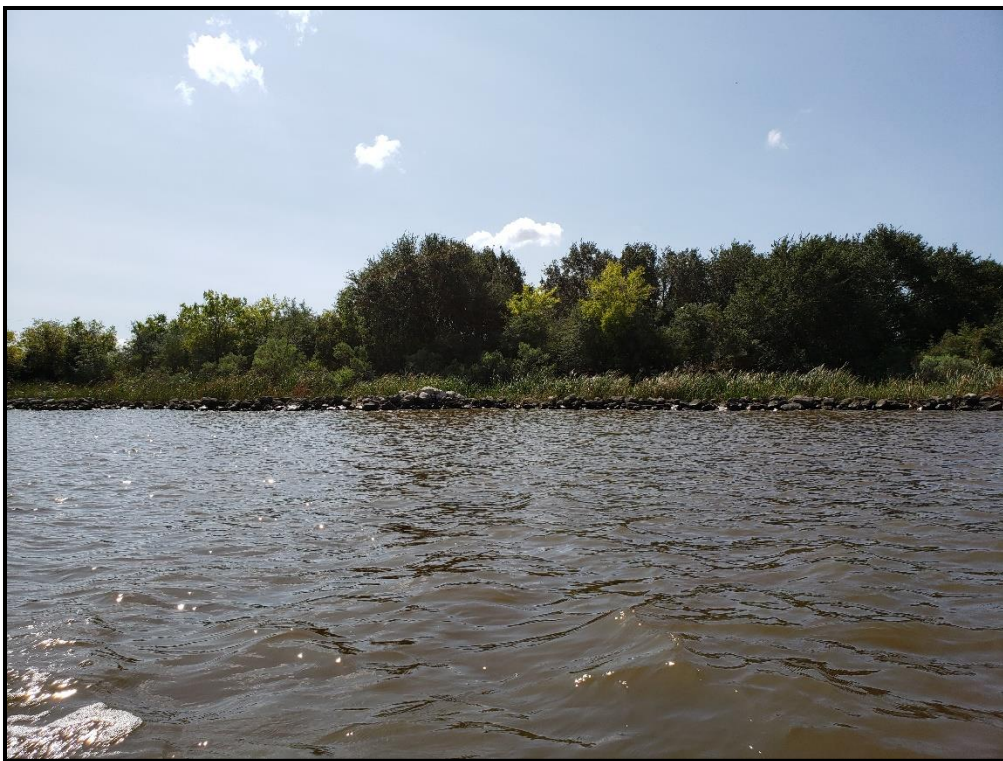
The rock dike is similar to immediate post construction condition and in no need of any repairs. (Appendix A; Photo 7)

**Photo No. 7,** Rock dike along south bank of GIWW

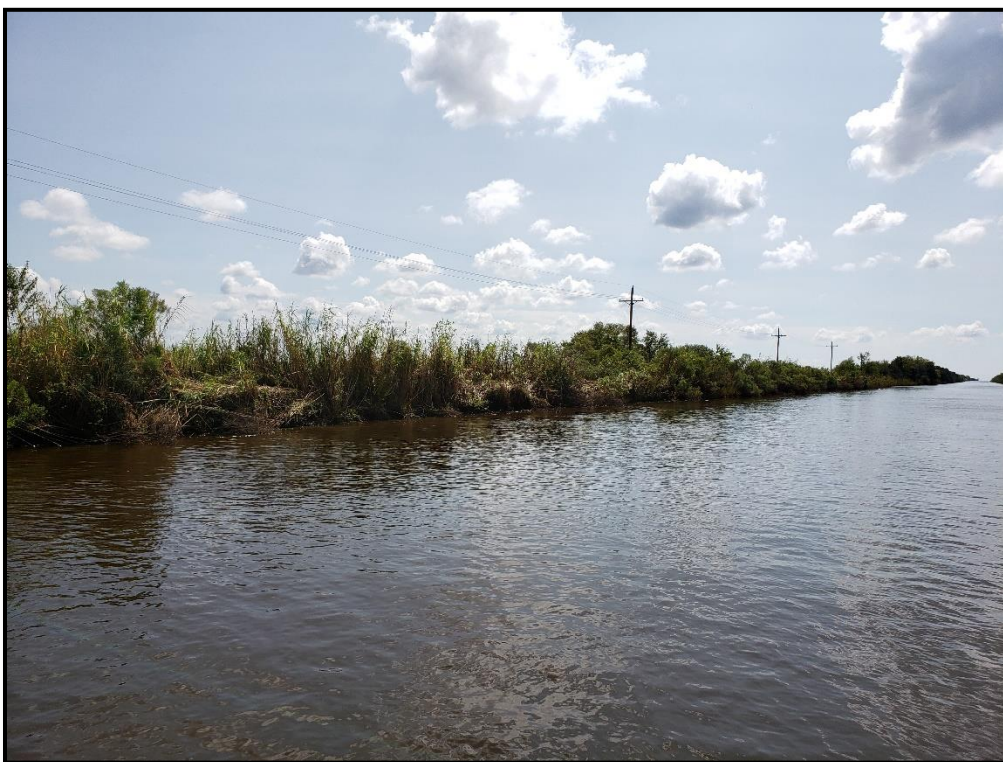
The spoilbank maintenance is in good condition and has fully vegetated. (Appendix A; Photo 8)

**Photo No. 8,** Spoilbank Maintenance along Oaks Canal

Item	Condition	Physical Damage	Corrosion	Photo #	Observations and Remarks
Steel Bulkhead / Caps	N/A				
Steel Grating	N/A				
Stop Logs	N/A				
Hardware	N/A				
Timber Piles	N/A				
Timber Wales	N/A				
Galv. Pile Caps	N/A				
Vegetation	Good			8	Vegetation Flourishing.
Signage / Supports	N/A				
Rip Rap (fill)	N/A				
Earthen Embankment	Good			8	Spoilbank looks good. Plug is still holding up.
What are the conditions of the existing levees?					
Are there any noticeable breaches?					
Settlement of rock plugs and rock weirs?					
Position of stoplogs at the time of the inspection?					
Are there any signs of vandalism?

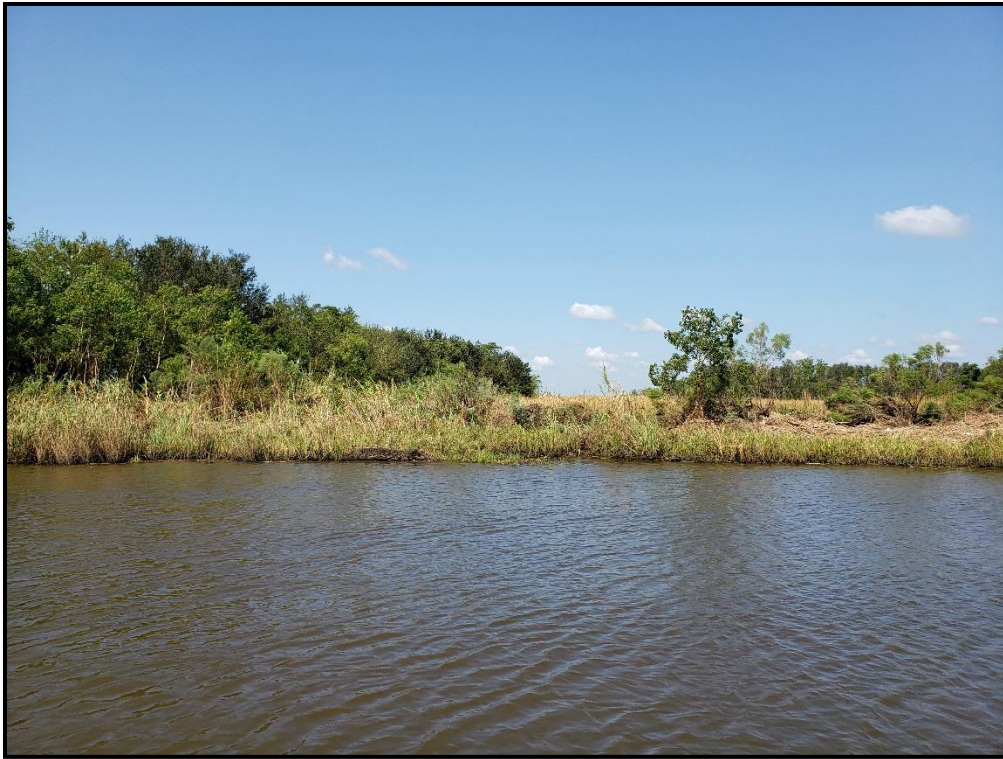
**Photo No. 9, Earthen Canal plug on Union Canal**

Item	Condition	Physical Damage	Corrosion	Photo #	Observations and Remarks
Steel Bulkhead / Caps	N/A				
Steel Grating	N/A				
Stop Logs	N/A				
Hardware	N/A				
Timber Piles	N/A				
Timber Wales	N/A				
Galv. Pile Caps	N/A				
Vegetation	Good			9-10	Vegetation Flourishing.
Signage / Supports	N/A				
Rip Rap/dike	N/A				
Earthen Embankment	Good			9-10	The earthen canal plug had experienced settlement initially, but is in good condition and does not require maintenance at this time.
What are the conditions of the existing levees?					
Are there any noticable breaches?					
Settlement of rock plugs and rock weirs?					
Position of stoplogs at the time of the inspection?					
Are there any signs of vandalism?
