**Coastal Protection and Restoration
Authority (CPRA)**

2020 Operations, Maintenance, and Monitoring Report

Marsh Island Hydrologic Restoration

State Project Number TV-14
Priority Project List 6

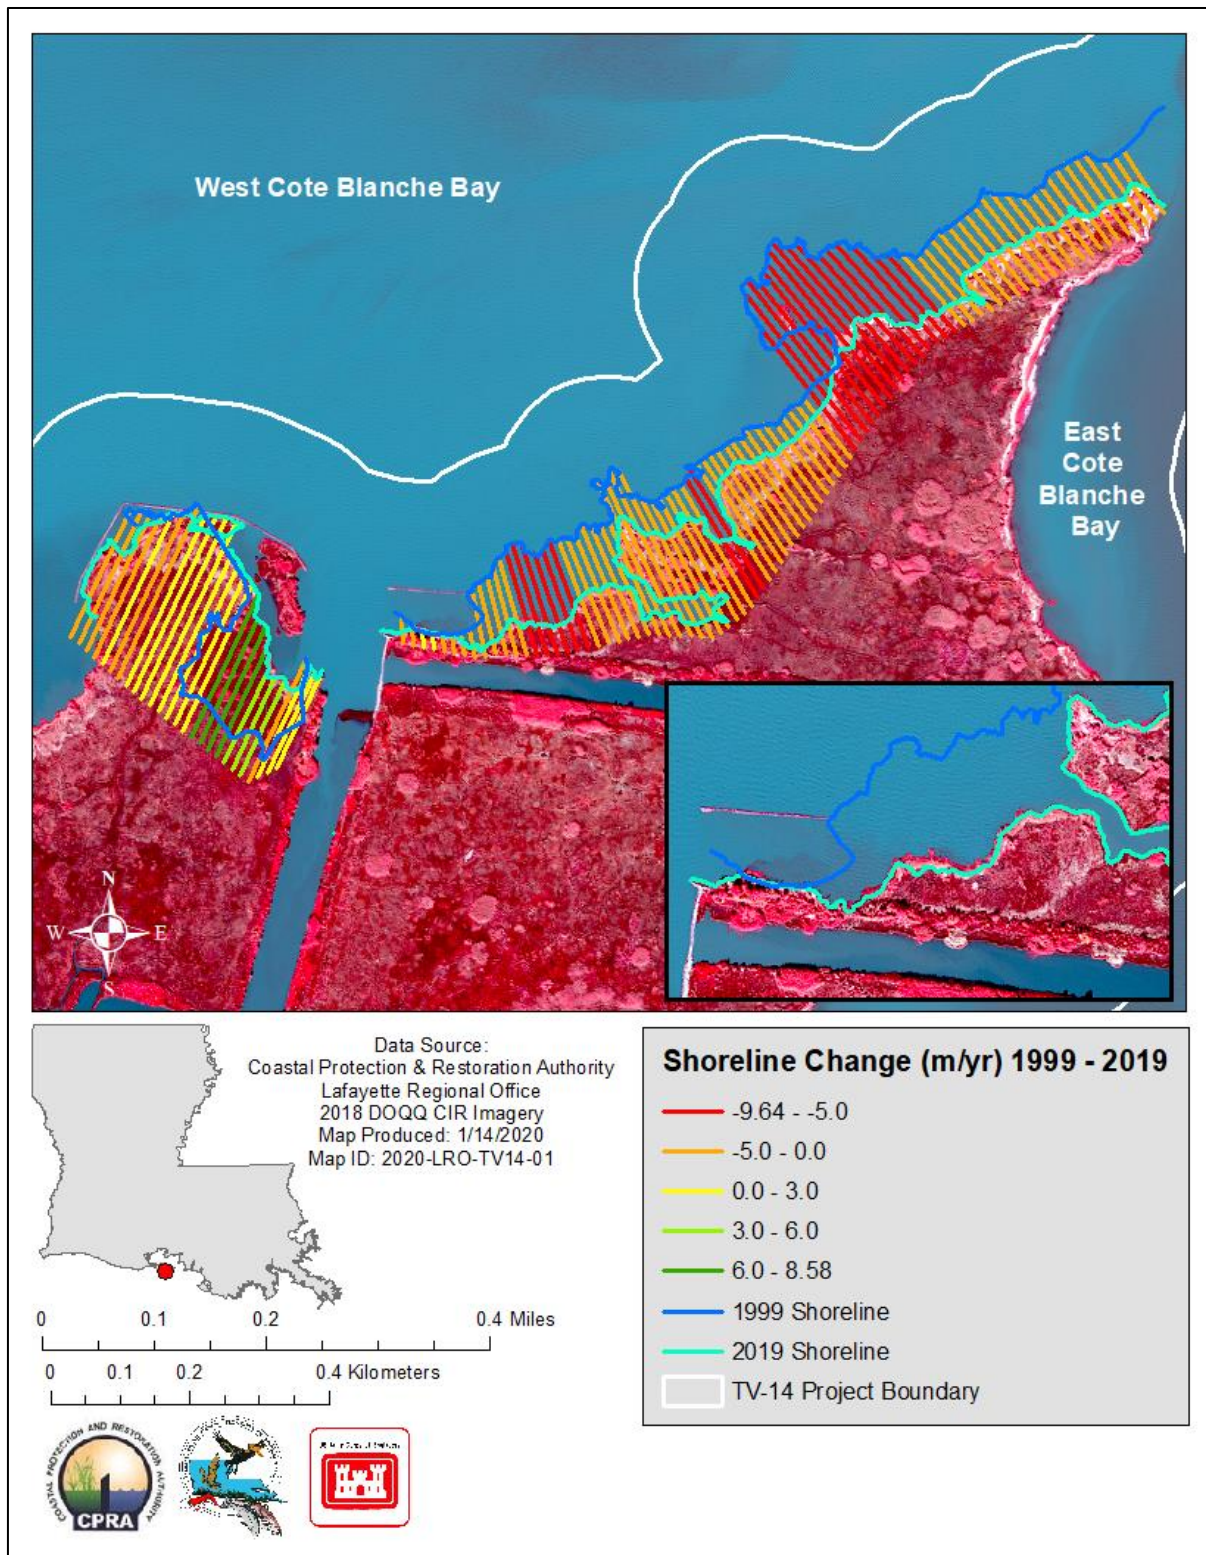
Figure 9. Marsh Island Hydrologic Restoration (TV-14) shoreline change 1999-2019.

Comparison of the 2003 dataset to the preconstruction (1999) data indicated a gain of 1.08 m/yr in the protected section of the shoreline and a loss of -0.62 m/yr in the unprotected section. Comparing the 2009 survey (post-Hurricanes Rita and Ike) to the 2003 survey indicated a loss of -0.77 m/yr in the protected area and -3.58 m/yr in the unprotected area. The post-Hurricane recovery period (comparing 2009-2012) showed a gain of 0.99 m/yr in the protected section while the unprotected section saw a loss of -2.68 m/yr. Comparison of the most recent time period (2012-2019) resulted in a gain of 3.66 m/yr in the protected section and a loss of -5.93 m/yr in the unprotected section. Overall loss from 1999 to 2019 was -4.25 m/yr in the unprotected section, while the protected section showed a gain of 1.22 m/yr (Figure 9).

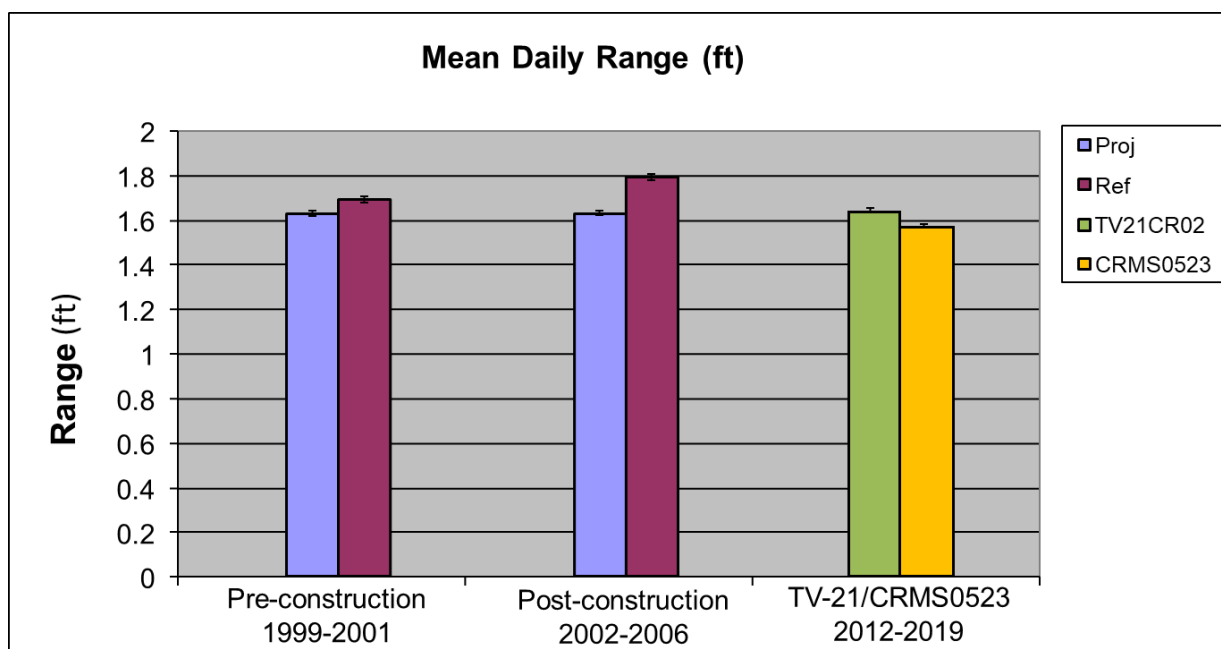
Figure 10. Mean daily water level range (variability) \pm standard error during the pre- and post-construction periods for the project and R1 stations as well as the 2012-2019 monitoring period at stations TV21CR02 and reference recorder CRMS0523.

The difference in project area and R1 water level range (variability) was significantly higher post-construction than pre-construction ($p < 0.0001$) (R1 had a water level range 0.16' higher than the project area post-construction and 0.06' higher preconstruction). Water level variability in the project area was found to be significantly less than that in R1, for both the pre- and post-construction periods (Figure 10). Water level variability appeared to increase following project construction in R1 and the project appears to have been successful at preventing a similar increase in the project area. It is not known what factors contributed to the increase in water level variability in R1 following project construction. However, it is not likely to be due to any effects of the project but rather variations in weather and tides. There was less variability in the project area before construction but ranges in the reference area increased relative to the project area post-construction. Thus, the project appears to have reduced water level variability as designed.

Water level variability at TV21CR02 was slightly higher than the reference site CRMS0523 during 2012 – 2019, indicating the project has not had an effect on variability within the southern part of the project area. This is not surprising considering the TV-21 recorder is situated within a canal that has open access to West Cote Blanche Bay, unlike the TV-14 recorders that were situated in the northern part of the project area behind the canal closures.

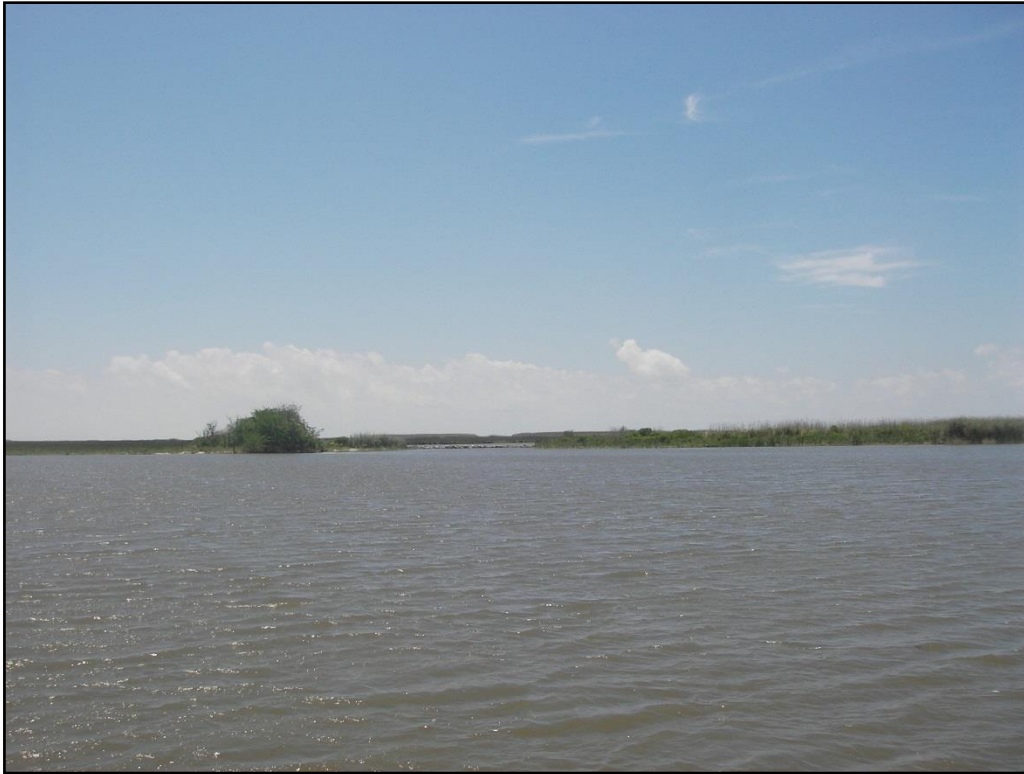
Photo No. 1, Closure No. 1

Erosion problems and Hurricane Rita damages were repaired through a maintenance project that was completed in February 2009. The dike was capped and bank paving installed on both ends of the closure. This site is in good condition since this work was performed. (Photos: Appendix A, Photo 1).

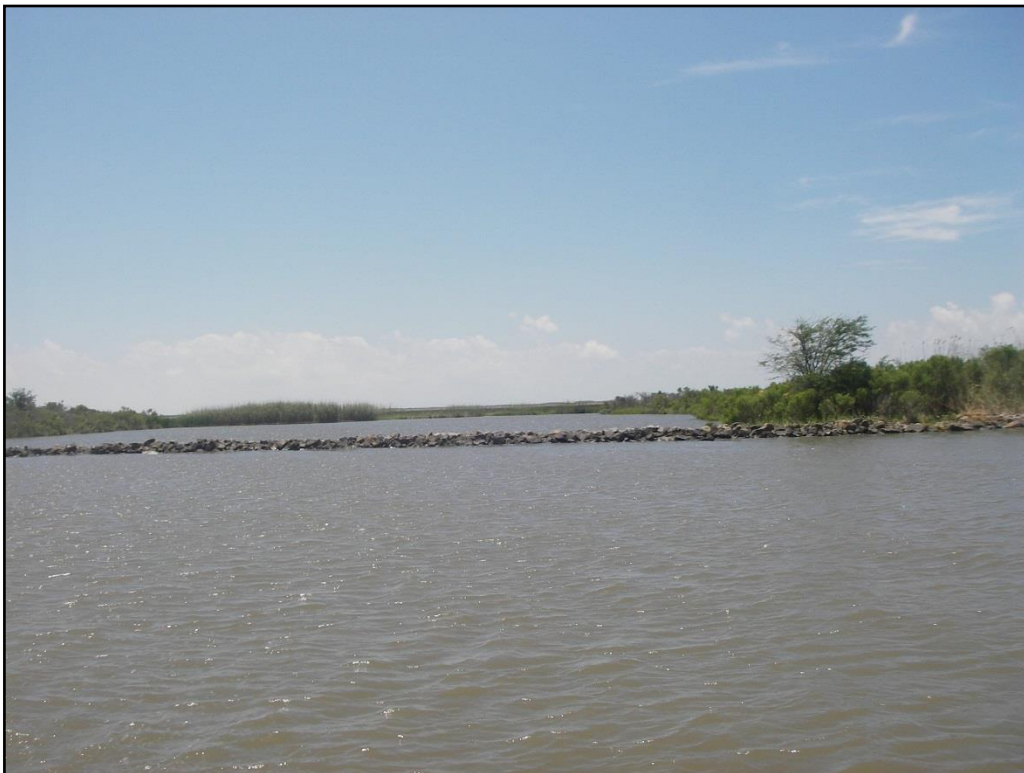
Photo No. 2, Closure No. 2

This structure is in good condition. (Photos: Appendix A, Photo 2)

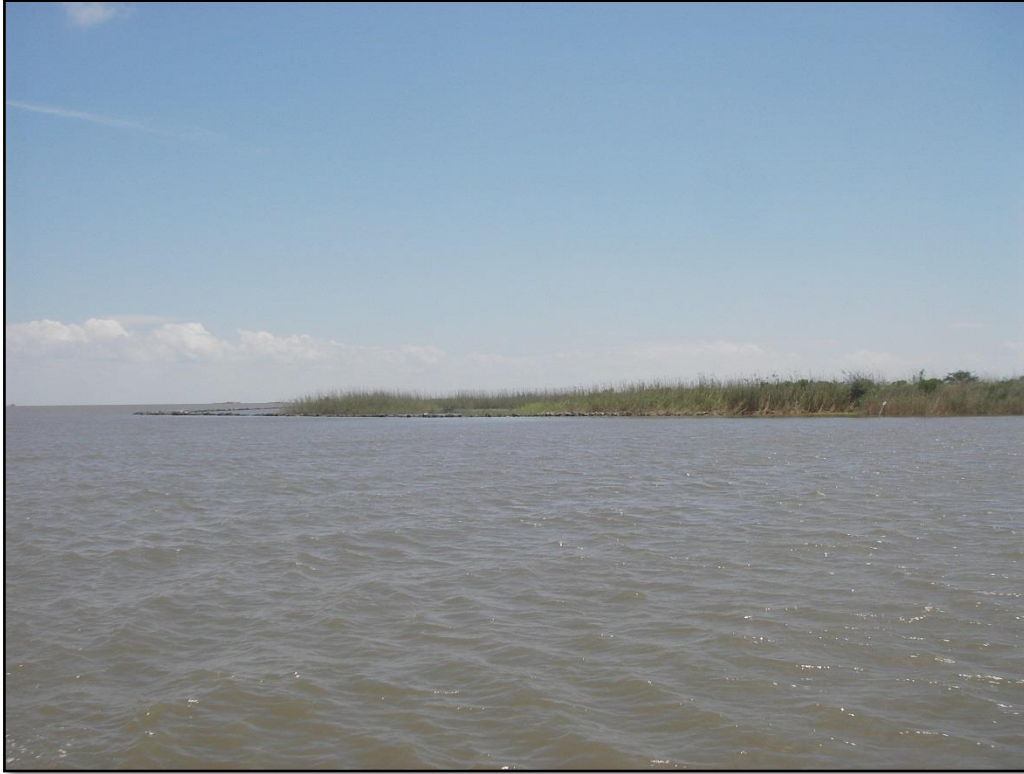
Photo No. 3, Closure No. 3

This structure is in good condition. (Photos: Appendix A, Photo 3)

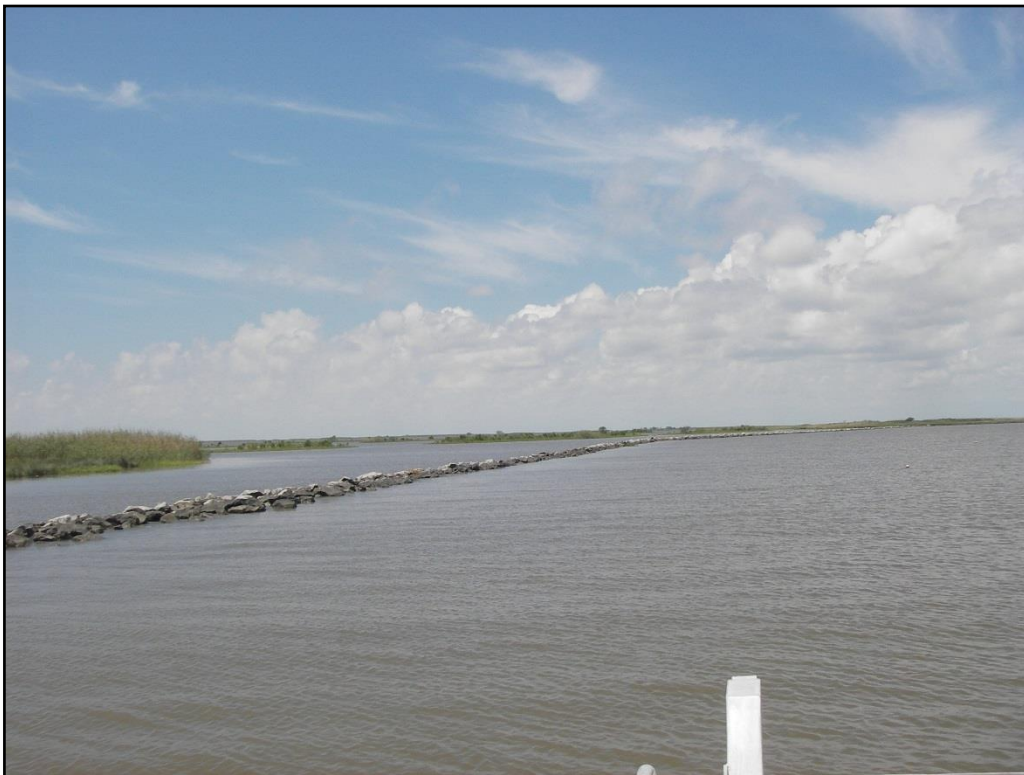
Photo No. 4, Closure No. 4

This structure is in good condition. (Photos: Appendix A, Photo 4)

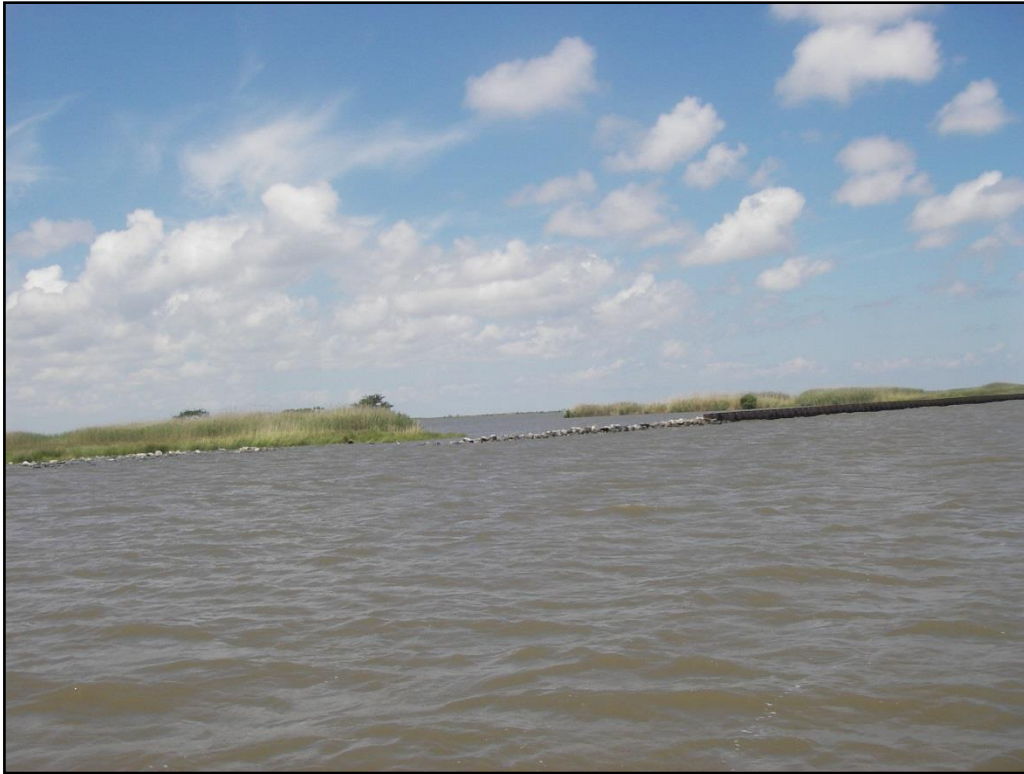
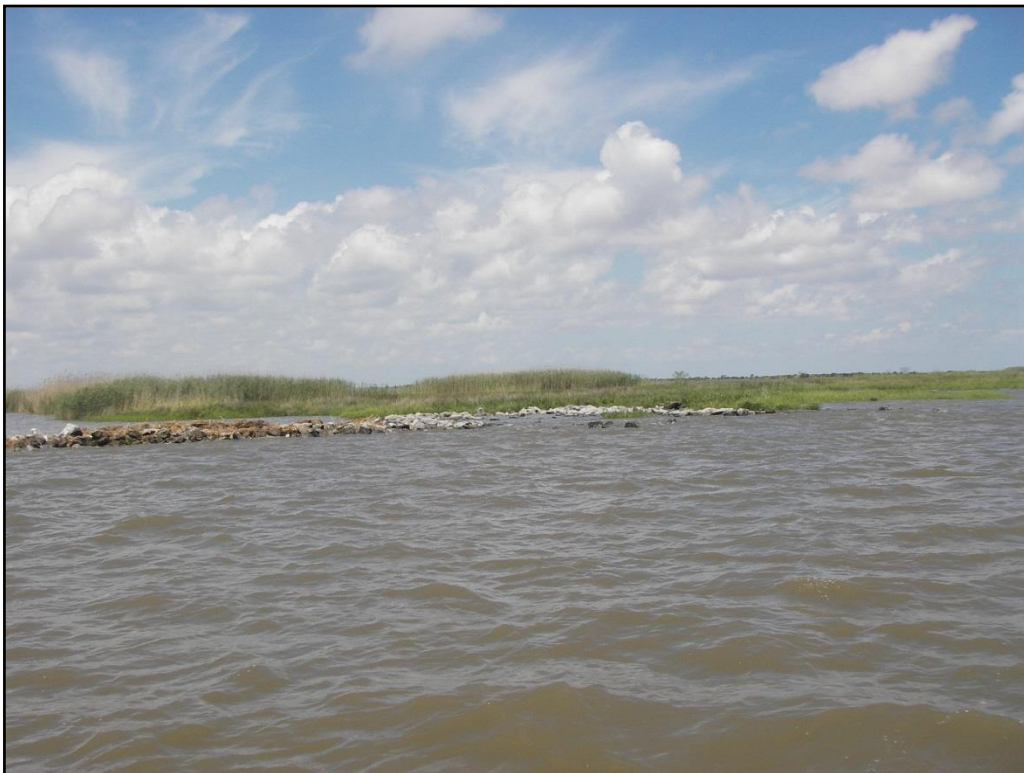
Water is migrating around the structure on both ends. (Photos: Appendix A, Photos 5 & 6)

Photo No. 5, Closure No. 5, Southern End

Photo No. 6, Closure No. 5, Northern End

- There is a breach on the southern end of the bank paving at Closure No. 5 as well as a section of broken marsh between Closures No. 5 and No. 6, which is allowing exchange to occur between Vermilion Bay and Lake Sand. It is recommended that an additional reach of shoreline protection dike be constructed,

an estimated 1,500 to 1,800 linear feet, to connect the southern end of Closure No. 5 to the northern end of Closure No. 6. NRCS proposed a new rock project to protect the shoreline between closure Nos. 5 & 6. The project was rejected. CPRA and USACE do not plan to pursue the matter further.

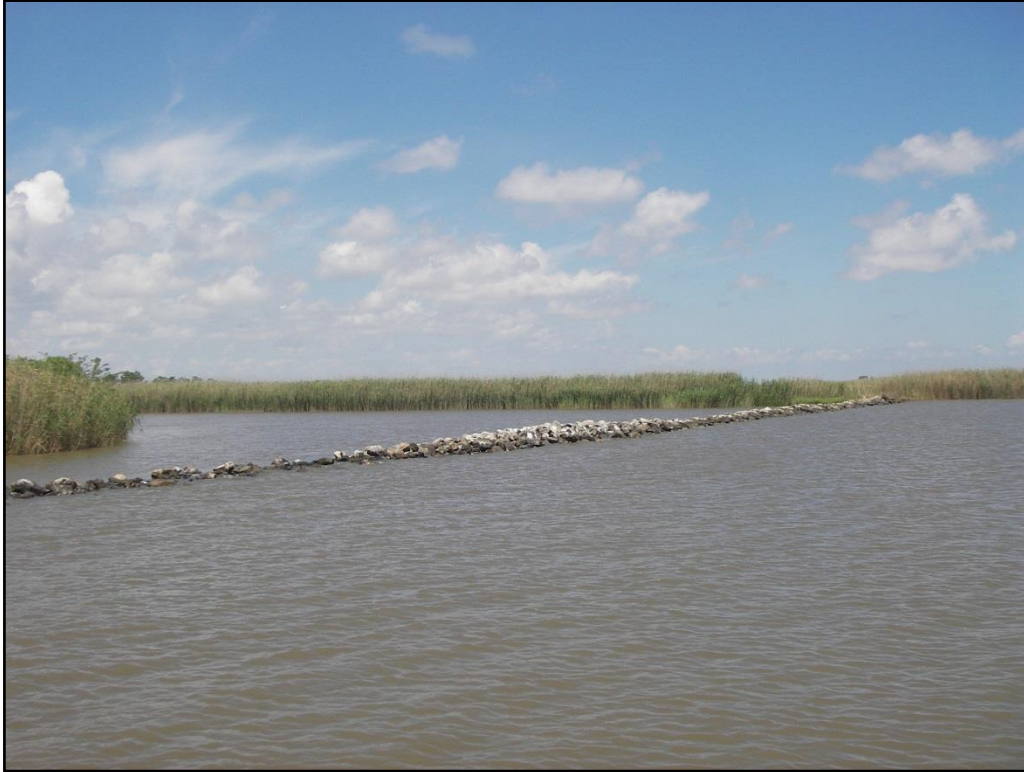
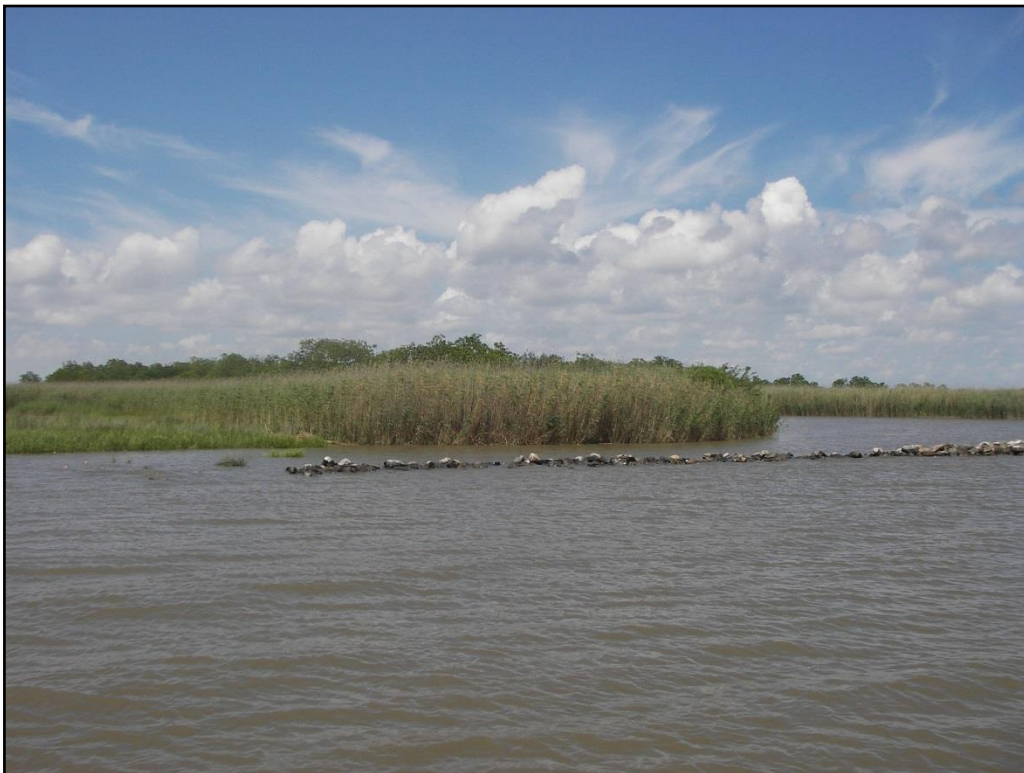
Water is migrating around the southern end of the structure. (Photos: Appendix A, Photos 7 & 8)

Photo No. 7, Closure No. 6

Photo No. 8, Closure No. 6, Southern End

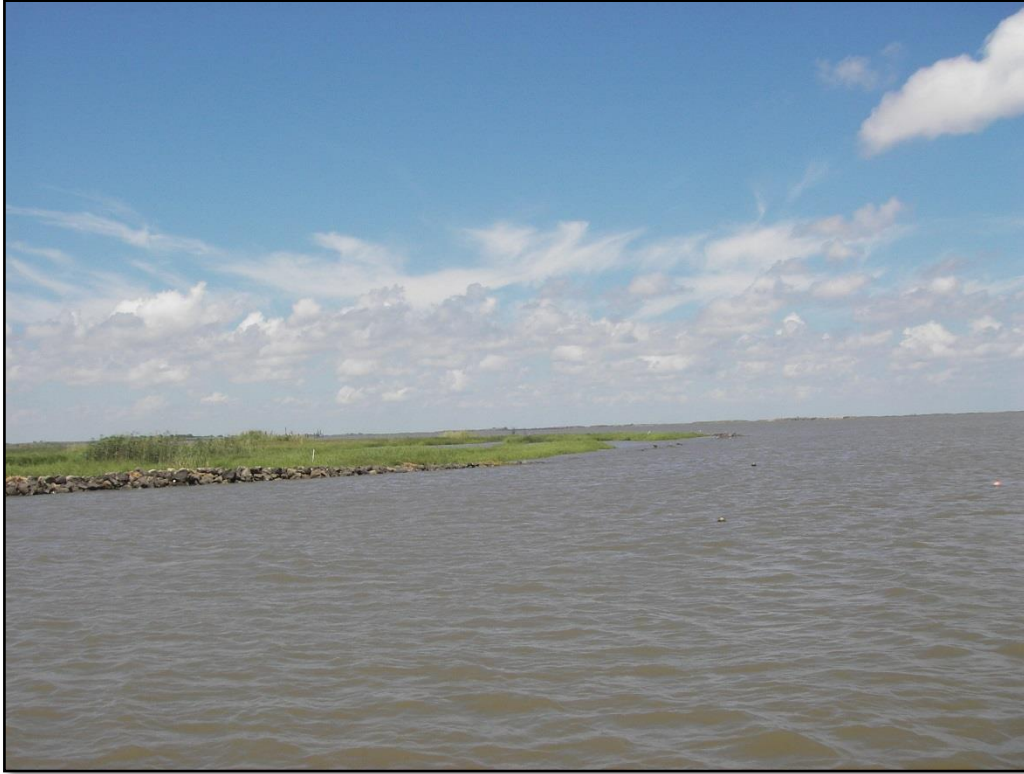
Photo No. 9, Closure No. 7

This structure is in good condition. (Photos: Appendix A, Photo 9).

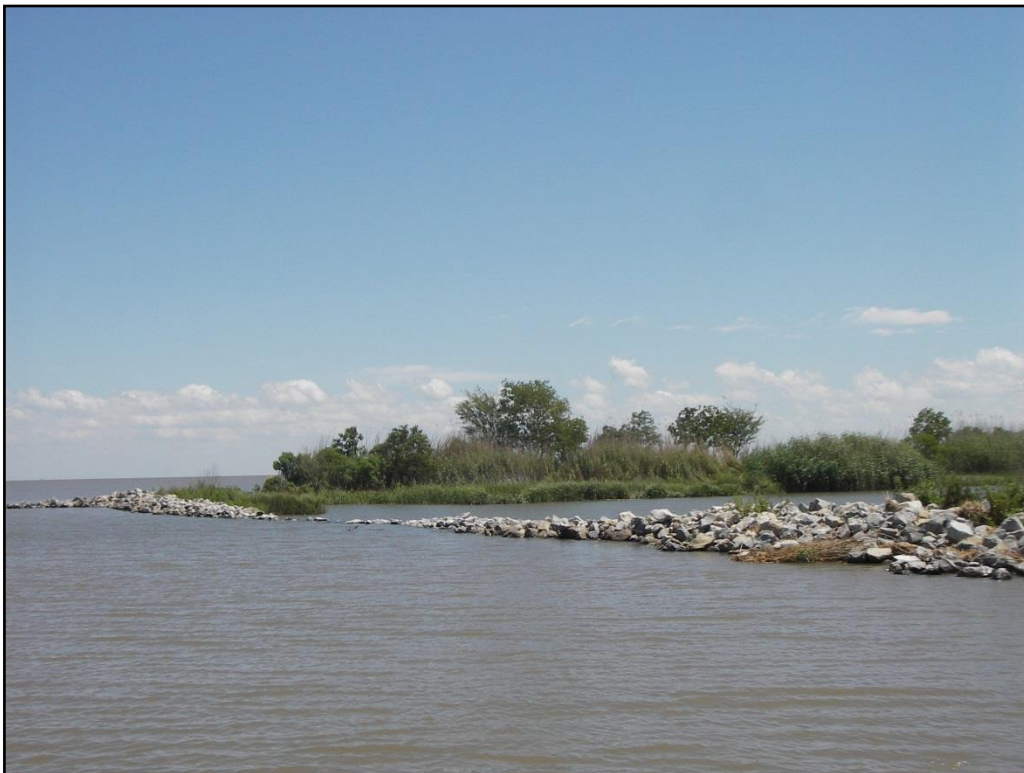
Photo No. 10, Closure No. 8

A maintenance event on the adjacent TV-21 project required the closure to be removed for access. At the conclusion of the TV-21 maintenance event, the contractor replaced the closure and added additional rock to repair the breach. There has been some settlement at the canal opening. (Photos: Appendix A, Photo 10).

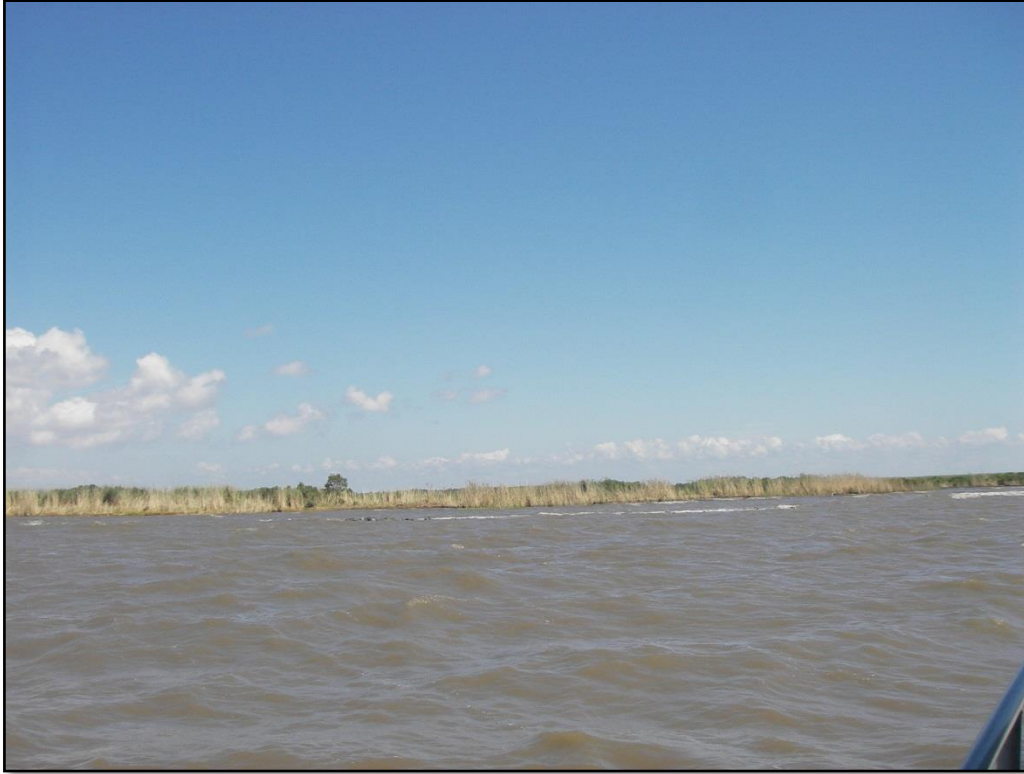
Photo No. 11, Closure No. 9

This rock shoreline feature functions as a breakwater protecting the earthen pipeline closure to the north. The recent construction of the TV-21 East Marsh Island Marsh Creation project has helped to reinforce the breach that had occurred on the southeast corner of the pipeline canal. (Photos: Appendix A, Photo 11)
