**Coastal Protection and Restoration
Authority (CPRA)**

2022 Operations, Maintenance, and Monitoring Report

Sediment Trapping at the Jaws (TV-15)

State Project Number TV-15
Priority Project List 6

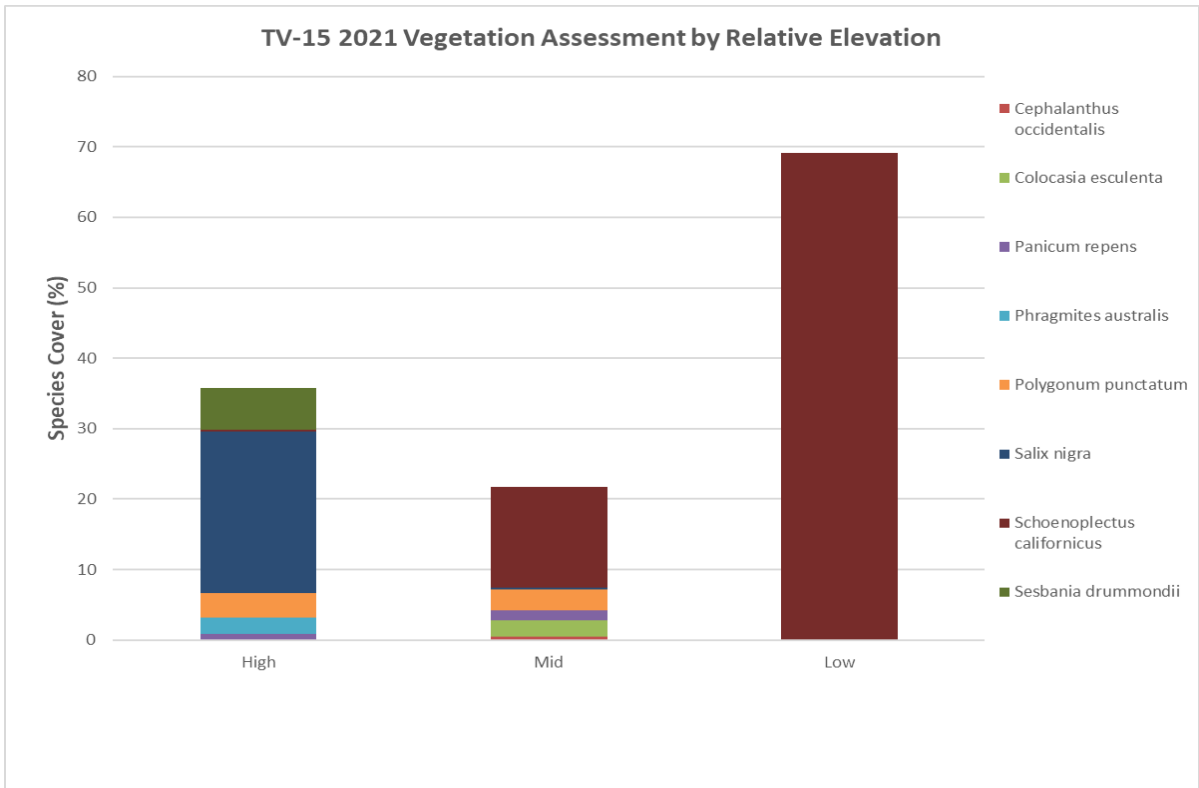
Figure 17. Sum of species percent cover across a relative elevation gradient from terrace crown to toe for TV-15; some of the higher elevations contained no vegetation due to 2020 storm damage and or rafting FAV's.

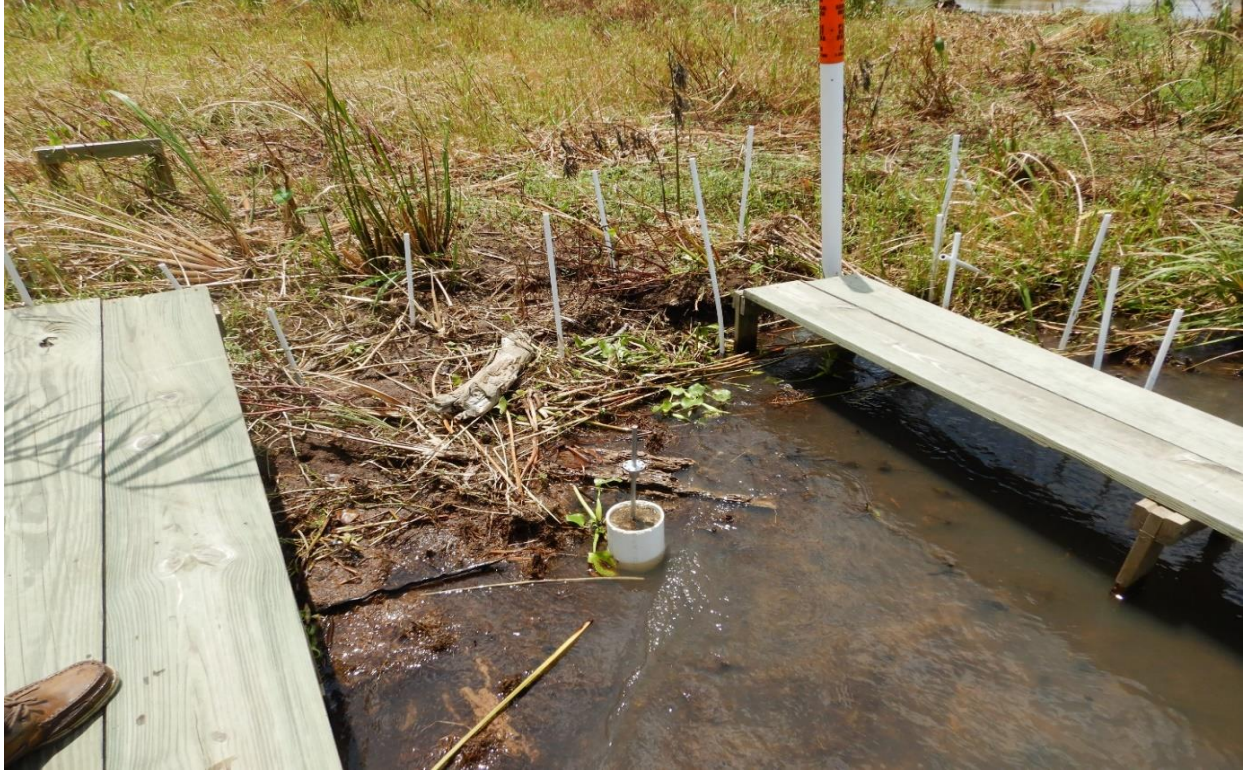
Figure 32. TV-15 interior marsh CRMS site CRMS0489 losing elevation as a result of shoreline erosion.

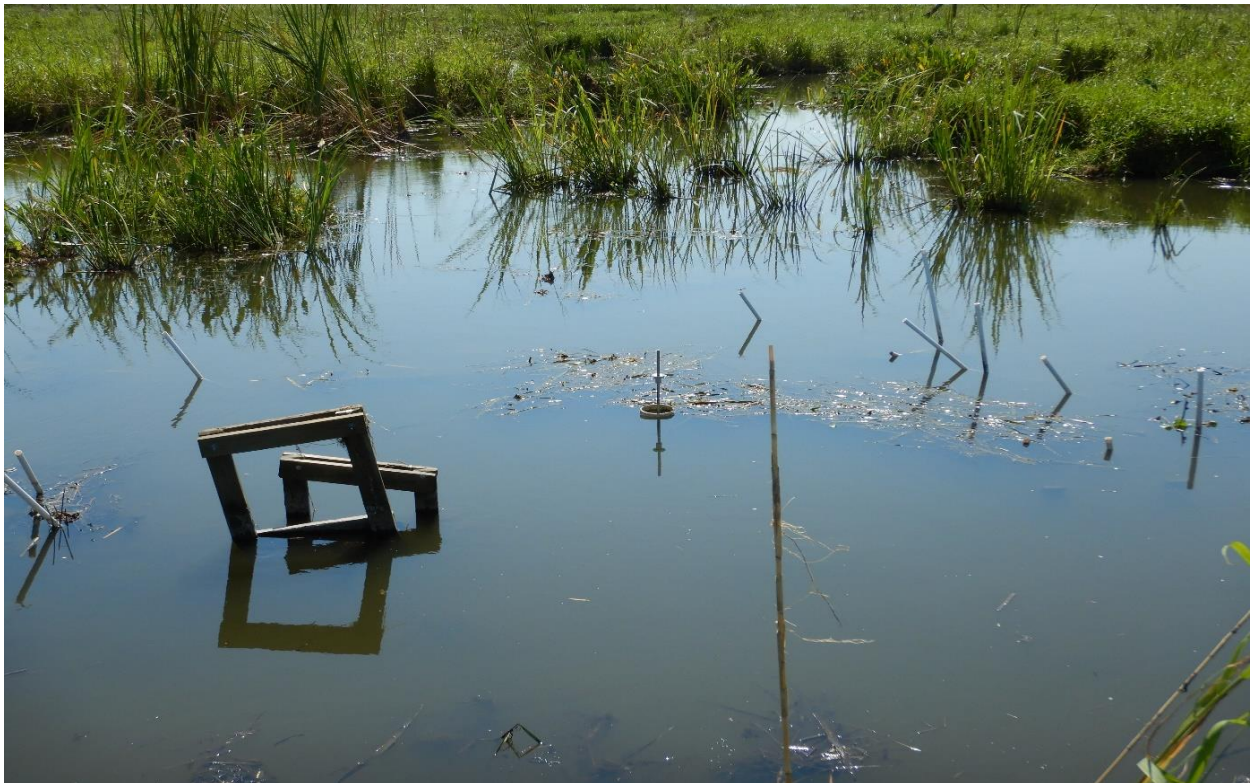
Figure 33. TV-15 interior marsh CRMS site CRMS0545 losing elevation as a result of hurricane damage likely exacerbated by prolonged flooding.

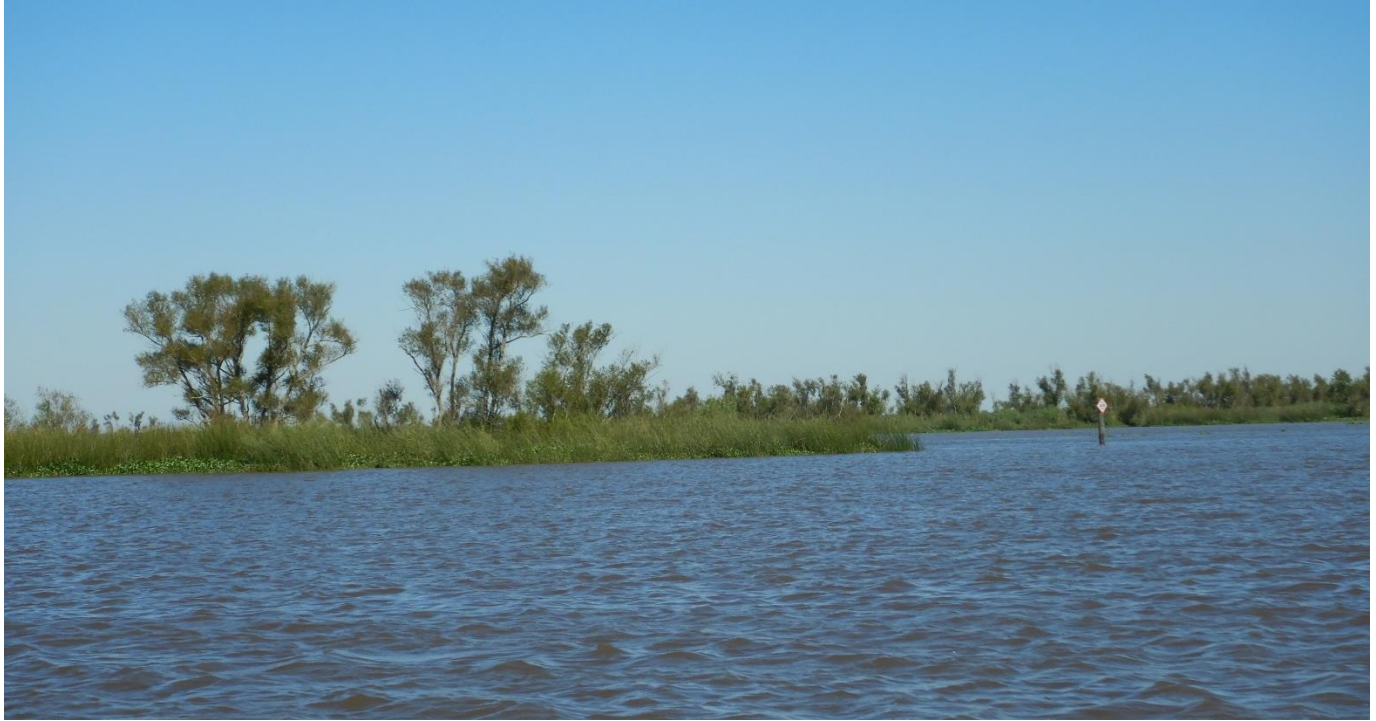
Looking from the main channel, the terraces appear to be still in very good condition. Warning signs appeared to be in place and stable. (Photos: Appendix A, Photo 1-2)

Typical terrace and sign

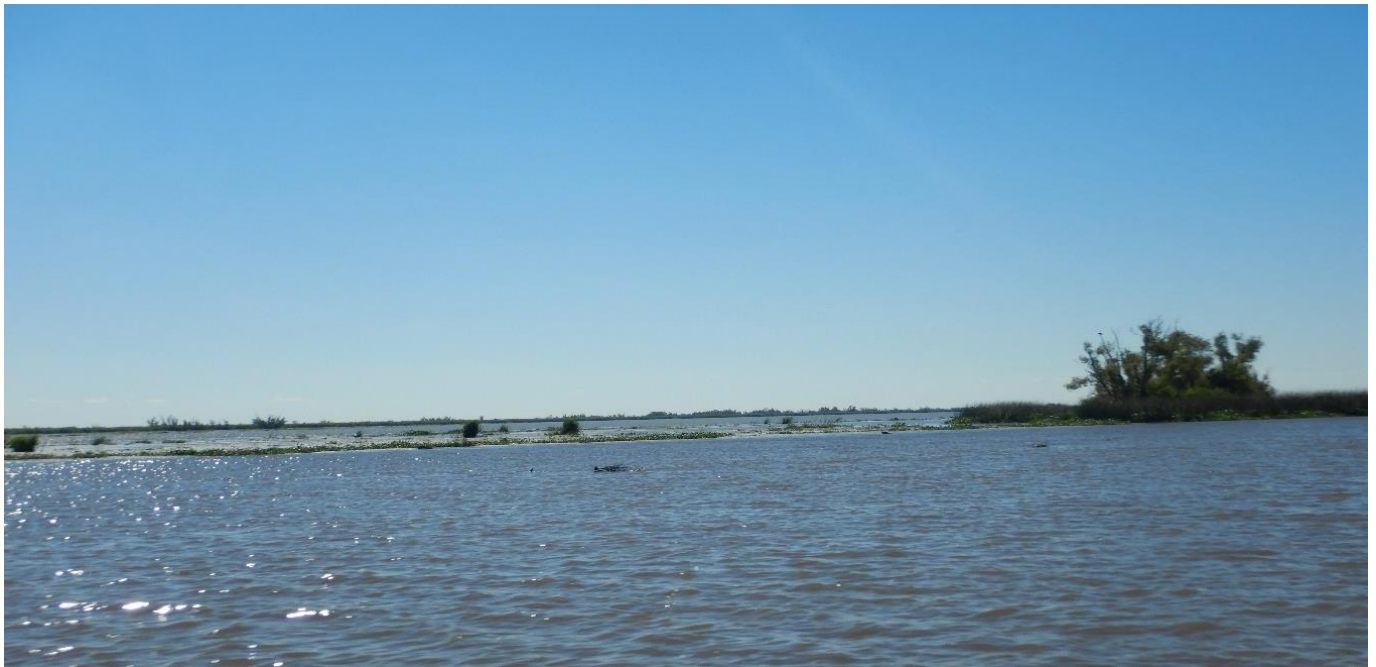
Submerged and emergent aquatic vegetation between the terraces continues to expand. No apparent need for any maintenance at this time. (Photos: Appendix A, Photo 1-3).

Mud flats and vegetation between terraces

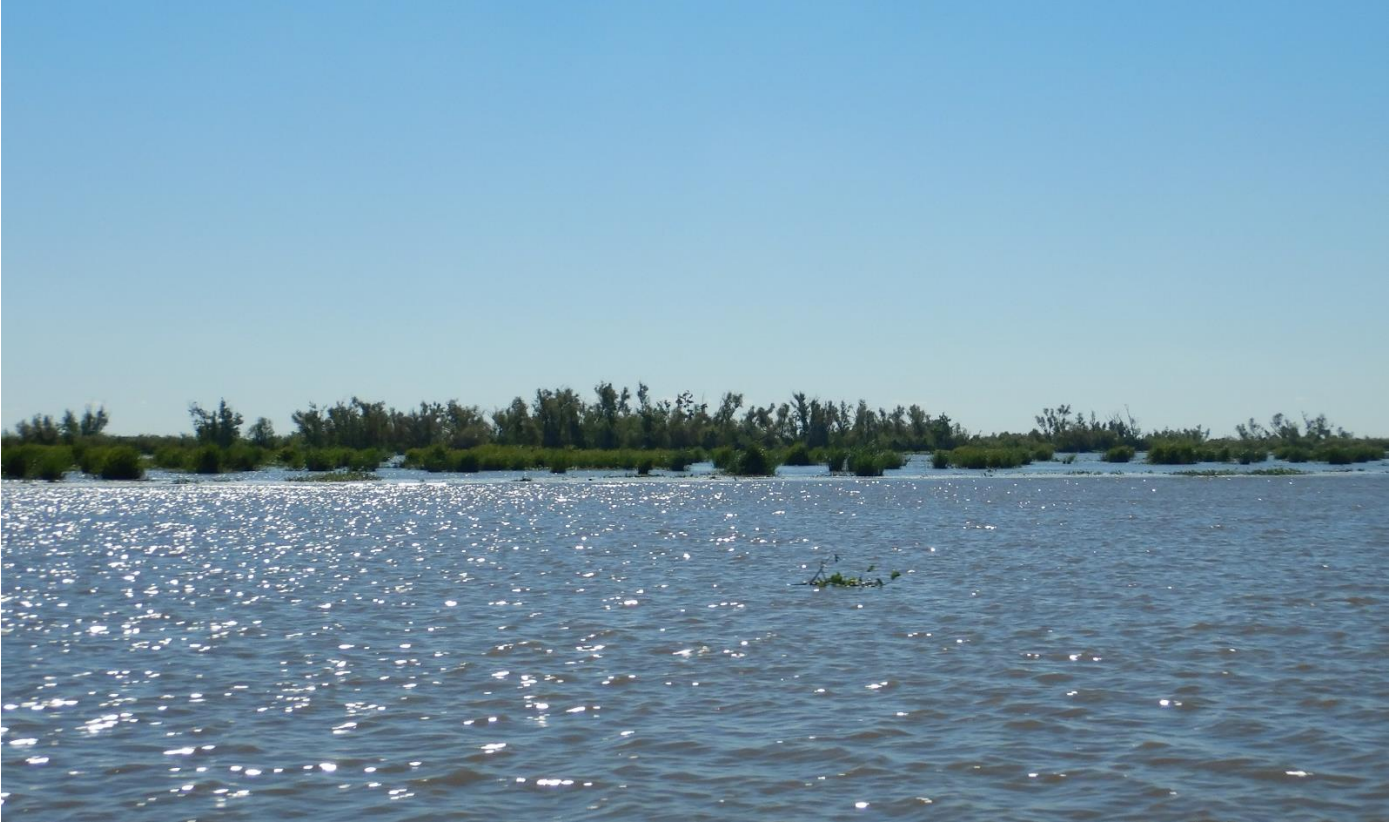
Emergent vegetation between Terraces
