**Coastal Protection and Restoration
Authority of Louisiana (CPRA)**

2021/2022 Annual Inspection Report

EAST MARSH ISLAND MARSH CREATION PROJECT (TV-21)

November 17, 2021
Iberia Parish

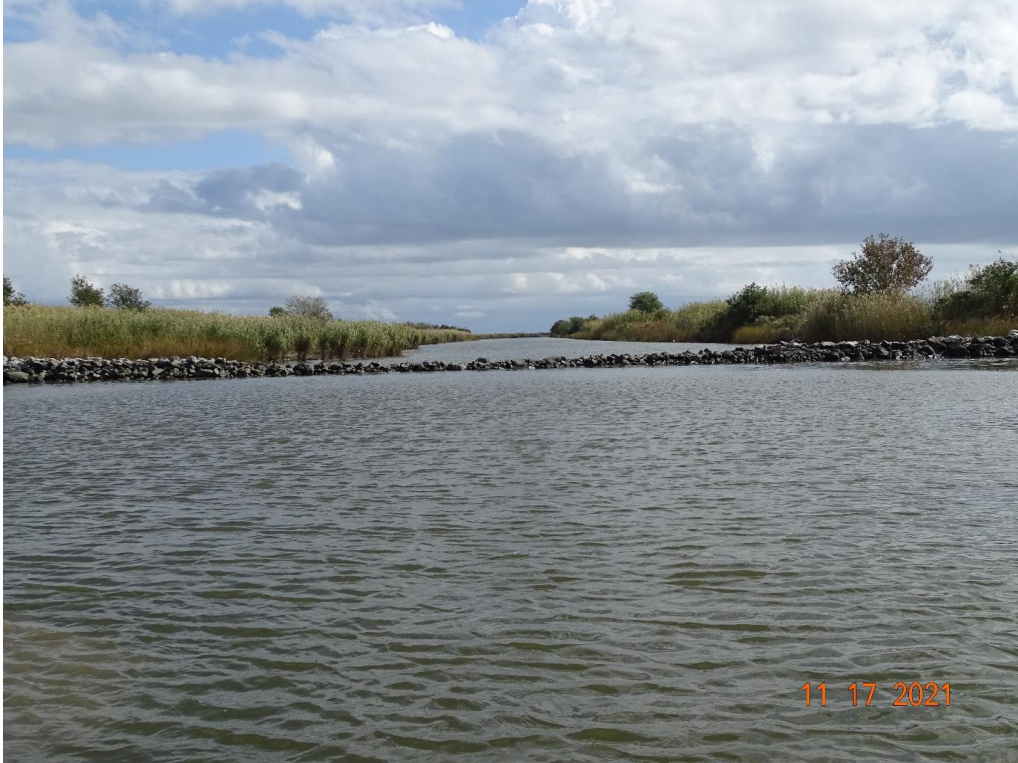
Only Nourished Areas No. 3 & 4 were visible during the site visit. Located on the Northeast tip of the island, shoreline erosion continues to degrade the point. The vegetation is thriving since the nutria population is under control.

Photo No. 1, MC Cell No.1 & Nourished Area No. 4 (Plug, TV-14 Project, West end of East-West Canal)

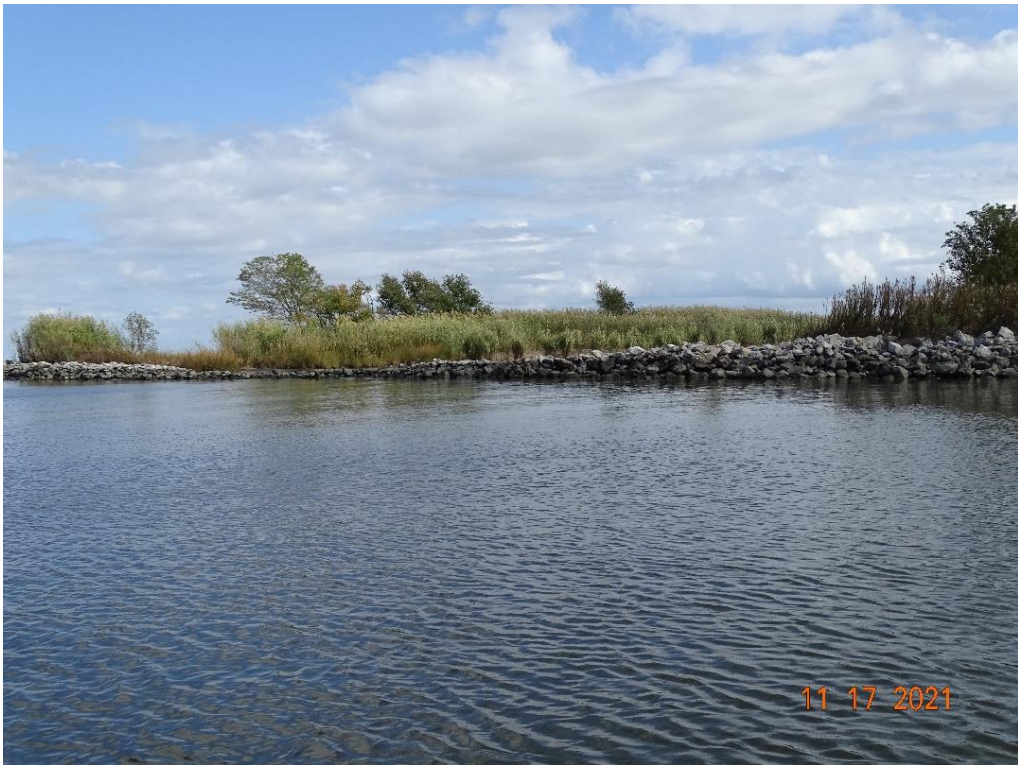
Nourished Areas No. 3 & 4 experienced relatively minor net change. Despite one location with a 10 in. decrease, each other location observed in Nourished Area No. 3 had a 1.2 in. elevation increase. Nourished Area No. 4 had an elevation change ranging from -2.4 in. to +2.4in.

Photo No. 2, Nourished Area No. 4, (Plug, TV-14 Project - West End of East West Canal Looking Northeast)

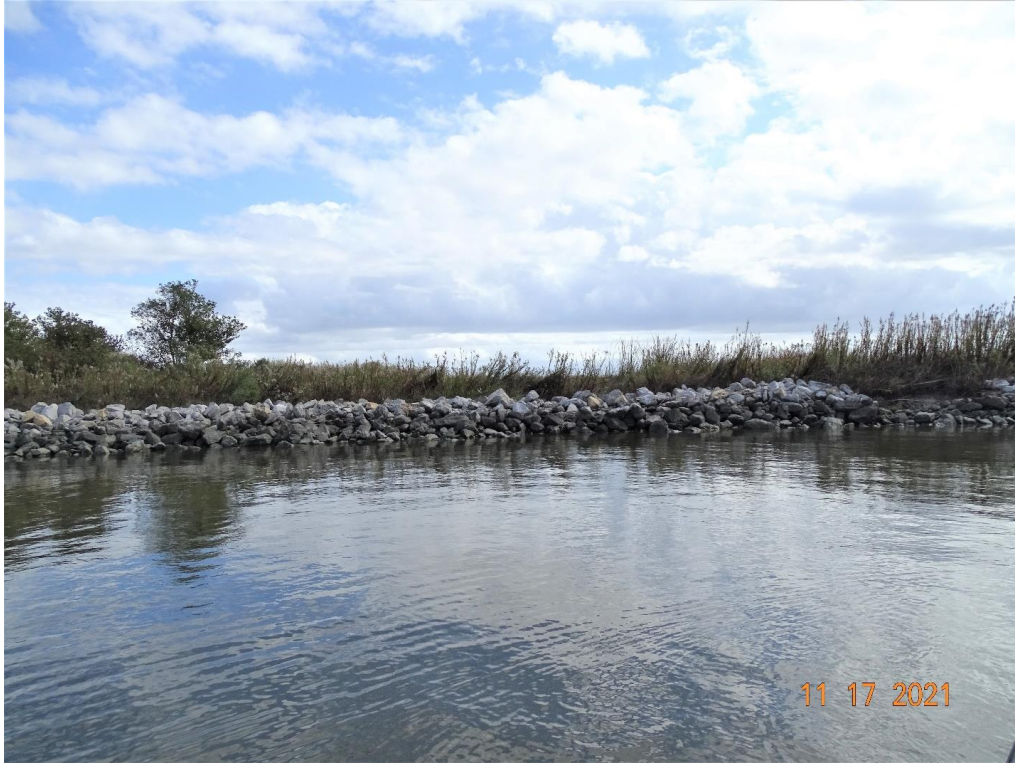
Photo No. 3, MC Area No. 1, (Plug tie in, TV-14 Project - West End of East West Canal Looking Southeast)

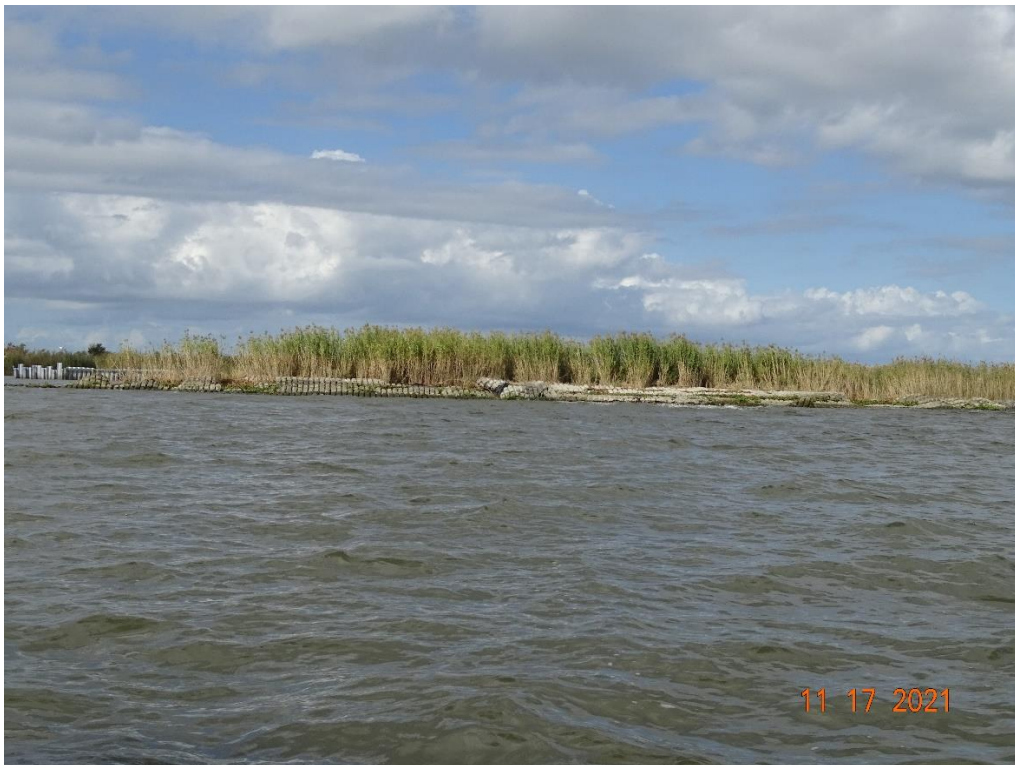
The concrete articulated mats placed in March 2015 on the Northeast corner of the island in Marsh Creation Containment Area No. 1 at the East-West Pipeline Canal have continued to settle at the original breach location since the 2016-2017 O & M inspection. However, those remaining above the waterline continue to break the wave action approaching the shoreline. Also, the PVC sheet pile wall installed by the LDWF on the interior of the containment dikes around the same time as the mats were installed has been breeched.

The 2015 maintenance performed to address the breaches near the East-West Canal has experienced settling due to the soil quality and site conditions during construction. It however is still protecting the area of concern.

Photo No. 4, MC Cell No. 1, Articulated Concrete Mat (2015 Maintenance Event)

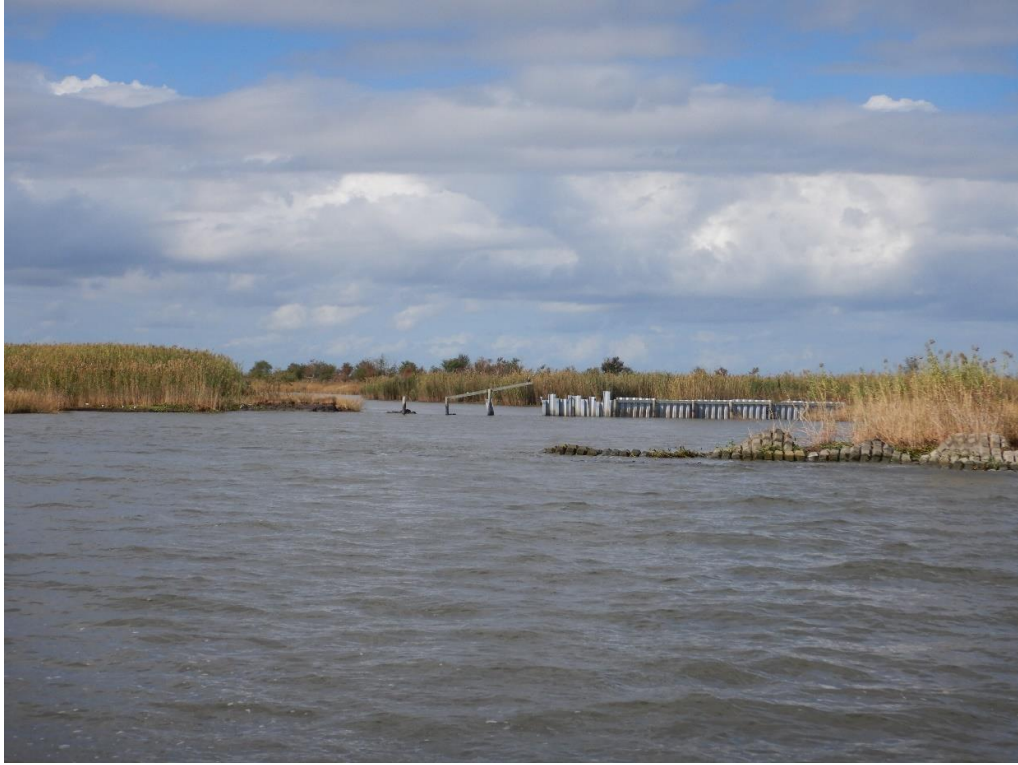
Photo No. 5, MC Cell No. 1, Articulated Concrete Mat (2015 Maintenance Event) & LDWF PVC Sheet Pile Wall

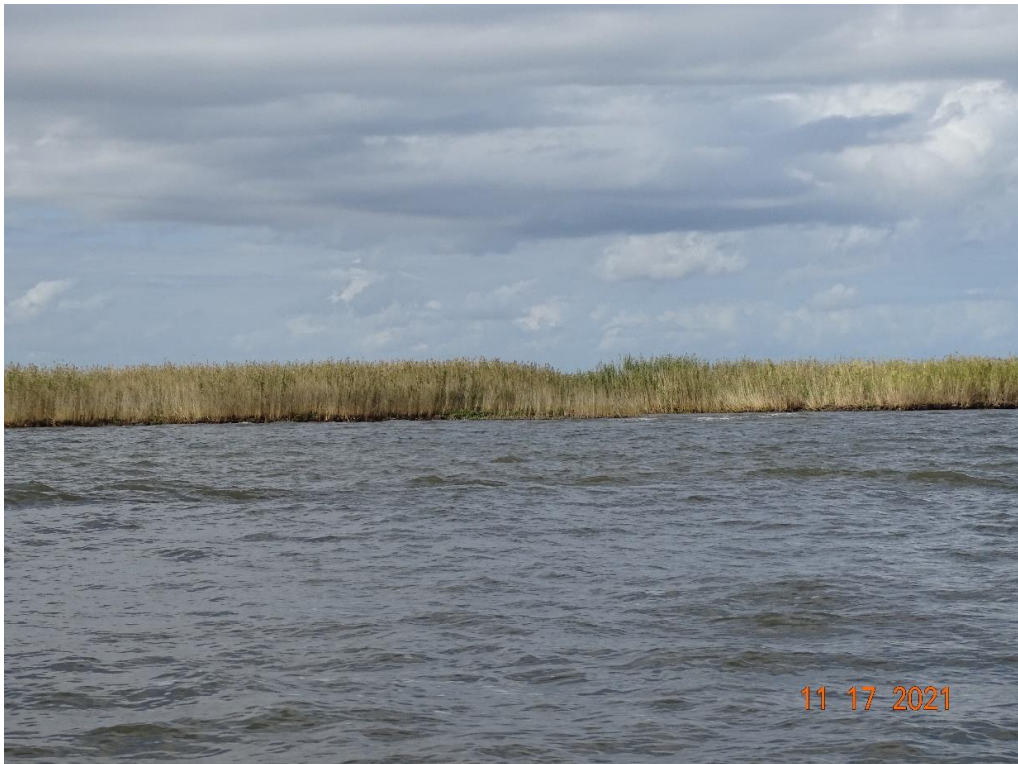
Unlike previous inspections, due to the siltation in the North-South Canal, MC area cell No. 2 was not observable from the plug at the end of the canal. However both MC Areas 1 and 2 were observable from the southeast shoreline. As observed during the previous 2016-2017 O&M Inspection, the two marsh creation containment areas are in good condition since constructed in 2010. Vegetation is thriving since curbing the nutria population.

Photo No. 6, MC Cell No. 1, Viewed from the Southeast Side of the Island

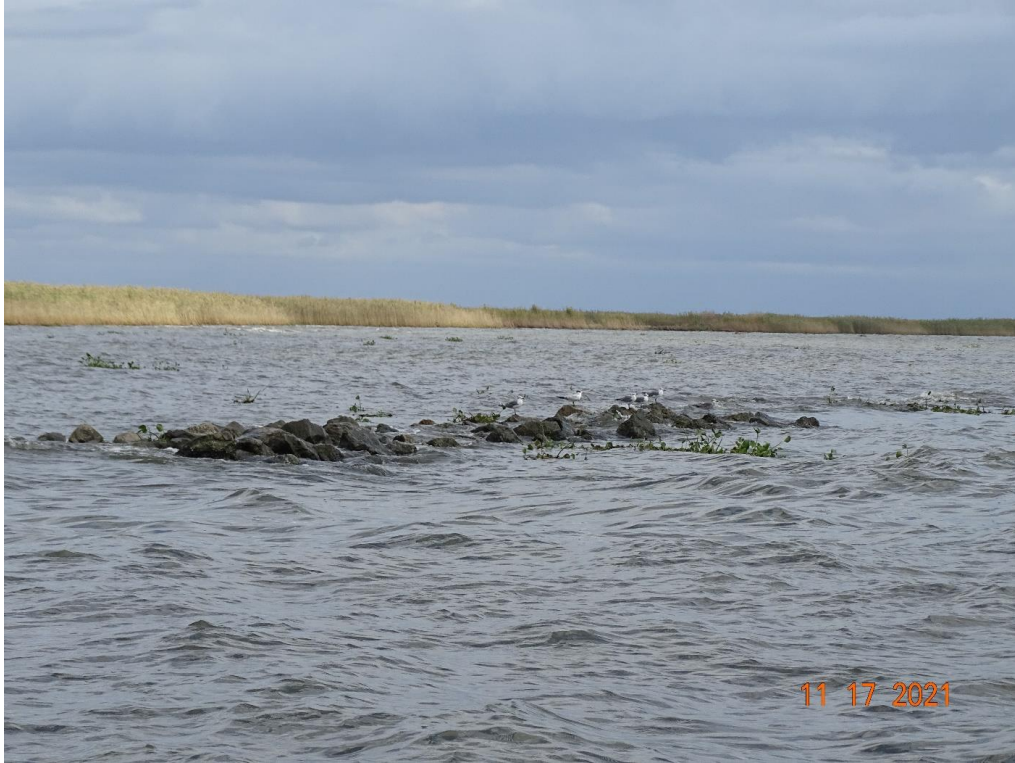
Photo No. 7, MC Cell No. 2, Viewed from the Southeast Side of the Island

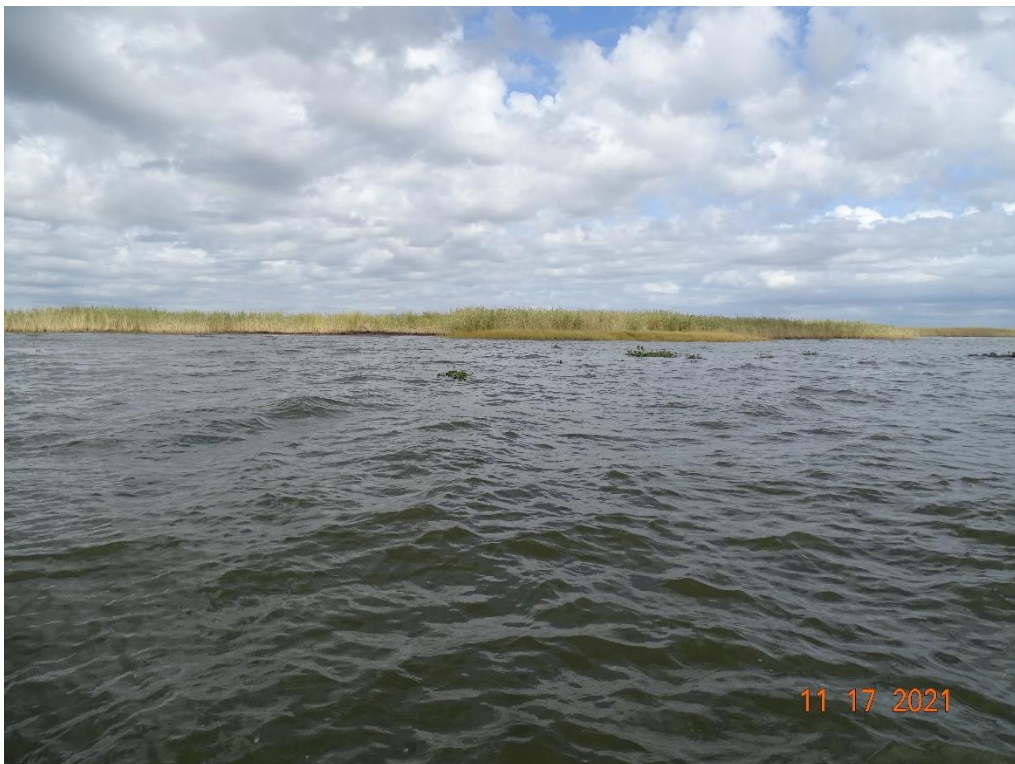
Photo No. 8, MC Cell No. 2, Viewed from the Southeast Side of the Island
