## **2022 Operations, Maintenance, and Monitoring Report**

### **East Marsh Island Marsh Creation**

State Project Number TV-21  
Priority Project List 14

June 2022  
Iberia Parish

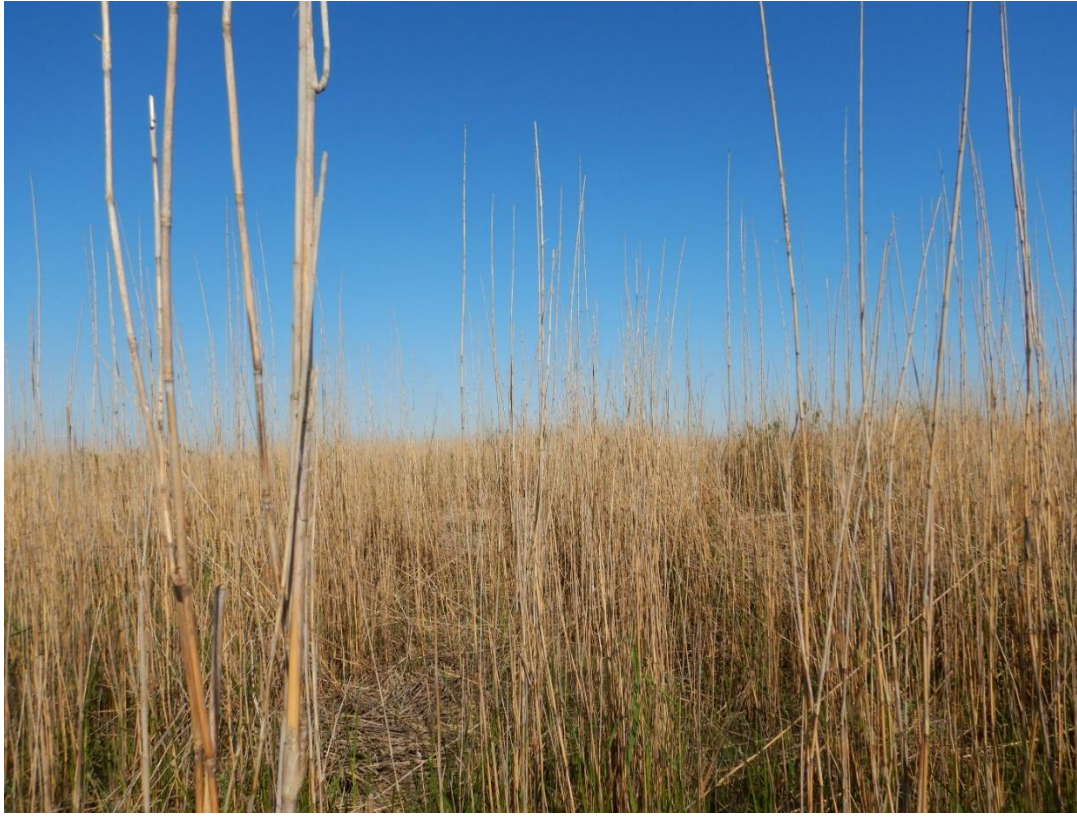
**Figure 6f.** View of stressed/dead *Phragmites australis* in containment area 2 in April 2021.

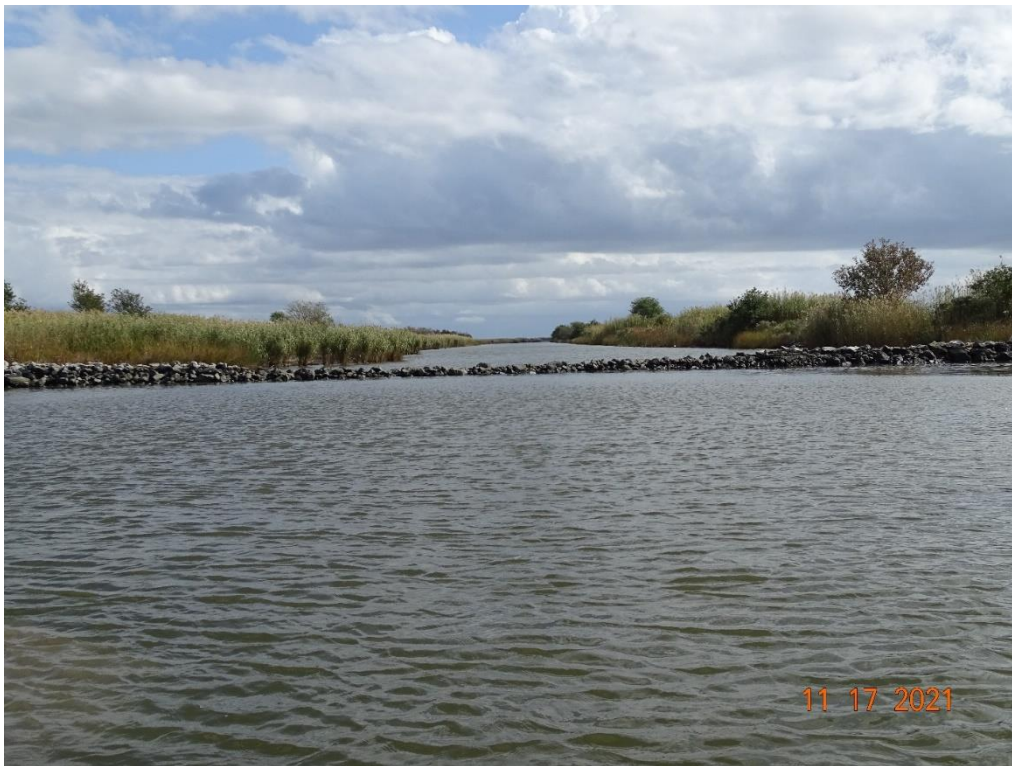
**Photo No. 1,** MC Cell No.1 & Nourished Area No. 4 (Plug, TV-14 Project, West end of East-West Canal)

Only Nourished Areas No. 3 & 4 were visible during the site visit. Located on the Northeast tip of the island, shoreline erosion continues to degrade the point. The vegetation is thriving since the nutria population is under control.

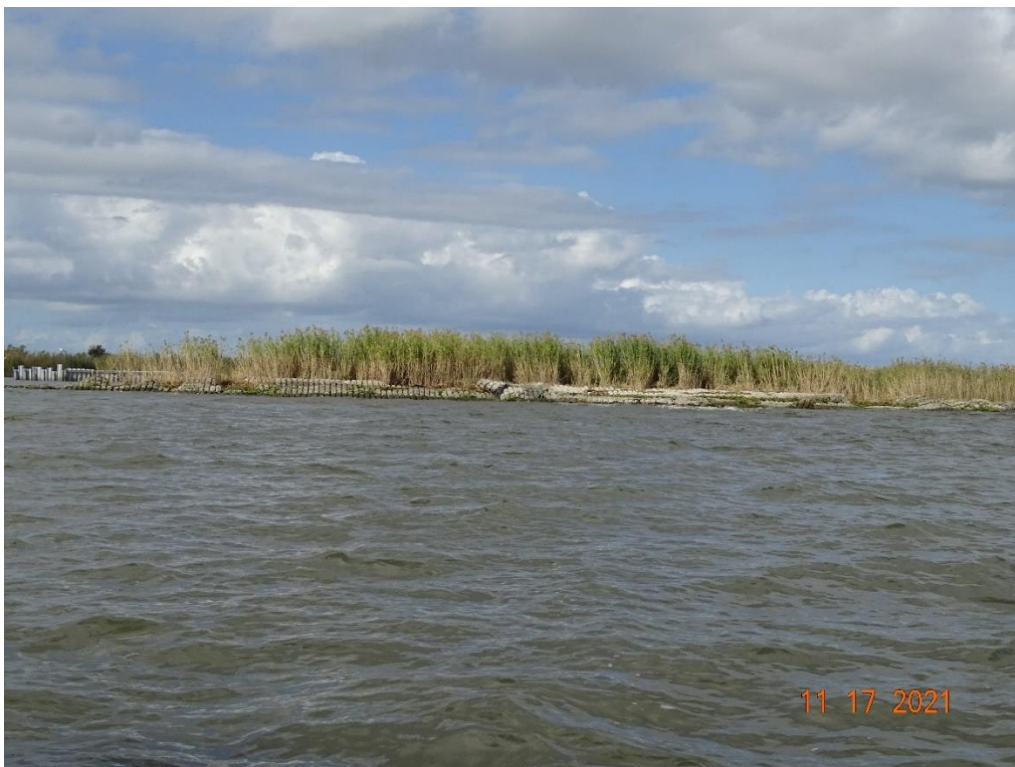
**Photo No. 4,** MC Cell No. 1, Articulated Concrete Mat (2015 Maintenance Event)

The concrete articulated mats placed in March 2015 on the Northeast corner of the island in Marsh Creation Containment Area No. 1 at the East-West Pipeline Canal have continued to settle at the original breach location since the 2016-2017 O & M inspection. However, those remaining above the waterline continue to break the wave action approaching the shoreline. Also, the PVC sheet pile wall installed by the LDWF on the interior of the containment dikes around the same time as the mats were installed has been breached.

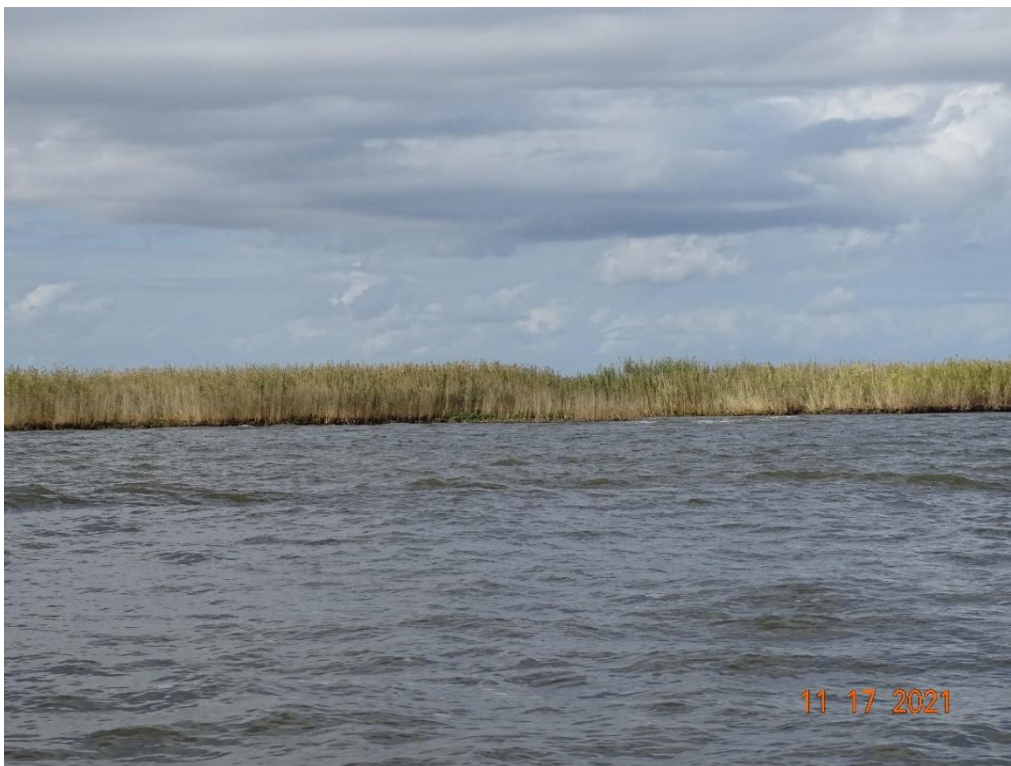
**Photo No. 6**, MC Cell No. 1, Viewed from the Southeast Side of the Island

Unlike previous inspections, due to the siltation in the North-South Canal, MC area cell No. 2 was not observable from the plug at the end of the canal. However both MC Areas 1 and 2 were observable from the southeast shoreline. As observed during the previous 2016-2017 O&M Inspection, the two marsh creation containment areas are in good condition since constructed in 2010. Vegetation is thriving since curbing the nutria population.
