**Coastal Protection and Restoration
Authority (CPRA)**

2024 Operations, Maintenance, and Monitoring Report

Cole's Bayou Marsh Restoration

State Project Number TV-0063
Priority Project List #21

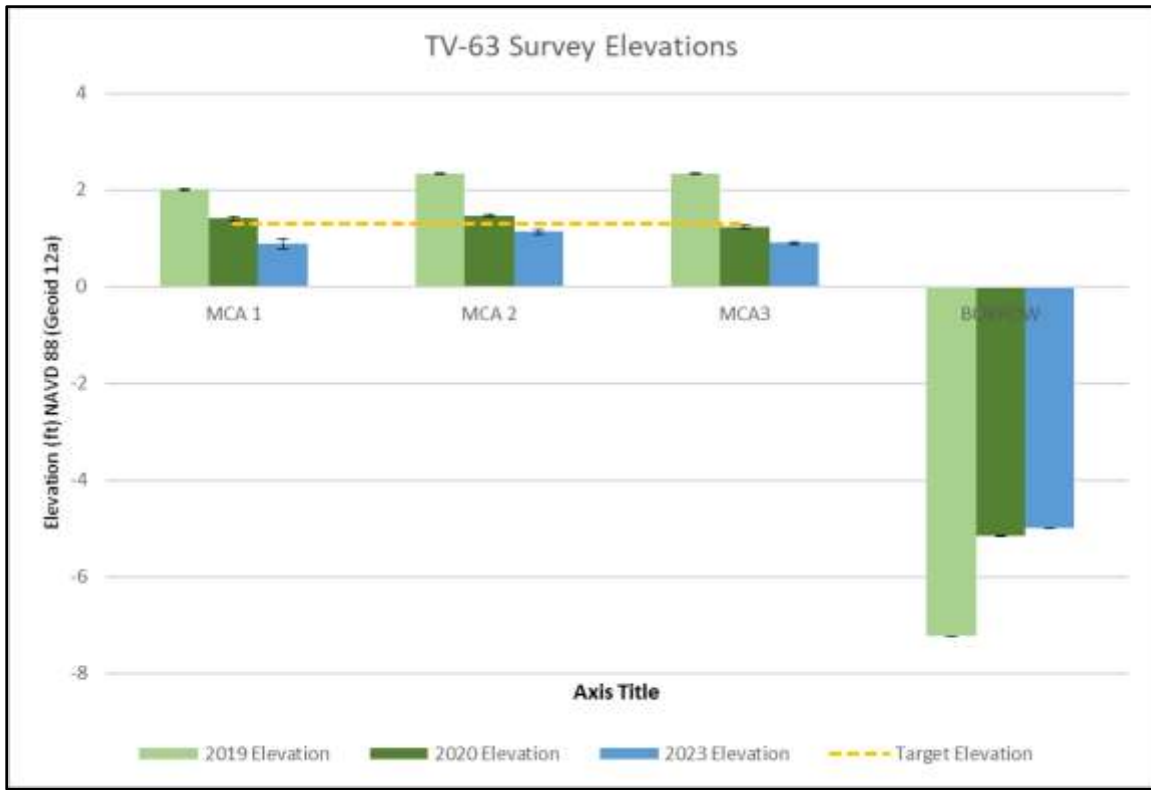
Figure 8. Survey Elevation data and target elevation data from 2019 (as-built), 2020, and 2023 for TV-63 marsh creation areas and borrow area.

An as-built survey was completed in the summer of 2019 (Figure 8). MCA 1 was constructed to the target elevation of 2.0 ft while MCA 2 was slightly above target at 2.34 ft. MCA 3 was also surveyed at 2.34 ft, but was below the target elevation of 2.5 ft for the area, which is roughly 54% of the MCA.

A survey of the fill areas was completed one year post-construction in December 2020 (Figure 8). MCA's 1 and 2 settled to approximately the same elevation of ~1.45 ft. MCA 3 settled a bit more to 1.24 ft. The elevations from the 2020 survey were compared to the settlement curves that were developed pre-construction to compare actual settlement to the predicted values as well as observed water levels during that time frame (Figures 9-11). MCA's 1 and 2 are slightly higher than the predicted elevation at 1 year post construction while MCA 3 is approximately 0.5 ft lower.

The most recent elevation and bathymetry survey was completed in late 2023 and showed lower elevations across the MCAs but showed the rate of settlement slowing down. MCA 1 settled to 0.891 ± 0.103 ft., which is 0.53 ft. lower than the 2020 survey. Comparatively, MCA 2 lost less elevation between the two surveys, dropping to 1.14 ± 0.049 ft. a decrease of 0.327 ft. between the 2020 survey and the 2023 survey. MCA 3 had an average elevation of 0.907 ± 0.027 ft. in 2023 which was 0.333 ft. lower than its elevation in 2020.

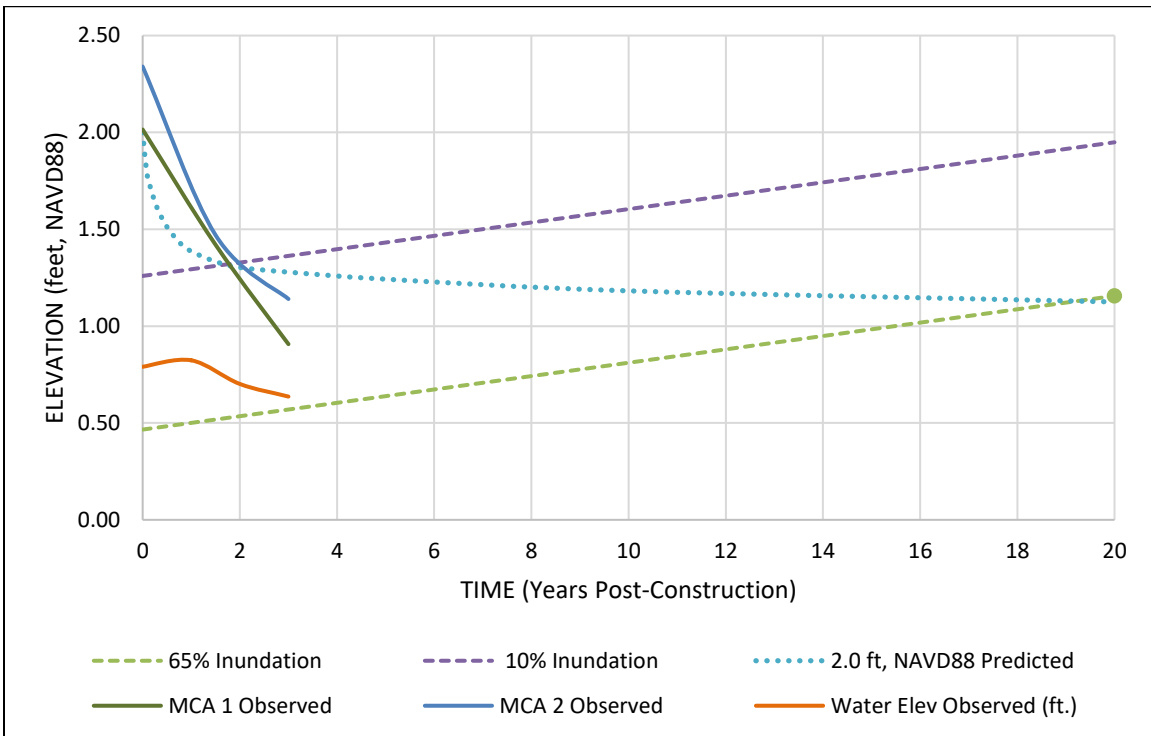
Figure 9. Predicted vs. observed settlement for the TV-63 Marsh Creation Areas 1 and 2 through 2023.

Elevations across all MCAs are significantly lower than the final 20-year target elevations. MCAs 1 and 2 should be around 1.795 ft at the 2020 survey but were closer to 1.45 ft. The elevations continued to drop for the 2023 survey that expected elevations of 1.710 ft, yet recorded elevations of the two areas that averaged 1.02 ft). We see the same decrease in settlement in MCA 3 with the expected elevation for the 2020 survey being around 1.5 ft when the recorded actual elevation was 1.24 ft, and again the same decrease in 2023 when the expected elevation was 1.494 ft but had an average elevation of 0.907 ft). All areas are seeing this rapid settlement and decrease in elevation across the entire project area.

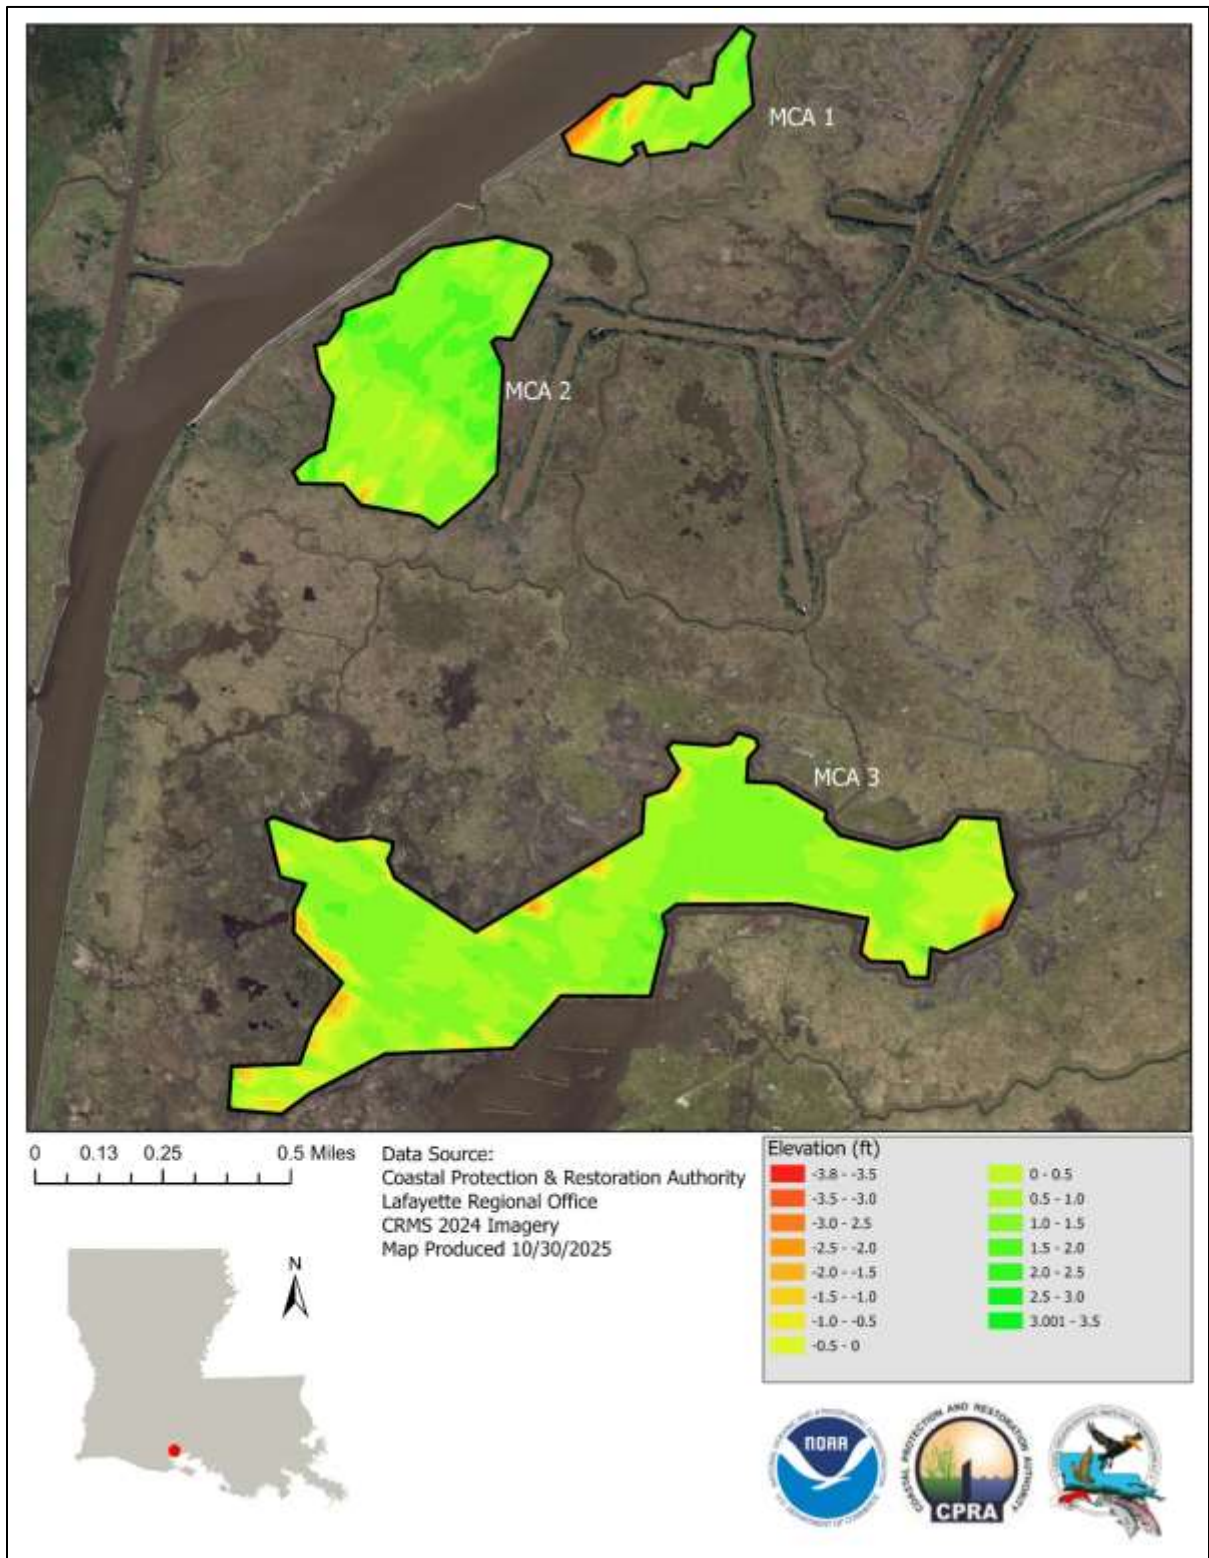
Figure 12. Elevation grid models for the TV-63 marsh creation fill areas from the June 2023 Survey.

Elevation grid models for the MCA's were also developed using the 2023 survey (Figure 12). All MCAs saw a decrease in elevation due to the sediment compacting and settling.

In MCA 1, we saw the development of a lower area along Freshwater Bayou on the southwest side of the area. This could be due to regular over wash from large ships' wakes or other wave actions as well as possibly from building containment dikes along FWB using interior borrow sources.

MCA 2 had elevation changes comparable to typical settling seen in recently created areas. Otherwise, the area has performed well and has not had any low spots arise between the first survey and the 2023 survey.

MCA 3 has a few low spots across the project area, specifically on the western and eastern edges. These areas held more water after construction and have taken longer to vegetate due to a lower starting elevations.

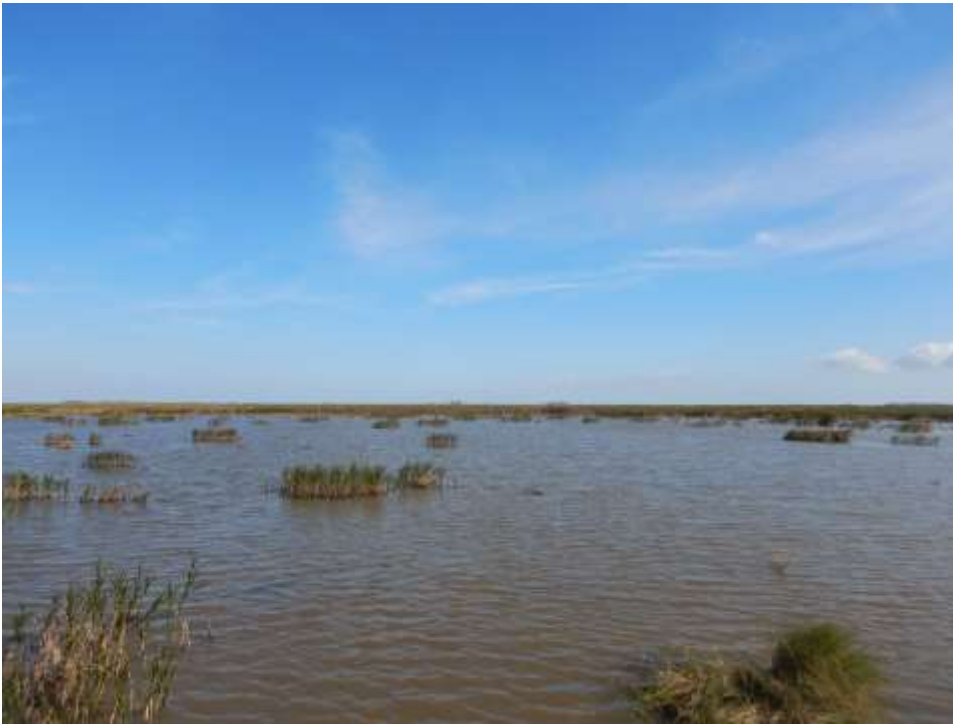
particularly on fresher species such as *Typha latifolia* and *Vigna luteola*. More significantly, the natural marsh stations exhibited signs of flood stress and were quaking/floating due to prolonged flooding throughout the fall of 2020. It was estimated that the marsh surface had popped up ~0.5 ft in response to the flooding and was difficult to walk on. Between clumps of vegetation, the surface was extremely soft down to two feet before reaching a firm substrate. In addition, there were isolated incidents of *Spartina patens* laying over or perched from becoming detached from the substrate (Figure 17). This is concerning as the intent of the water control structure modifications was to relieve interior ponding that leads to these floating habitats. However, the vegetation survey was conducted following a very active storm season that produced prolonged flooding from storm surge. Further surveys will determine the project's effect on vegetation in the future.

Figure 16. Detached *Spartina patens* within the natural marsh of the project area in October 2020.

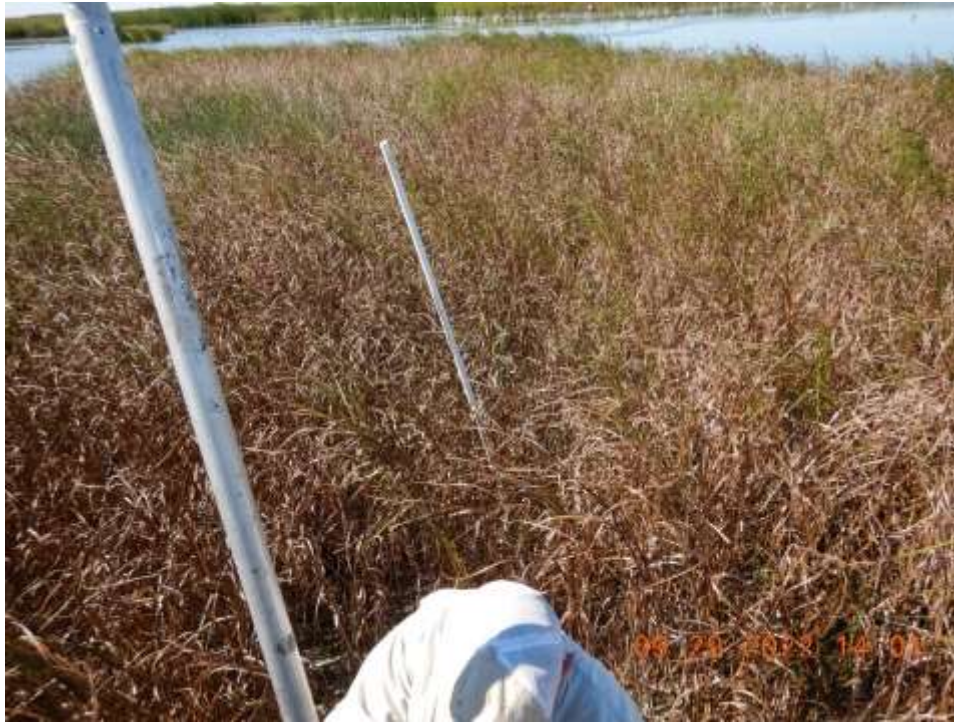
The project area saw the FQI increase in overall total plant coverage in the MCAs (Fig 15). We saw an increase of more than 30% between the first vegetation survey in 2020 and the second one that was completed in 2022. Project areas are typically vegetated around year three post construction of the MCA. TV-63 was completed in 2019 and a majority vegetated before 2022. As mentioned we saw low coverage percentages in the MCA area in 2020 with the area mainly being composed of *Schoenoplectus americanus*, *Bolboschoenus robustus* and both species of *Typha*. We didn't see an increase in the main vegetation seen between 2020 and 2022 other than a boom in the percentage of *Spartina patens*, along with an increase in multiple smaller flora species which were classified in the Other portion of the percentage. In addition, the eastern section of MCA3 saw significant vegetation colonization compared to the 2020 survey (Figure 18).

Figure 18. View of the same area on the east side of MCA 3 taken during the September 2022 site visit showing vegetation colonization.
