2009 Operations, Maintenance, and Monitoring Report

Pecan Island Terracing (ME-14)

State Project Number ME-14 Priority Project List 7

June, 2009 Vermilion Parish

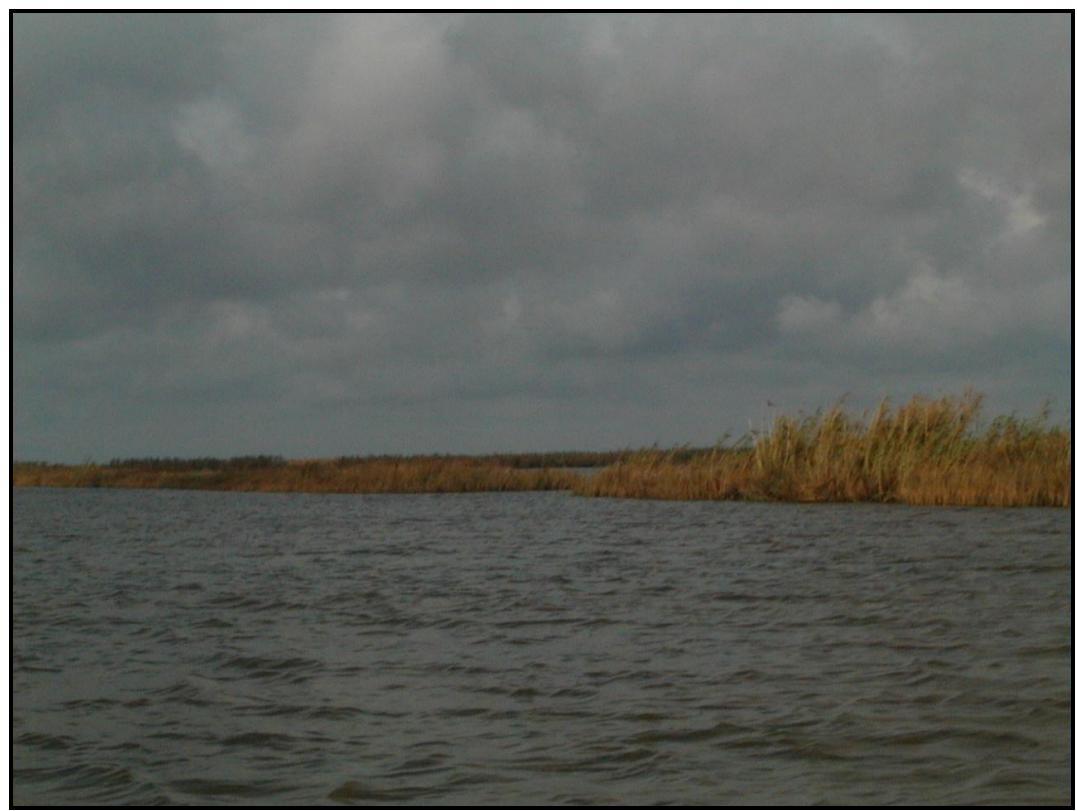
Overall the majority of the earthen terraces are in good condition and did not appear to suffer any major damage from Hurricane Ike. Previously noted erosion in past O&M Inspections of the southern sacrificial terraces has worsened. The southern sacrificial terraces are providing less protection for the interior earthen terraces than in previous years. (Photos: Appendix A, Photo 1)

The tops of the terraces are approximately 50 per cent covered with vegetation. Species noted include *Spartina alterniflora*, *Juncus*, *Baccharis*, and *Spartina patens*. (Photos: Appendix A, Photo 1).

Photo No. 1, Typical earthen terrace

ltem	Condition	Physical Damage	Corrosion	Photo #	Observations and Remarks
Steel Bulkhead	N/A				
/ Caps					
Steel Grating	N/A				
Stop Logs	N/A				
Hardware	N/A				
Timber Piles	N/A				
Timber Wales	N/A				
Galv. Pile Caps	N/A				
Cables	N/A				
Signage	N/A				
/Supports					
Rip Rap (fill)	N/A				
Earthen	Good			1	Terraces are in good condition
Terraces
