2012 Operations, Maintenance, and Monitoring Report

Sediment Trapping at the Jaws (TV-15)

State Project Number TV-15 Priority Project List 6

June, 2012 St. Mary Parish

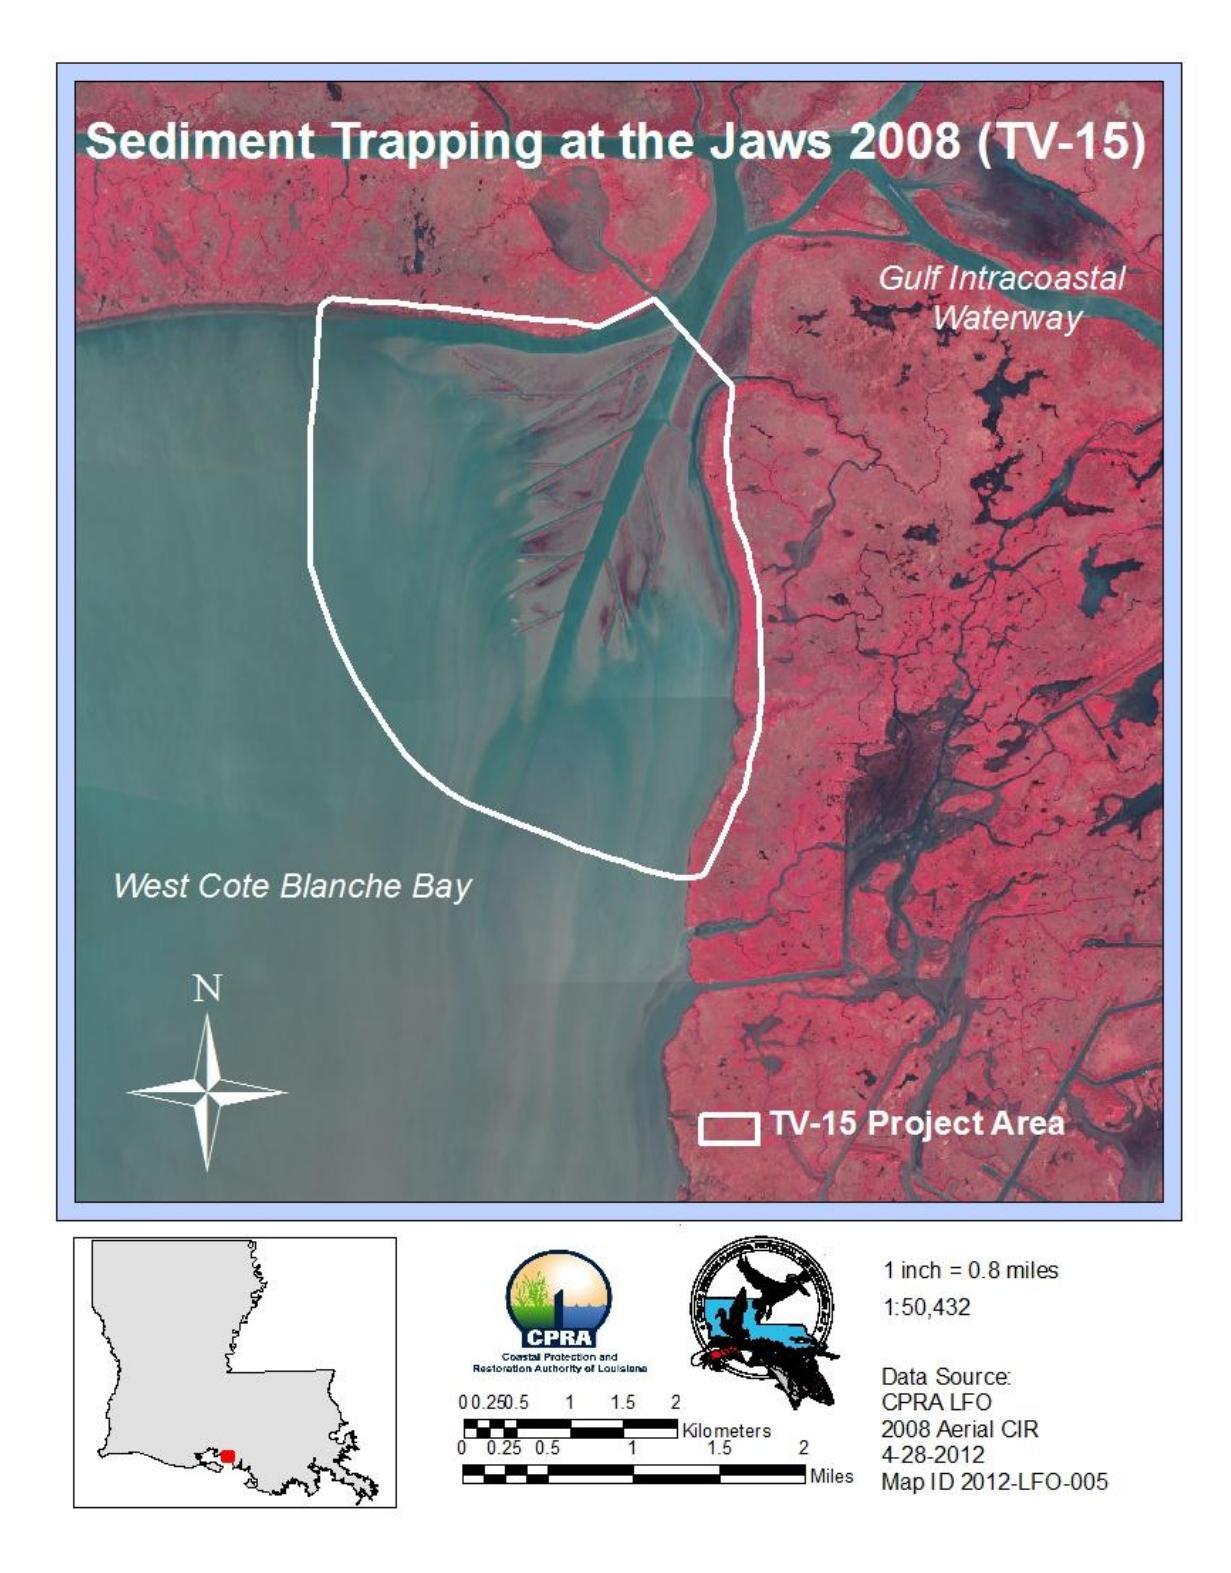
Figure 3. The areas in between and around the constructed deltaic ridges of TV-15 have trapped substantial amounts of sediment as visible in 2008.

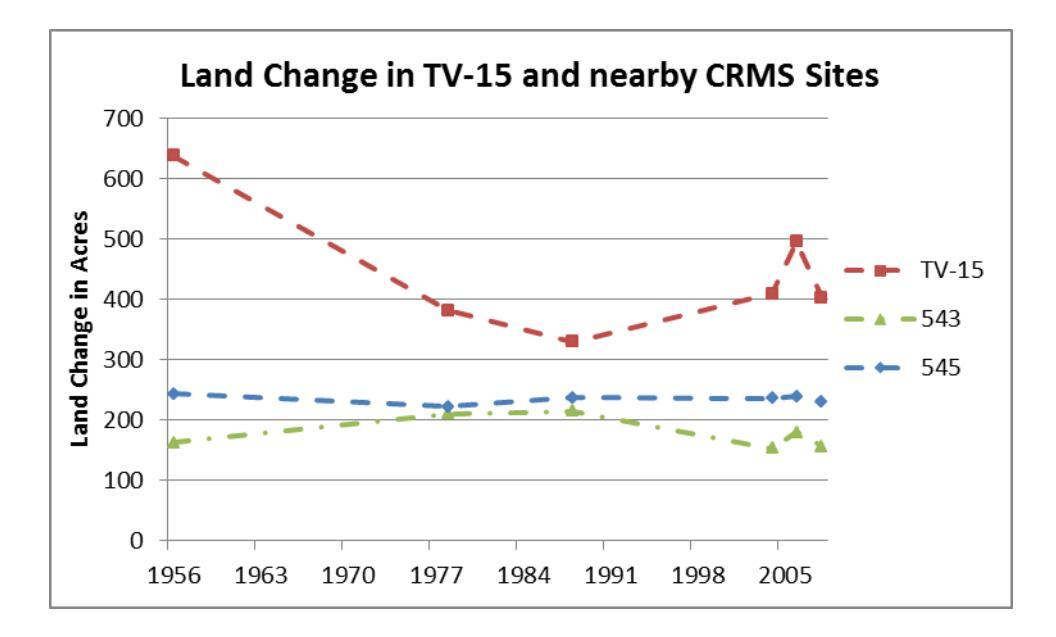
Figure 5. General trends in land change of TV-15 and local CRMS sites near the Jaws, most of the land loss in the project area was likely caused by shoreline erosion (CRMS spatial viewer land/water, Barras et al. 2008).

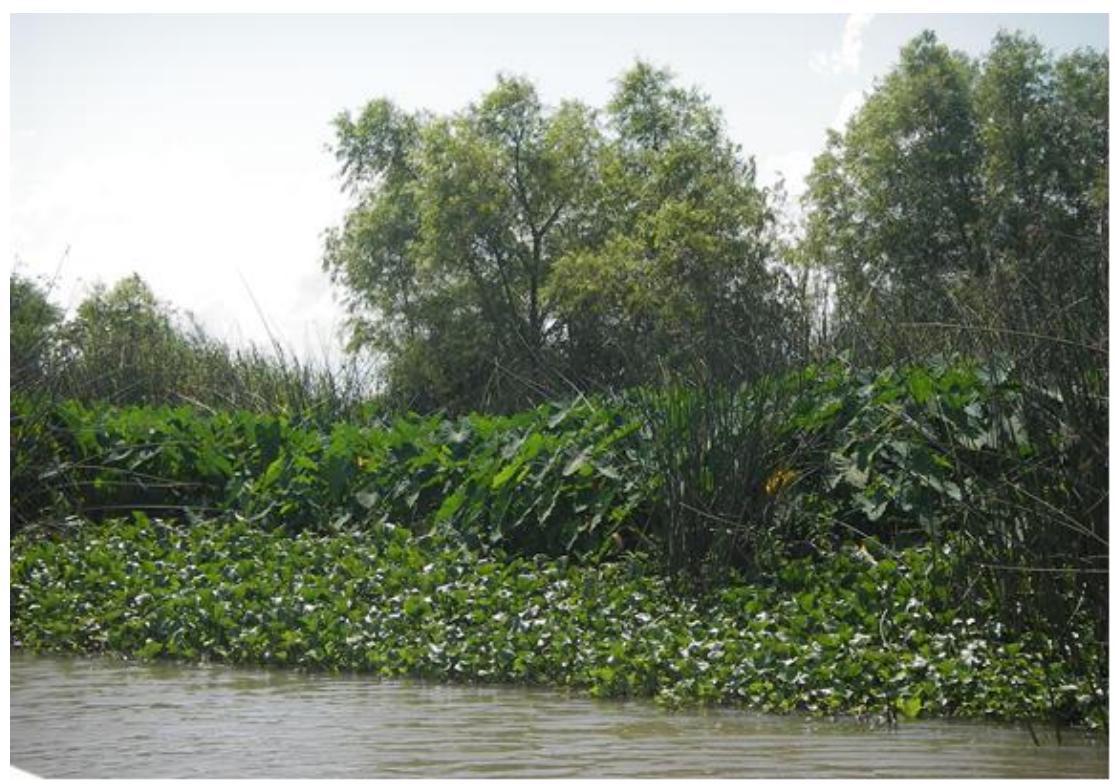
Photo No. 1--Typical Terrace

The terraces remain in very good condition. Settlement on the ends of the terraces has stabilized. GPS locations were obtained at the end of three terraces for future comparison. Vegetation on the terraces is thriving. The noted varieties were Giant Cut Grass, Elephant Ear, Bullwhip, Bull tongue, and Willow trees. In addition, Parrot Feather and Hyacinths were noted adjacent to the terraces. Vegetation still exists in areas where terraces have settled substantially. There was no apparent damage from nutria as seen before. Warning signs were all in place and stable. Submerged and emergent aquatic vegetation between the terraces continues to expand. Channels remain clear. No need for any maintenance at this time. (Appendix A, Photos 1–4)

No maintenance is recommended at this time.

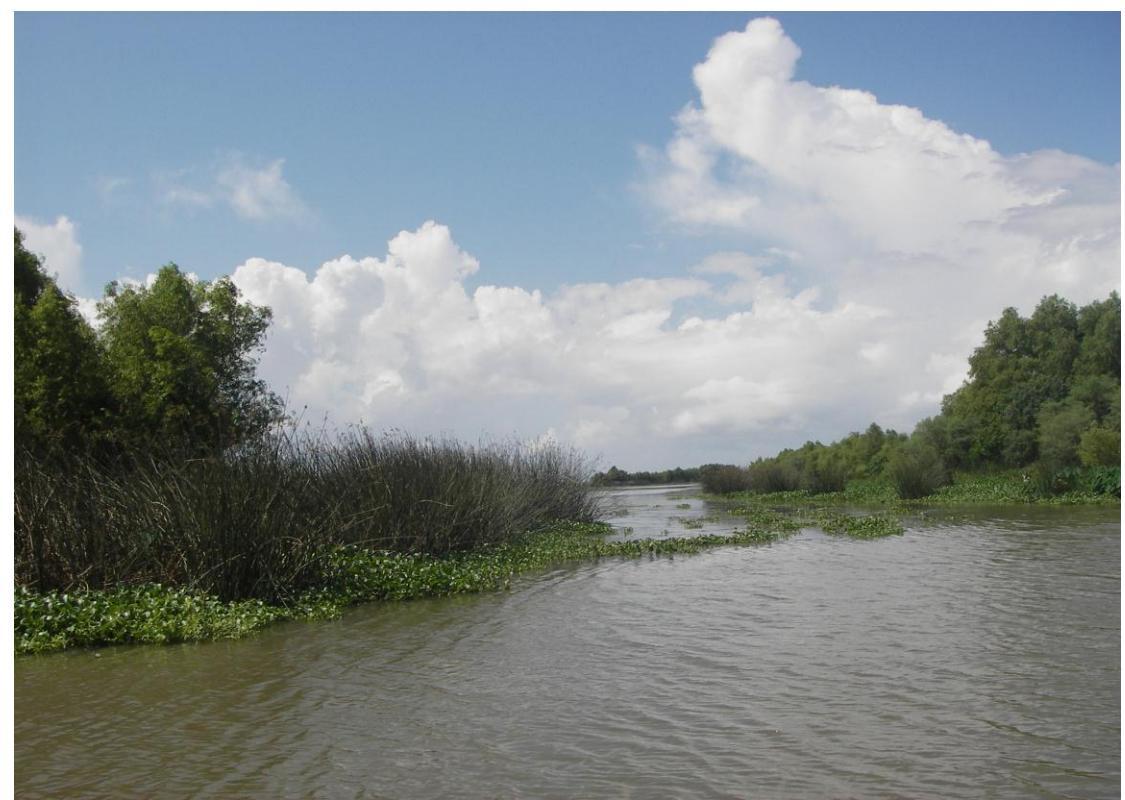
Photo No. 4 - Gap Left Between Terraces Closing 20
