2013 Operations, Maintenance, and Monitoring Report

Delta Wide Crevasses (MR-09)

State Project Number MR-09 Priority Project List 6

July 2013 Plaquemines Parish

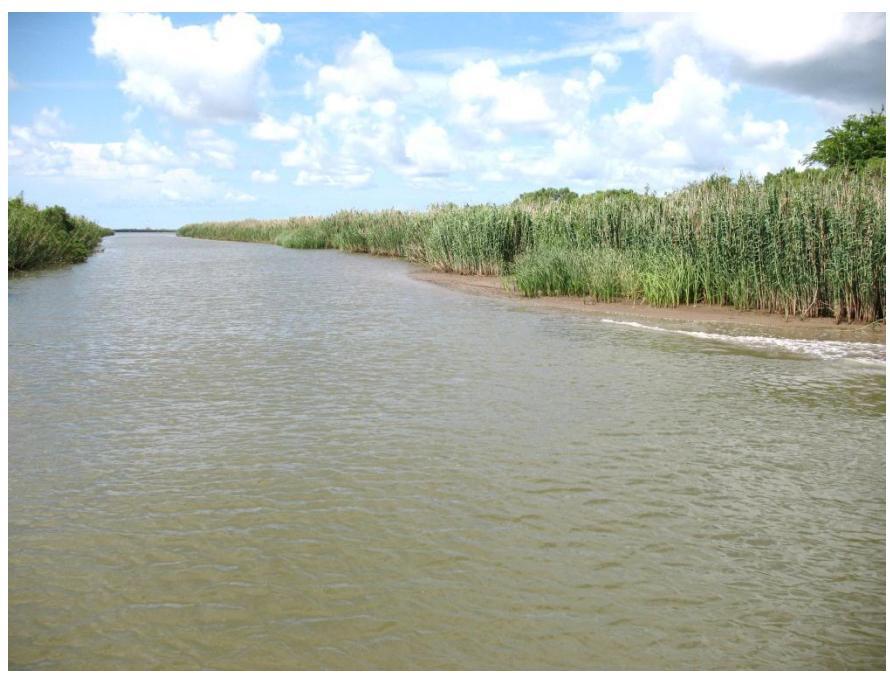
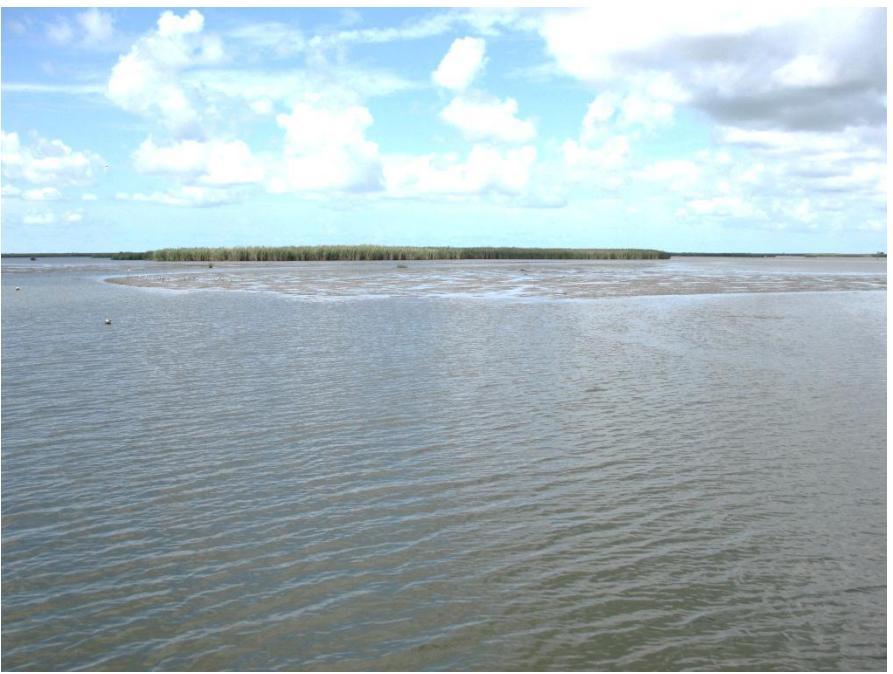
- v. <u>Crevasse 12 (1999)</u>: (2,000 ft. X 75 ft. X -8.0 ft. NAVD 88) This crevasse has silted in on the right bank and is forming a channel ranging from 4'-8' deep. Mudflats spread across the receiving bay indicating development of new land.

Crevasse No. 12 (View 1) Looking into crevasse from South East Pass.

Crevasse No. 12 (View 2) Looking west. Spoil area in center of view.

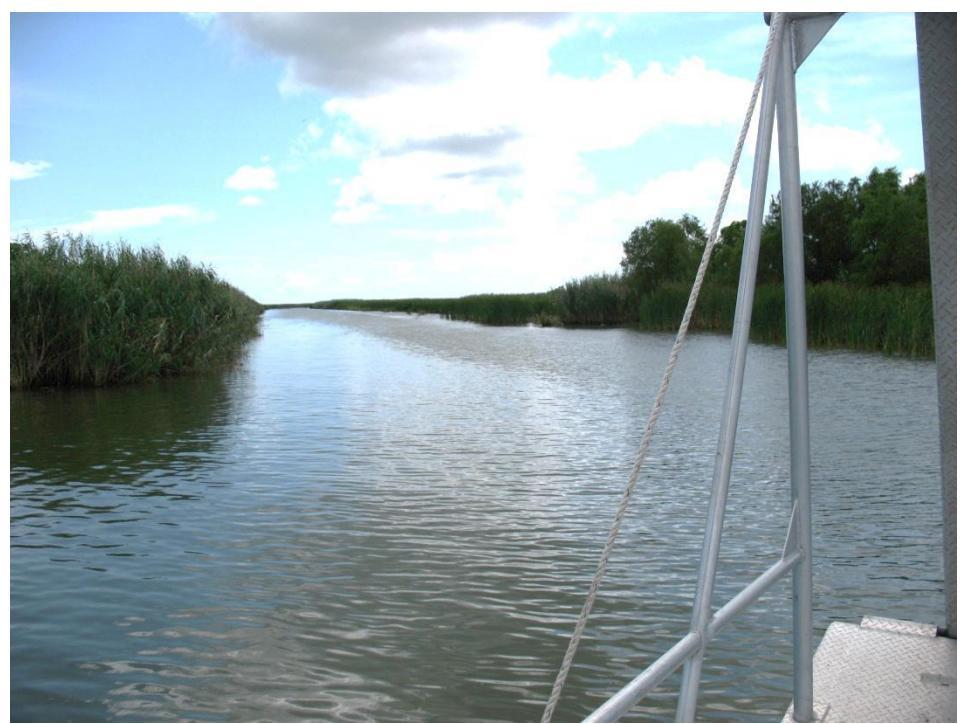
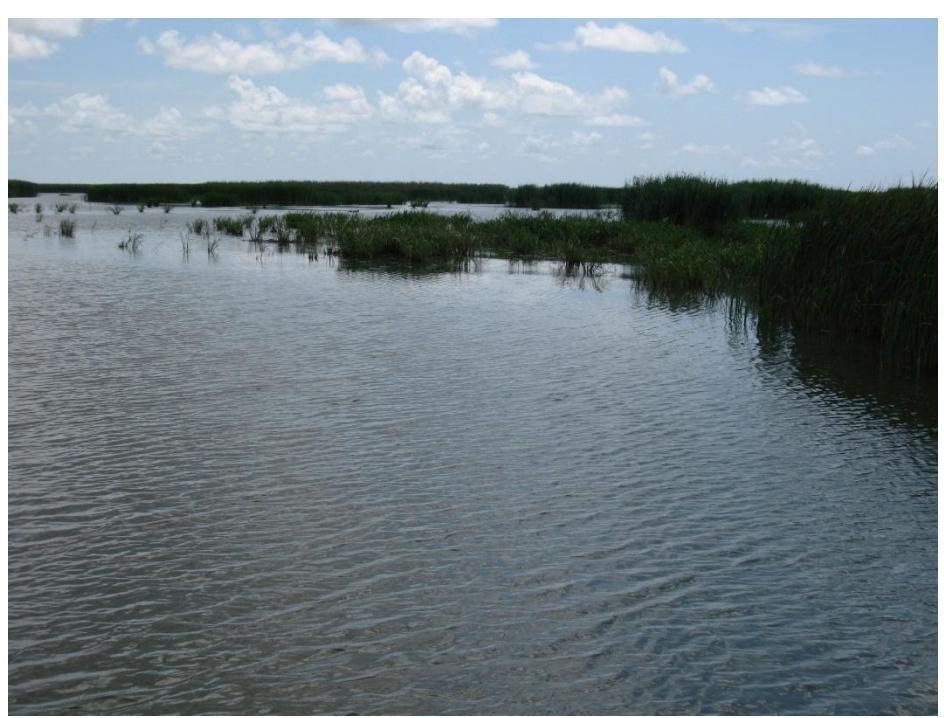
- **iv.** <u>Crevasse 11 (1999)</u>: (2,600 ft. X 100 ft. X -8.0 ft. NAVD 88) This re-dredged crevasse (1999) is maintaining a good flow throughout its length. Soundings indicate that it has maintained 5'-7' depth throughout the channel. The low water levels in the river have allowed more vegetation growth on sediment deposits. Wild rice (*Zizania aquatica*) is now growing in the interior receiving bay.

Crevasse No. 11. (View 1) Looking back to Pass a Loutre. Crevasse has maintained its constructed width throughout.

Crevasse No. 11. (View 2) Vegetated crevasse dredging spoil in bay area, foreground.

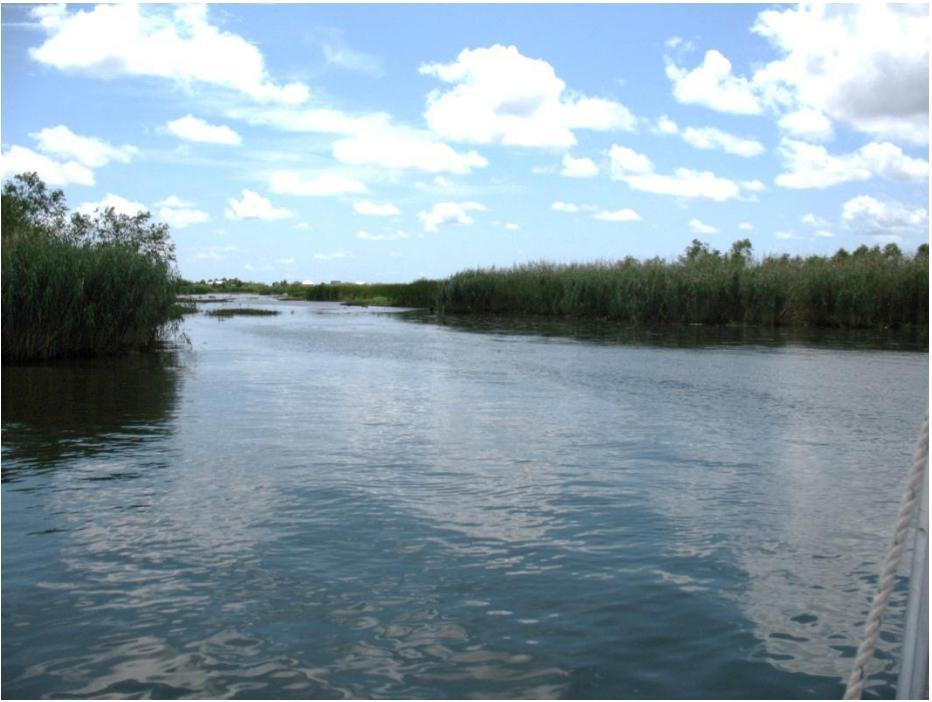
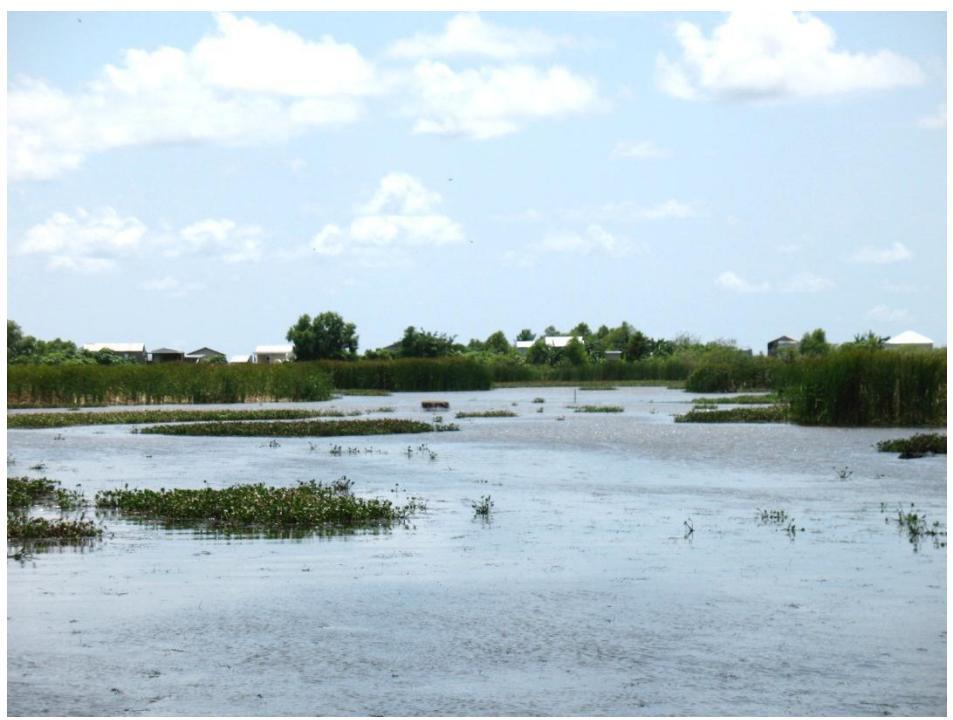
i. <u>Crevasse NC-1 (2005)</u>: (1,000 ft. X 100 ft. X -8.0 ft. NAVD 88) This crevasse appears to be in good condition. Soundings indicate that it has retained slightly more than half of its originally constructed depth. The interior indicates that river water is flowing very well through the channel carrying large amounts of sediment, and the receiving bay is heavily vegetated. SAV's densely populate the spoil islands.

Crevasse No. NC-1. (View 1) Looking into Receiving Bay.

Crevasse No. NC-1. (View 2) Vegetated spoil deposition in inside bay area.

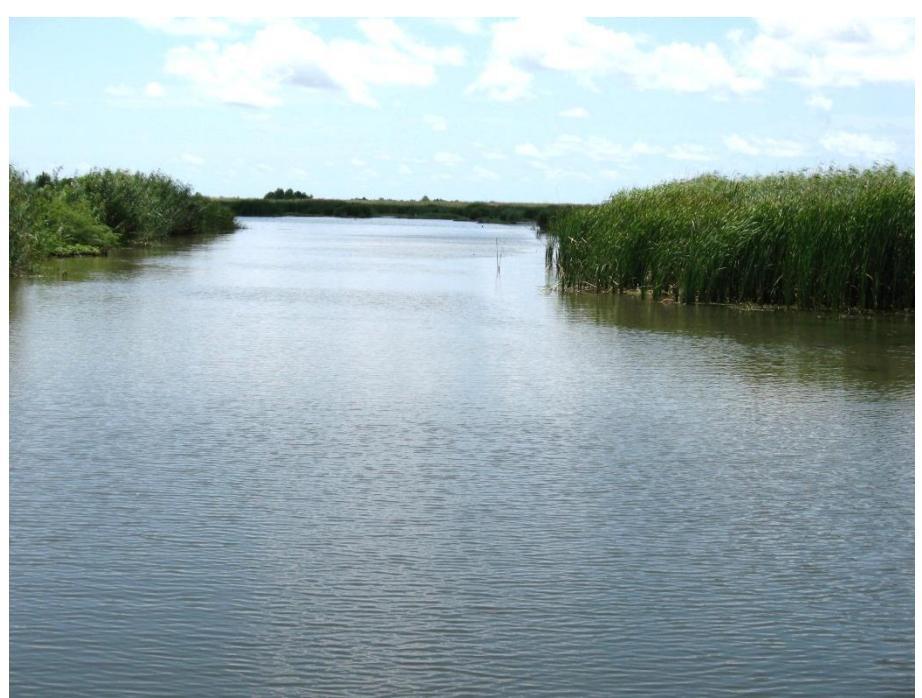
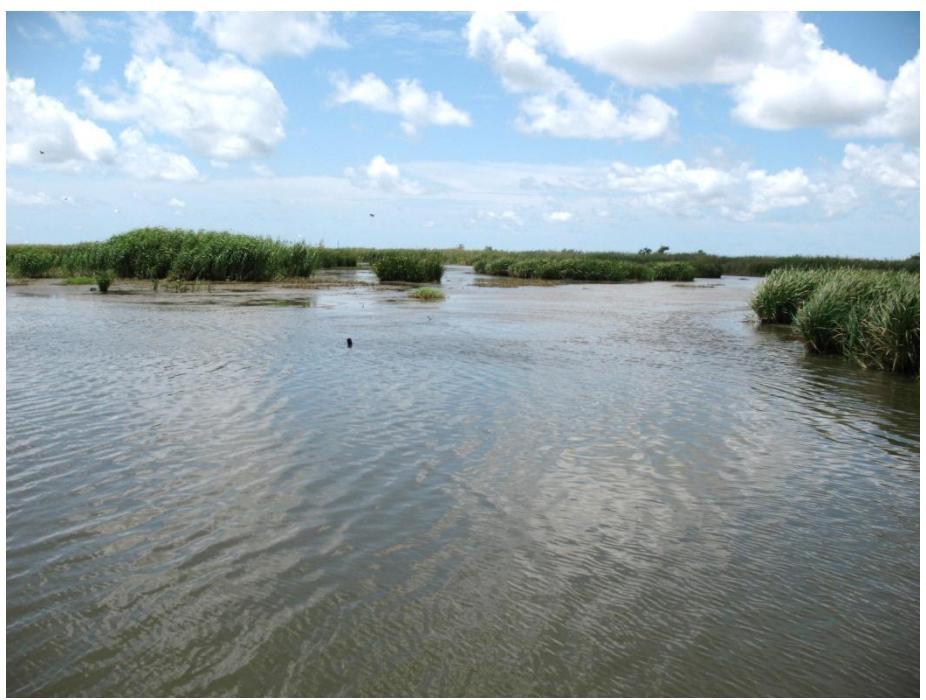
- iii. <u>Crevasse 9 (1999)</u>: (2,200 ft. X 75 ft. X -8.0 ft. NAVD 88) Dog-leg shaped crevasse. Soundings indicate that this crevasse is maintaining a 5'-6' depth. The spoil deposition from this cut is very heavily vegetated with cut grass and Roseau cane.

Crevasse No. 9. (View 1) From Pass-A-Loutre looking south into the crevasse.

Crevasse No. 9. (View 2) Crevasse end looking at spoil area vegetation sediment deposits from the recent high river.

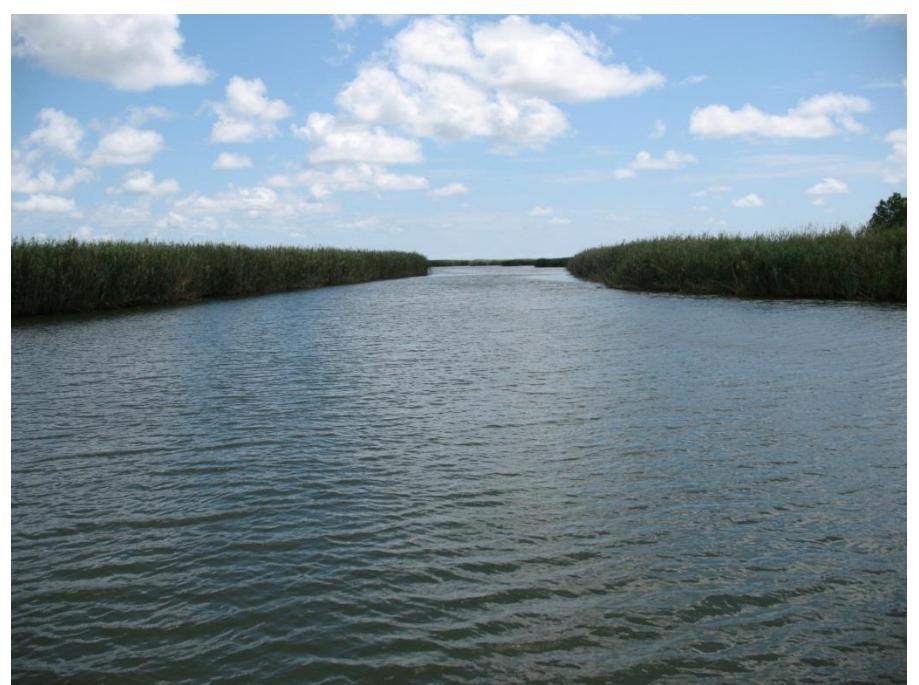
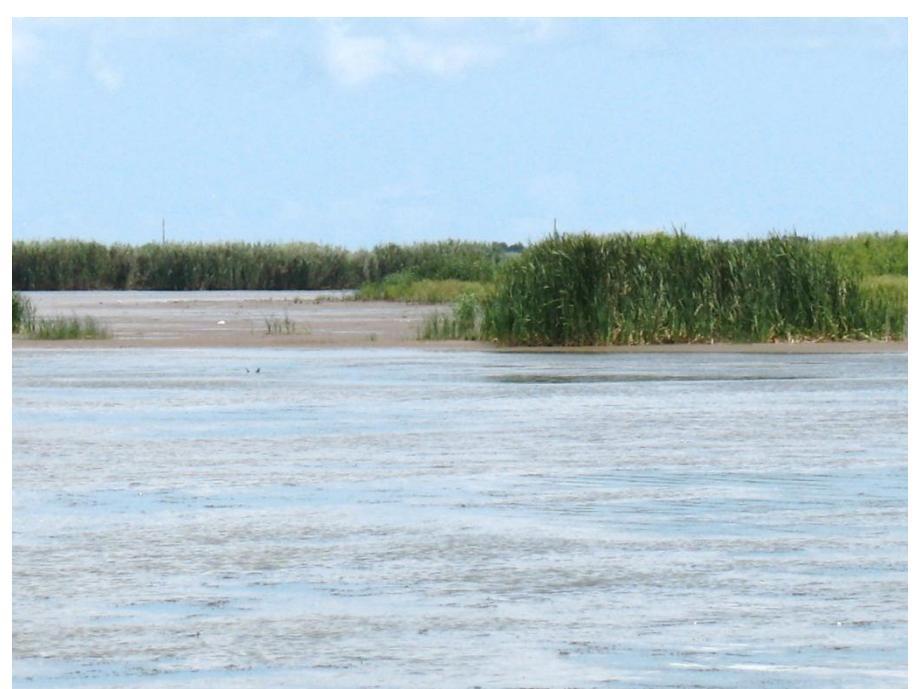
- **ii.** <u>Crevasse NC-3 (2005)</u>: (1,400 ft. X 100 ft. X -8.0 ft. NAVD 88) This is the second of the two new crevasses and the only one on South Pass. Our soundings show that the crevasse is maintaining its original depth throughout its channel length and the spoil from the crevasse dredging has completely vegetated. The crevasse channel has extended into the receiving bay, creating a visible, subaerial channel bank.

Crevasse No. NC-3. (View 1) Looking into crevasse from South Pass showing heavy vegetation on both banks.

Crevasse No. NC-3. (View 2) Crevasse terminus looking east into open pond area. Notice shallow depth of water in center.

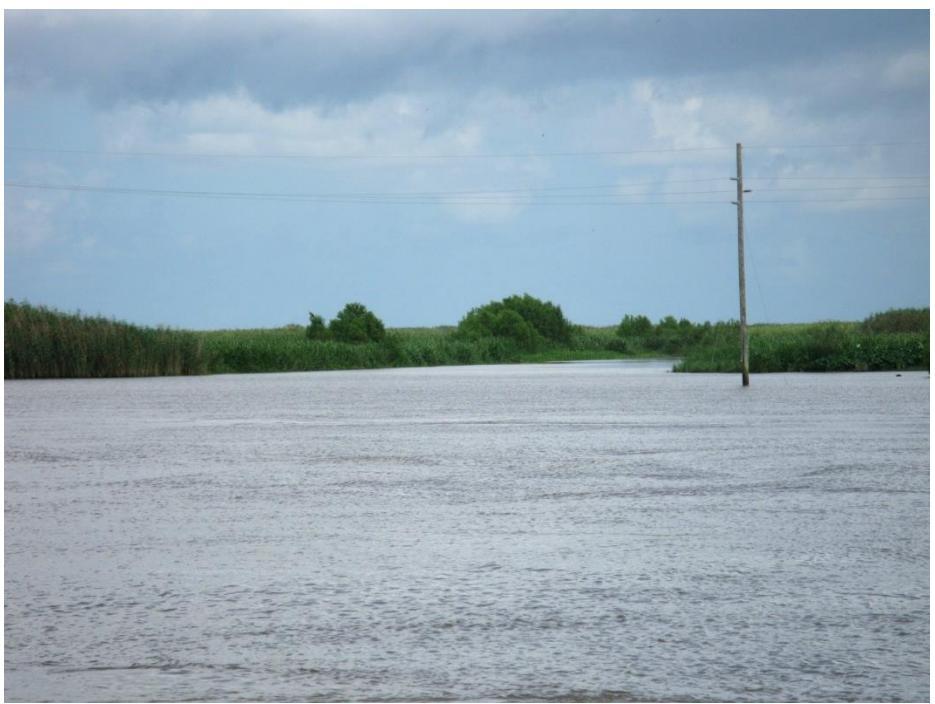
- vi. <u>Crevasse 81 (2005)</u>: (1,200 ft. X 100 ft. X -8.0 ft. NAVD 88) This crevasse was not visited by the inspection team. It is located off Baptiste Collette in the Delta Wildlife Management Area. Conditions from the 2011 inspection are presumed to be the same: "Despite soundings indicating that the mouth of this crevasse has silted up from the large amounts of sediments moving into the cut, [sediment continues flowing] into the interior marsh area. The 3.5' draft of the boat was too deep to travel into the crevasse."

Crevasse No. 81. (2011 Stock Photo). This crevasse location was not visited by the crew.
