State of Louisiana Coastal Protection and Restoration Authority

2019 Annual Inspection Report

Delta Management at Fort St. Philip (BS-11)

State Project Number BS-11 Priority Project List 10

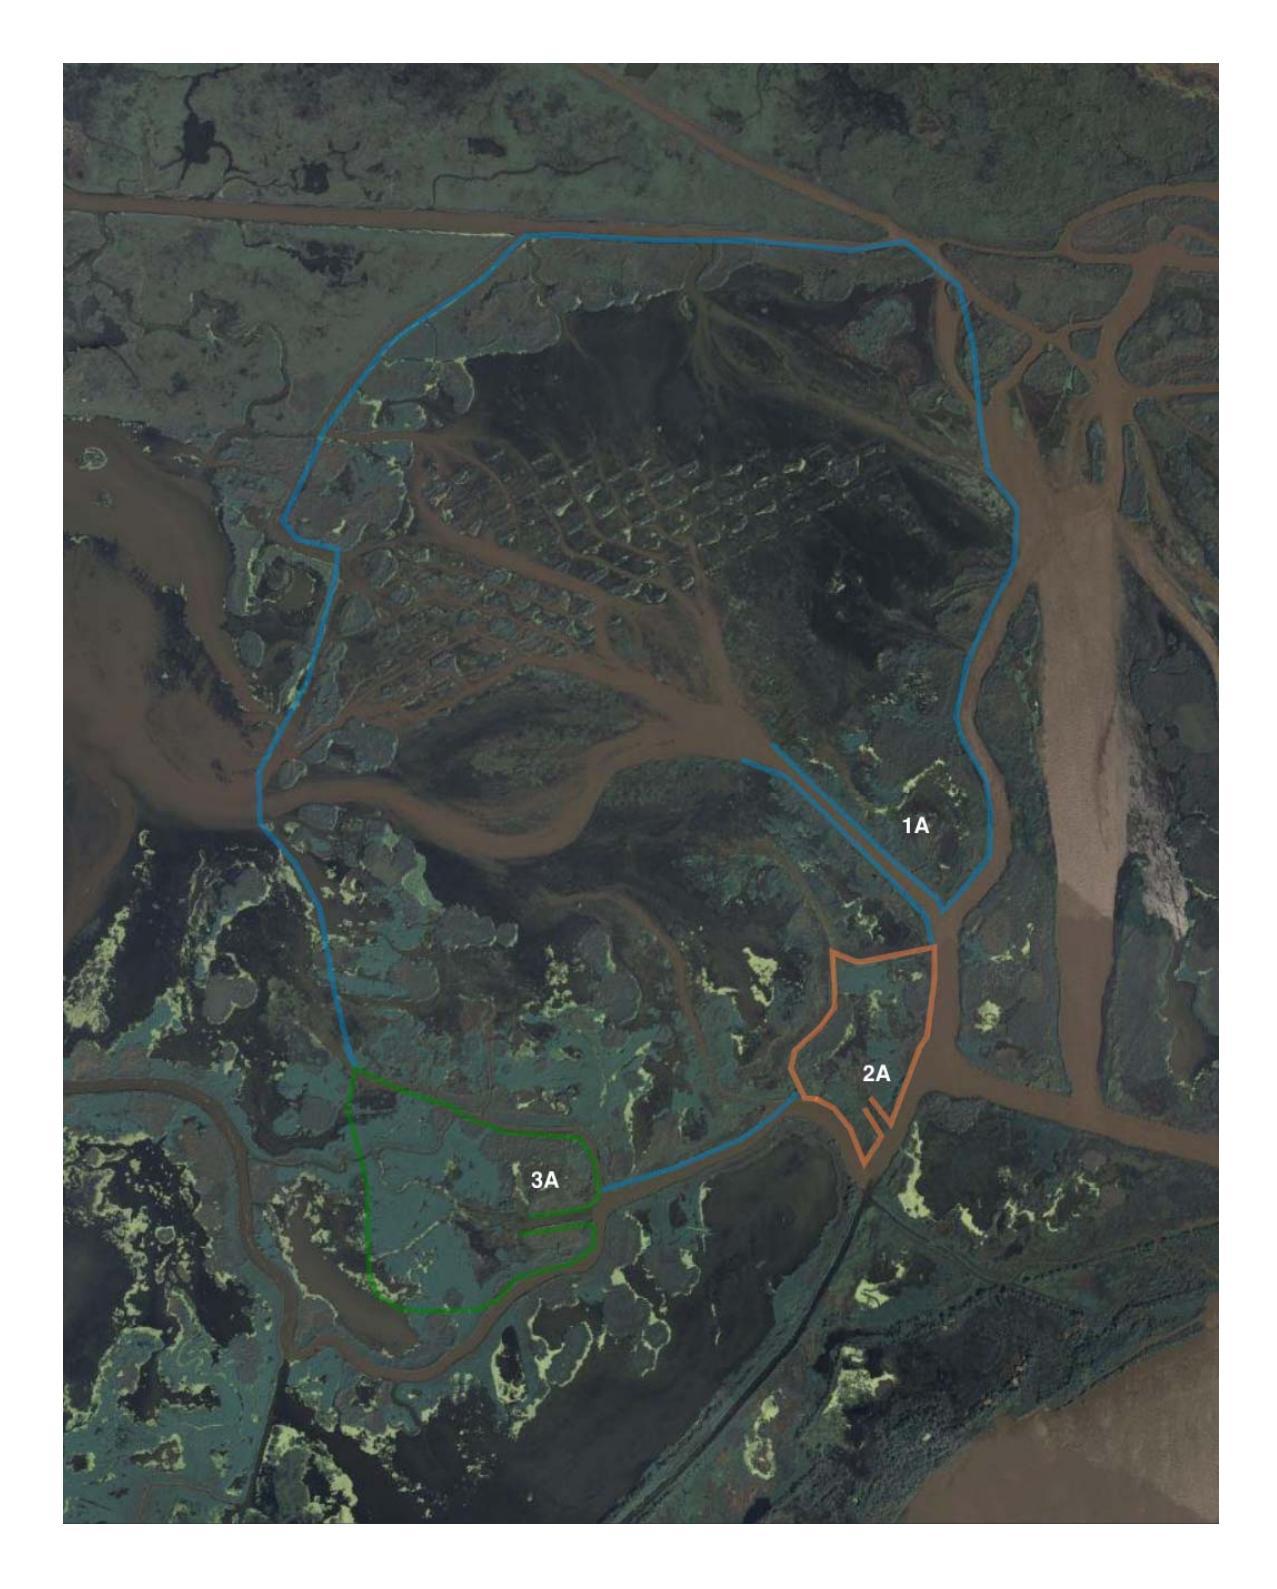
Subarea 1 (GCAM Aerial Imagery from 2018)

- A. <u>Terraces</u>: As viewed from aerial imagery provided by GCAM, the terrace field appears to be intact and dense vegetation covers each terrace.
- **B.** <u>Crevasse No. 1A</u>: This crevasse appears to be funneling river water directly into the Bay Denesse terrace field.

- C. <u>Crevasse No. 1B</u>: This crevasse has infilled. The channel outfall shows colonization of emergent vegetation.
- **D.** <u>Crevasse No. 1C</u>: The crevasse remains intact. Dense growth of emergent vegetation was observed just beyond the outfall, and healthy marsh grass rings the entire perimeter of this site.

Item	Condition	Physical Damage	Ob	servations and R	emarks				
Terrace Field	Good	None	Terrace seems to be preserved and vegetation covers the terrace field.						
Crevasse 1A	Excellent	None	Crevasse clearly remains intact and continues to carry water into the terrace field.						
Crevasse 1B	Fair	None	Crevasse has infilled; however, dense growth of emergent vegetation was observed in the rec						
Crevasse 1C	Good	None	The channel is well-vegetated. Emergent v	egetation was obs perimeter of this	erved, and healthy site	/ marsh grass rings the entire

The recommendation from the project team is to continue annual inspection and assessment of site conditions utilizing updated aerial imagery

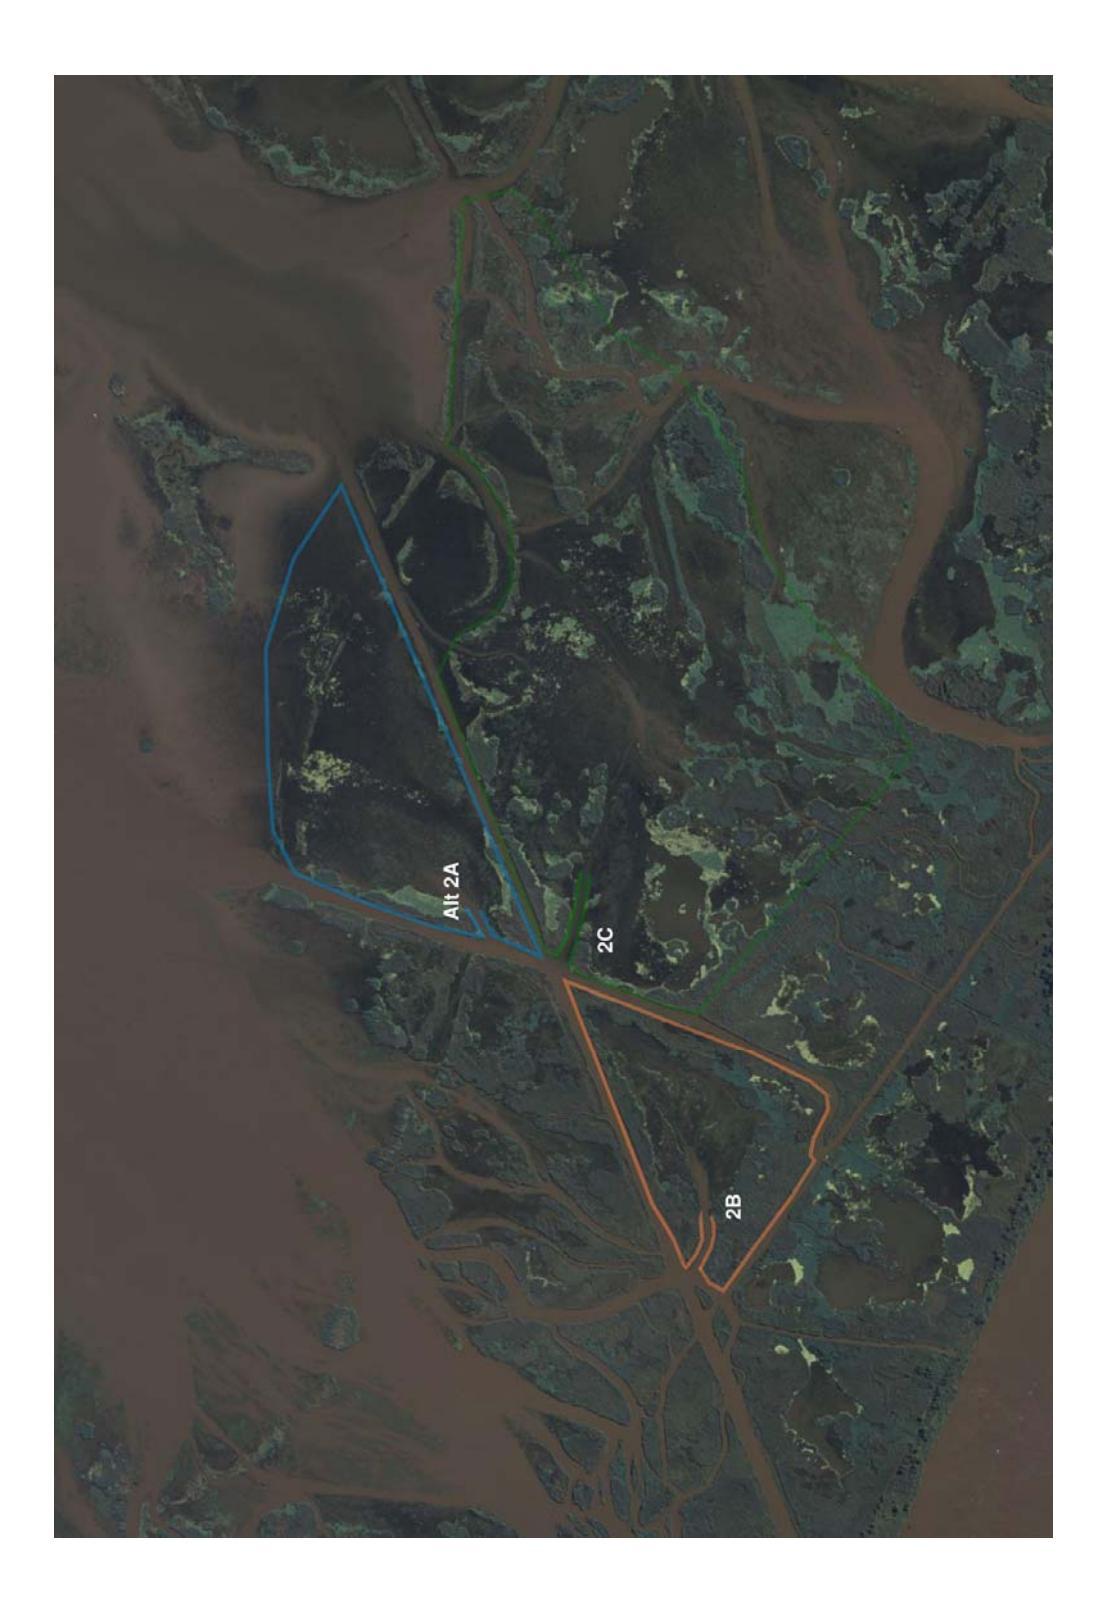
Subarea 2 (GCAM Aerial Imagery from 2018)

- E. <u>Crevasse No. Alt. 2A</u>: The crevasse remains intact, channel banks are well-vegetated, and significant emergent vegetation was observed in the receiving area.

- **F.** <u>Crevasse No. 2B</u>: The crevasse remains intact. Dense growth of emergent vegetation was observed in the receiving bay.
- **G.** <u>Crevasse No. 2C</u>: The crevasse appears to have begun infilling. The receiving area appears to have large areas of emergent vegetation near the crevasse outfall.

FIELD INSPECTION CHECK SHEET											
Project No. / Name:	BS-11 Delta Mg	gmt. @ Ft. St. Philip	Date of Inspection:	8/19/2019	Time:	N/A					
Structure No.:	ŀ	Area 2	Inspector(s):	Ernest Blan	ry from GCAM)						
Structure Description:	Cre	evasses	River Stage:	N/A	N/A						
Type of Inspection:	A	Annual	Weather Conditions:								
ltem	Condition	Physical Damage	Observations and Remarks								
Crevasse 2A Alt.	Good	None	Channel bank seems well-vegetated. Emergent vegetation was observed throughout the re-								
Crevasse 2B	Good	None	Crevasse is preserved. Dense growth of vegetation was observed throughout the receiving								
Crevasse 2C	Fair	None	Both channel banks were vegetated, l significar	but the crevasse so at growth of emerge	eems to be infilling ent vegetation.	g. Receiving area shows
