2022 Operations, Maintenance, and Monitoring Report

Black Bayou Hydrologic Restoration

State Project Number CS-27 Priority Project List 6

September 2023 Calcasieu and Cameron Parishes

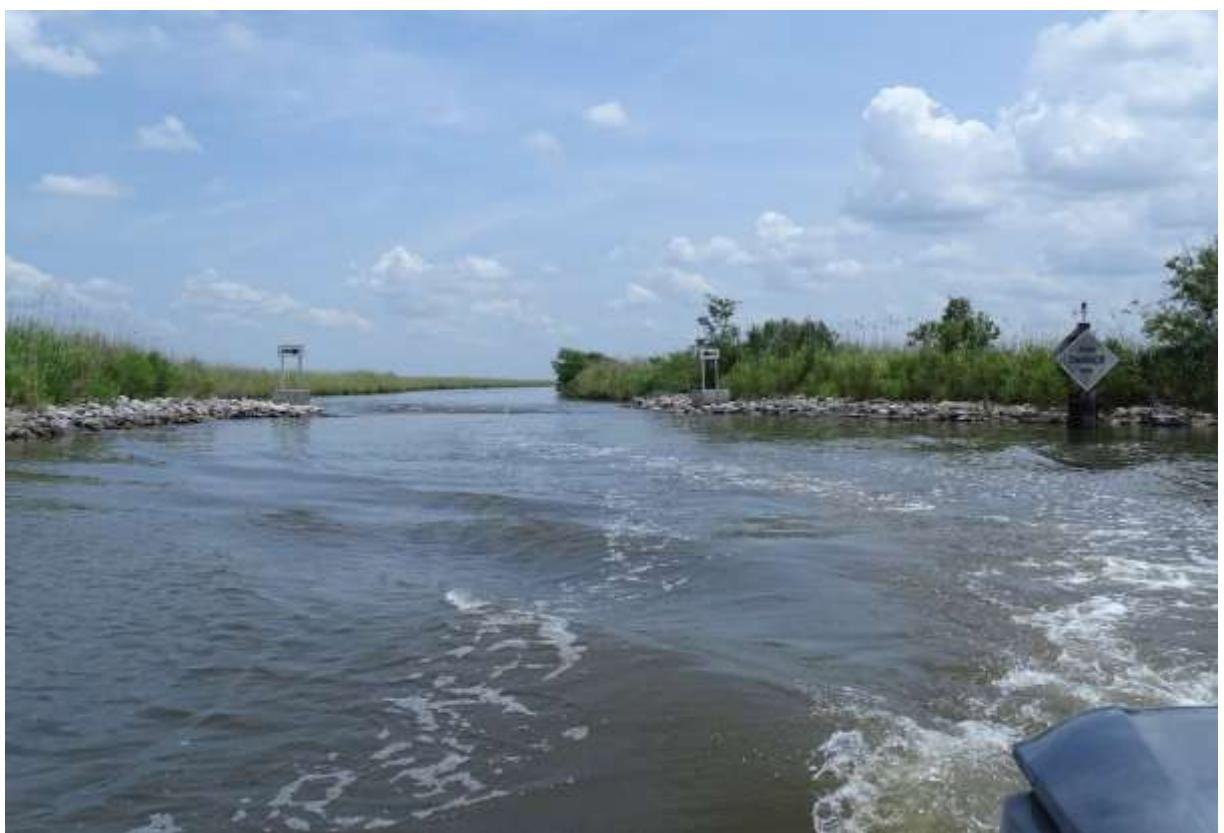
The rock weir appears to be in excellent condition after the repairs performed during the maintenance event of 2019. Arrow signs and navigational lights are present and functional. (Photos: Appendix A, Photo 1)

Photo 1—Navigational Aids and signage at Block's Creek

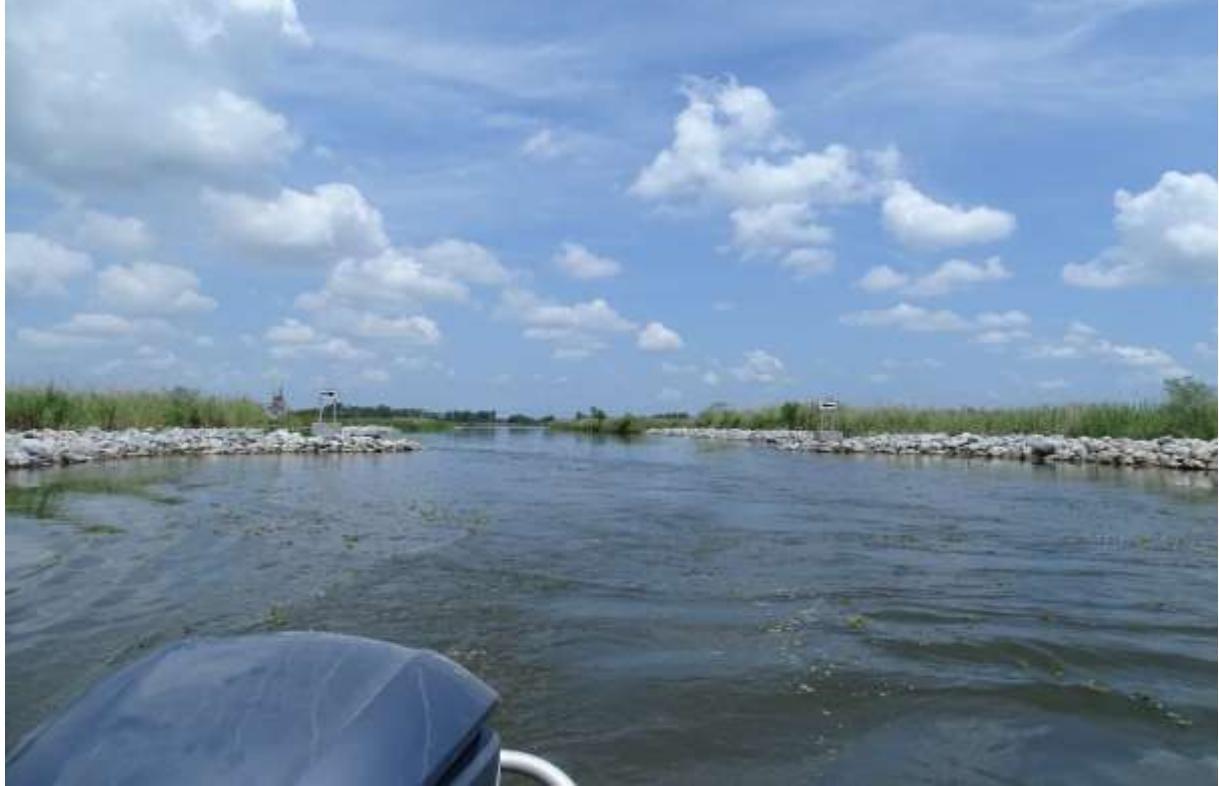
The new structure and signage are all functioning as intended and stable. A private landowner, Mr. Jones, explained a potential issue regarding water bypassing the structure via a trenasse beginning to form on the north side of the structure; however, nothing obvious was noted during this inspection. (Photos: Appendix A, Photo 2)

Photo 2—New Burton Canal Structure

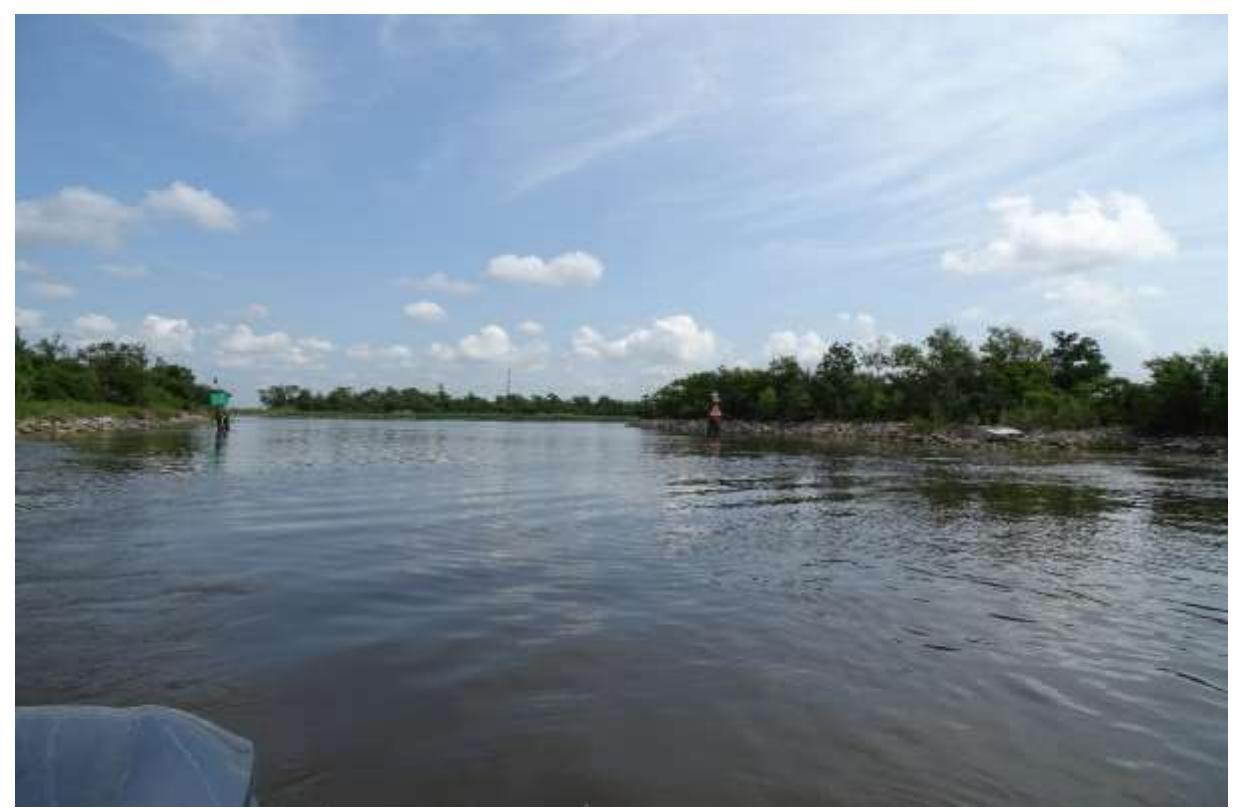
Additional rock to repair scouring around the structure during the last maintenance event has apparently stabilized the area. Navigational lights and signs are inspected quarterly by contractor. Channel marker on the east side of the weir is broken. (Photos: Appendix A, Photos 3-4)

Photo 3—Black Bayou Cut Off Canal structure

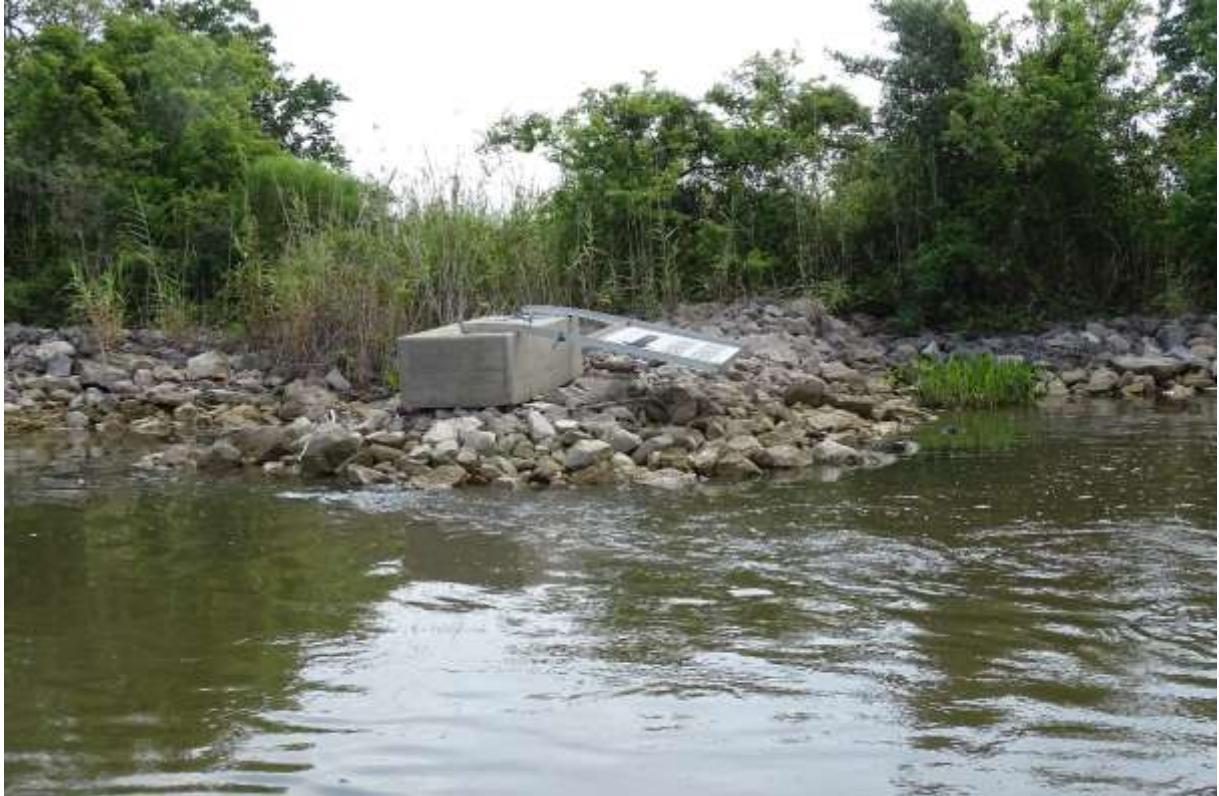
Photo 4—broken sign on Black Bayou Cut Off weir

1. Possibly repair the broken directional sign on the east end of the Black Bayou Cut Off weir.

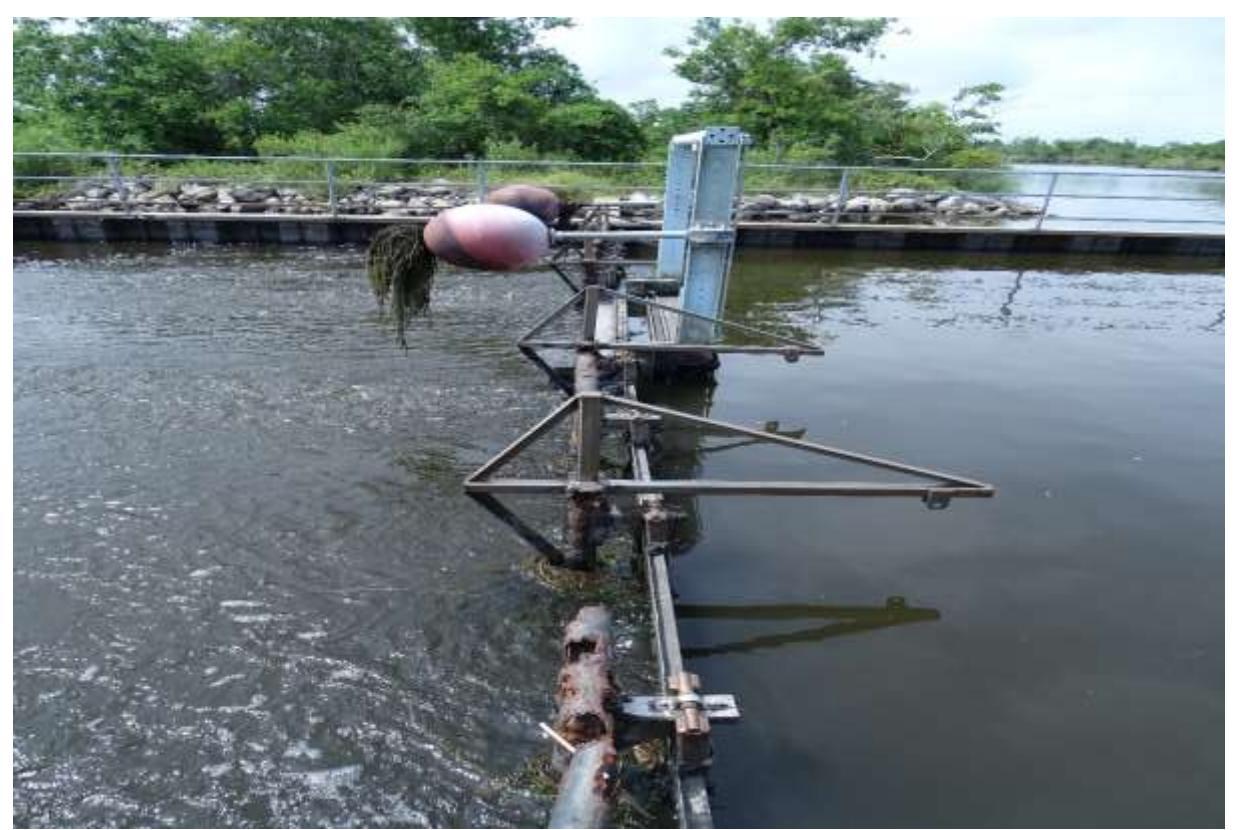
The structure is showing signs of significant rust on the top railings, but nothing to prevent it from working as designed. Pillow blocks, signage, railings, wing walls, etc. remain in good condition. (Photos: Appendix A, Photos 5-6)

Photo 5—pillow block on SRT Gate flap & railing rust

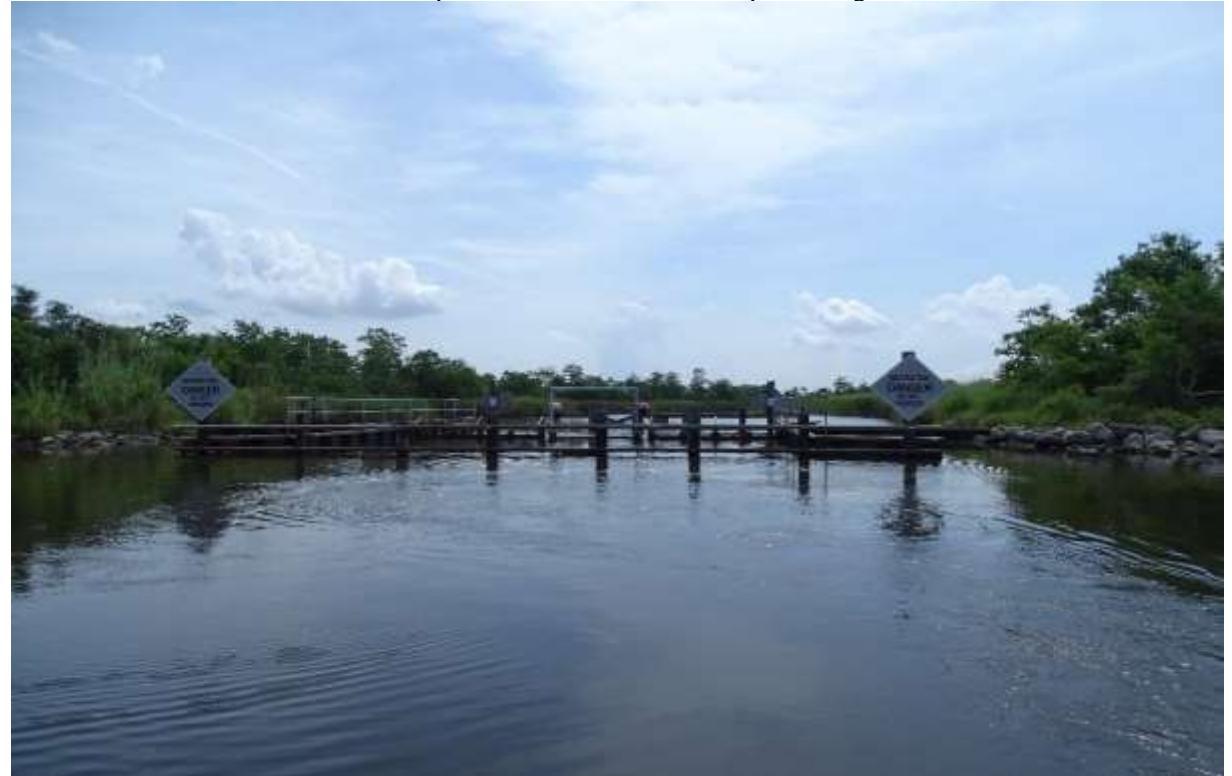
Photo 6—SRT Gate

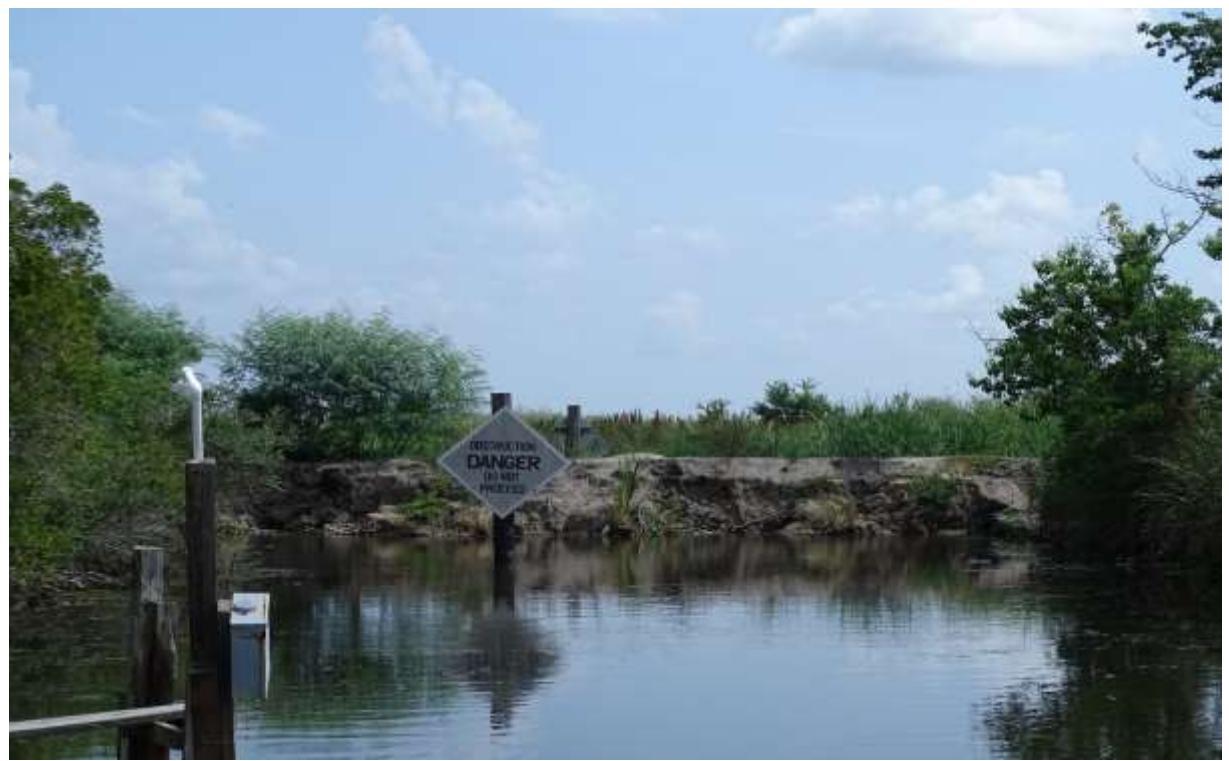
The rock dike is functioning as designed. Concrete sacks are solid. Tie-ins are stable. No maintenance required. (Photos: Appendix A, Photo 7)

Photo 7—Rock plug near SRT Gate

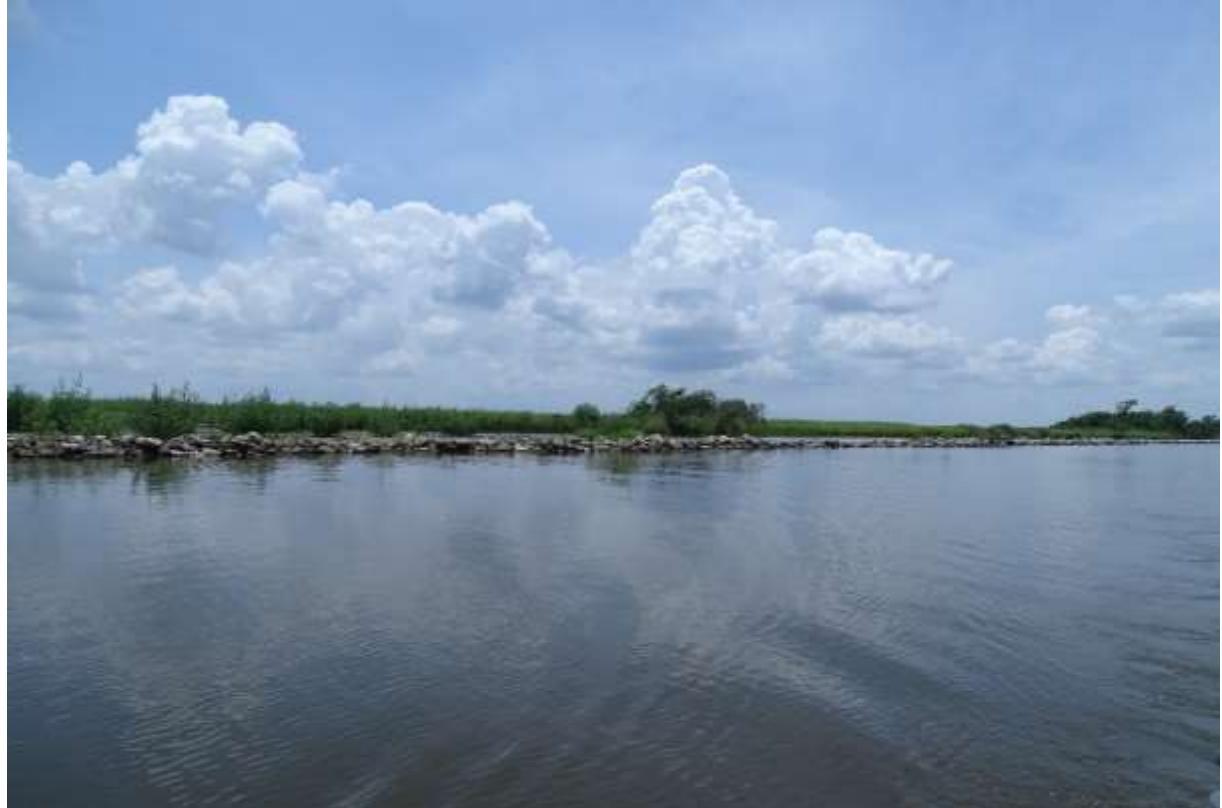
Tie-ins on both the east and west end of the dike are stable. Repairs to the gaps during the last maintenance event are stable. Build-up of sediment continues between the dike and the shoreline. Emergent vegetation has established in large areas behind the dike between the dike and the shoreline. (Photos: Appendix A, Photos 8-9)

Photo 8—Typical section of rock dike

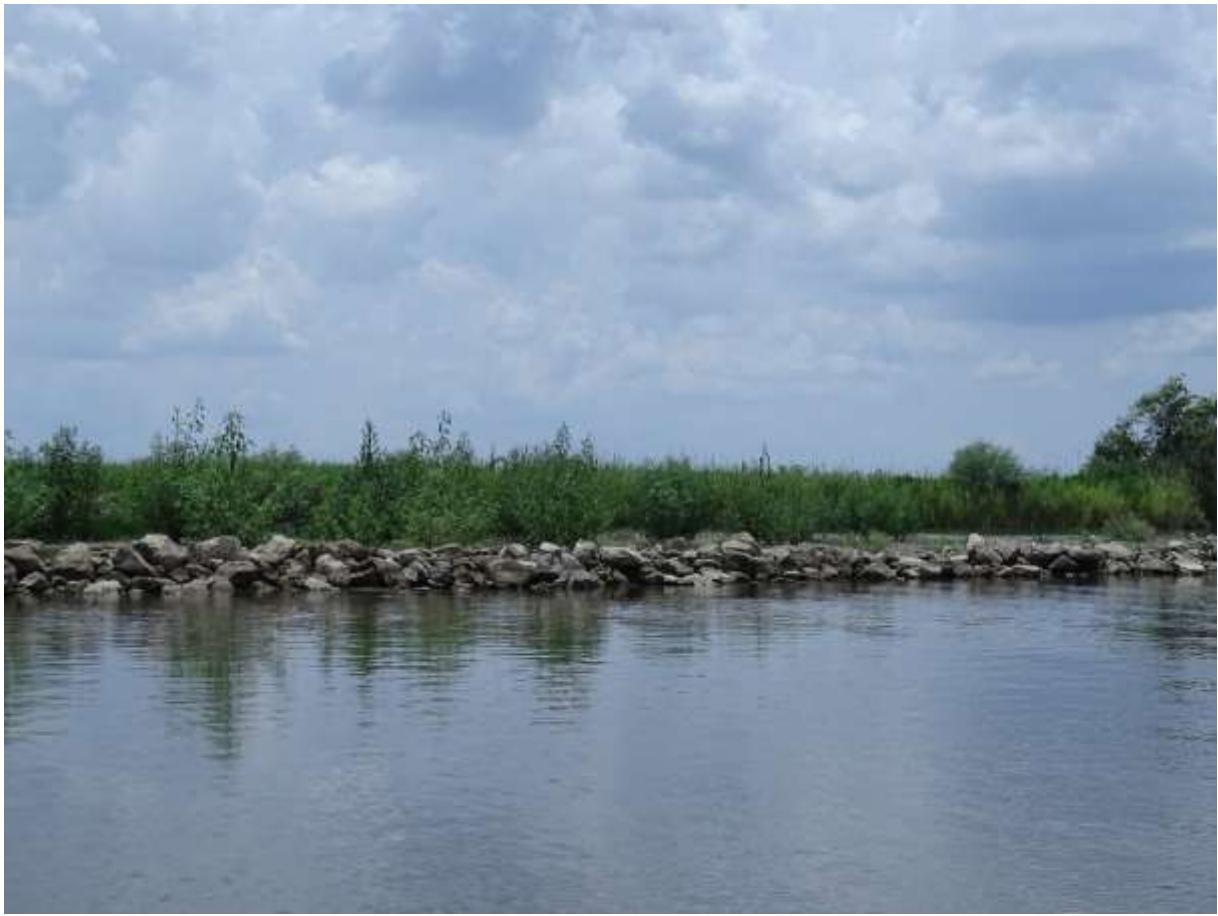
Photo 9—typical section of dike
