2022 Operations, Maintenance and Monitoring Report

South White Lake Shoreline Protection

State Project Number ME-22 Priority Project List 13

December 2022 Vermilion Parish

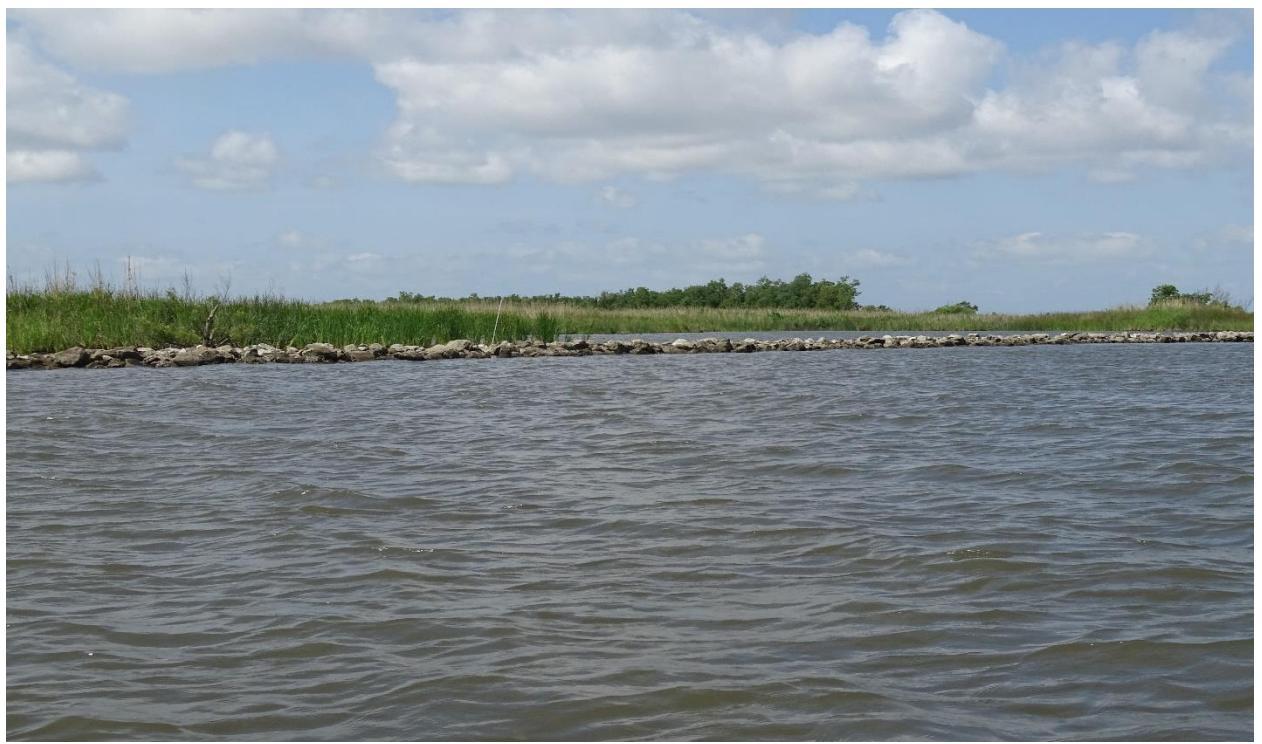
The rock dike is in excellent post construction condition. Water levels were too low to access the dike along the northern shore of Bear Lake. Low areas noticed during previous inspections in this area where there was some initial settling during construction seem to have stabilized, as best seen from a distance, and the dike appears to still be functional in these areas. They will continue to be monitored during future inspections. Signage along the entire project is also in good condition. Approximately six (6) signs were noticed as completely missing. Reflective taping on nearly all signs has deteriorated. The spoil bank material placed behind the rock dike generated from the flotation excavation is nearly covered in natural vegetation. (Photos: Appendix B, Photo 1)

Photo 1—typical section of rock dike

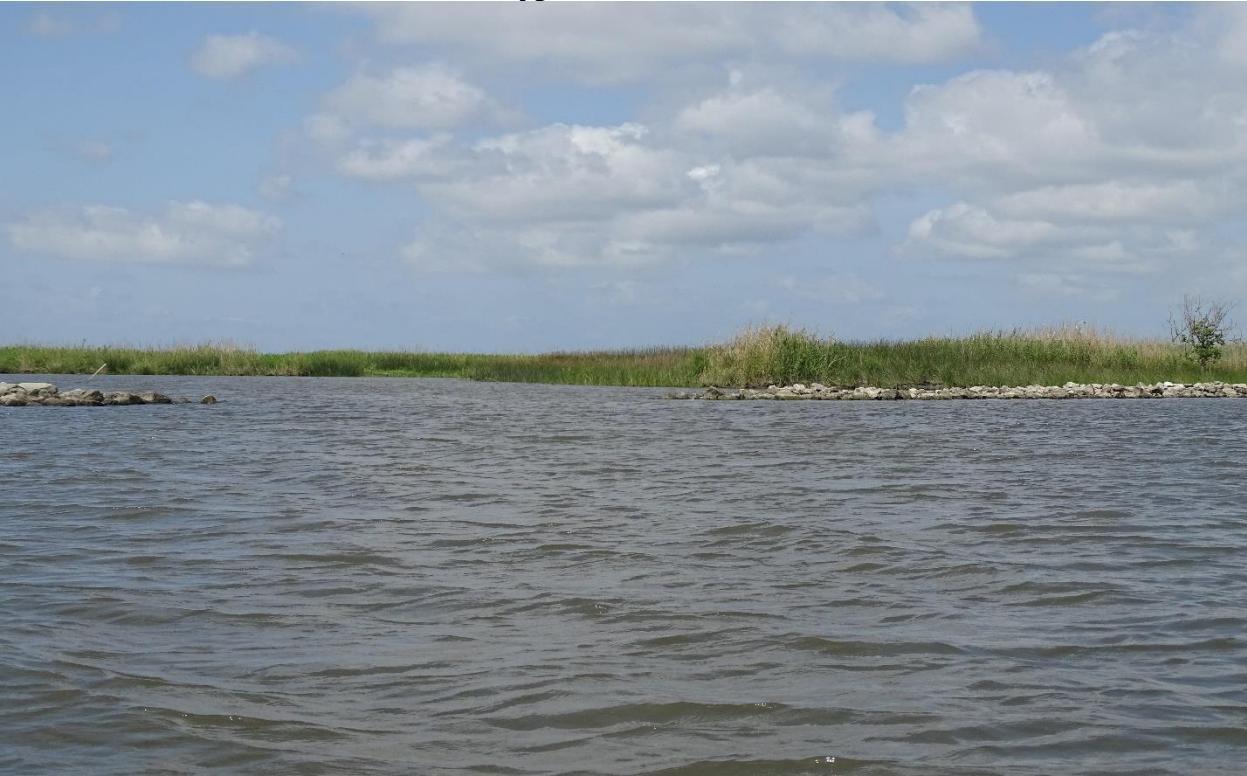
Photo 2—fish gap where sign is missing

With the project life nearing the end of the CWPPRA life, it is recommended that missing signs be replaced. New reflective taping should be placed on all signs where required.

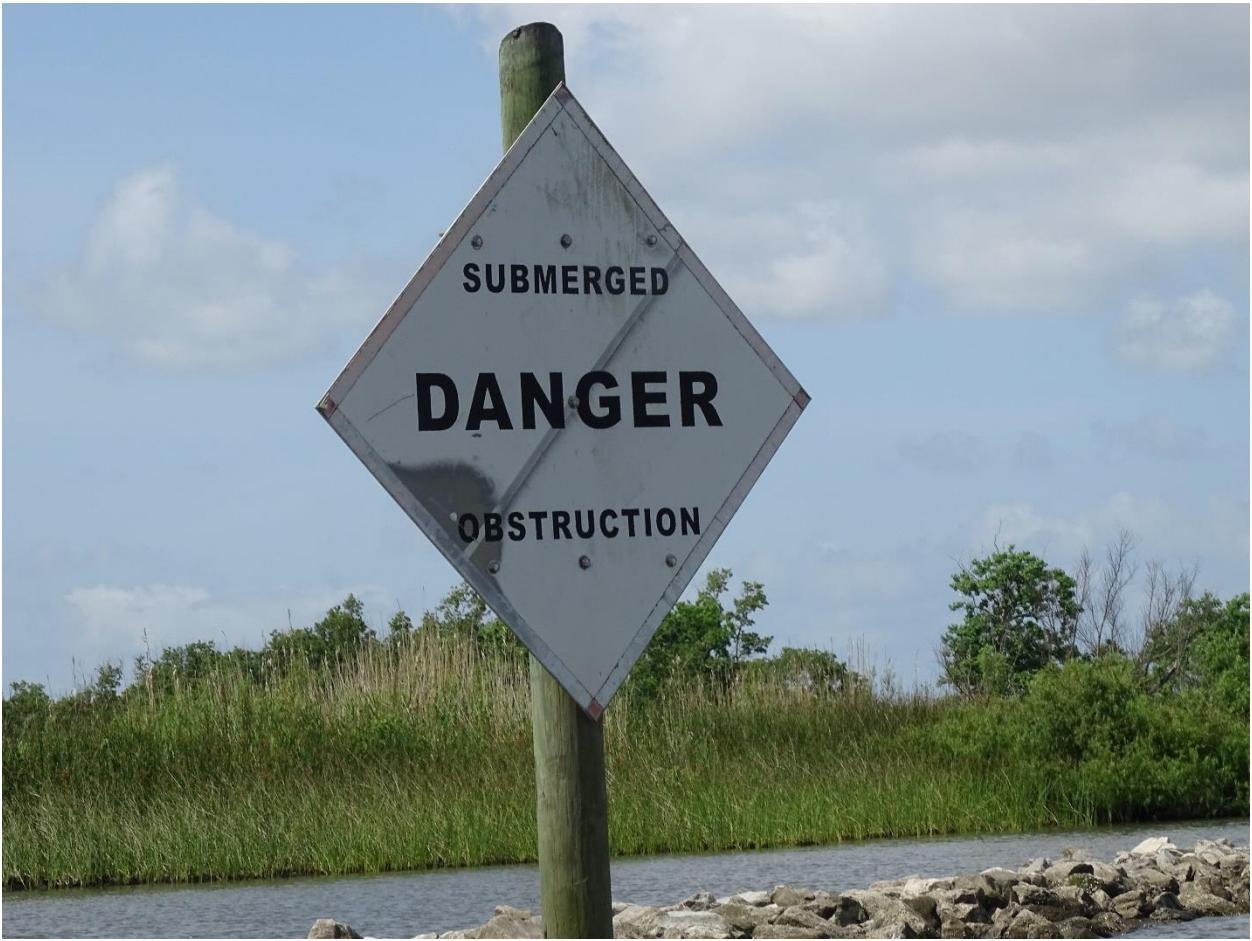
Photo 3—typical sign with deteriorated reflective tape
