# LAKE CHAPEAU SEDIMENT INPUT AND HYDROLOGIC RESTORATION (TE-26)

PTE-23/26a/33 (TE-26)

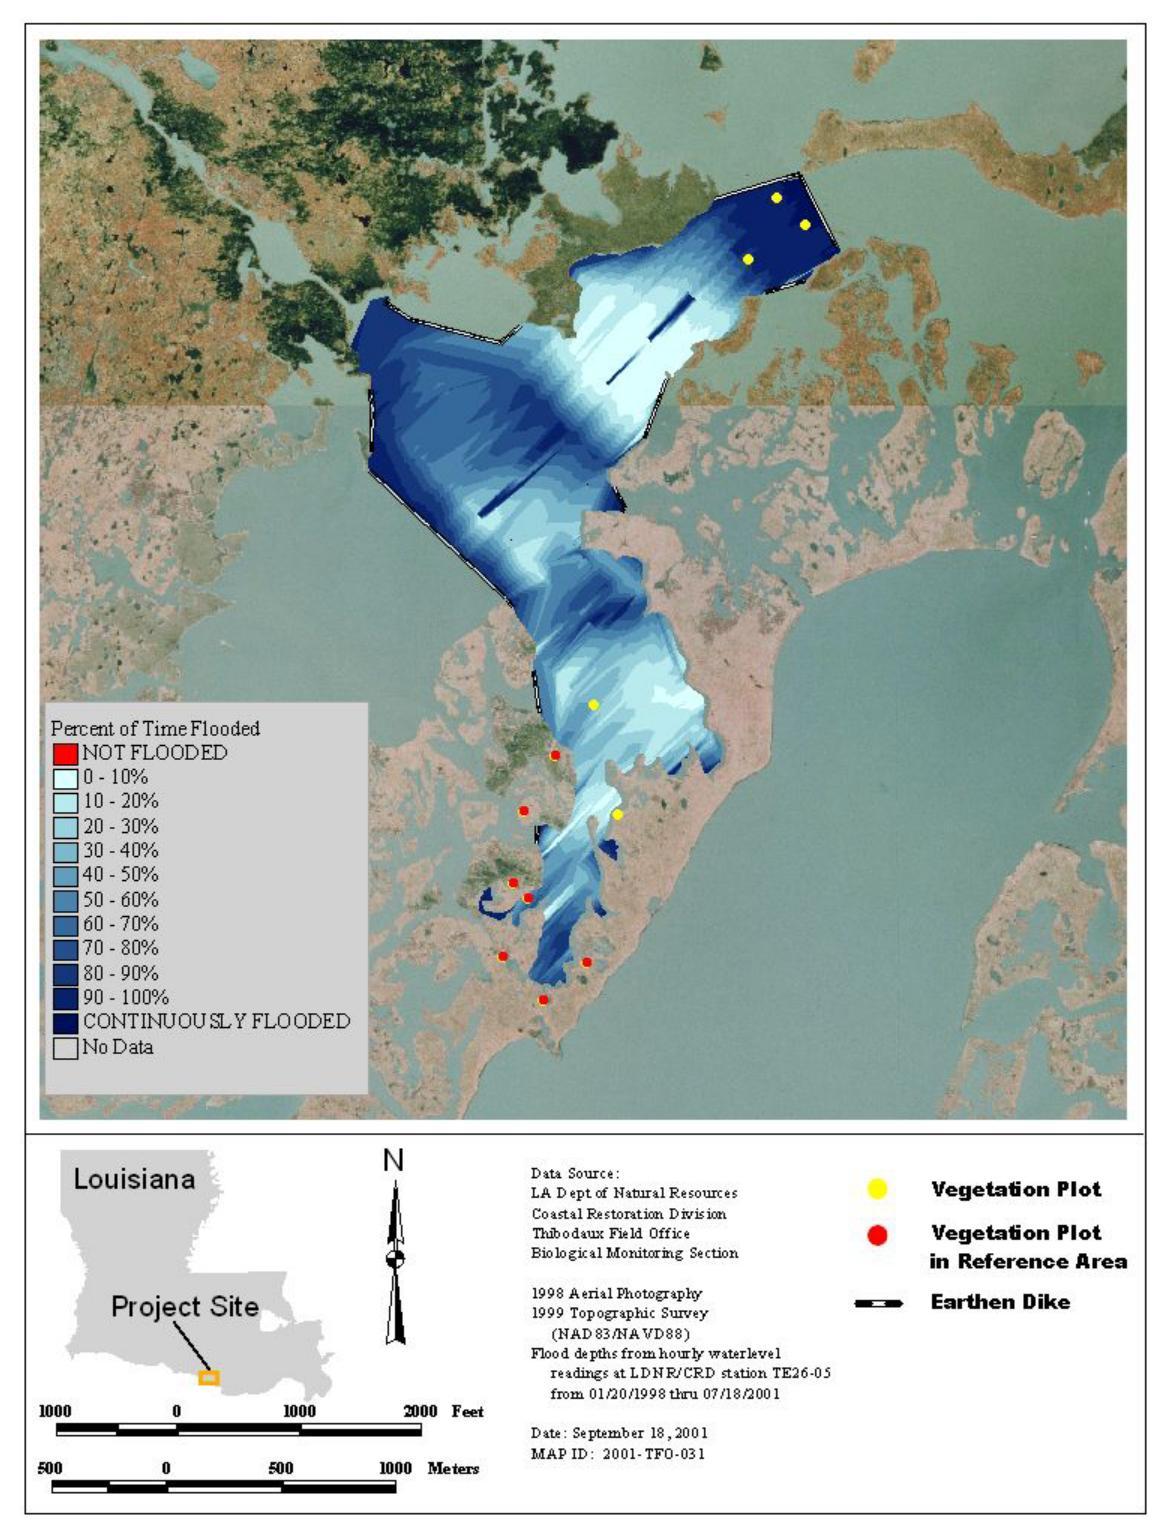
Figure 2. Percent of Time Flooded for Lake Chapeau Sediment Input and Hydrologic Restoration (TE-26).

*Did the project meet its target elevation?* The desired final fill elevation was +0.55 feet NGVD. Post-construction monitoring data indicated that the dredged fill areas were slightly lower than adjacent marsh. The surrounding marsh elevation ranged 0.41-0.71 m, with the fill area ranging from 0.03 to 0.39 m. The benchmarks used

*Does the project have the correct hydrology for its marsh type?* No, the dredged spoil area is at a lower elevation and is flooded more often and deeper than surrounding marshes (Figure 2). Roughly 30% of the dredged fill area was flooded more than 60% of the time (Table 1).

Another dredge placement may be done to increase the elevation to that of the surrounding marsh elevation and establish the hydrologic separation. Then, seed the new fill areas, and back fill the pipeline canal.

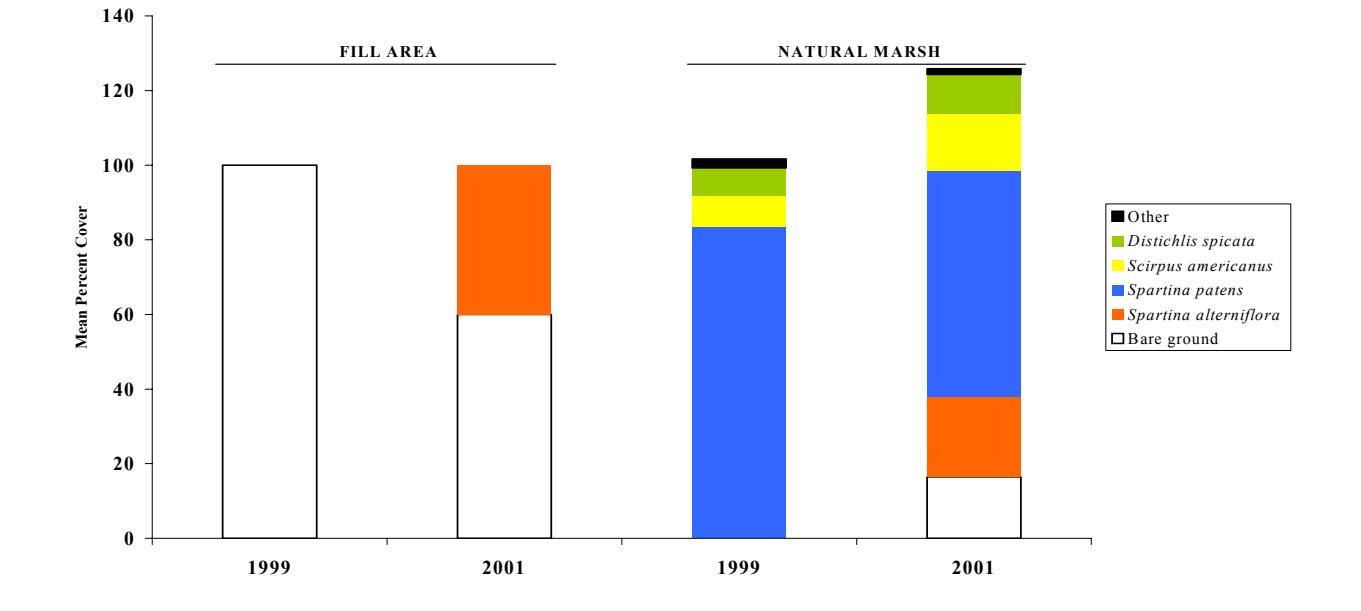
Percent cover of species combined is around 80% in the natural marsh. Percent cover in the reference plots of the fill area was around 40 % (Figure 3), which is half the coverage of the natural marsh. However, the reference plot locations were randomly selected prior to construction. Three of the five reference plots are in the north fill area that is flooded more than 80% of the time (Figure 2). Of the fill area above water, cover is similar to surrounding marshes at 80% cover (personal communication from Rick Hartman, NMFS and Darin Lee, LDNR).

*Does the project have the correct species composition and cover for its type?* No. *S. alterniflora* was planted in April 2000 and was the only species present in the fill area in 2001 vegetative plots (Figure 1). So the species composition is different from the natural marsh for the first year after planting (Figure 3).
