## **2018 Operations, Maintenance, and Monitoring Close-out Report**

## **Brady Canal Hydrologic Restoration** (TE-28)

State Project Number TE-28 Priority Project List 3

March 2019 Terrebonne Parish

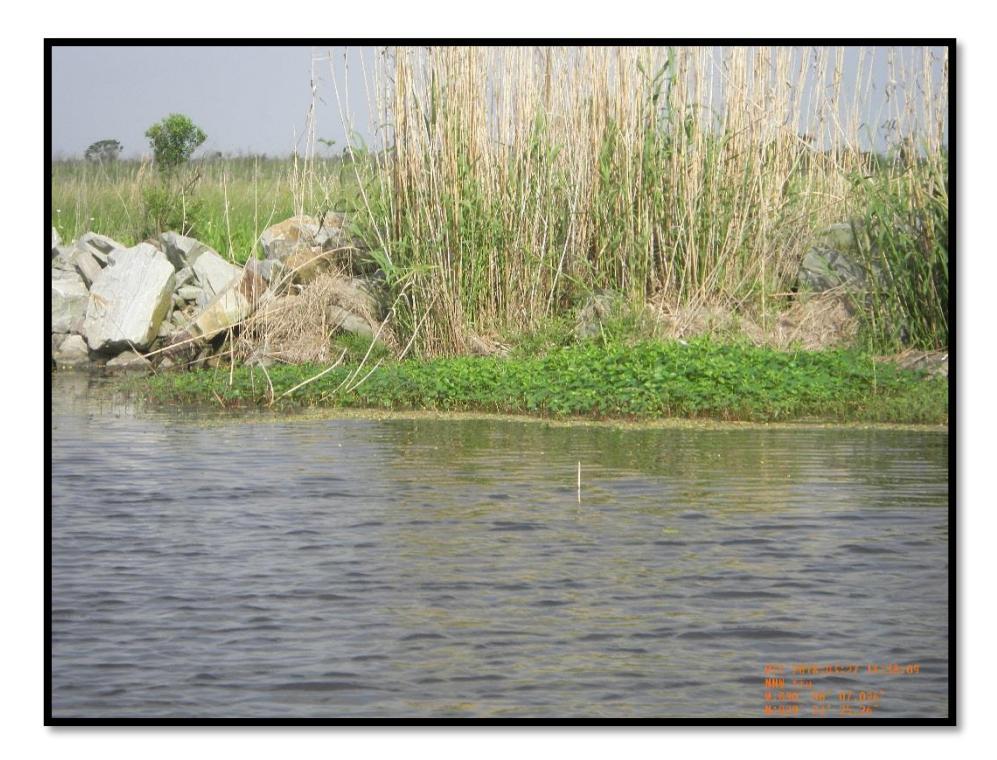
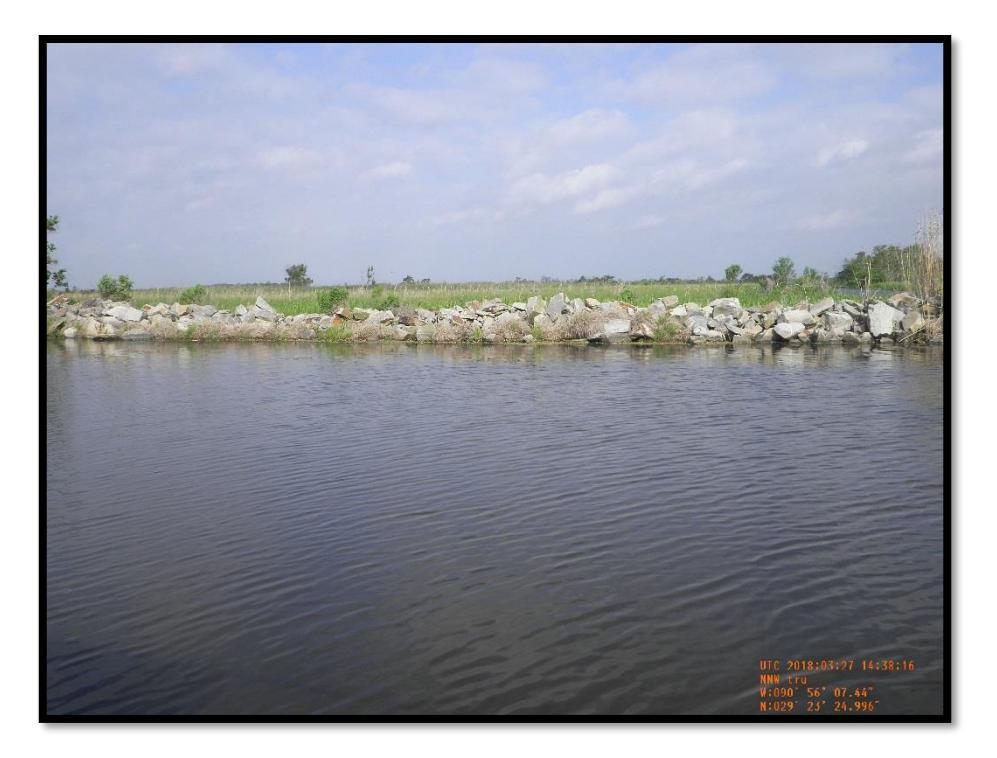
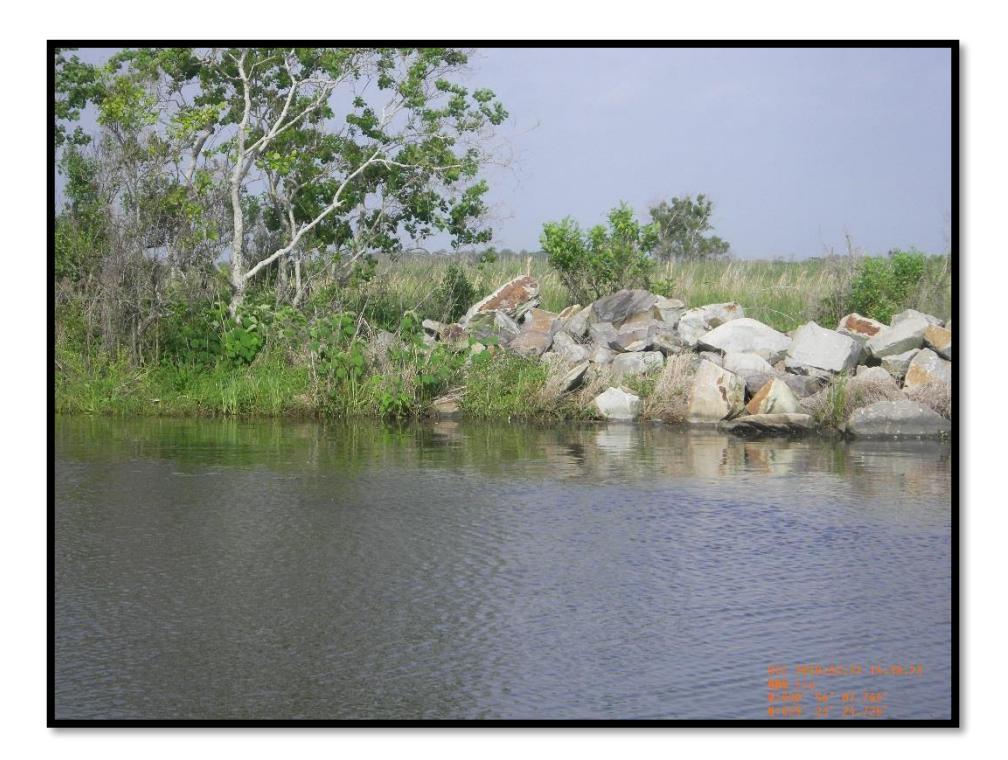
The rock plug known as "Breach 7" and located along an existing oil field access canal connected to Superior canal is in good condition. There was no observed settlement along the length of the embankment and no erosion or washouts around the embankment tie-ins. There are no recommendations for corrective action at this time. (Appendix A, Photos 1-3)

Photo No.1 – View of northeast side of rock plug (Breach Closure No.7) on north bank of location canal along Superior Canal.

Photo No.2 – View of rock plug (Breach Closure No. 7) on north bank of location canal along Superior Canal.

Photo No.3 – View of southwest side of rock plug (Breach Closure No.7) on north bank of location canal along Superior Canal

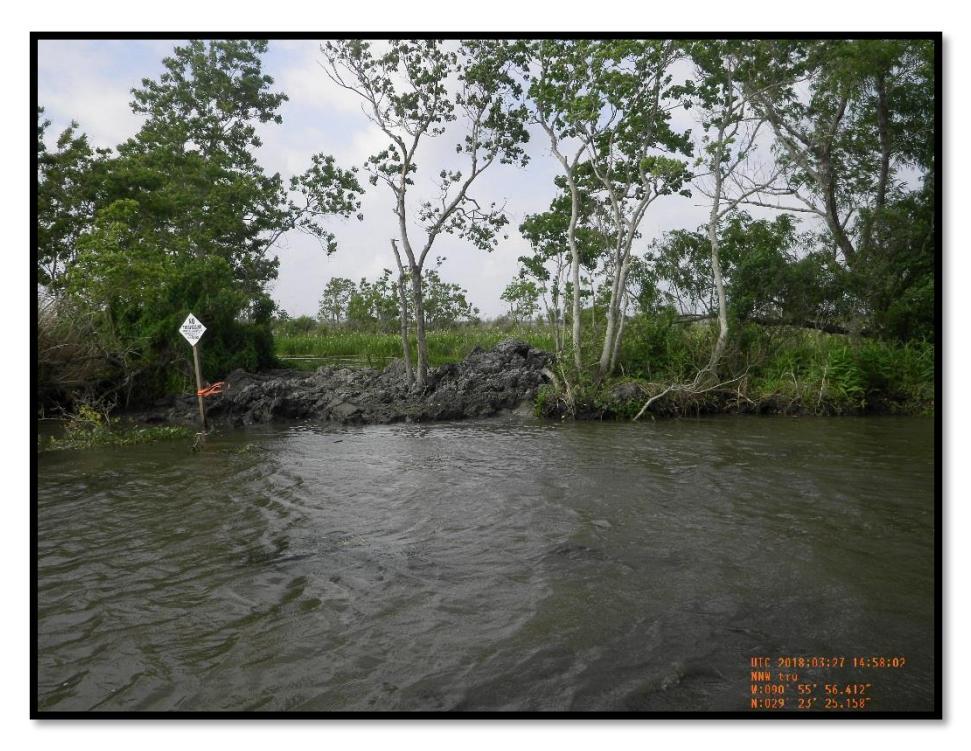
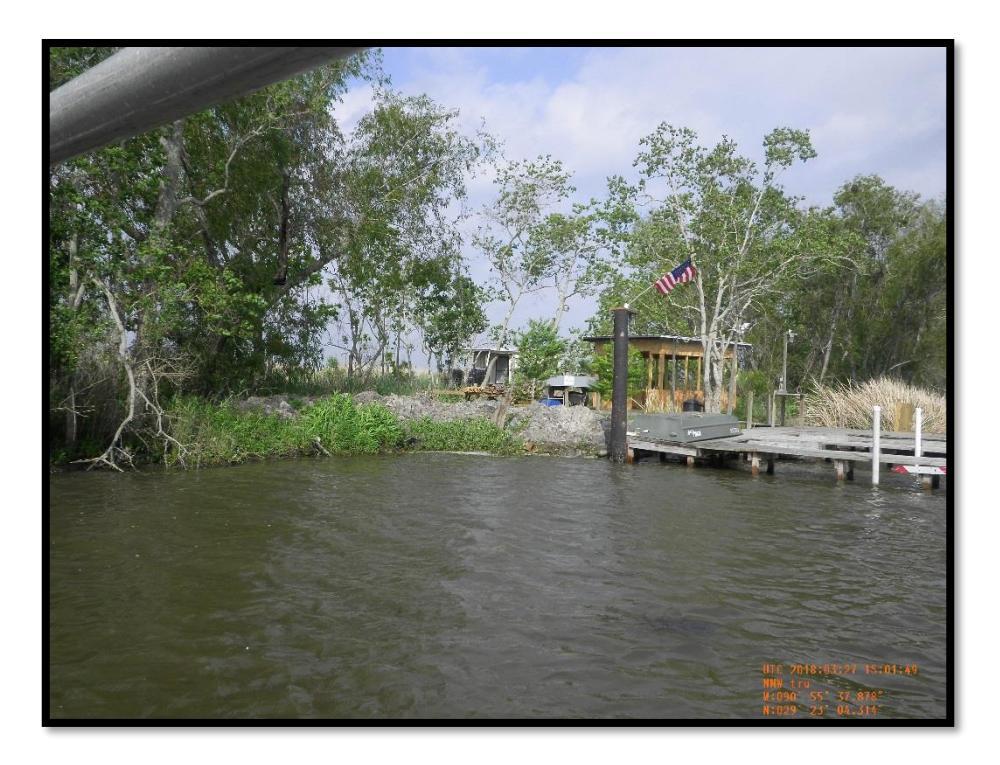
The inspection of the earthen embankments included the west bank of Turtle Bayou to Superior Canal (Appendix A, Photos 1, 4-5), the dead end canal connected to Superior Canal, the Jug Lake perimeter (Appendix A, Photos 10-11, 17-21, 24-27 and 31-31), Bayou Decade from Jug Lake to Voss Canal (Appendix A, Photo 43), Voss Canal to Bayou Carencro (Appendix A, Photos 46-49), and Bayou Carencro to Brady Canal (Appendix A, Photos 53-54). The earthen embankments along Turtle Bayou and Superior Canal are in good condition with a couple of recent repairs made by the landowner along Superior Canal (Photos 4-5). The

Photo No.4 – recent earthen embankment repairs made by landowner along southwest bank of Superior Canal.

Photo No.5 – recent earthen embankment repairs adjacent to existing dock made by landowner along southwest bank of Superior Canal.

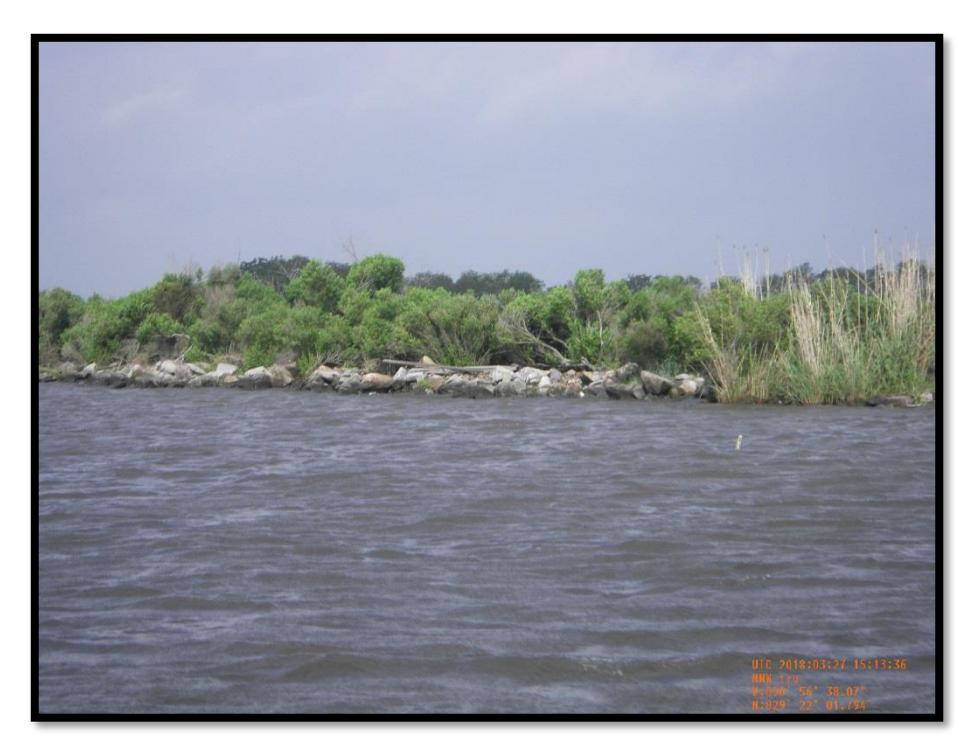
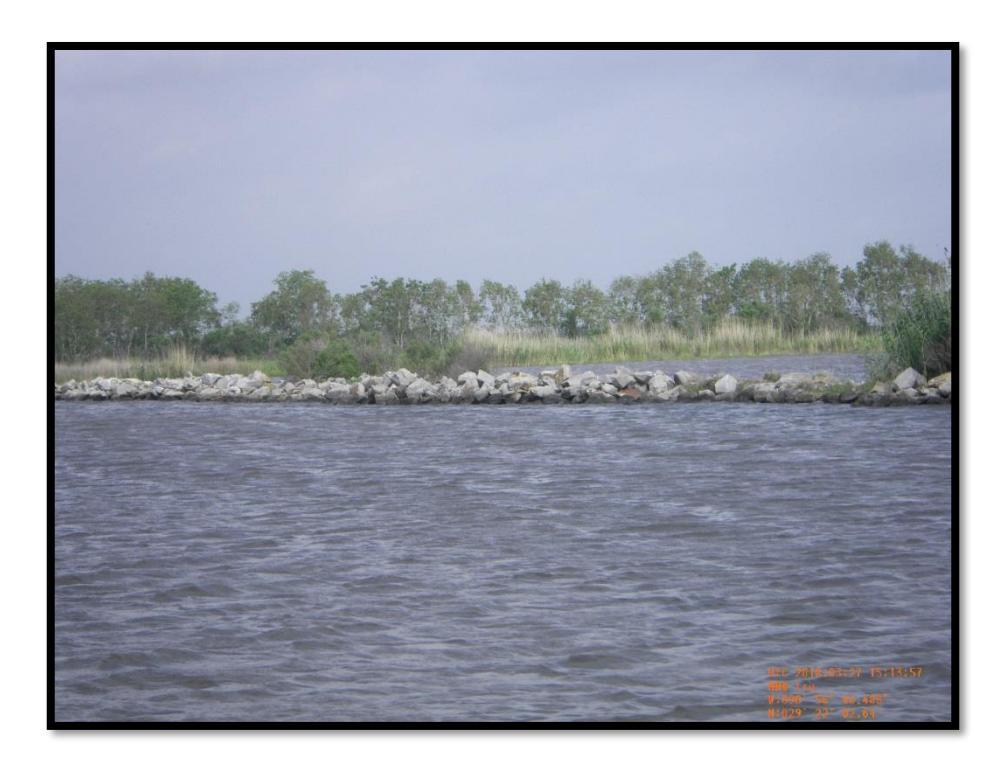
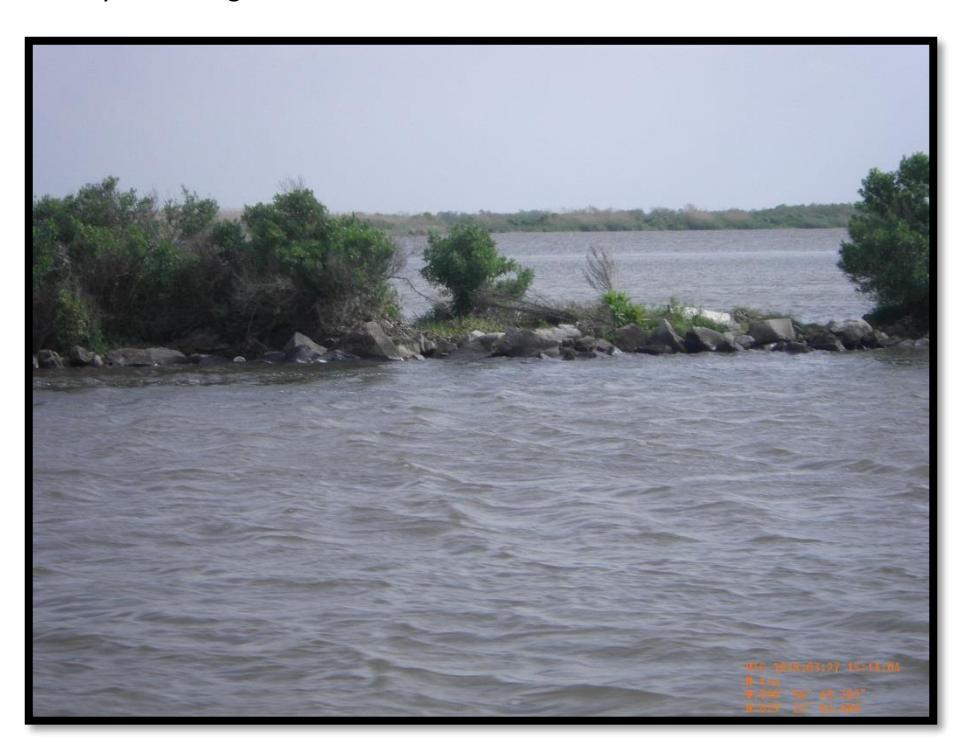
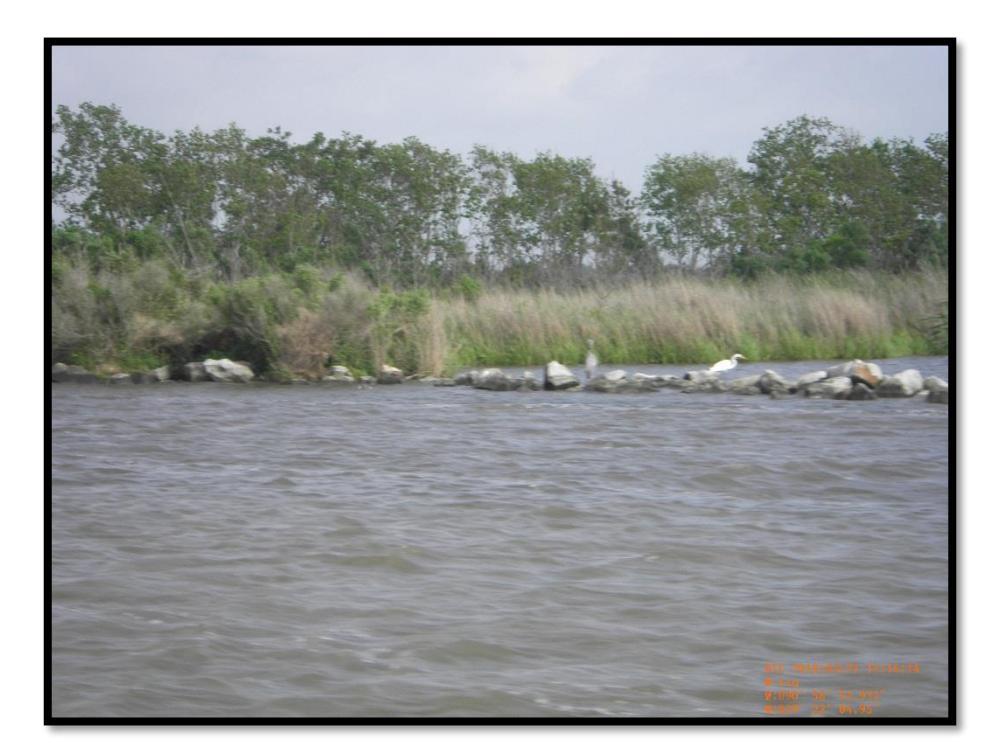
The rock armored embankments and rock dikes along the north bank of Bayou Decade (Appendix A, Photos 6-9, 38, 42) and Voss Canal (Appendix A, Photo 44) are in good condition. The rock dike along Bayou Decade between Jug Lake and Turtle Bayou appears to be in fair condition with isolated low areas and moderate displacement of rock riprap. The earthen embankment with rock revetment west of Structure 7 along Bayou Decade appears to be in good condition with no apparent settlement. The earthen embankment with rock revetment beginning at the intersection of Bayou Decade and Voss Canal had some initial settlement after construction but has experienced little change since previous inspections. Despite some minor deficiencies, the rock armored embankments appear to be functioning as intended and no maintenance will be required at this time.

Photo No.6 – east end of existing rock revetment (Breach Closure 1-4) along north bank of Bayou Decade near Turtle Bayou.

Photo No.7 – existing rock revetment (Breach Closure 1-4) along north bank of Bayou Decade between Turtle Bayou and Jug Lake.

Photo No.8 – existing rock revetment (Breach Closure 1-4) along north bank of Bayou Decade between Turtle Bayou and Jug Lake.

Photo No.9 – existing rock revetment (Breach Closure 1-4) along north bank of Bayou Decade between Turtle Bayou and Jug Lake.

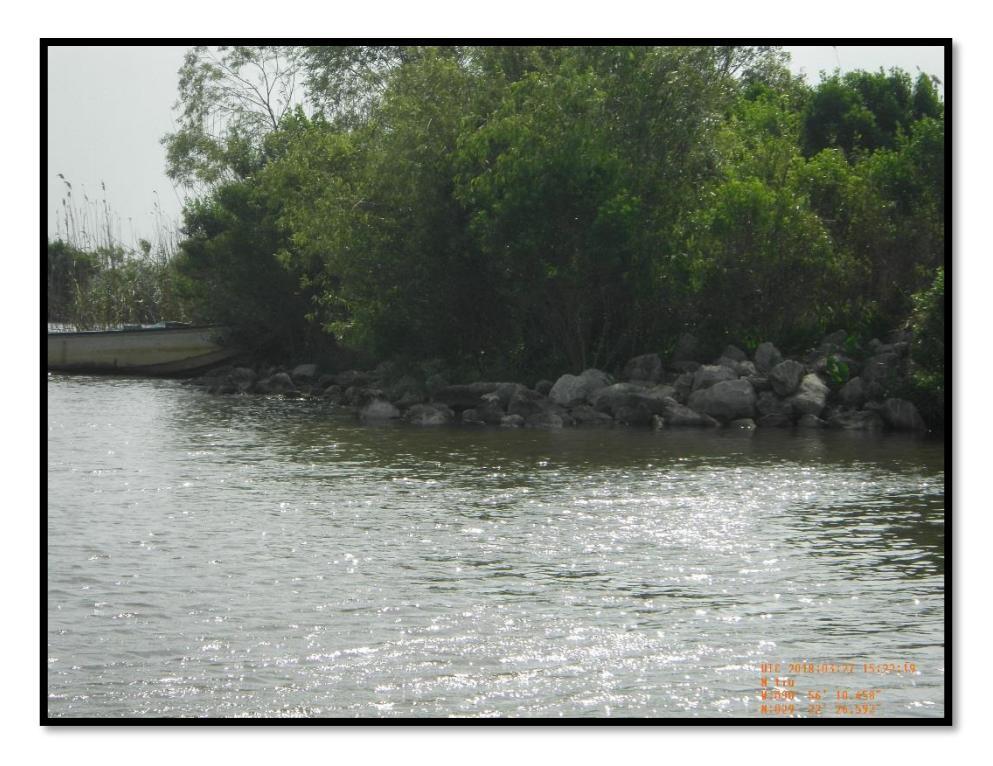
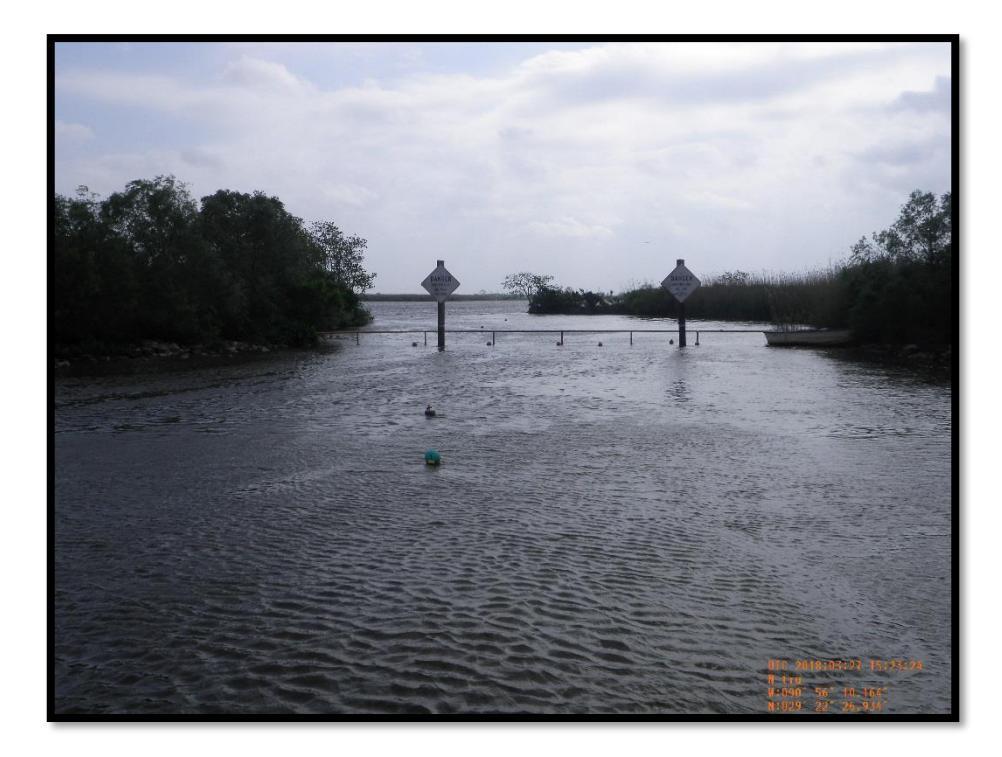
Overall, Structure 24 is in fair condition. There were no visible damages to the steel bulkhead, platform, or the warning signs and their timber supports. However, as reported in the 2017 inspection report, we did note that one section of the steel handrail had sheared at the welded seam. It is not clear if the steel pipe had been intentionally cut or if the damage was caused by corrosion. The handrail is welded to the top of the steel bulkhead channel cap and does not affect the structure integrity of the weir itself. As noted on previous inspections, there was a hull of a small recreational fishing boat that is lodged against the south bank of the structure near the structure. The hull does not appear to be causing damage or hindering the function of the structure. The rock armored bank tie-ins on both sides of the structure are in good condition with no apparent breaches or erosion. (See Appendix A, Photos 12 - 13)

Photo No.12 – rock revetment tie-in to the bank line of Jug Lake on the south side of Structure No.24.

Photo No.13 – Fixed crest weir (Structure No.24) along the south bank of Jug Lake.

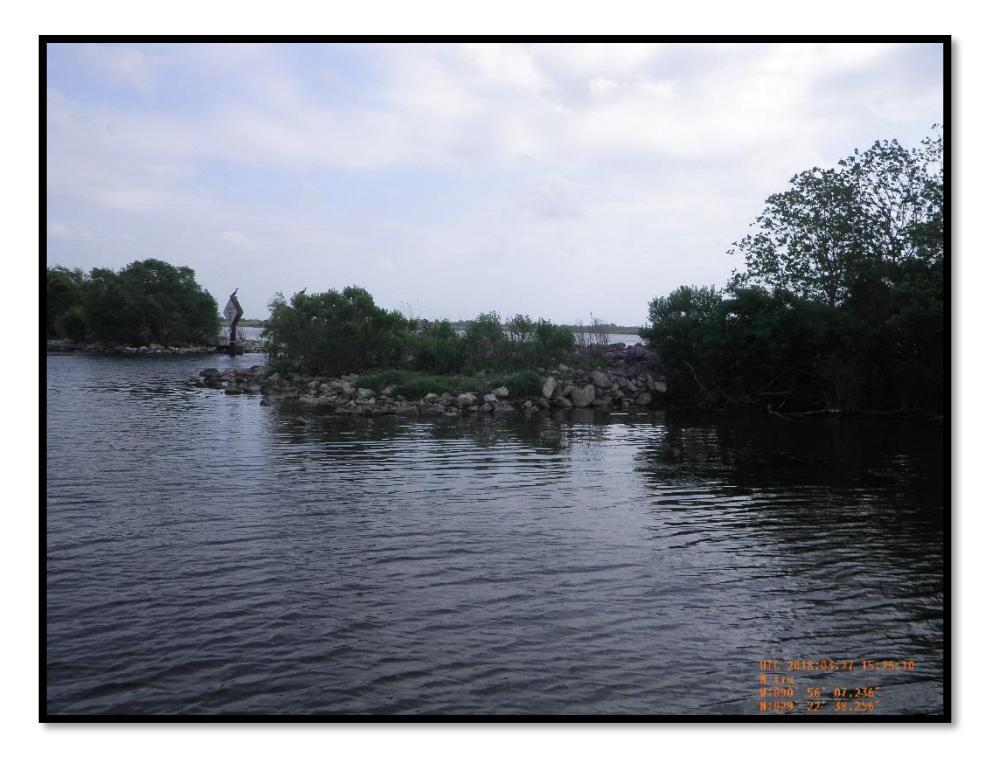
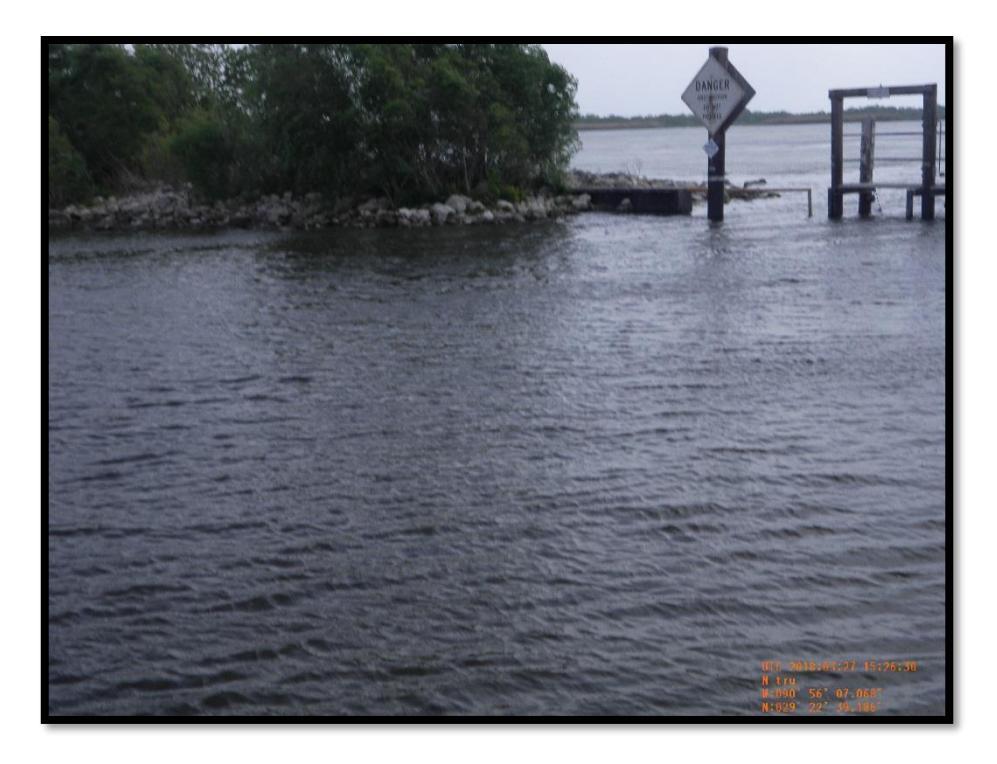
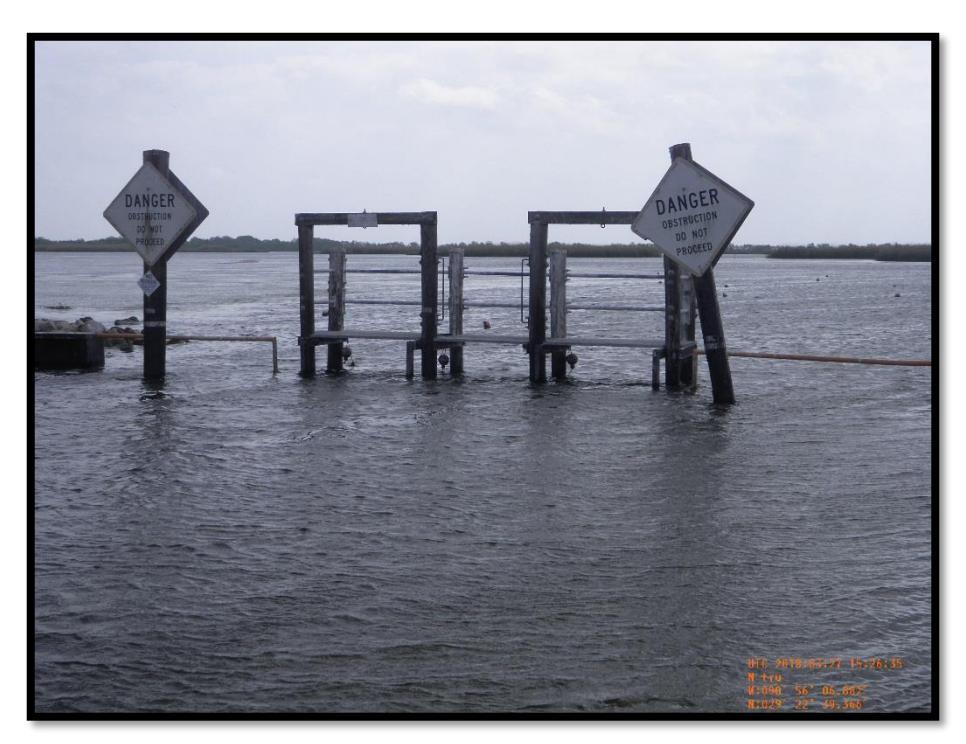
Structure 23 appears to be in good condition as well. There were no visible damage to the steel bulkhead, railings, platform, or the warning signs and their timber supports. The rock armored embankment tie-in to the structure were also in good condition with no obvious settlement or erosion between bank and the structure. Structure 23 will not require maintenance at this time. (See Appendix A, Photos 14 -16)

Photo No.14 – south side of the rock revetment tie-in of the Variable crest weir (Structure No.23) along the east bank of Jug Lake.

Photo No.15 – north side of the rock revetment tie-in of the Variable crest weir (Structure No.23) along the east bank of Jug Lake.

Photo No.16 – Variable crest weir (Structure No.23) along the east bank of Jug Lake.

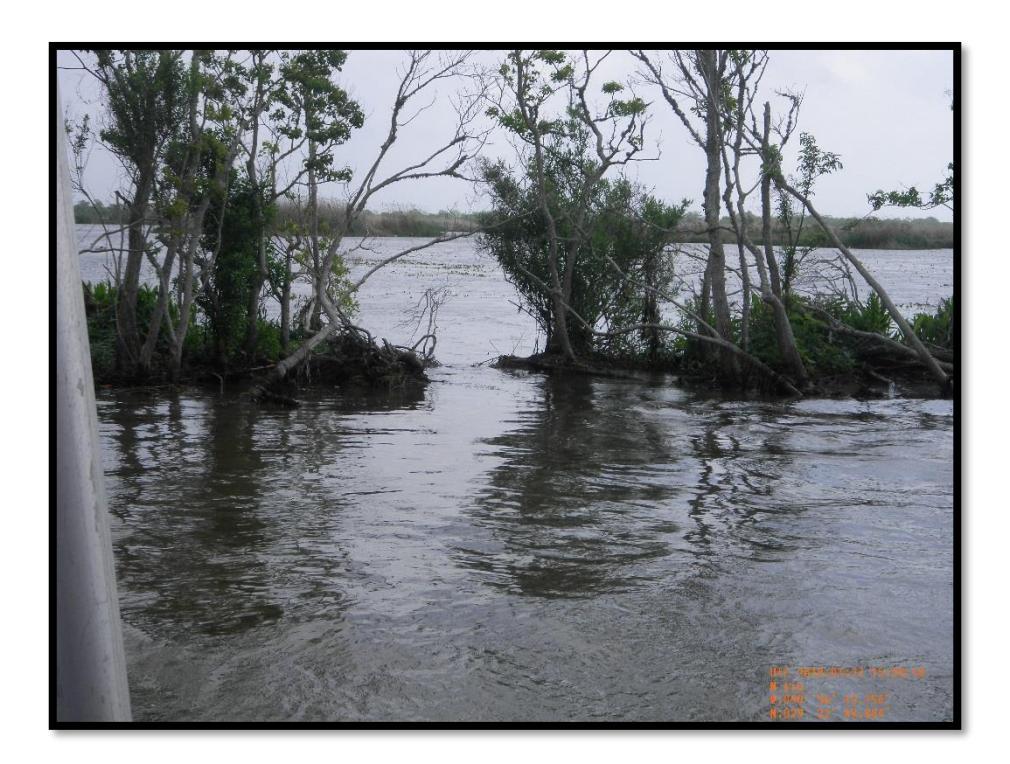
Jug Lake perimeter was in good condition along the south bank of the existing embankment that was refurbished in 2012. The vegetation was thick and the embankment appears to be stable. The north bank of Jug Lake from Structure 23 around the western perimeter to Bayou Decade was is fair to poor condition. There were large areas of the embankment that were very low with a large breach in the bank south of Structure 21. We also noticed areas of the existing south bank along Bayou Decade that were low and thin near the entrance to Voss Canal (Photo 43). The remaining earthen embankments along Voss Canal, Bayou Carencro and Brady Canal were in fair condition with only two (2) small breaches in the bank along Bayou Carencro north of Structure 14. Since the Brady Canal project is approaching the end of its 20-year life, NRCS and CPRA have decided to proceed with a final maintenance event to refurbish the earthen embankments within the project area that are in need of repairs. The repairs include embankment restoration along the northern and eastern perimeter of Jug Lake, breach closures along Bayou Carencro, and refurbishment of existing embankment along the north bank of Bayou Decade near Voss Canal. The plans and specifications are complete and the bid process should begin by the end of March 2019. It is anticipated that construction will begin by June 2019.

Photo No.19 – breach in the earthen bank line on the northeast side of Jug Lake north of Structure No.23.

their current IDIQ contract to prepare plans and specifications to address the deficiencies outlined during the 2018 inspection. The plans and specifications are complete and advertisement for bids should begin by the end of March 2019, with construction to begin in June 2019. All other features inspected during the 2018 annual inspection appear to be in good condition with no other obvious defects that would require immediate attention or action.

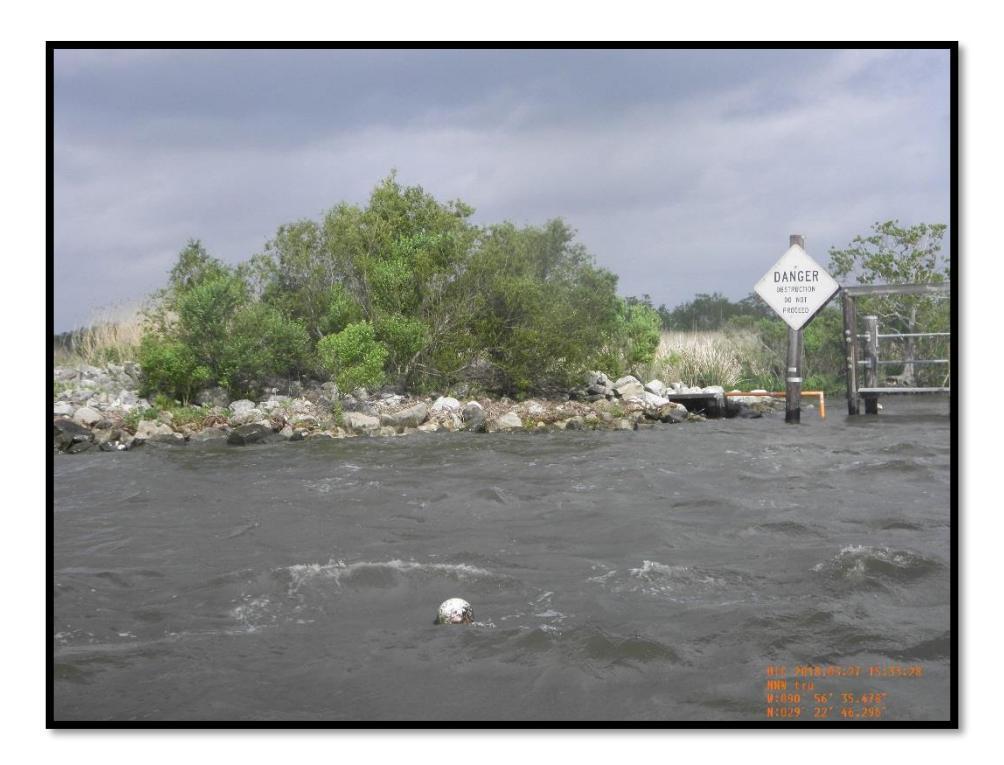
Overall, Structure 21 is in good condition. There was no visible damage to the steel bulkhead, railings, platform or the warning signs and their timber supports. The rock armored embankments was also in good condition with no signs of settlement since refurbished in 2012. Structure 21 will not require maintenance at this time. (See Appendix A, Photos 22 - 23)

Photo No.22 – rock revetment tie-in on the south side of Structure No.21 along the north bank of Jug Lake.

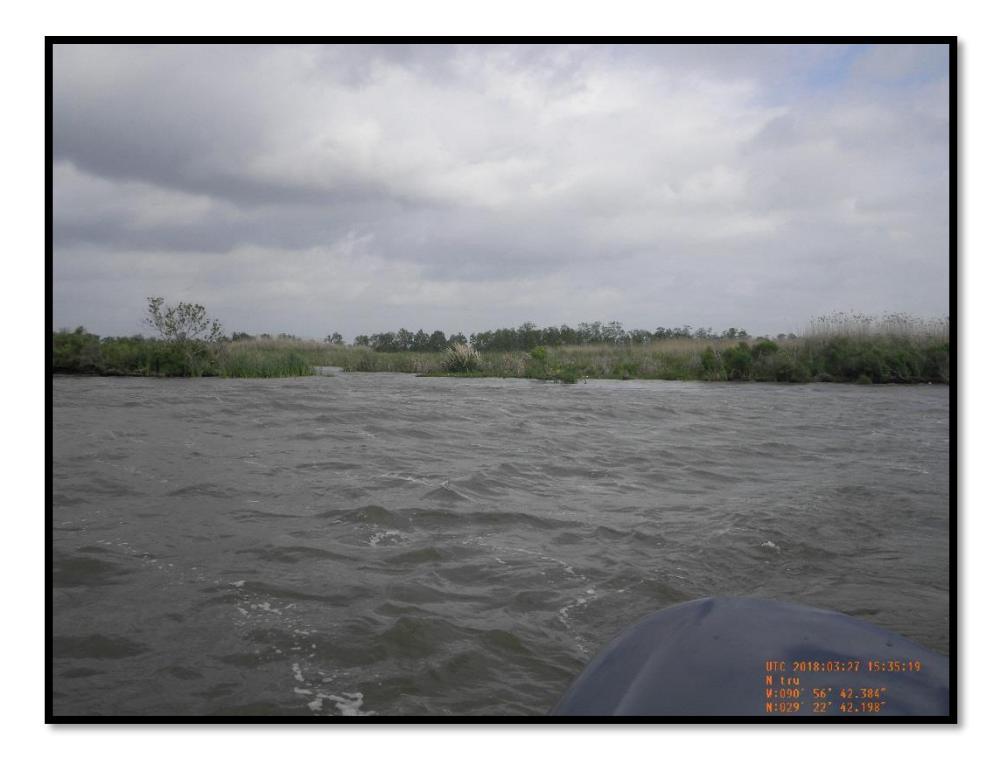
Photo No.25 – breach in the existing bank line on the northwest side of Jug Lake between Structure No.21 and Structure No.20.

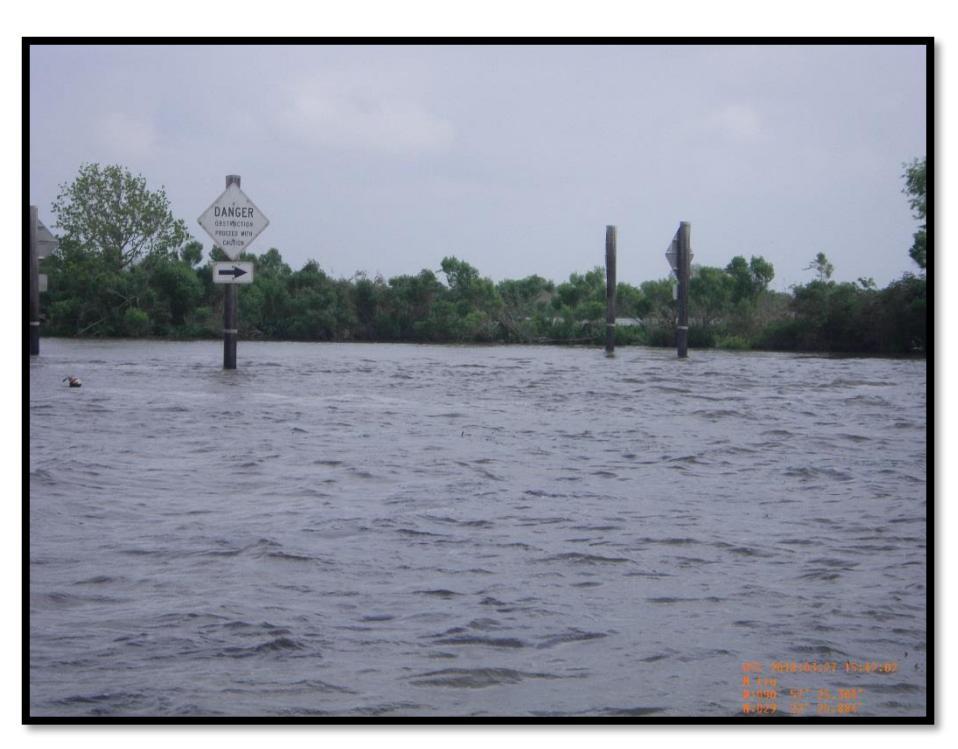
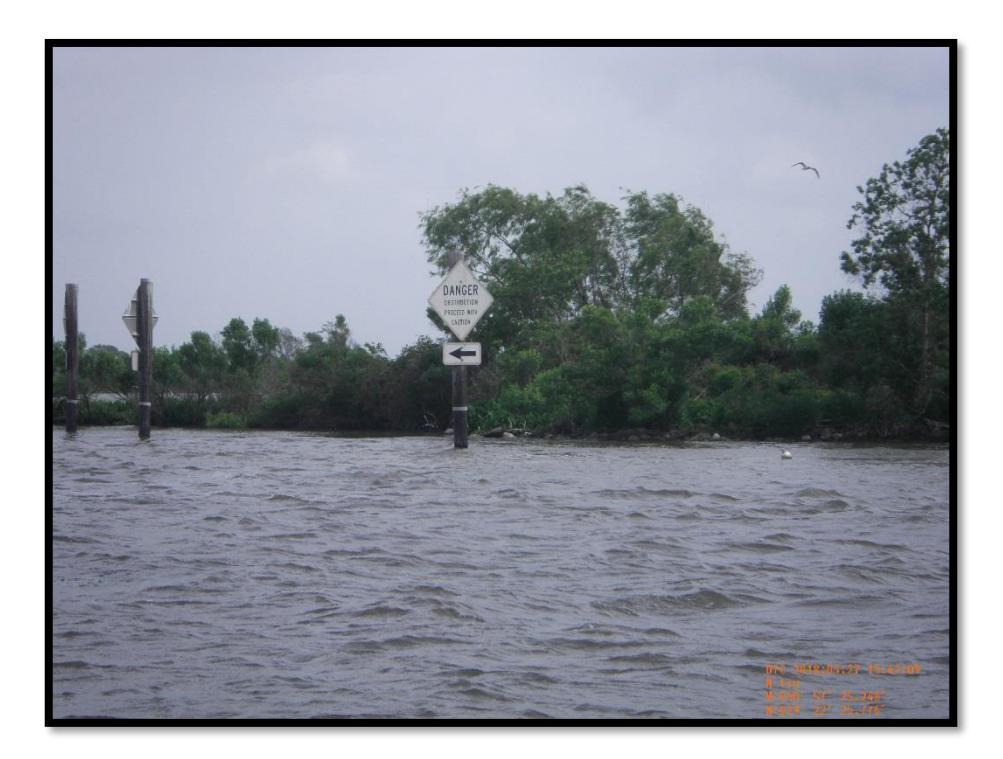
Structure 20 is in fair to good overall condition. There appears to be some settlement of the rock riprap on the bank tie-ins and submerged crest of the structure based on elevation depths collected along the crest of the channel liner. Depths along the channel liner crest were approximately 7.7' at the time of this inspection with water levels at 1.7' NAVD. The calculated elevation of the channel liner crest in the center of the opening was approximately -6.0' NAVD with a settlement of approximately 1.2' to 1.5' since the structure was installed. The warning signs and timber supports were also in good condition. At this time, Structure 20 is in good condition and no maintenance will be required. (See Appendix A, Photo 28 - 30)

Photo No.28 – rock lined channel (Structure No.20) located along the northwest bank of Jug Lake.

Photo No.29 – rock lined channel (Structure No.20) located along the northwest bank of Jug Lake.

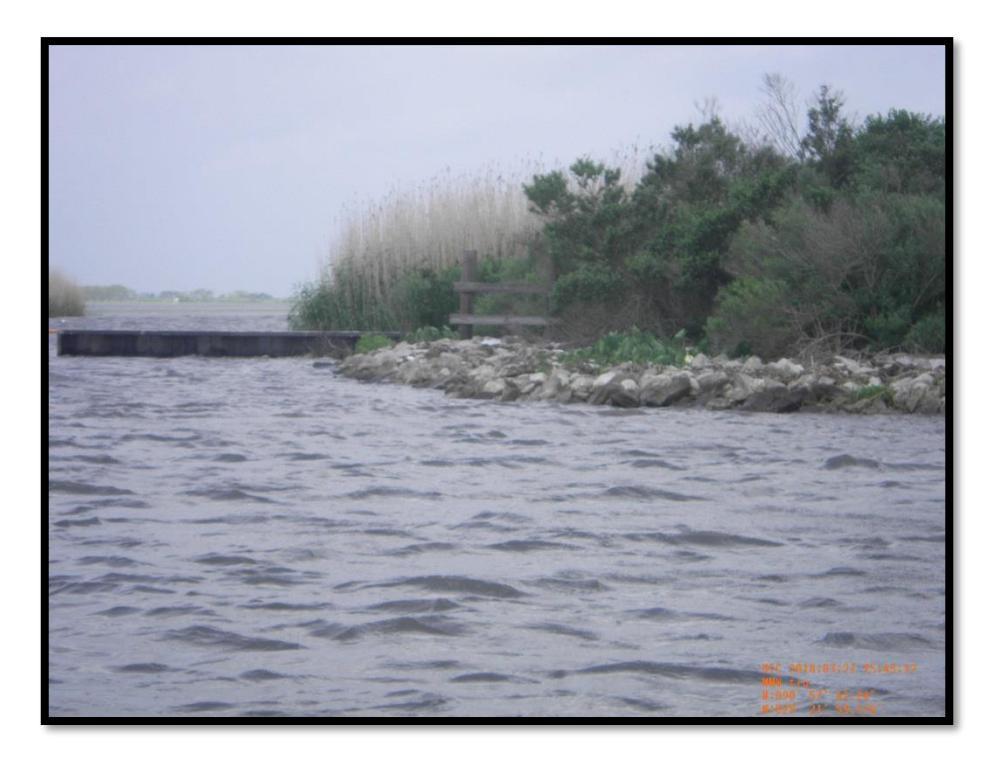
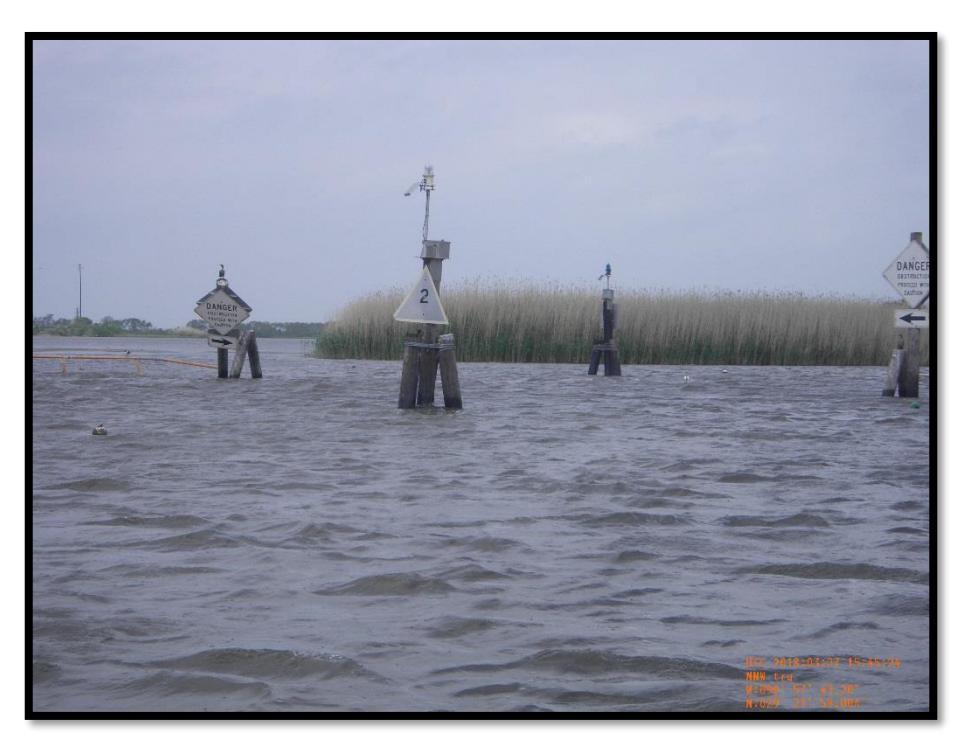
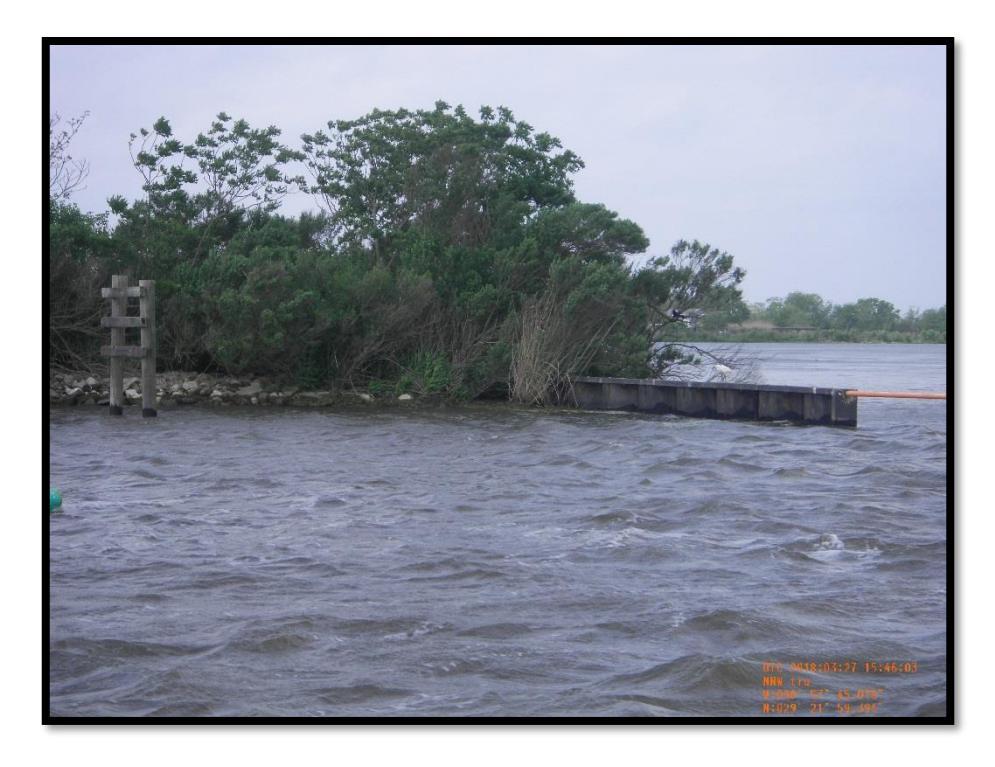
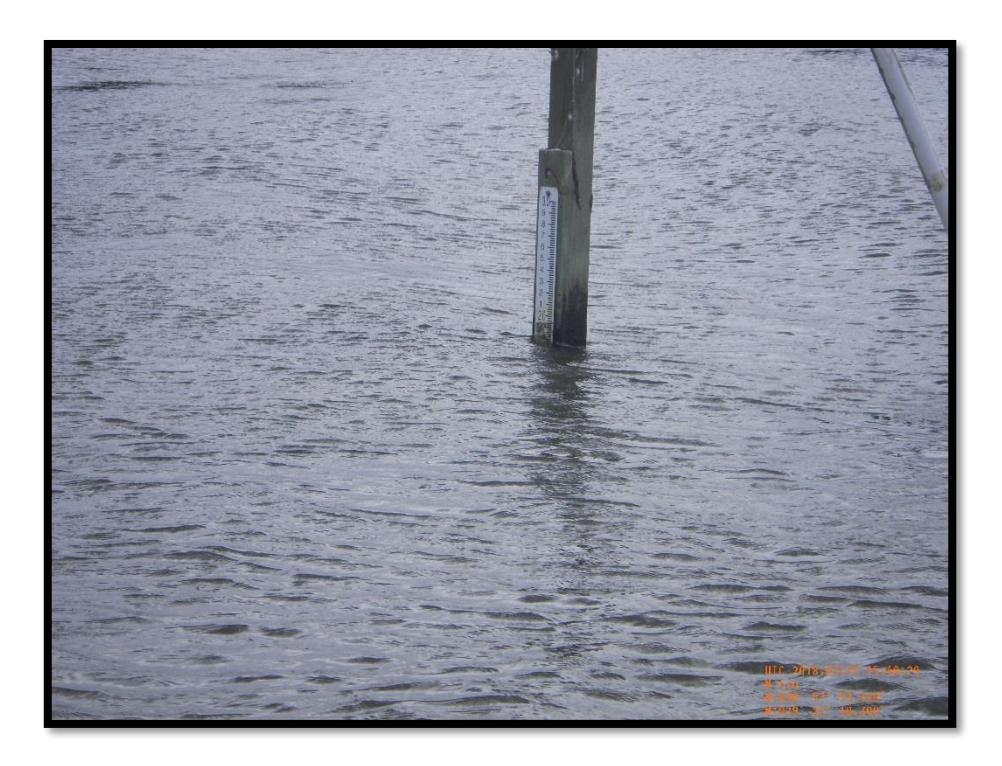
Structure 6 appears to be in good condition. The rock armored bank tie-ins appear to be stable and there are no signs of erosion or breaching around the steel bulkhead. The timber navigational aid supports, signs and lights are visible and appear to be in good condition. Francis Field with Apache did indicate that one of the navigational aid lights was not working properly. Pharo-Marine Automatic Power, the contractor hired to maintain navigational aids for the state, was notified of the possible outage and shall perform test and repair the navigation aid during their upcoming inspection, if needed. The only damaged noted during

Photo No.33 – rock revetment bank tie-in on east side of Structure No.6 along Bayou Decade.

Photo No.34 – Navigational Aids at the entrance to the barge bay of Structure No.6.

Photo No.35 – northeast steel sheetpile tie-in at Structure No.6 along Bayou Decade.

Photo No.37 – staff gauge in channel on the north side of Structure No.6 (Elev: 1.7' @ 10:00 a.m.)

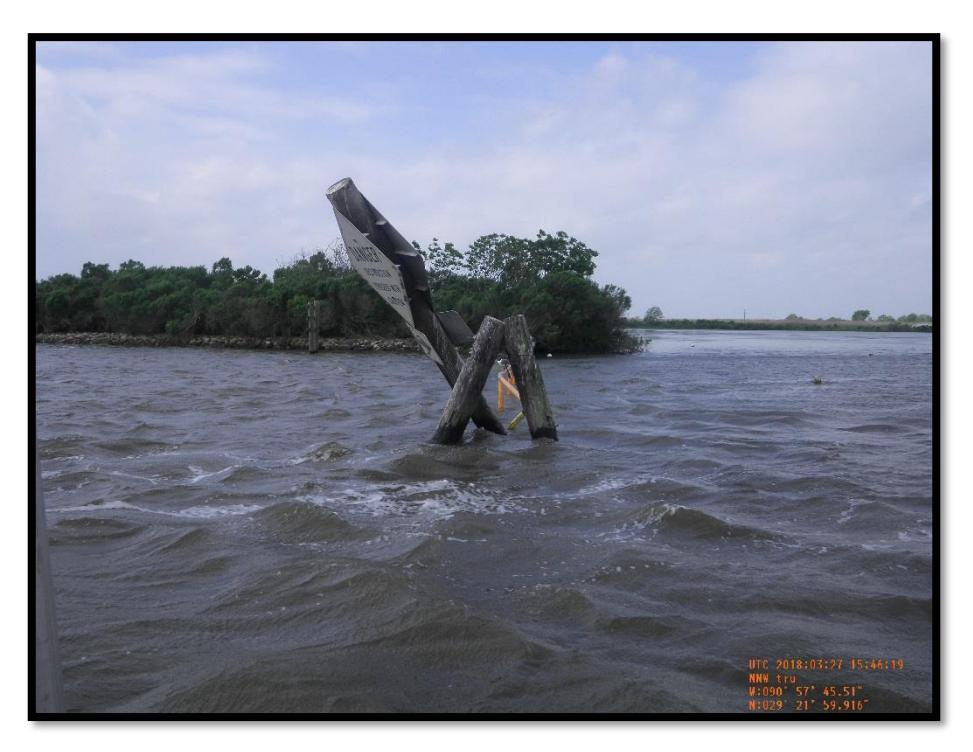
the inspection of Structure 6 was to the timber pile and warning sign next to the timber bollard on the west side of the barge bay entrance. The timber pile was leaning over and appeared to be broken below the water line. We are recommending that the timber pile and sign be replaced during the next maintenance event. The gauge reading from the CPRA continuous recorder, located just north of Structure 6 indicated that the water elevation was approximately +1.7' NAVD at 10:00 a.m. No other maintenance will be required at Structure 6. (See Appendix A, Photos 33 - 37)

Photo No.36 – damaged timber bollard and warning sign on the southwest side of the barge bay at Structure No.6.

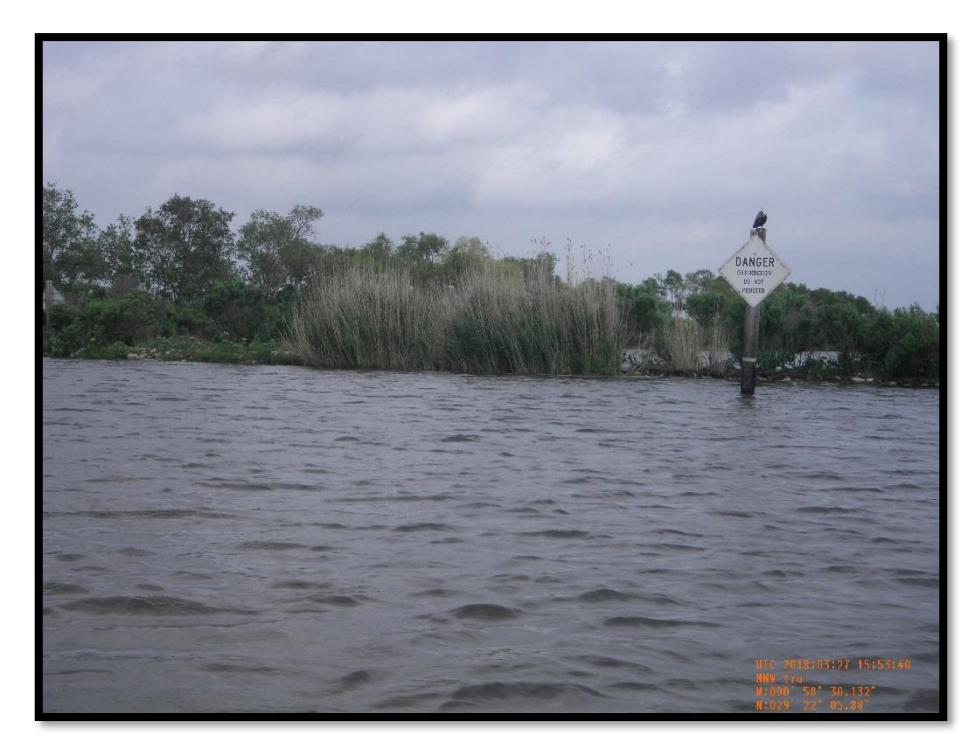
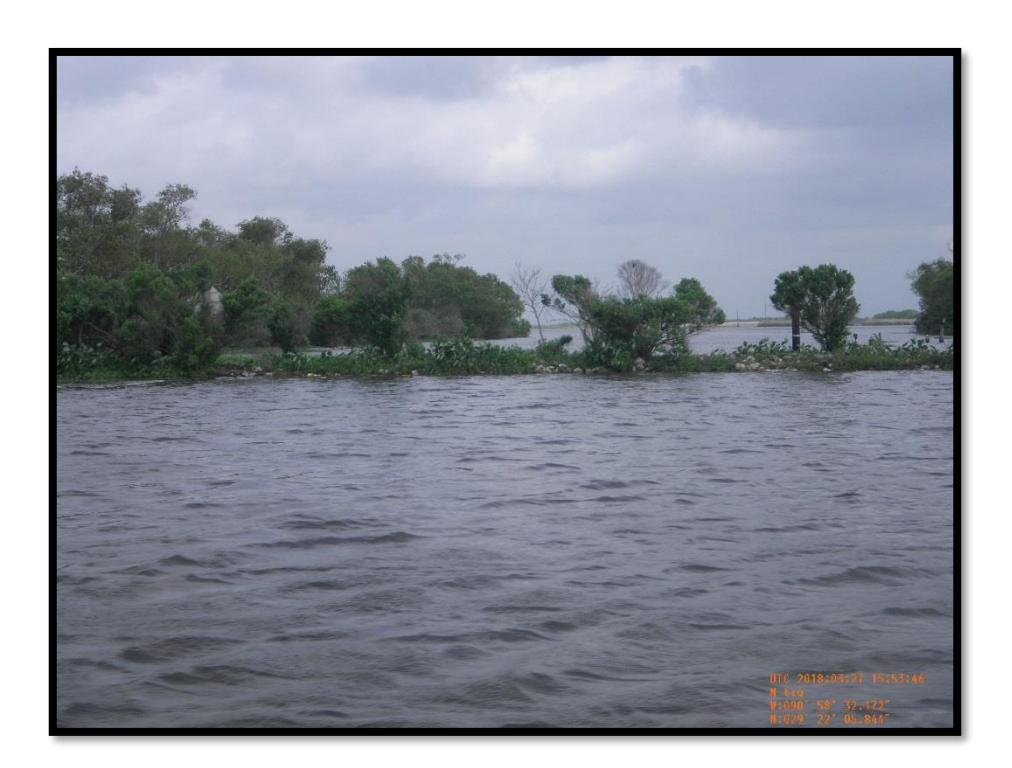
Structure 7 appears to be in good condition with no obvious settlement, breaches, or defects other than heavy vegetation on and around the rock plug. The warning signs and supports located on both sides of the structure are in good condition. Currently, there are no recommendations for maintenance (Appendix A, Photos 40 - 41).

Photo No.40 – rock plug (Structure No.7) across pipeline canal along the north bank of Bayou Decade.

Photo No.41 – rock plug (Structure No.7) across pipeline canal along the north bank of Bayou Decade.
