## **2018 Operations, Maintenance, and Monitoring Close-out Report**

## **Brady Canal Hydrologic Restoration** (TE-28)

State Project Number TE-28 Priority Project List 3

March 2019 Terrebonne Parish

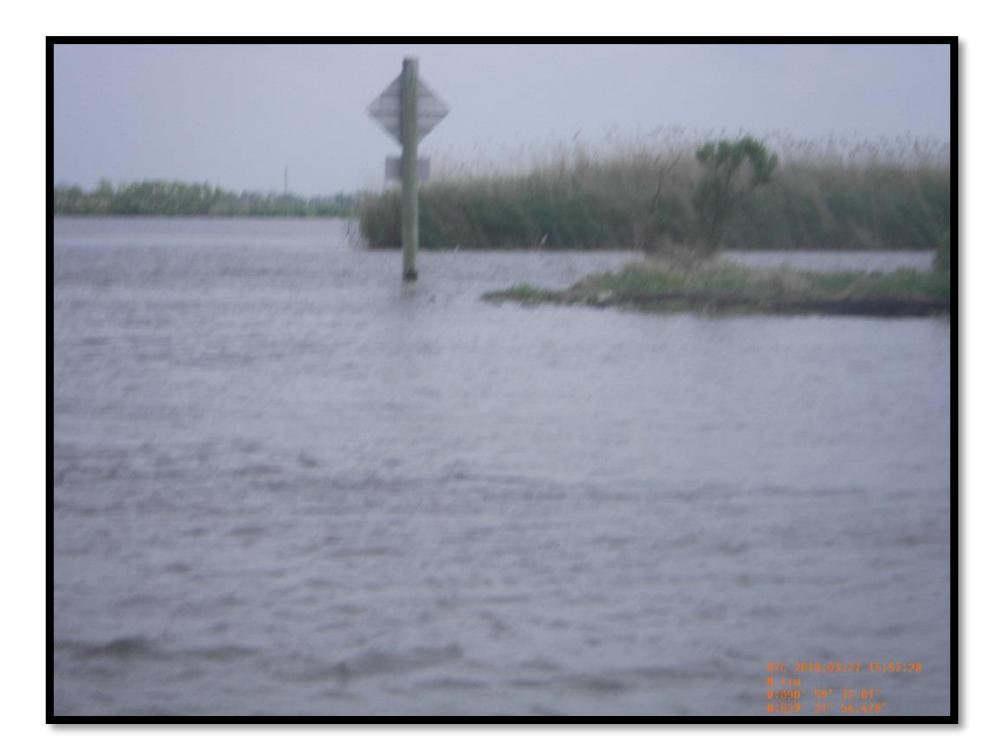
Structure10 appears to be in fair condition. The rock tie-ins to the bank on both sides of the structure appear to be thin and were mostly submerged which is attributed to minor settlement and higher than normal water levels during the inspection. Depths along the center of the rock channel liner taken with a handheld fathometer showed readings between 7.9' and 8.3' with an average of 8.1'. Using the water elevation shown on the staff gauge behind Structure 6, the estimated elevation at the center of the rock channel liner was approximately -6.4 NAVD. The constructed sill elevation was -4.75', indicating that the structure has settled approximately 1.7' feet since it was constructed. All of the timber piling and warning signs appear to be in good condition (See Appendix A, Photo 45)

Photo No.45 – rock channel liner (Structure No.10) at the southern end of Voss Canal along the east bank.

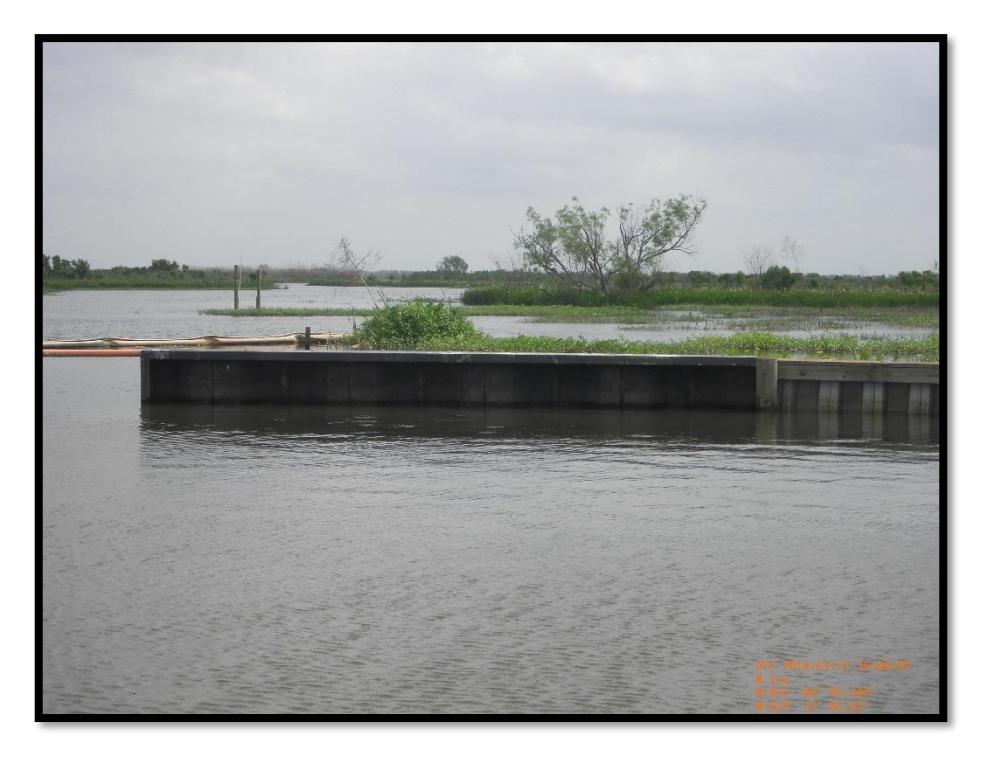
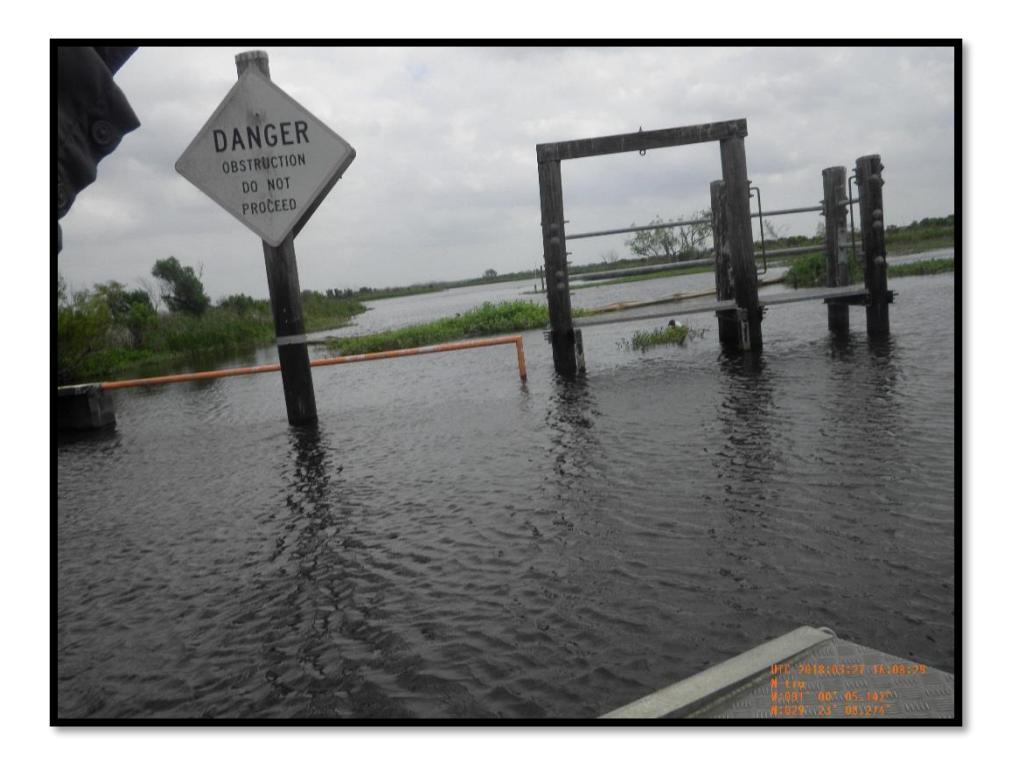
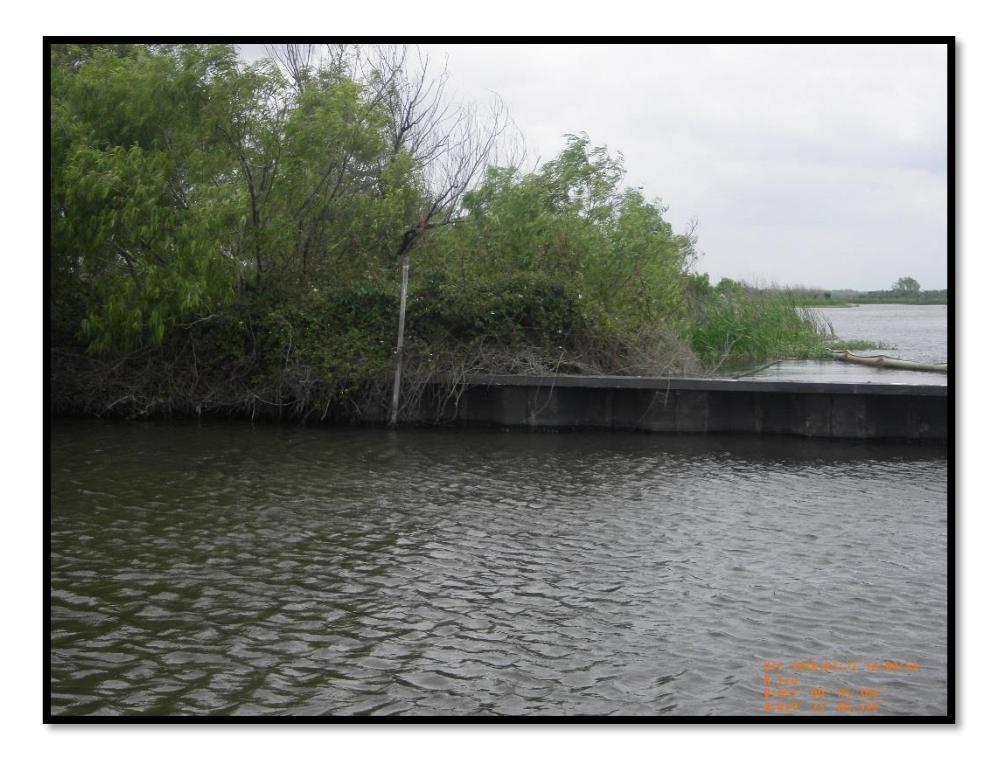
Structure 14 appears to be in fair condition. There was no visible damage to the railings, platform, steel bulkhead or warning signs. The bank tie-in on the north side of the structure is still thin with very little material between the existing bank and the steel bulkhead. The south side of the steel bulkhead connects to a vinyl bulkhead installed by the adjacent camp owner and is in good condition. We are recommending that the eroded earthen embankment connecting the steel bulkhead to the bank on the north side of the structure be refurbished during the next maintenance event. Other than the erosion near the north end of the bulkhead, the structure remains in fair condition. (See Appendix A, Photos 50 - 52)

Photo No.50 – steel sheetpile wing wall on the south side of the Variable Crest Weir (Structure No.14).

Photo No.51 – Variable Crest Weir (Structure No.14) along the east bank of Carencro Bayou.

Photo No.52 – steel sheetpile wing wall on the north side of the Variable Crest Weir (Structure No.14).

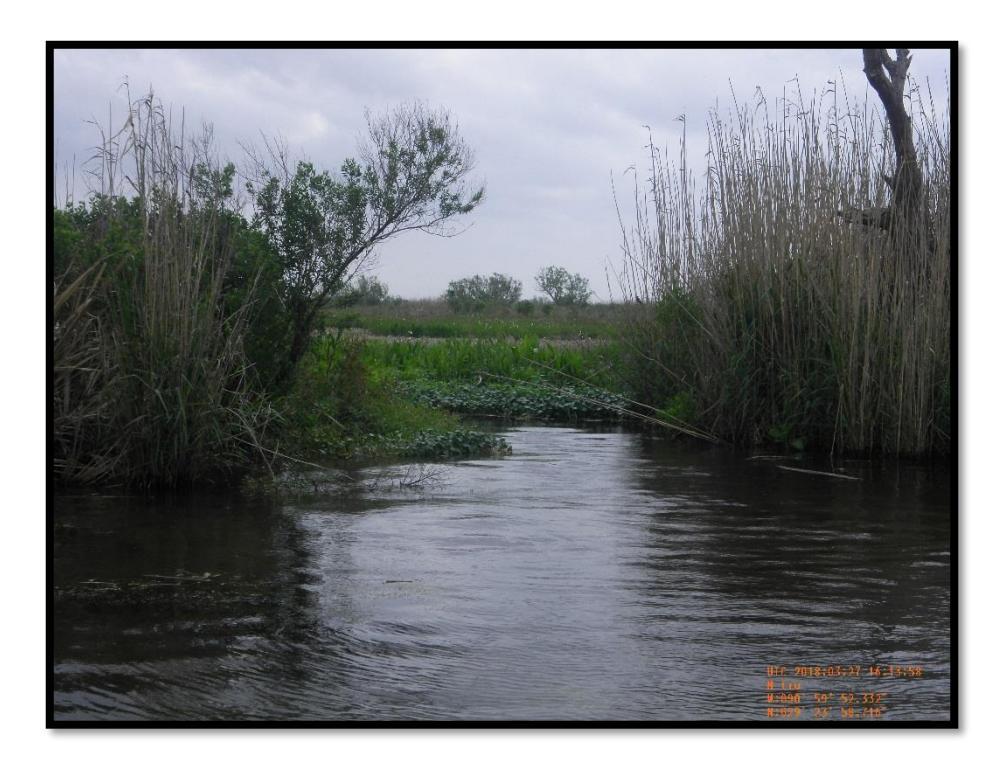
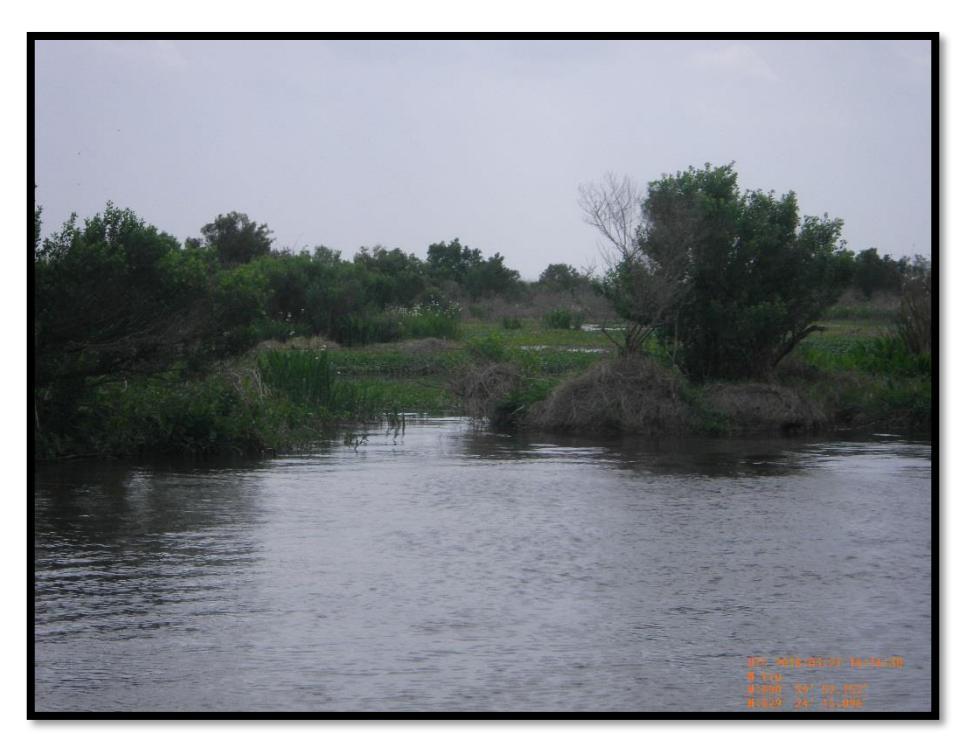
Photo No.53 – breach in the overflow bank along Bayou Carencro north of Structure No.14

Photo No.54 – breach in the overflow bank along Bayou Carencro north of Structure No.14

their current IDIQ contract to prepare plans and specifications to address the deficiencies outlined during the 2018 inspection. The plans and specifications are complete and advertisement for bids should begin by the end of March 2019, with construction to begin in June 2019. All other features inspected during the 2018 annual inspection appear to be in good condition with no other obvious defects that would require immediate attention or action.

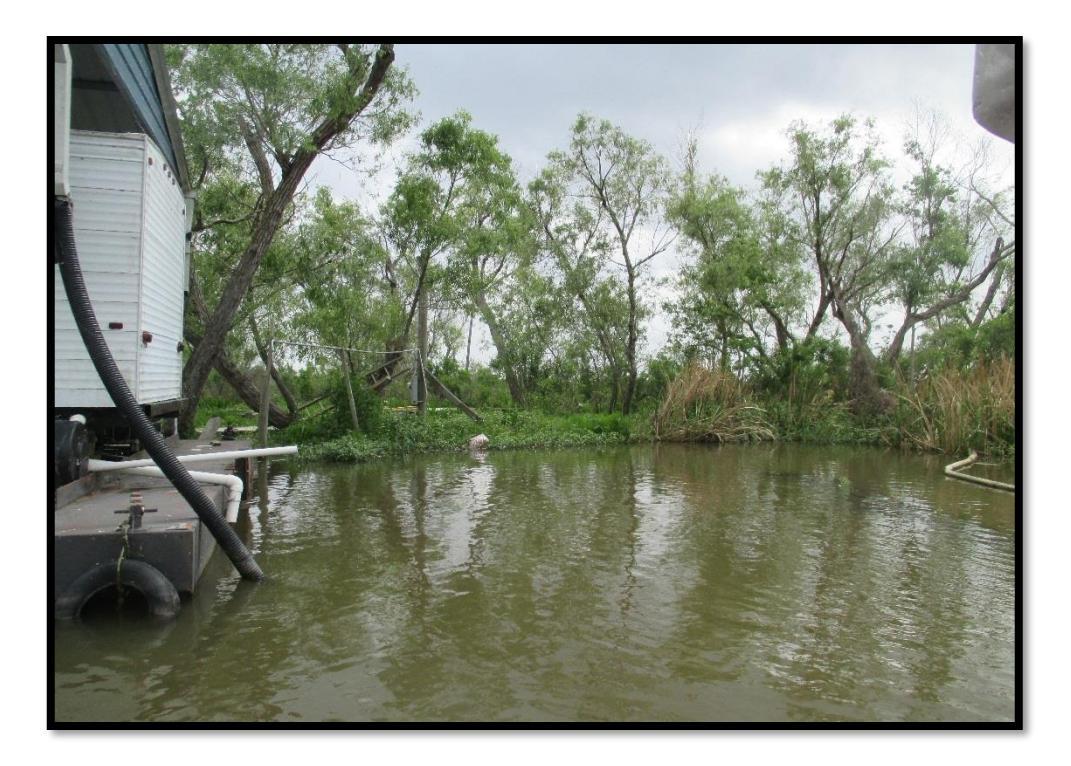
The timber bulkhead at the head of Brady Canal is an old existing oilfield structure that is not an original feature of the Brady Canal project. Over time, a small breach had developed on the southern end of the bulkhead. The breach was repaired during the 2012 Maintenance Project with rock riprap to close off the flow around the structure. The riprap material appeared to have settled allowing flow around the structure into Brady Canal. We do not believe that this requires immediate remedial action and will continue to monitor this location on future site visits. (See Appendix A, Photo 55)

Photo No.55 – existing rock closure between bankline and timber bulkhead at intersection of Brady Canal and Carencro Bayou. The rock closure is below the water line and is not visible in photo.
