# **2017 Annual Inspection Report**

# North Lake Mechant Landbridge Restoration Project (TE-44)

State Project Number TE-44 Priority Project List 10

December 4, 2017 Terrebonne Parish

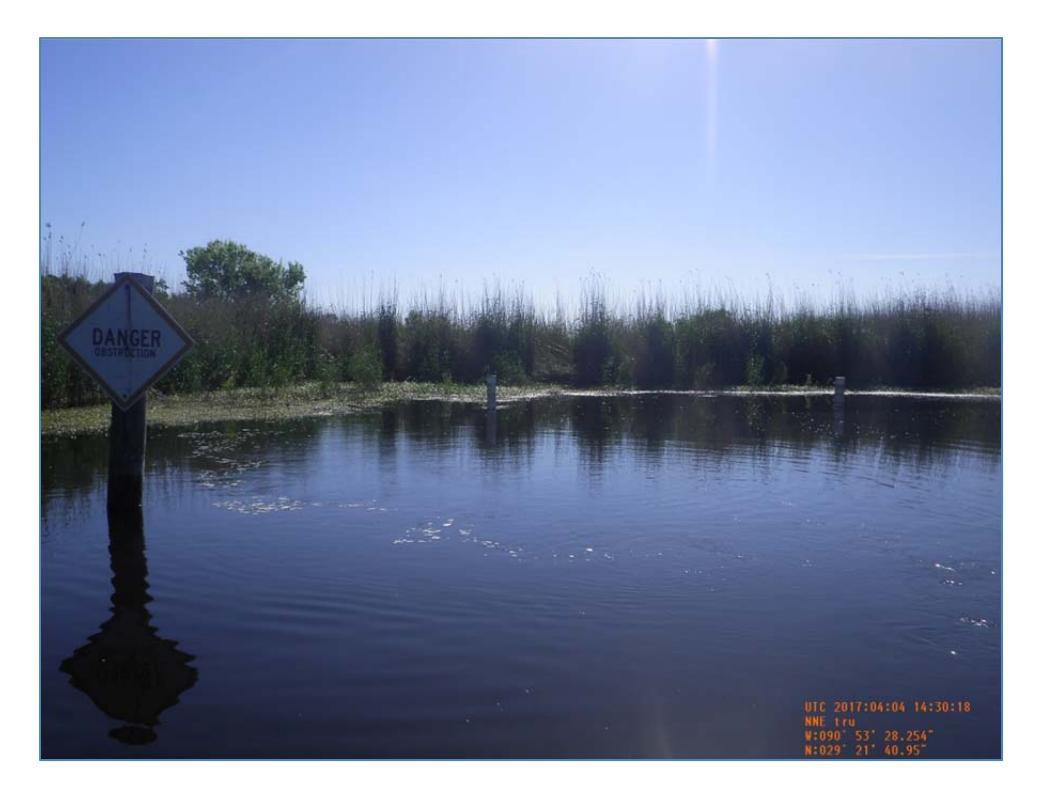
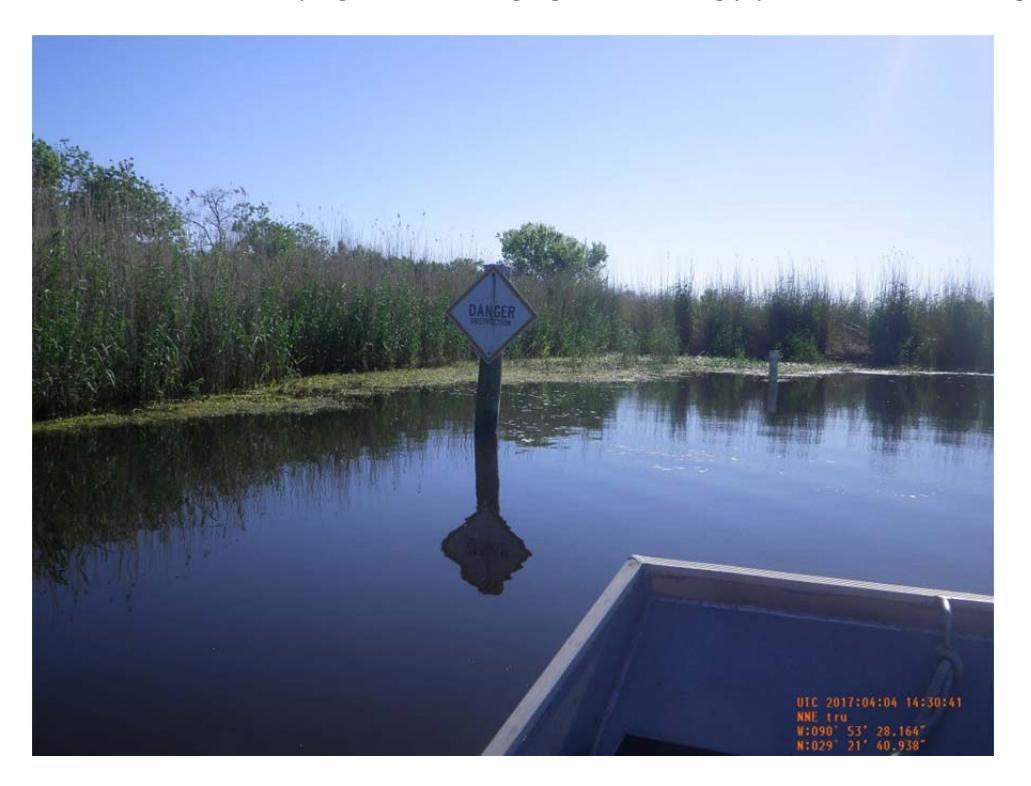
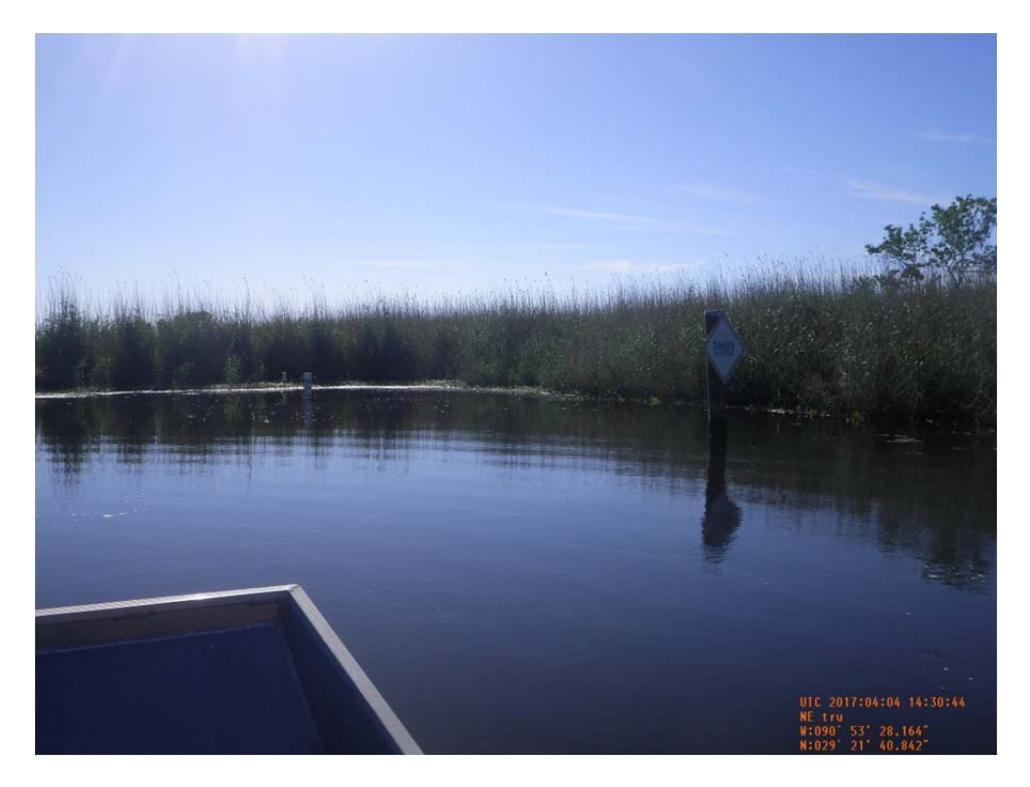
Rock plug 2 appears to be in fair condition. At the time of the inspection, the rock plug was over-grown with vegetation making it difficult to view the structure. We were unable to inspect the bank tie-ins due to the amount of vegetation covering the structure. We did not notice any signs of breaching on either end of the structure, or flow around the structure. The warning signs in front of the structure were in fair condition with only slight damage to the southwest sign which has been vandalized and damaged by a shotgun. (Appendix B, Photos 1 through 3)

Photo No.1 – view of rock plug No.2, warning sign and floating pipeline markers looking east.

Photo No.2 – view of rock plug No.2, warning sign and floating pipeline markers looking east.

Photo No.3 – view of rock plug No.2, warning sign and floating pipeline markers looking east.

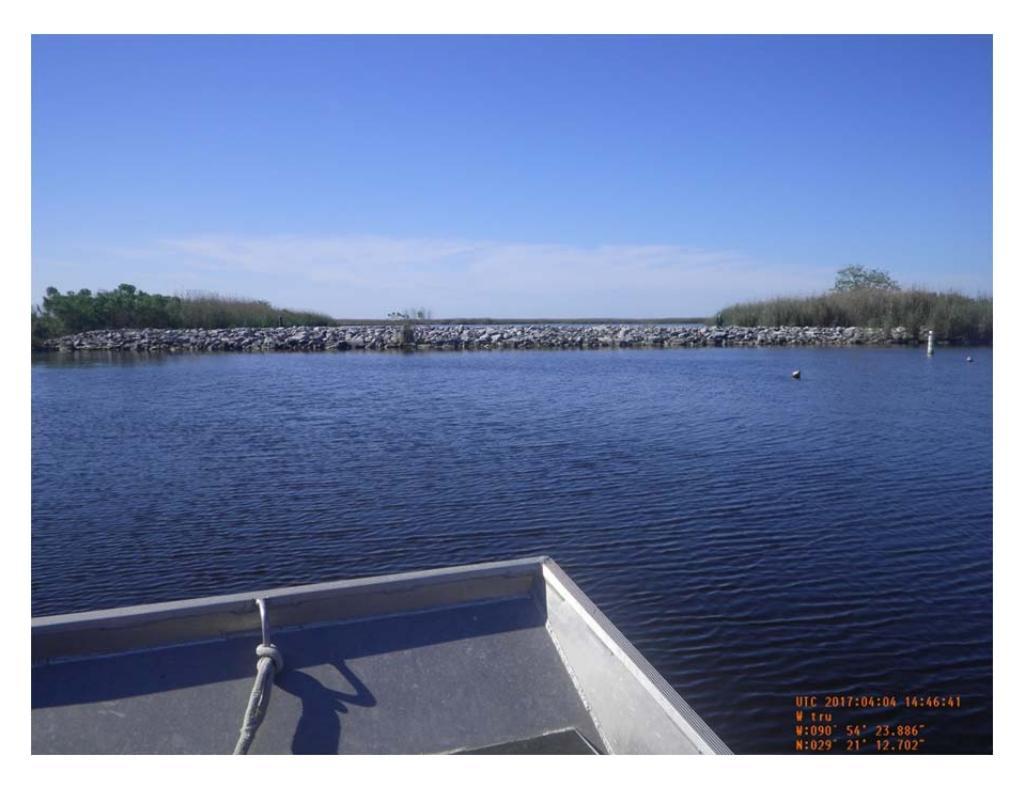
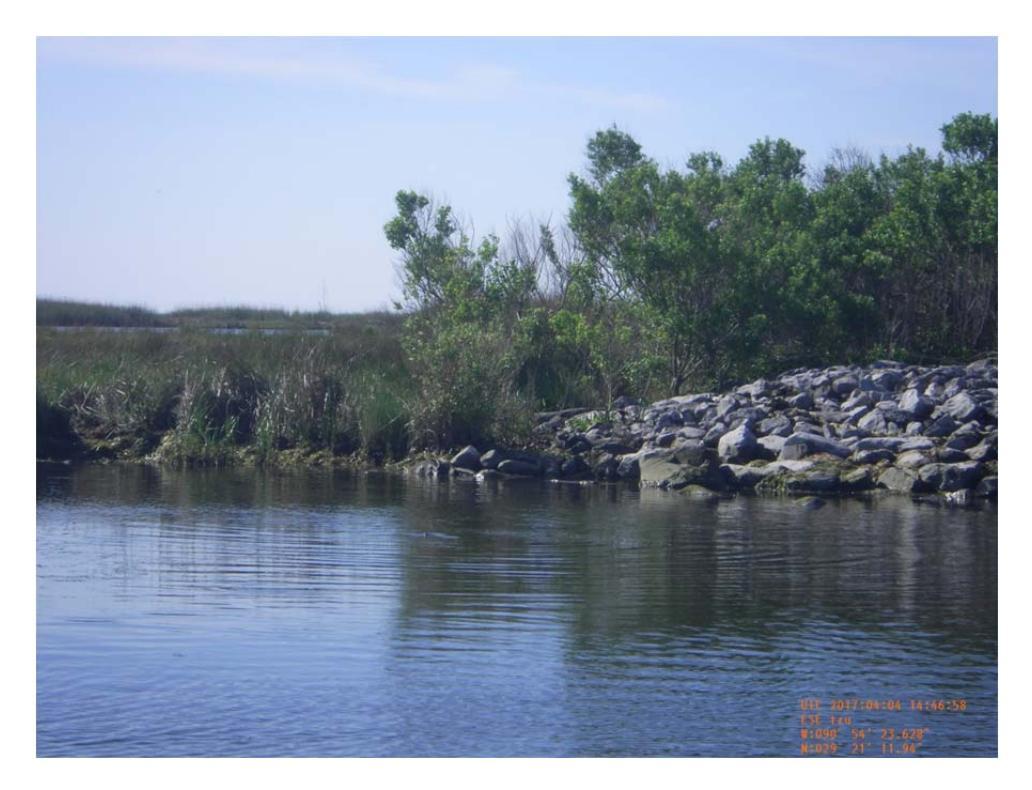
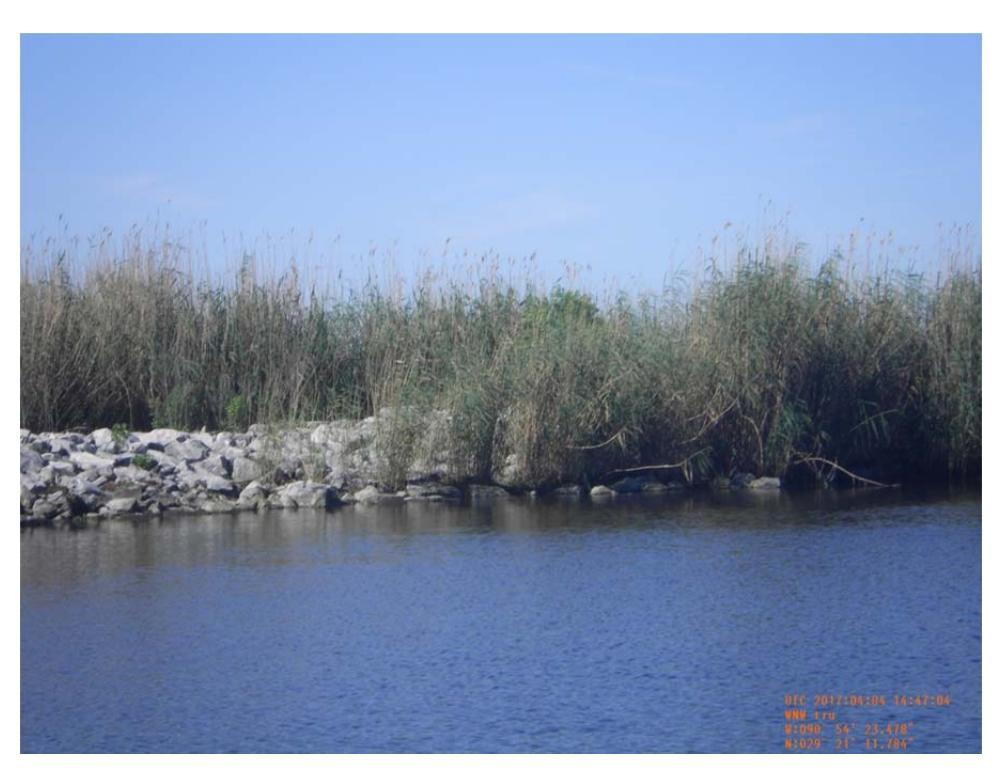
The Rock Plug 1 structure located along the south bank of Small Bayou LaPointe across the old Lil' Deuce Cut appears to be in very good condition. There are no visible signs of settlement since construction or evidence of erosion and washouts around the embankment tie-ins. The timber warning signs and buoys were also in good condition. There are no recommendations for corrective action at this time. (Appendix B, Photos 4 through 6)

Photo No.4 – view of Rock Plug No.1 along Small Bayou Lapointe Ridge at the old Lil' Deuce opening looking south.

Photo No.5 – view of east bank tie-in of rock plug No.1 along Small Bayou Lapointe ridge at the old Lil' Duece opening looking south.

Photo No.6 – view of west bank tie-in of rock plug No.1 along Small Bayou Lapointe ridge at the old Lil' Duece opening looking south.

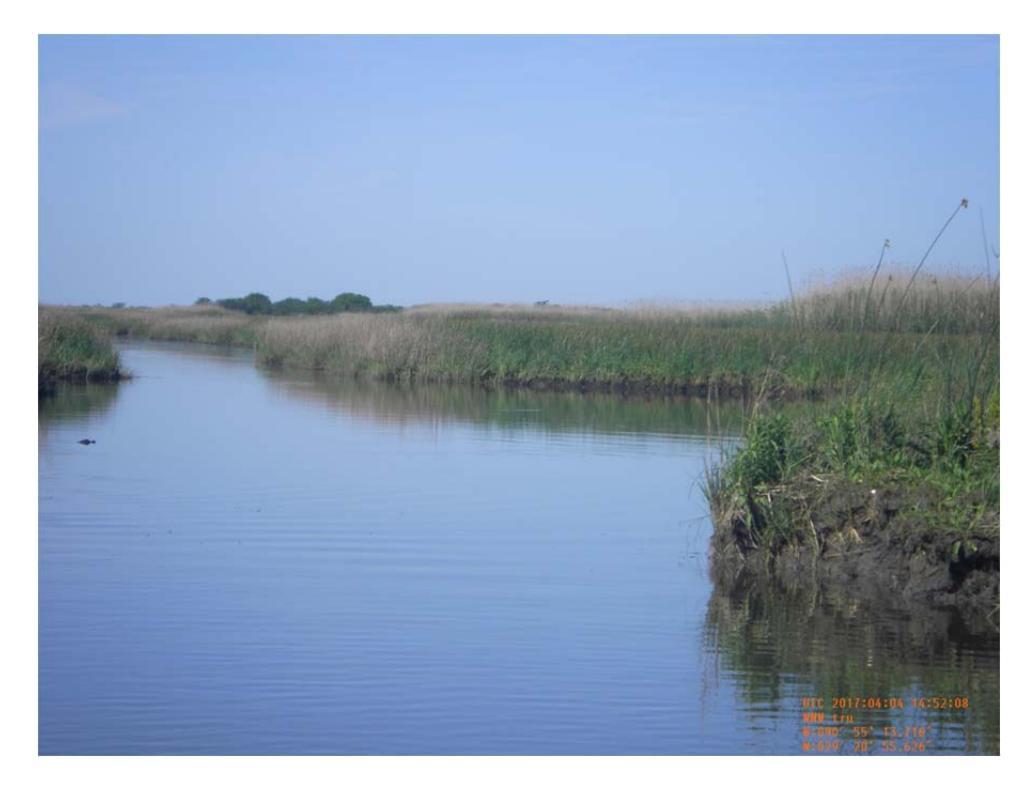
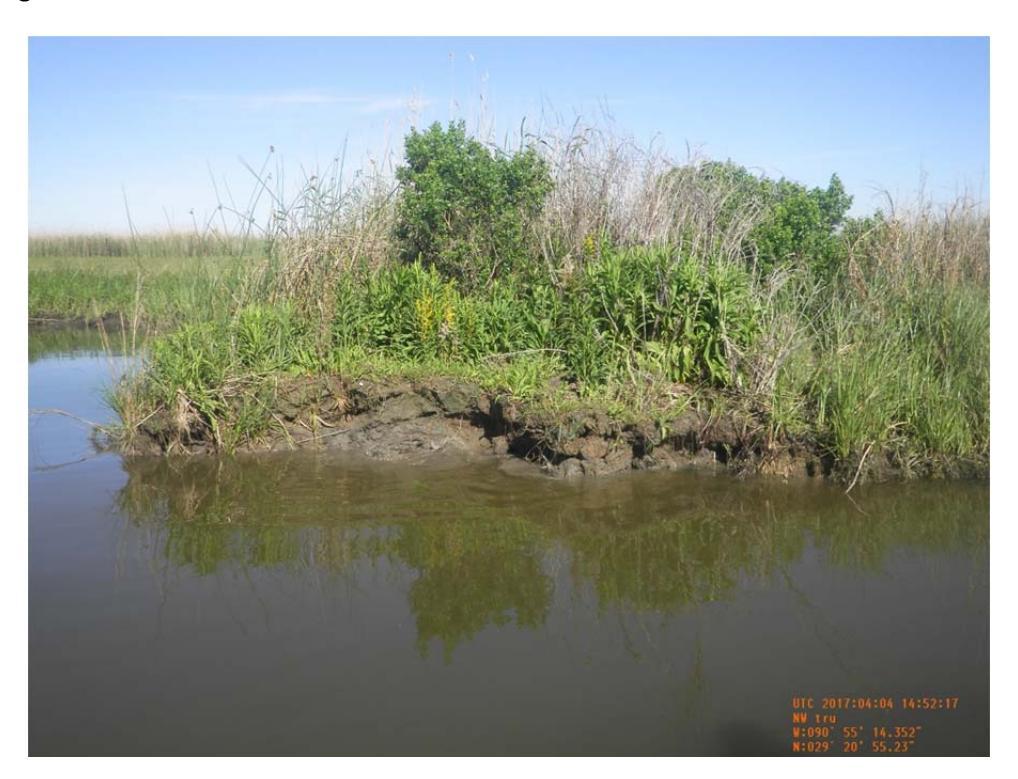
Earthen Plug No. 4 was not included in the original design of the project but was added to the proposed features during construction. It is located along the Small Bayou LaPointe Ridge between Rock Plug 1 and Fill Area 8. At some point after construction, the earthen plug was vandalized by cutting a small breach in the earthen embankment. The breach has completely eroded away with a small portion of the earthen plug connecting the north bank. Due to the remote location of this structure, any corrective action would require a marsh excavator tracking long distances to make repairs. We will continue to work with the landowner and federal sponsor on identifying other areas of the ridge that may be breached or eroded and include these repairs in the first scheduled maintenance event. (Appendix B, Photo 7 and 8).

Photo No.7 – view of breach in earthen plug crossing Small Bayou Lapointe ridge west of Rock Plug No.1

Photo No.8 – view of breach in earthen plug crossing Small Bayou Lapointe ridge west of Rock Plug No.1

General Breach Repairs: Since the project was completed, we have noticed that the earthen embankments along the Small Bayou Lapointe Ridge are thin and endanger of breaching (very little marsh protecting the ridge). Below are estimated costs for refurbishing sections of the embankment.

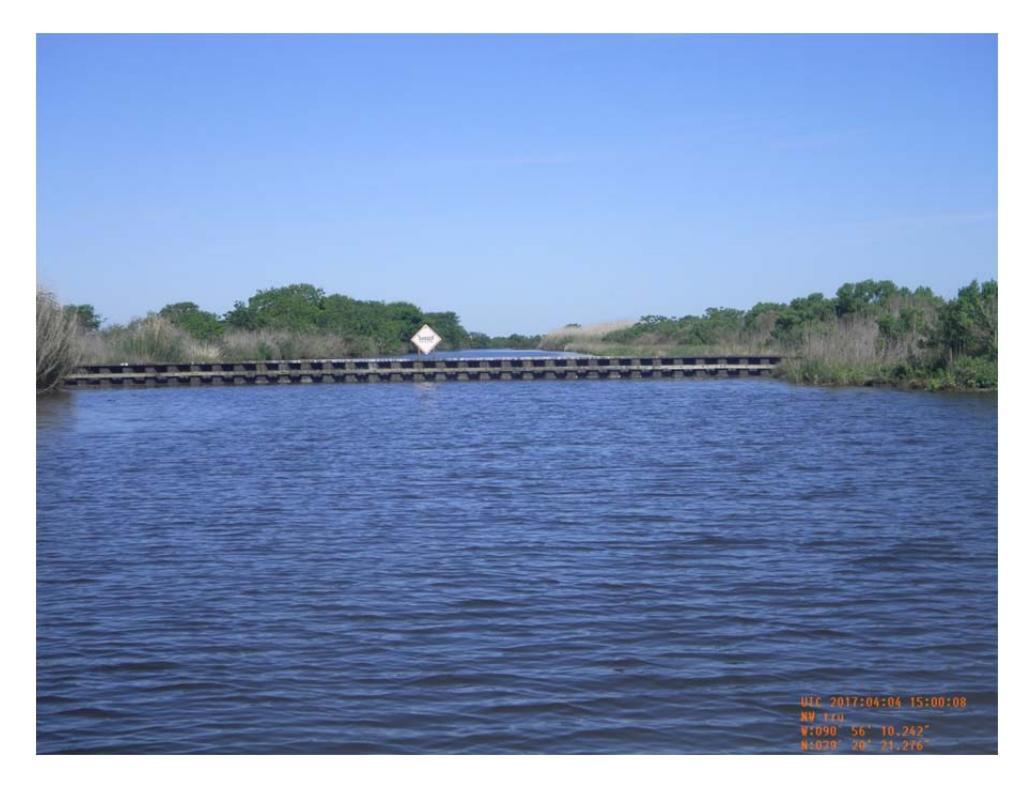
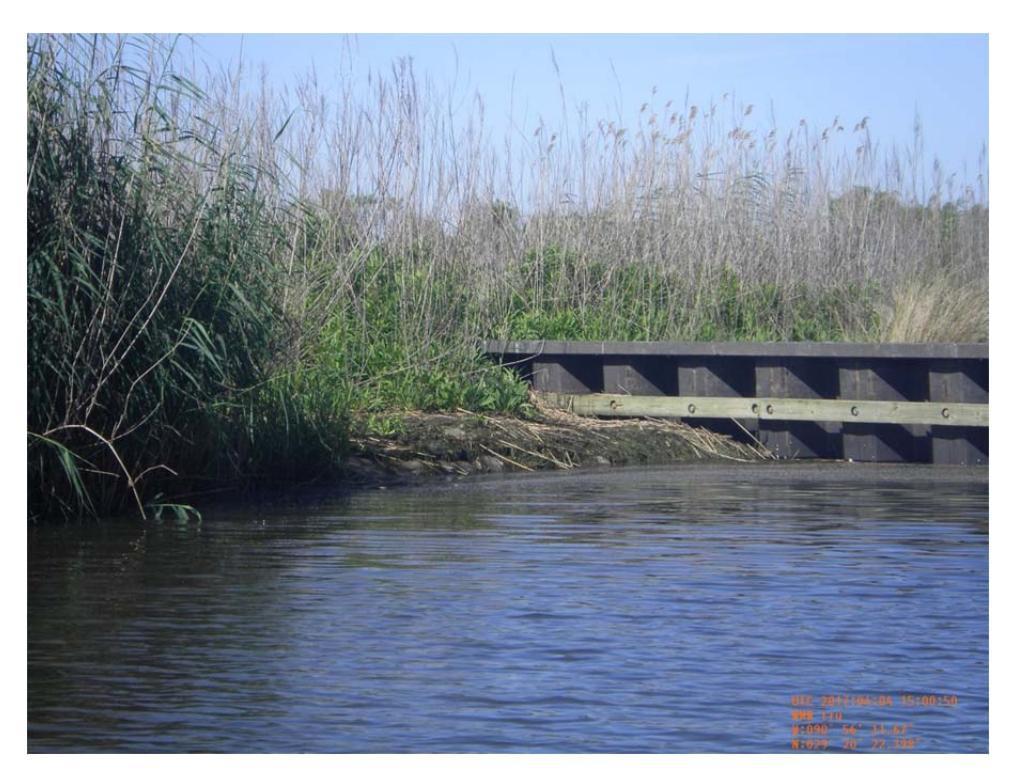
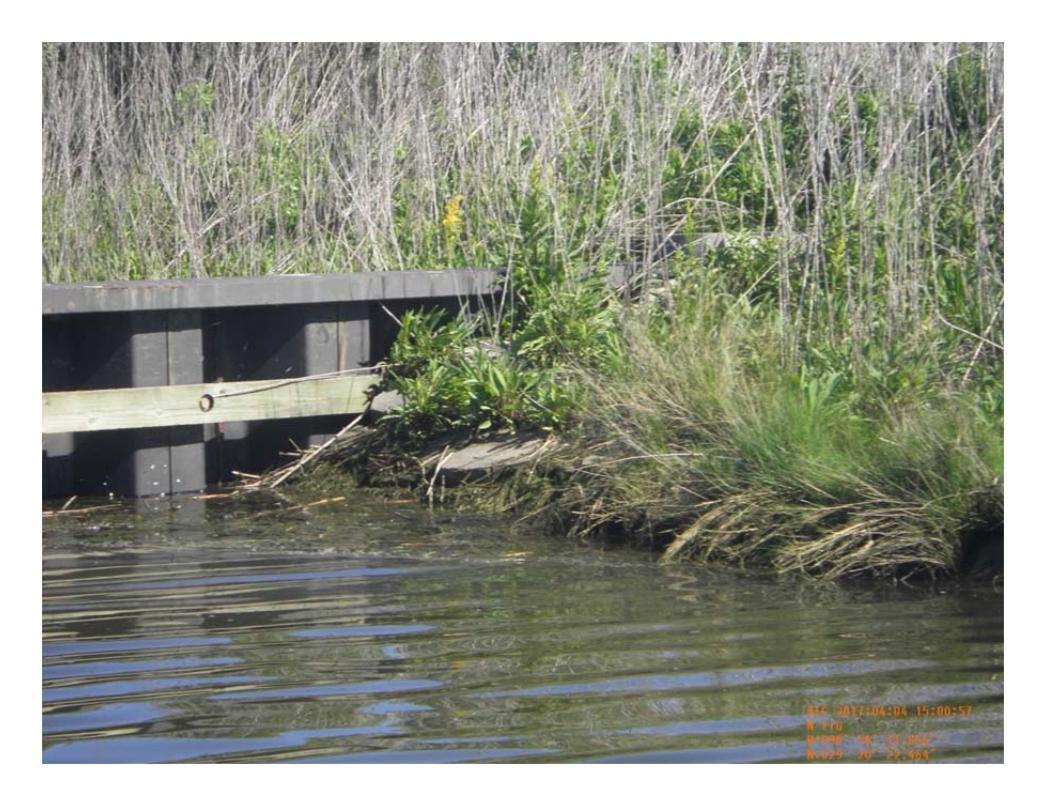
Overall, Sheet Pile Plug No. 3 appeared to be in good condition with no damage or corrosion of the steel sheetpile or channel cap. The bank tie-ins and articulated mats were also in good condition with no erosion or washouts present, and the warning signs on the structure were intact and visible. There are no recommendations for corrective action at this time. (Appendix B, Photos 9 through 10)

Photo No.9 – view of Sheetpile Plug No.3 between Fill Areas No.7 and No.8 looking north.

Photo No.10 – view of southwest bank tie-in along Sheetpile Plug No.3 between Fill Areas No.7 and No.8.

Photo No.11 – view of northeast bank tie-in along Sheetpile Plug No.3 between Fill Areas No.7 and No.8.

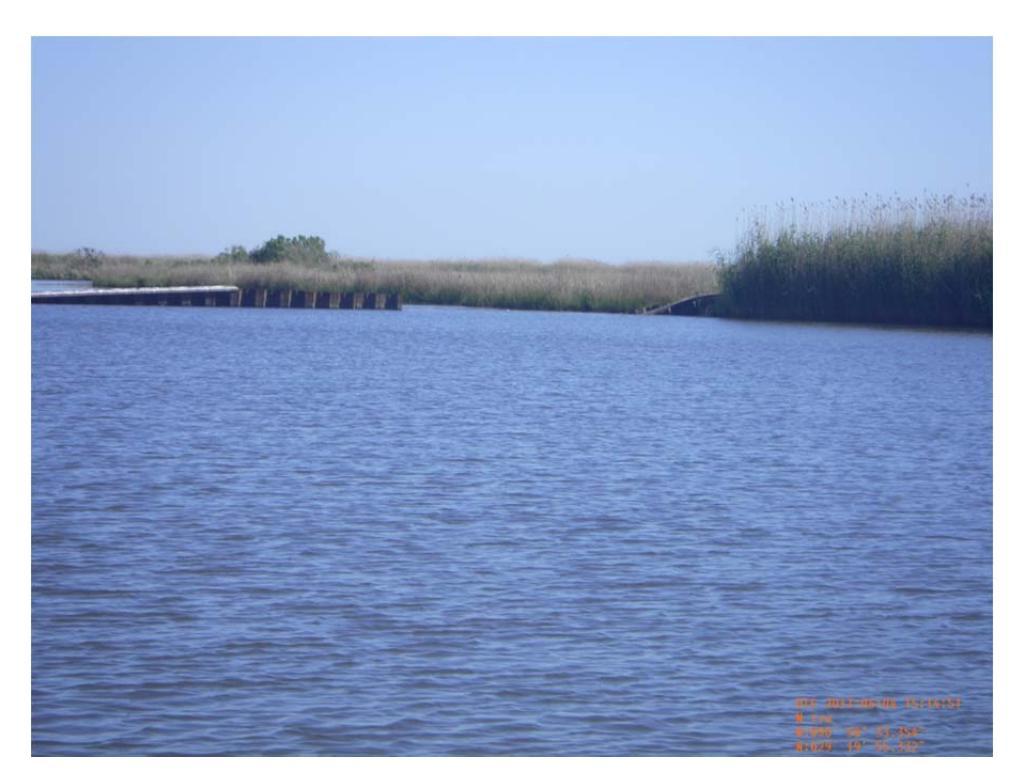
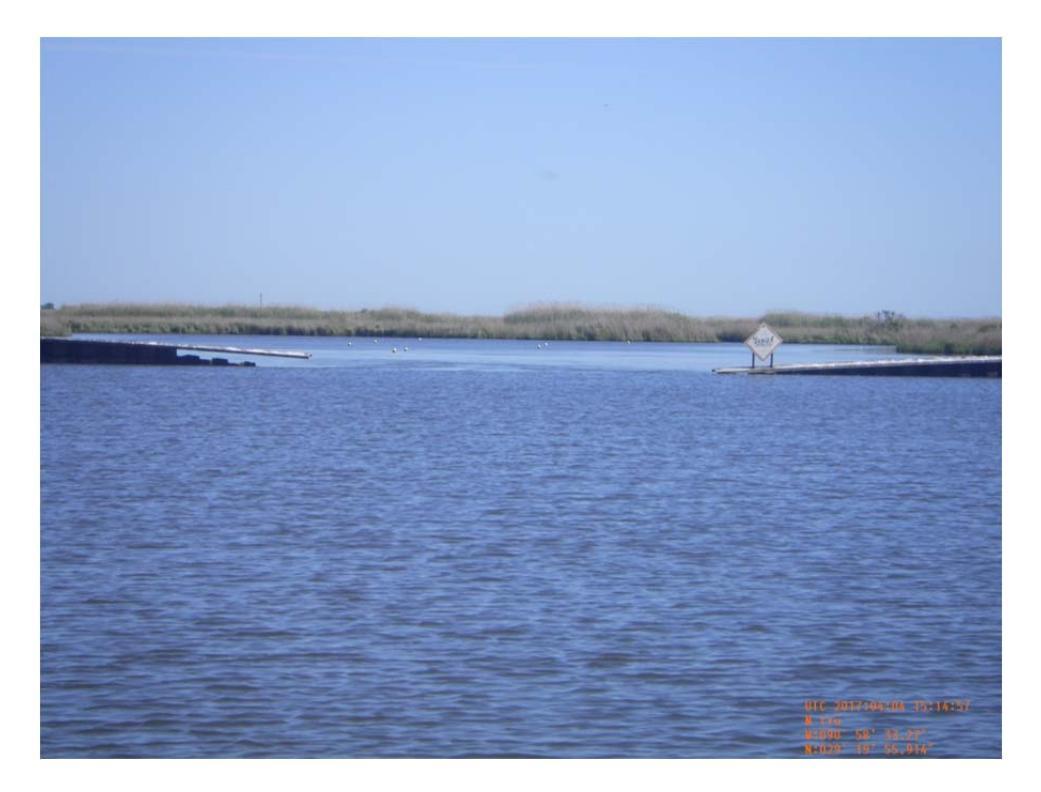
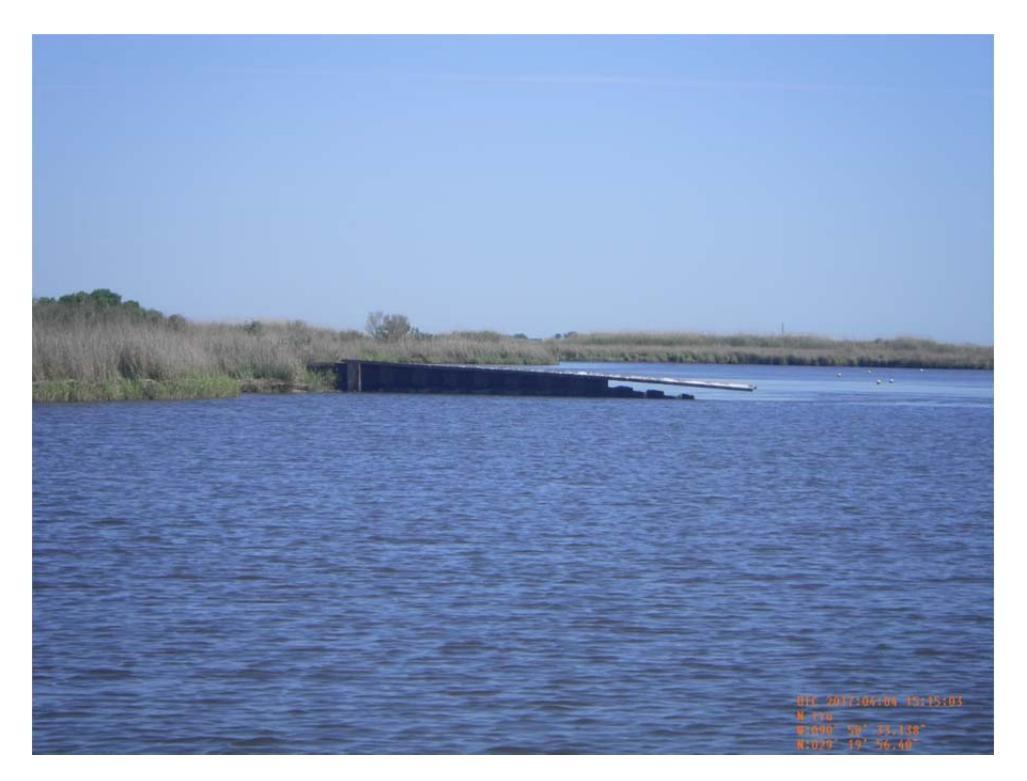
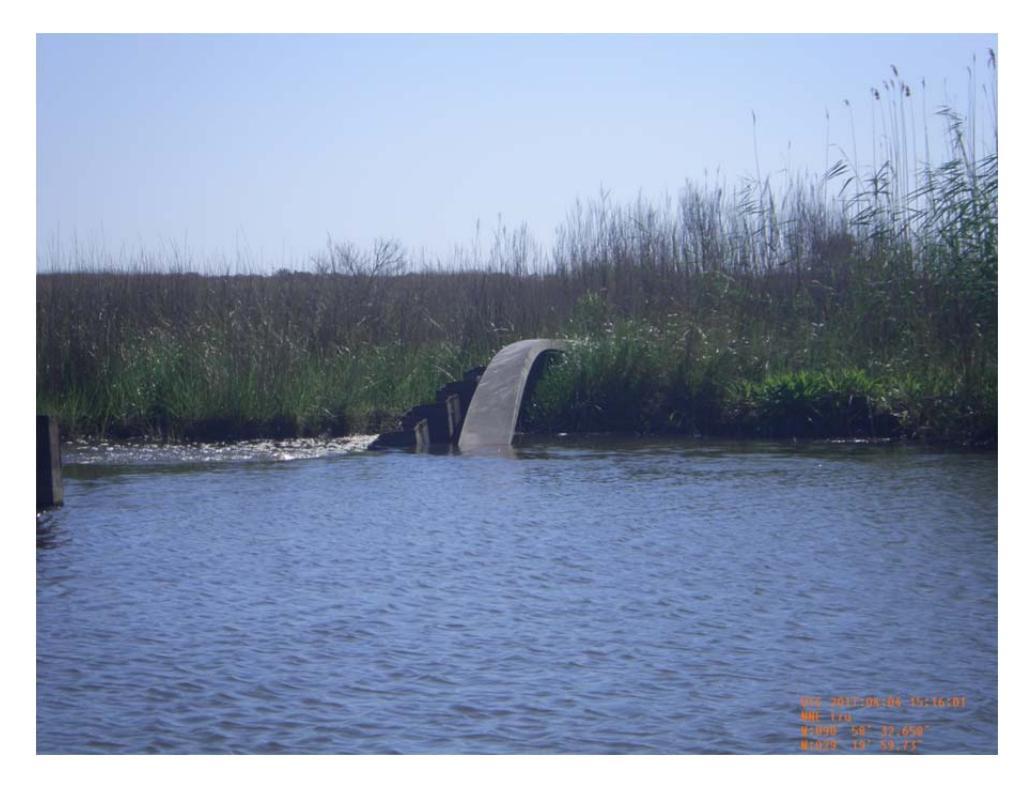
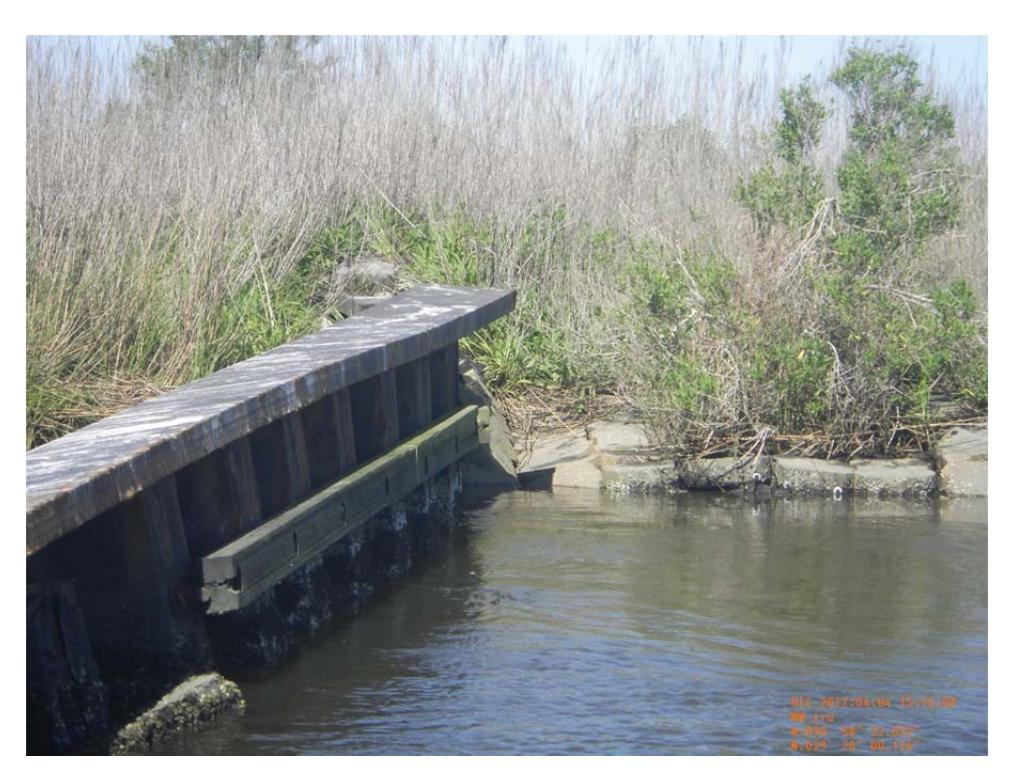
The Sheetpile Plug 2 suffered catastrophic structural damage due to Hurricane Isaac in August 2012. It appears that a large water level differential during the storm caused the bottom of the free standing wall to kick-out and the structure to fail. A large portion of the center section of the sheet pile wall has collapsed over into the channel allowing water to pass through/over the structure. The structure is damaged in such a way that there are minimal options for repairing the structure, it must be removed and then replaced. CPRA has initiated a claim with the Federal Emergency Management Agency (FEMA) as the structure was damaged during a natural disaster. In May 2015, FEMA had rejected CPRA's claim for funding the repair of the steel sheetpile structure. CPRA has appealed FEMA's decision and is currently awaiting a ruling on the appeal. Floating warning buoys and navigational lighting was recently installed on both sides of the structure to warn boaters of the obstruction across the channel. (Appendix B, Photos 12 through 16)

Photo No.12 – view of the east side of damaged Sheetpile Plug No. 2 between Lake Mechant and the intersection of the "Y' Canal.

Photo No.13 – view of the center section of damaged Sheetpile Plug No. 2 between Lake Mechant and the intersection of the "Y' Canal.

Photo No.14 – view of the west side of damaged Sheetpile Plug No. 2 between Lake Mechant and the intersection of the "Y' Canal.

Photo No.15 – closer view of the damage on the east side of Sheetpile Plug No. 2 near bank tiein.

Photo No.16 – closer view of the damage on the west side of Sheetpile Plug No. 2 near bank tiein.

fair to good overall condition. Regarding the FEMA claim for Sheetpile No.2, CPRA has filed an appeal to FEMA's initial ruling and is currently awaiting a decision from FEMA on the appeal. We will also continue to monitor the narrowing land at the bottom of the "Y" canal and any other areas of concern. It is anticipated that the first maintenance event to address all of the project deficiencies outlined in this report will occur once a final ruling on the FEMA claim is resolved and funding is in place for the replacement of Steel Sheetpile No.2.

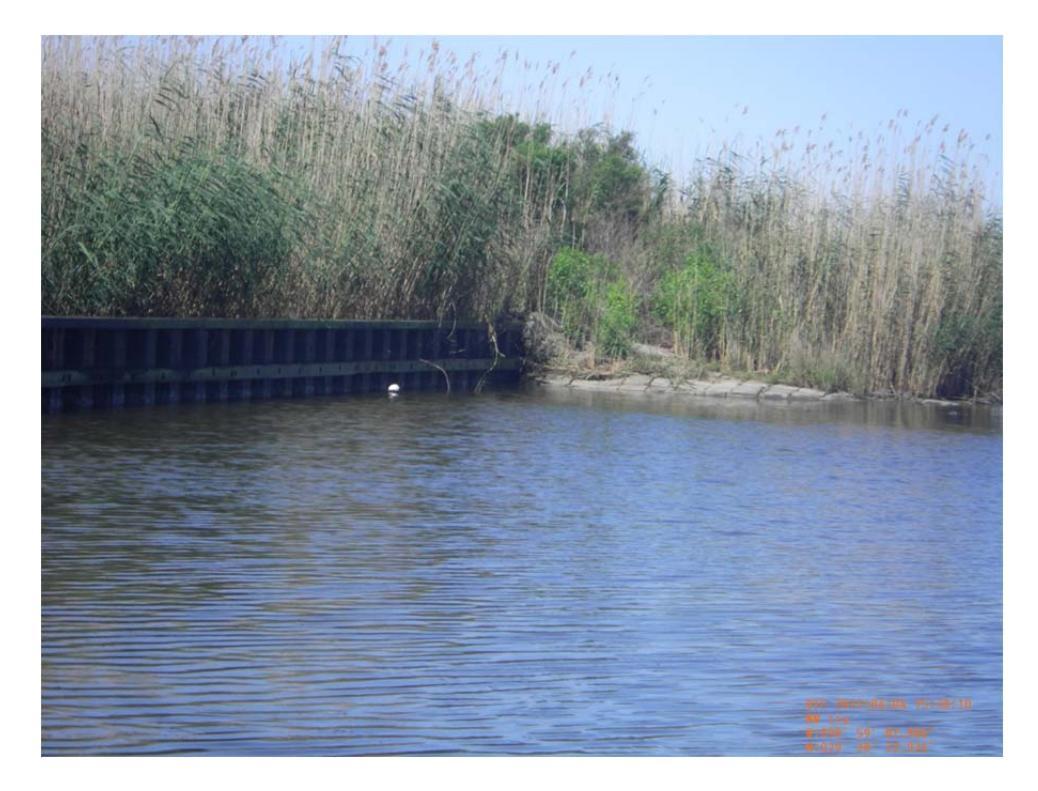
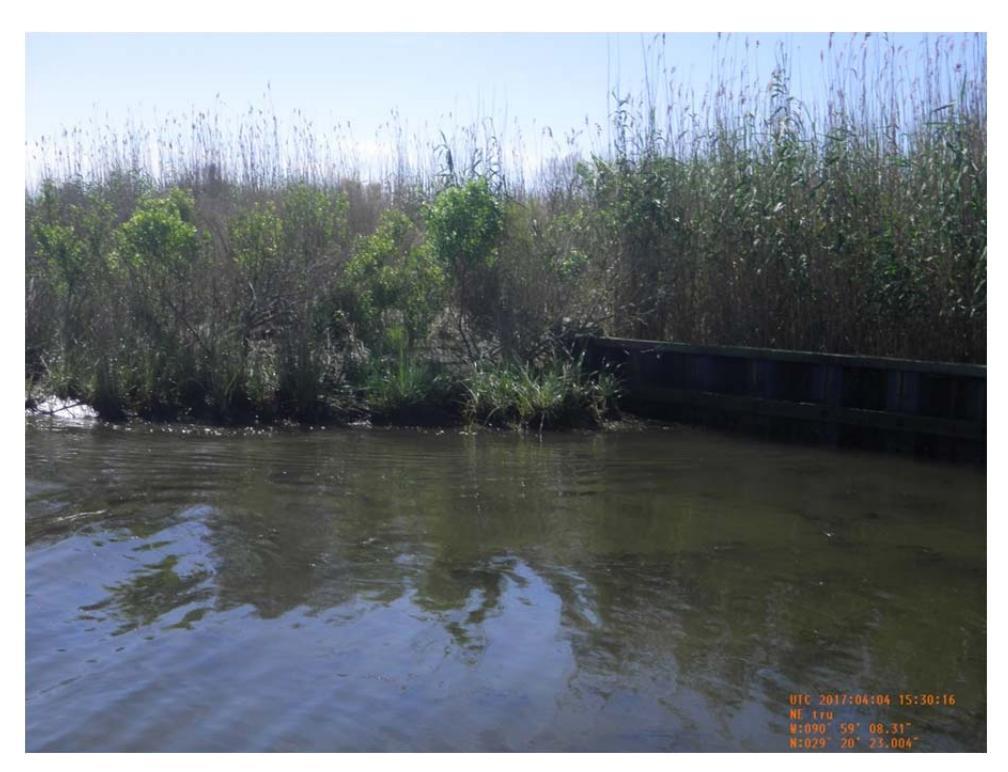
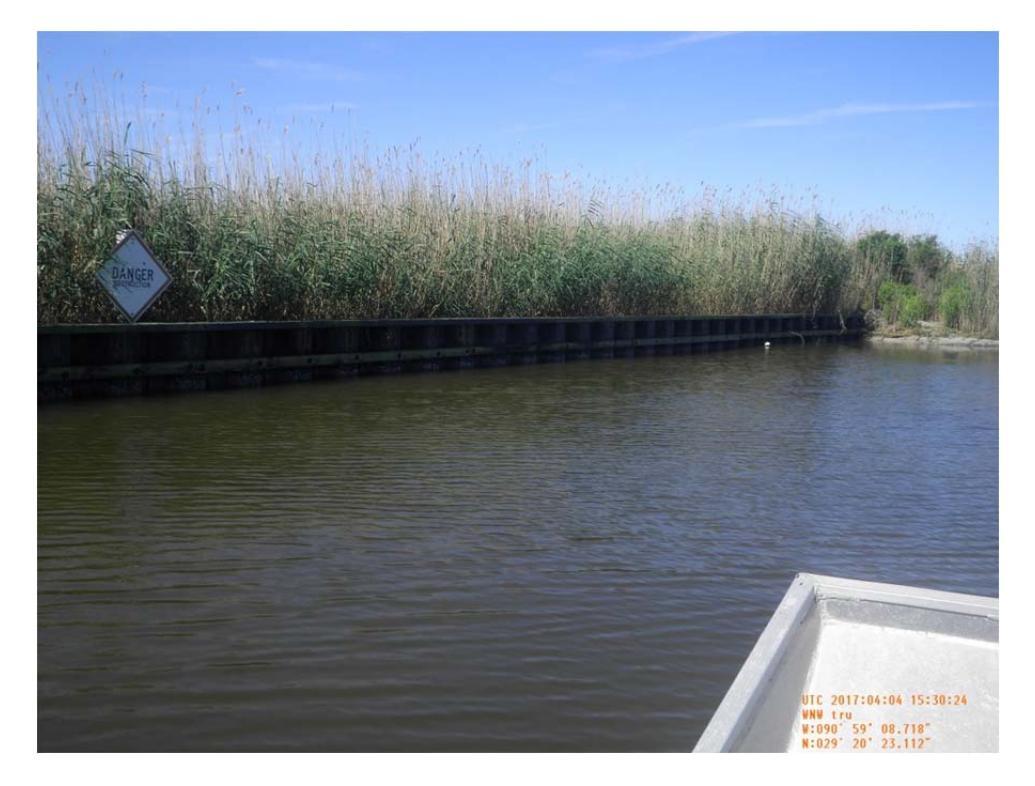
Sheet pile plug 1 is located along the south bank of the northwest reach of the "Y"Canal, just north of Lake Mechant. There are no signs of settlement or excessive corrosion of the sheet pile, cap, warning signs or supports. The embankment tie-ins are armored with articulated concrete mats and also show no signs of settlement or erosion around structure. The structure appears to be stable and functioning as intended. However, there is a breach in the bank on the western side that leads to a long canal. It is uncertain whether tidal exchange is present, the opening will be closely monitored. There are no recommendations for corrective actions at this time. (Appendix B, Photos 17 through 19)

Photo No.17 – view of west bank tie-in along Sheetpile Plug No.1 looking southwest.

Photo No.18 – view of east bank tie-in along Sheetpile Plug No.1 looking southeast.

Photo No.19 – view of Sheetpile Plug No.1 along northeast leg of the "Y" Canal.

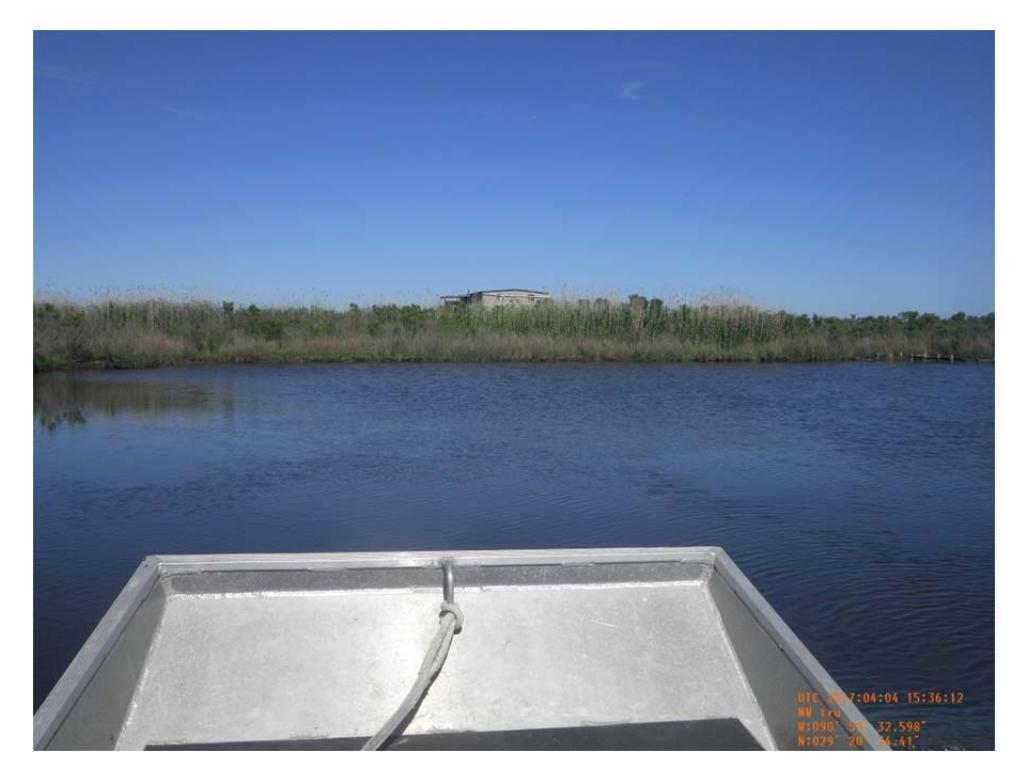
The Earthen Plug 1 structure located on the eastern edge of Lake Pagie appeared to be in good condition. The plug was viewed from the "Y" canal and was heavily vegetated with no signs of erosion or washouts of the bank tie-ins. There are no recommendations for corrective action at this time. (Appendix B, Photos 20)

Photo No.20 – view of Earthen Plug No.1 at the west end of the northeast leg of the "Y" Canal near Lake Pagie.

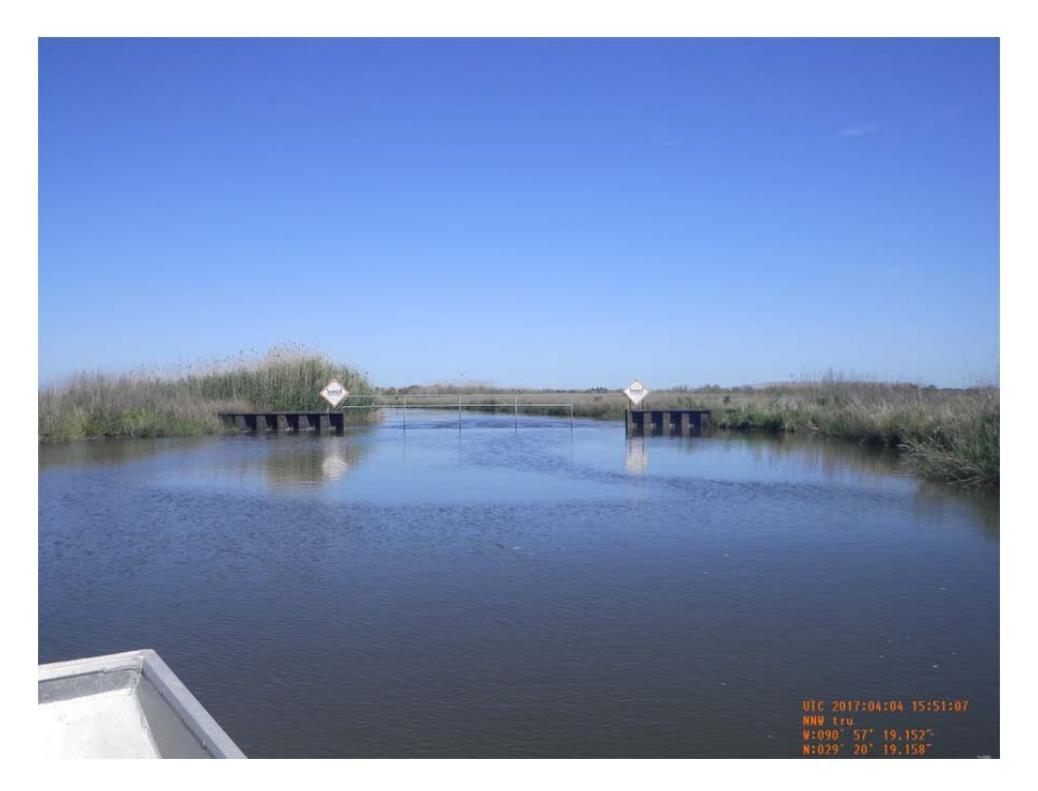
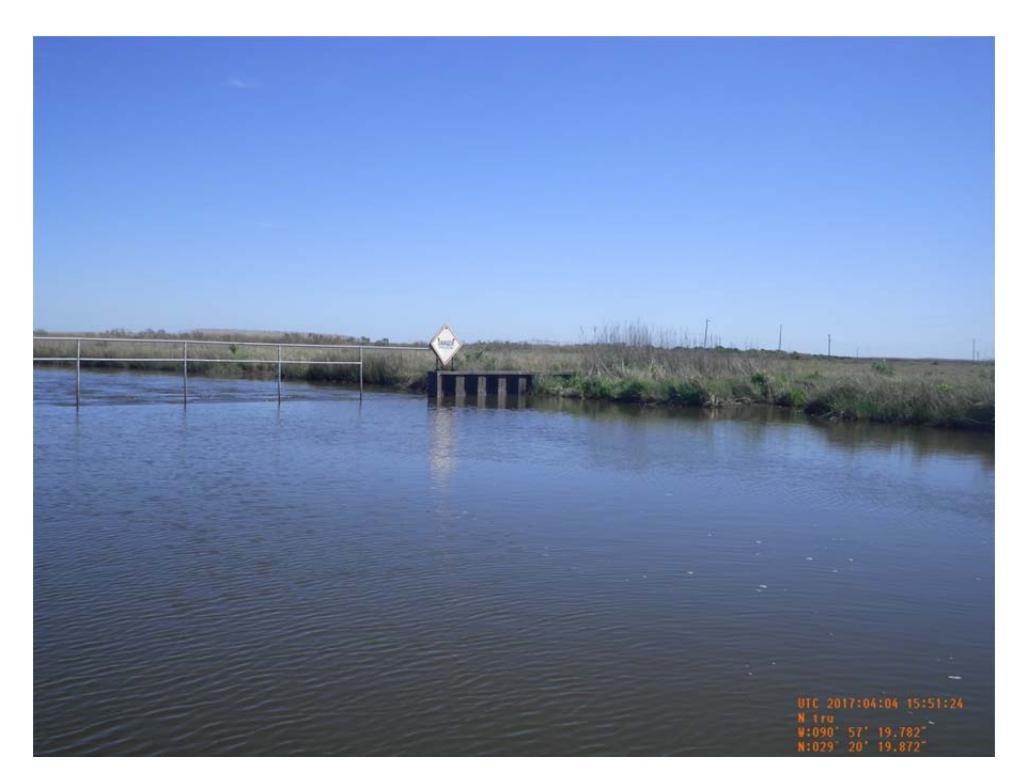
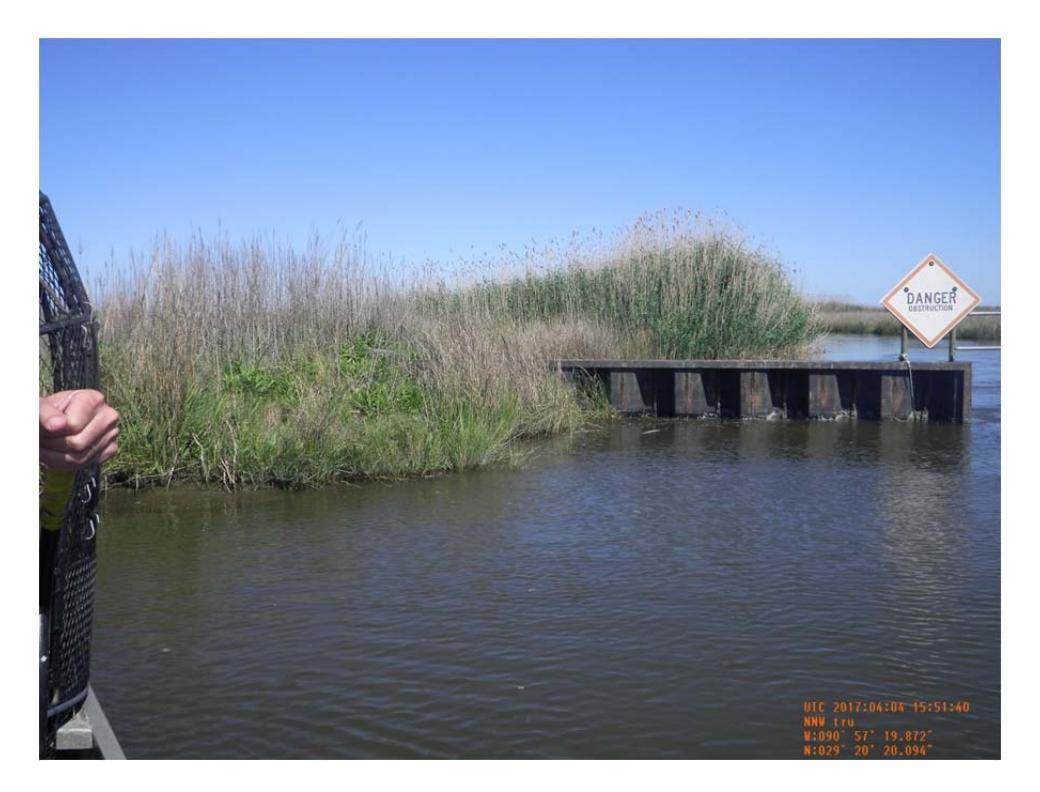
Overall, the sheetpile weir structure appears to be in good condition. There were no visual signs of corrosion or damage to the sheet pile or top channel cap. There doesn't appear to be any erosion or washouts around the embankment tie-ins as well. The warning signs and

supports are also in good condition. There are no recommendations for corrective action at this time. (Appendix B, Photos 21 through 23)

Photo No.21 – view of weir replacement structure across existing channel off of Bayou Raccourci.

Photo No.22 – view east bank of weir replacement structure across existing channel off of Bayou Raccourci.

Photo No.23 – view west bank of weir replacement structure across existing channel off of Bayou Raccourci.
