# **2017 Annual Inspection Report**

# North Lake Mechant Landbridge Restoration Project (TE-44)

State Project Number TE-44 Priority Project List 10

December 4, 2017 Terrebonne Parish

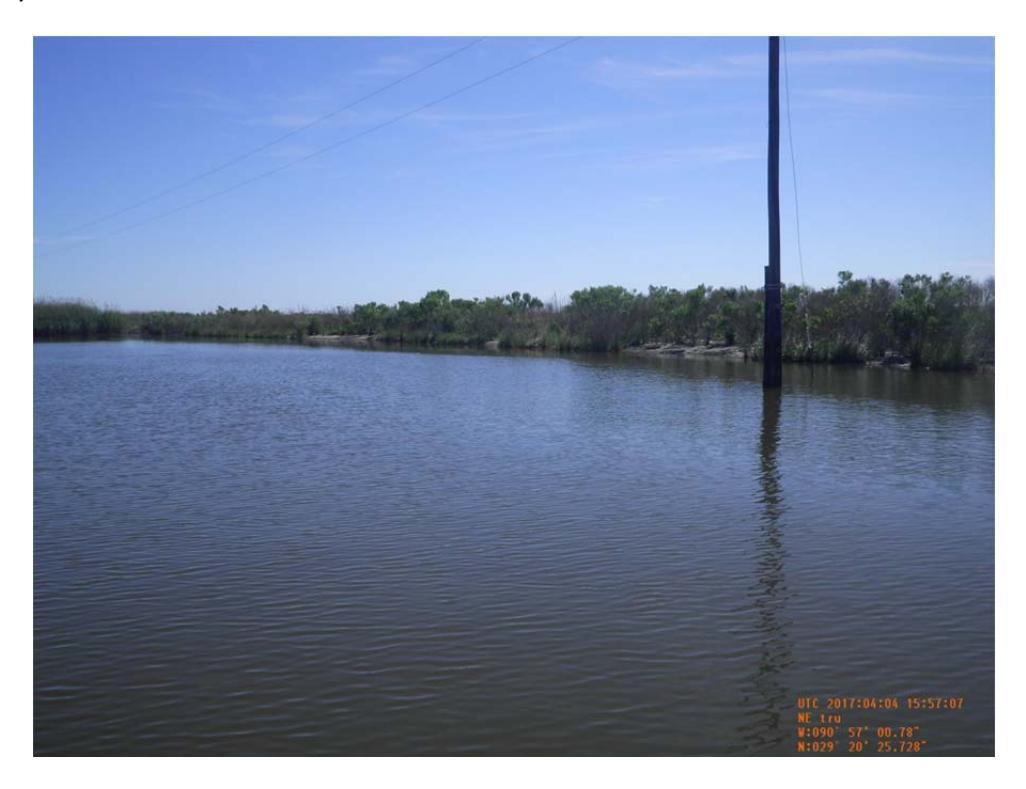
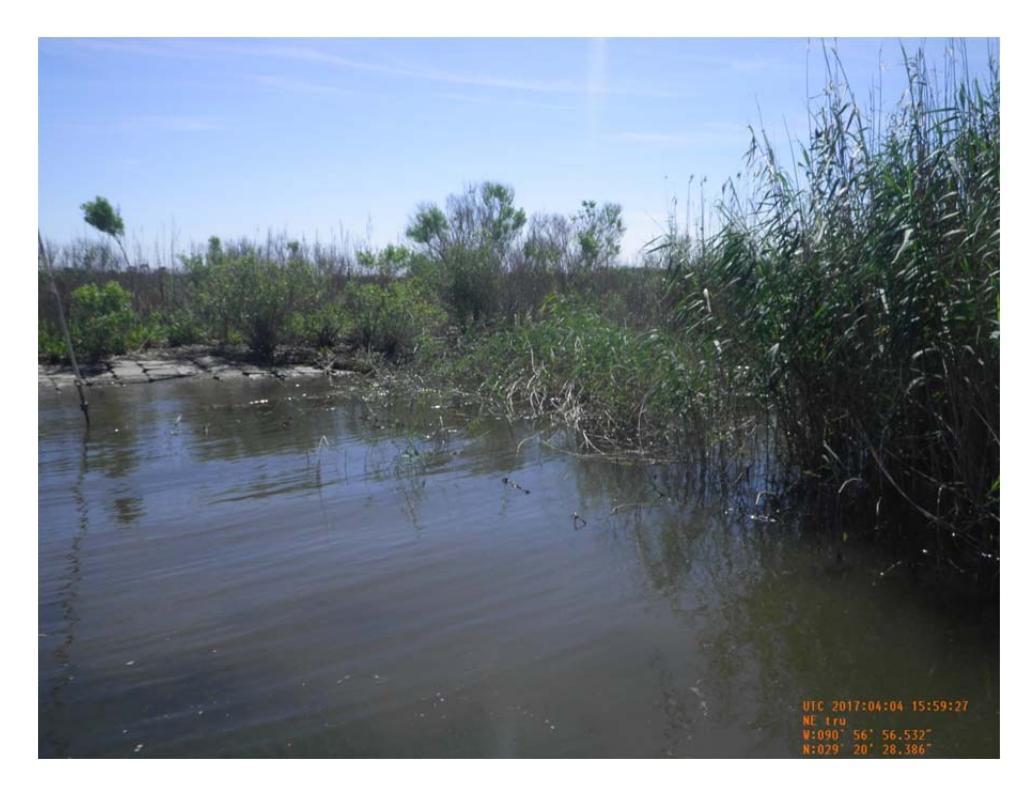
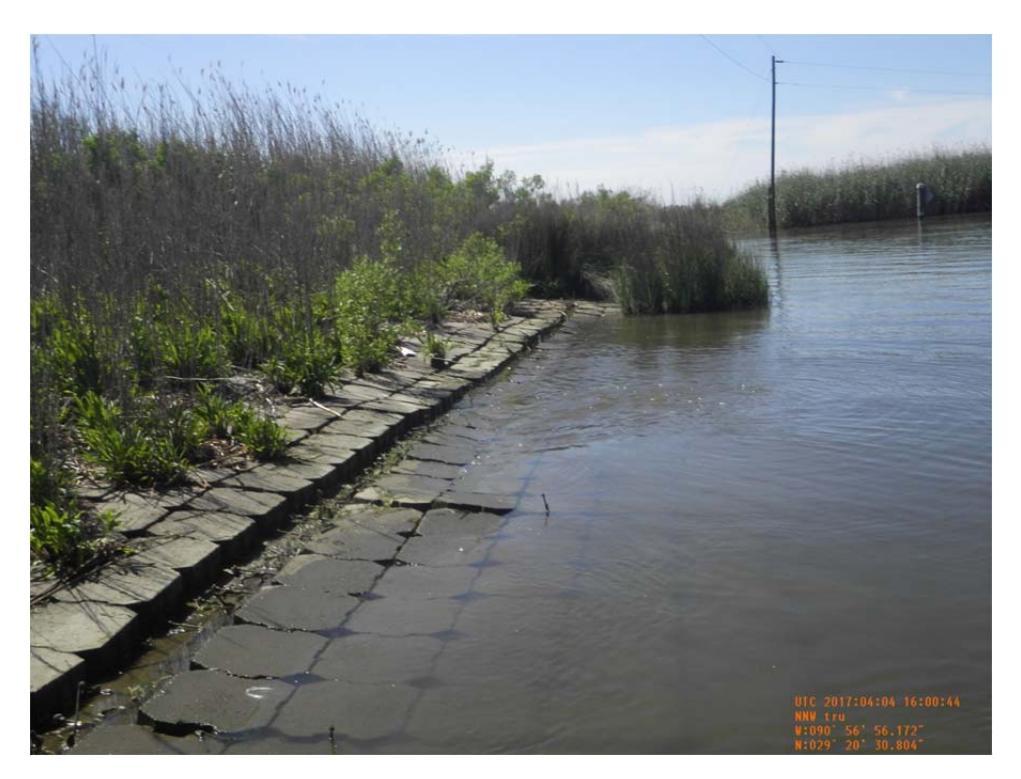
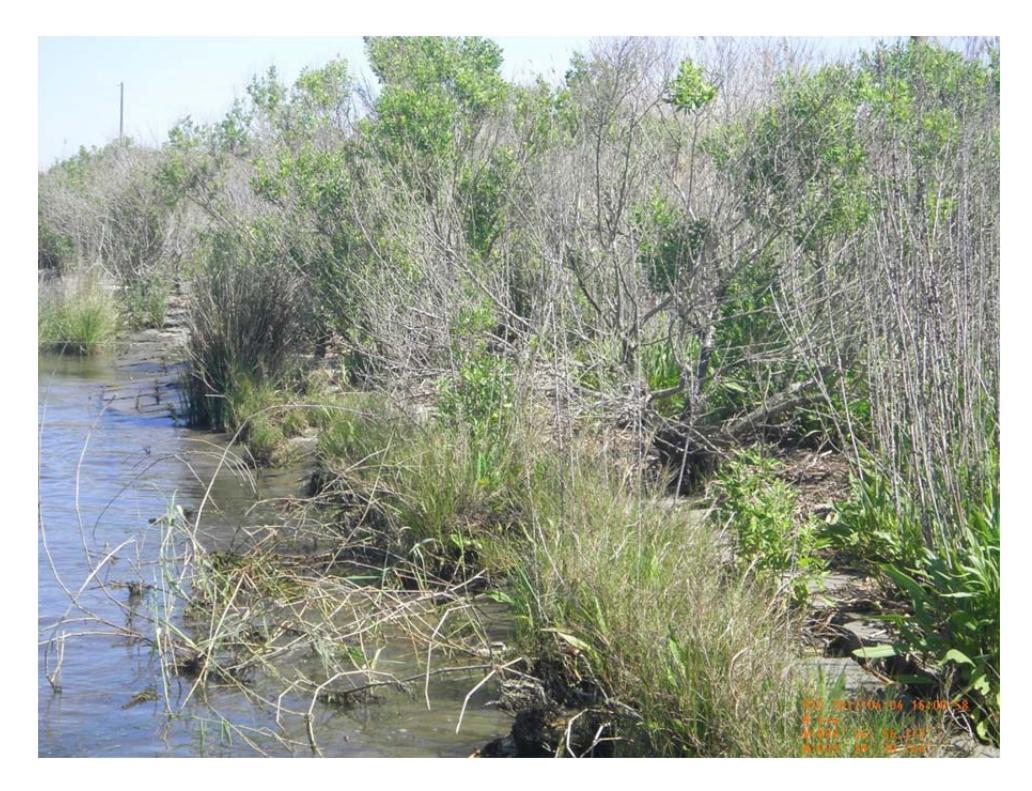
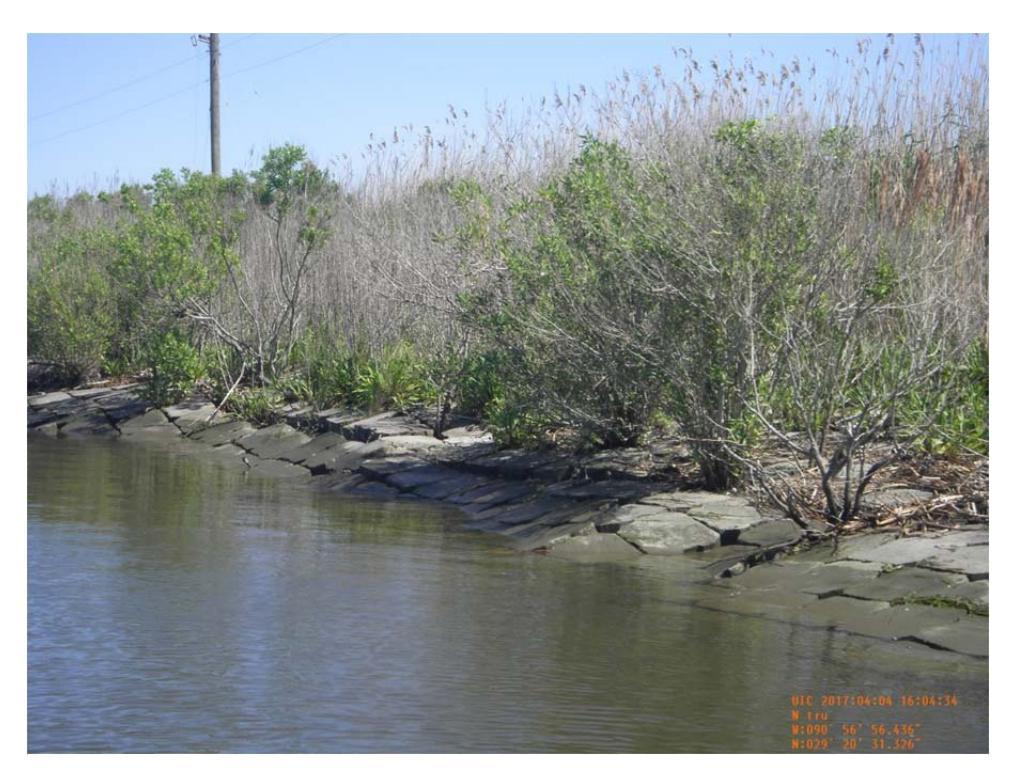
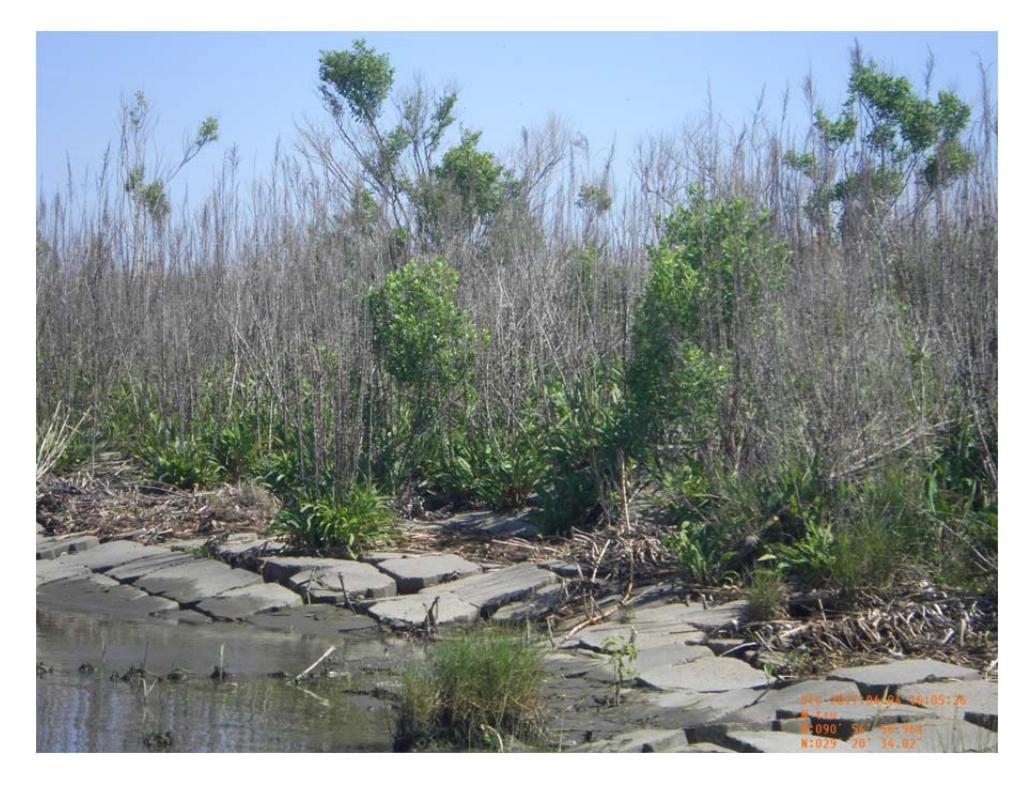
The Armored Earthen Dike on the west bank of Bayou Raccourci appears to be in fair condition. The articulated concrete blocks were coupled by copolymer rope and installed over a newly constructed earthen embankment. At the time of the inspection, the articulated mats were inundated with woody vegetation emerging through the gaps in the concrete blocks and in front of the mats. The woody vegetation that is growing through the mats raises some concerns regarding the stability of the rope as the trees/shrubs continue to grow. The vegetative growth will be monitored during future inspections. We also notice that isolated sections of the mat appeared to be sliding towards the channel creating a separation of the concrete blocks at several locations causing a strain on the copolymer rope. Also, there are some variations in height of the embankment along the length of the armored earthen dike. This is believed to be caused by differential settlement of the dredged material and the weight of the articulated mats. These areas of concern will be monitoring closely on future site visits to determine if corrective actions are needed. (Appendix B, Photos 24 through 29)

Photo No.24 – view of the articulated concrete mats on the east bank of Bayou Raccourci.

Photo No.25 – view of the articulated concrete mats on the east bank of Bayou Raccourci.

Photo No.26 – view of the gap in concrete blocks of the articulated concrete mats on the east bank of Bayou Raccourci.

Photo No.27 – view of the articulated concrete mats on the east bank of Bayou Raccourci.

Photo No.28 – view of the articulated concrete mats on the east bank of Bayou Raccourci.

Photo No.29 - view of the articulated concrete mats on the east bank of Bayou Raccourci.

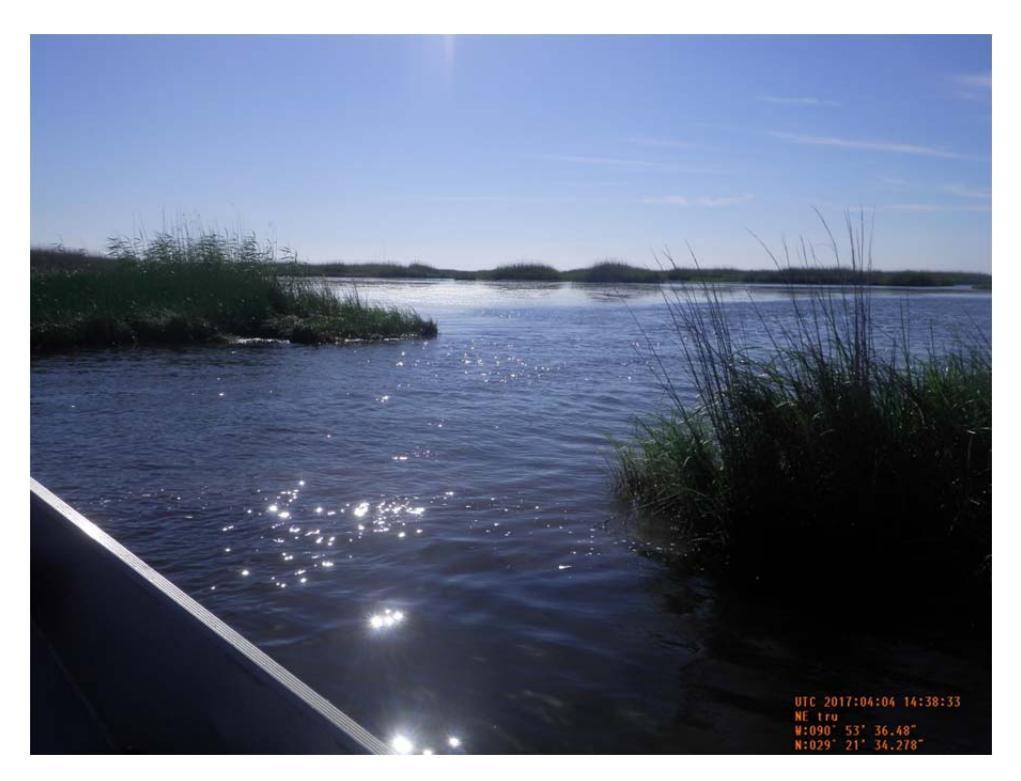
The Earthen Plug 2 structure located along the south bank of Small Bayou LaPointe Ridge appeared to be in good condition. However, we did notice a breach in south bank of ridge embankment east of Plug No.2 which was approximately 25 ft. wide. This breach was not present at the time that the project was constructed and may need to be repaired during the next scheduled maintenance event. We will continue to monitor this breach on future site visits. (Appendix B, Photos 30)

Photo No. 30 - breach in south bank of Small Bayou LaPointe Ridge east of Earthen Plug No.2.
