State of Louisiana Coastal Protection and Restoration Authority

2016 Annual Inspection Report

West Lake Boudreaux Shoreline Protection and Marsh Creation Project (TE-46)

April 15, 2016 Terrebonne Parish

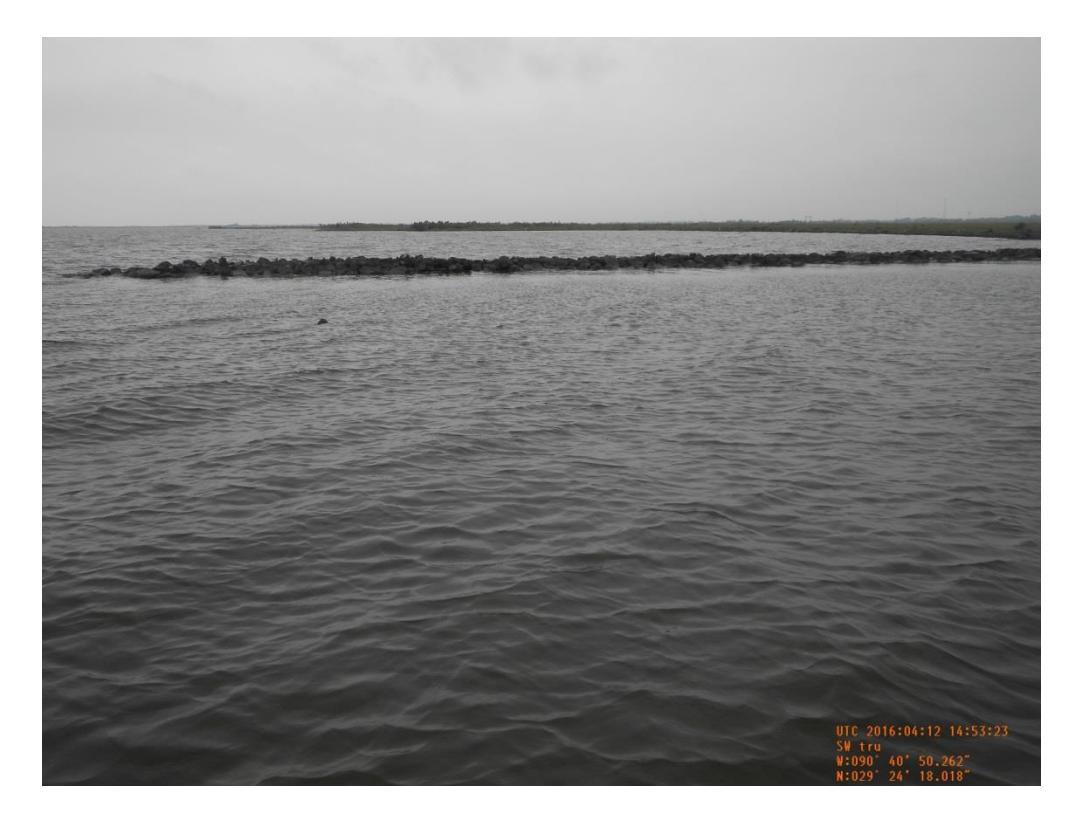
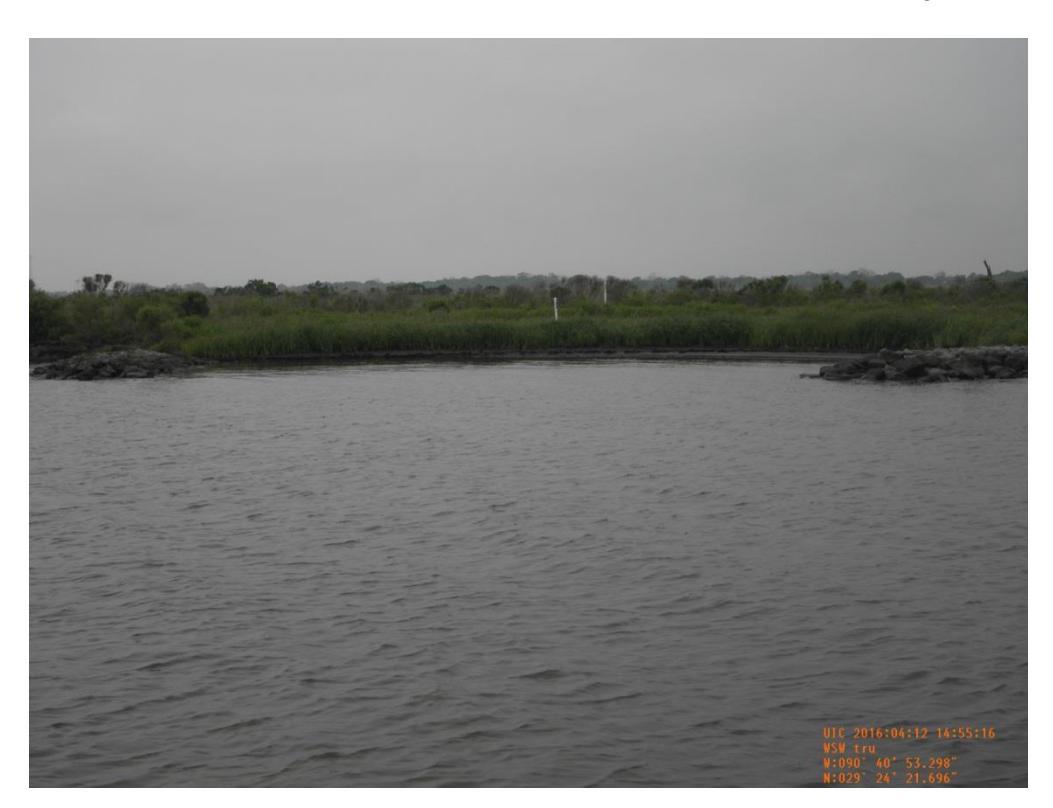
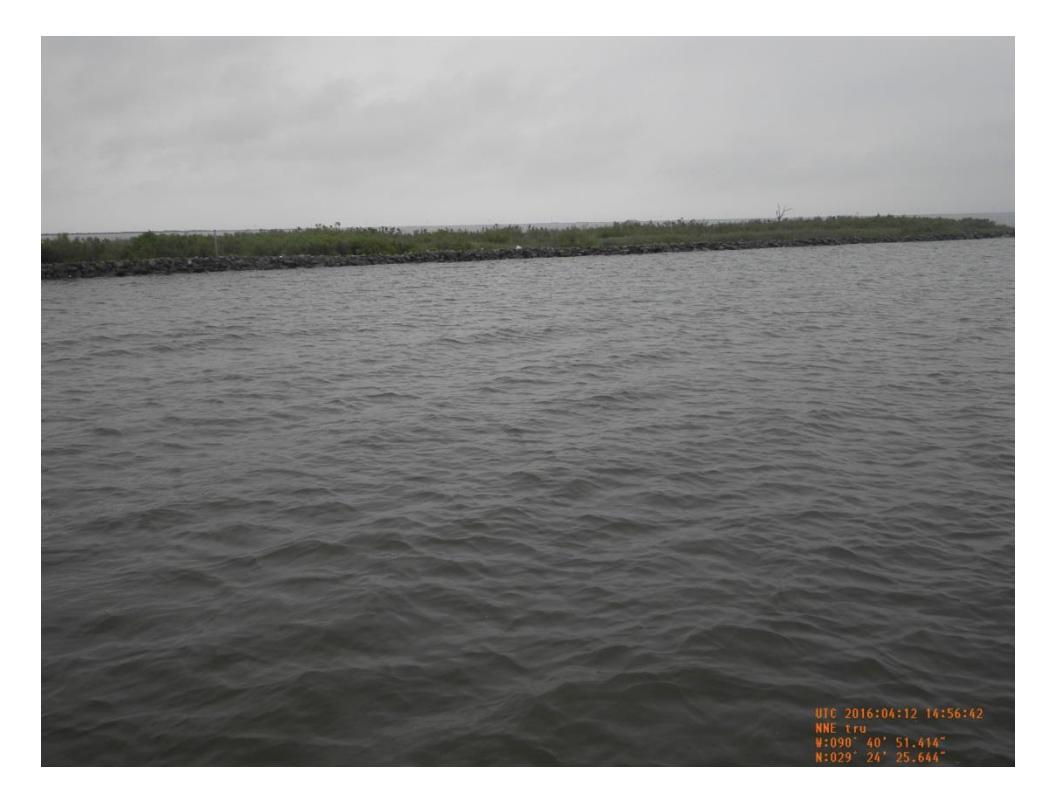
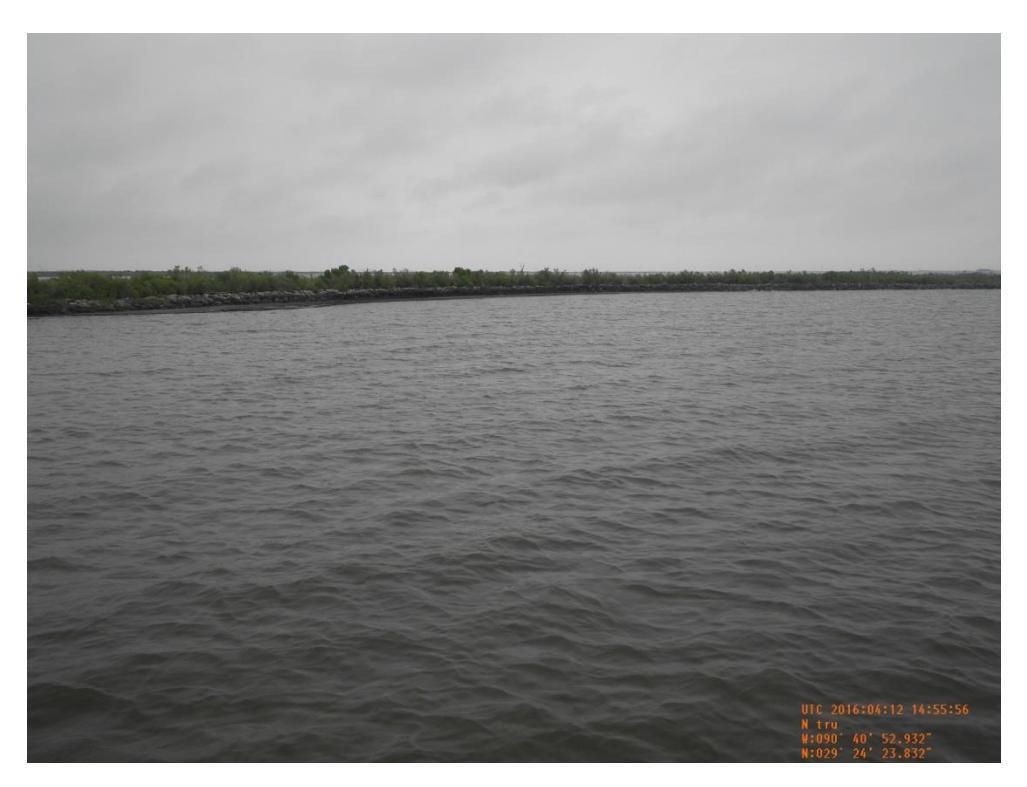
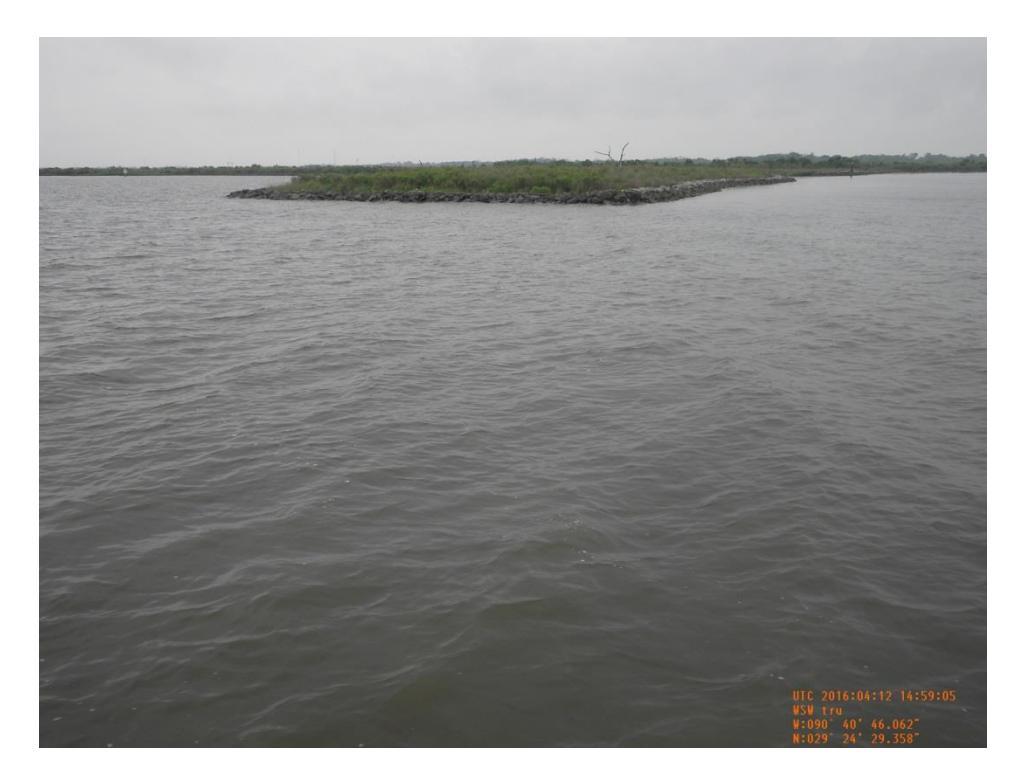
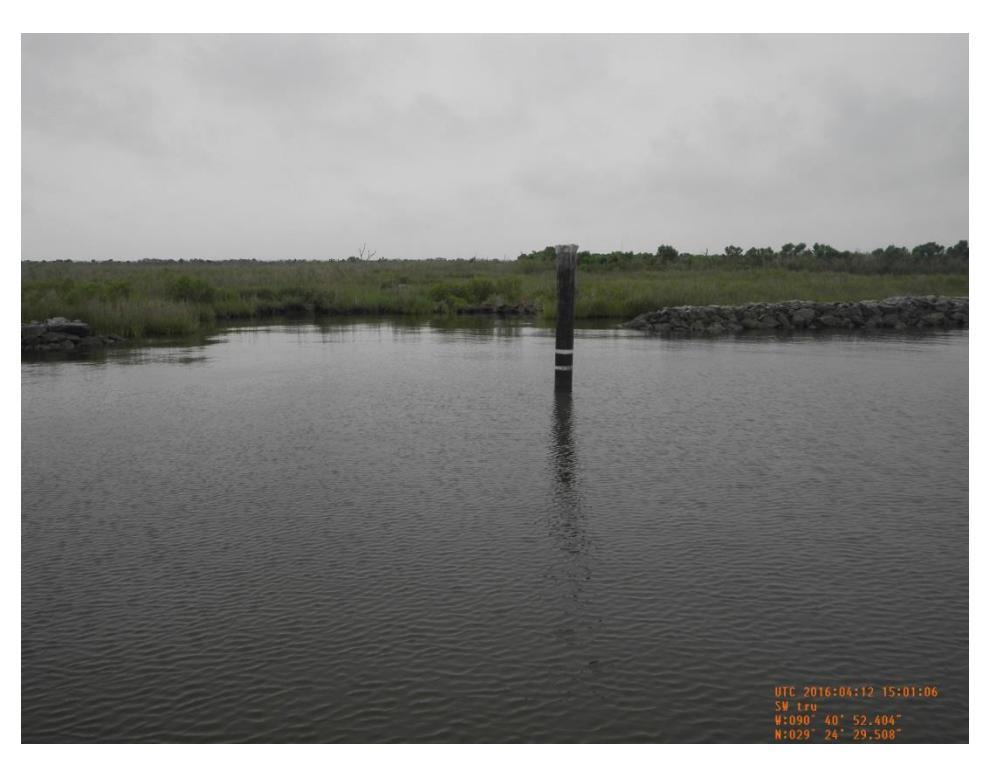
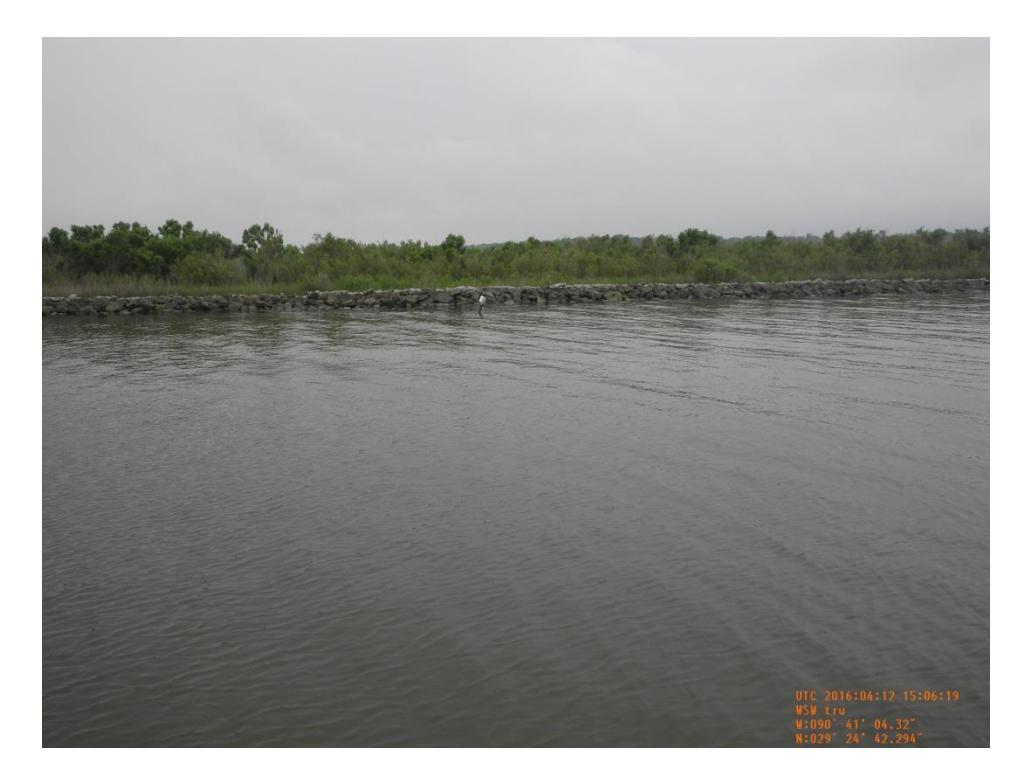
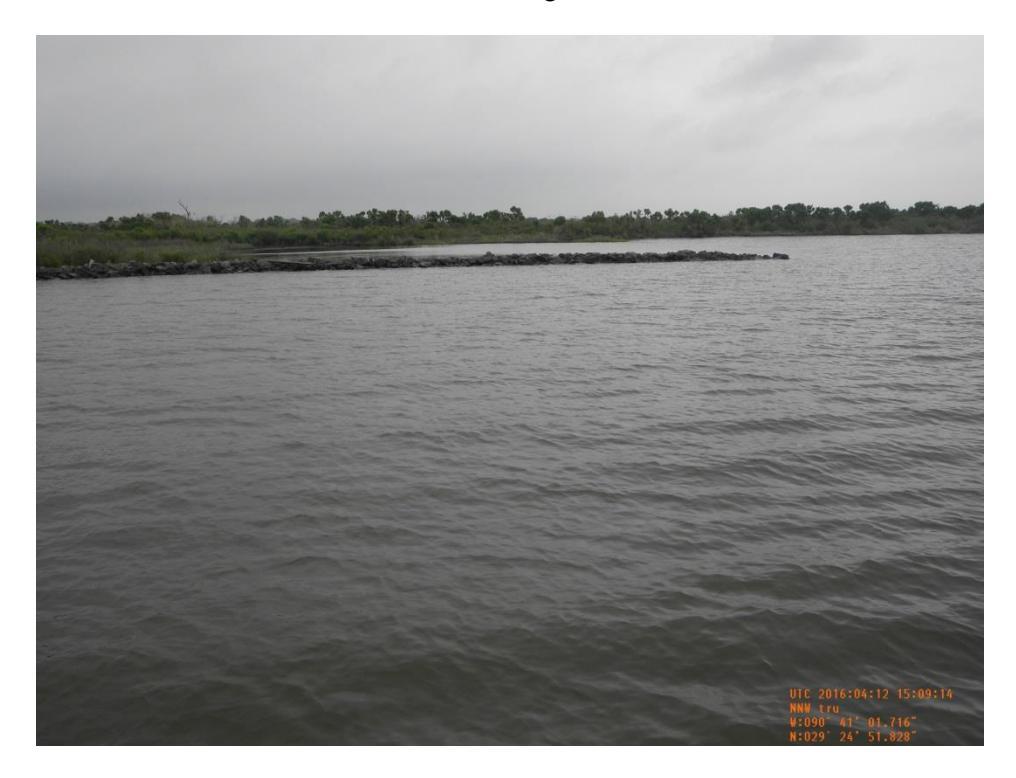
The southern segment of the rock dike appeared to be in good condition. There are no signs of settlement along the rock dike; the elevation is consistent throughout the entire length of the structure. All of the warning signs along this segment are visible and appear to be in good condition. On the southern end of the structure, the adjacent marsh shoreline has eroded significantly since the time of construction. This has caused the southern end of the rock dike to protrude approximately 150 feet into the lake. There are no recommendations for maintenance at this time, but this area will continue to be monitored on future inspections to determine if any corrective actions need to be made. (See Appendix B, Photos 1 through 8)

Photo 1: View of the southernmost end of the foreshore rock dike, looking west

Photo 2: View of access corridor for Gulf South pipeline in foreshore rock dike, looking west

Photo 3: View of the foreshore rock dike near the south end of the marsh creation southern section, looking north

Photo 4: View of the foreshore rock dike near the south end of the marsh creation southern section, looking north

Photo 5: View of the foreshore rock dike near the south end of the marsh creation southern section, looking west

Photo 6: View of the fish dip near the south end of the marsh creation southern section, looking south

Photo 7: View of the foreshore rock dike along the southern section of marsh creation

Photo 8: View of the foreshore rock dike along the southern section of marsh creation near the no work

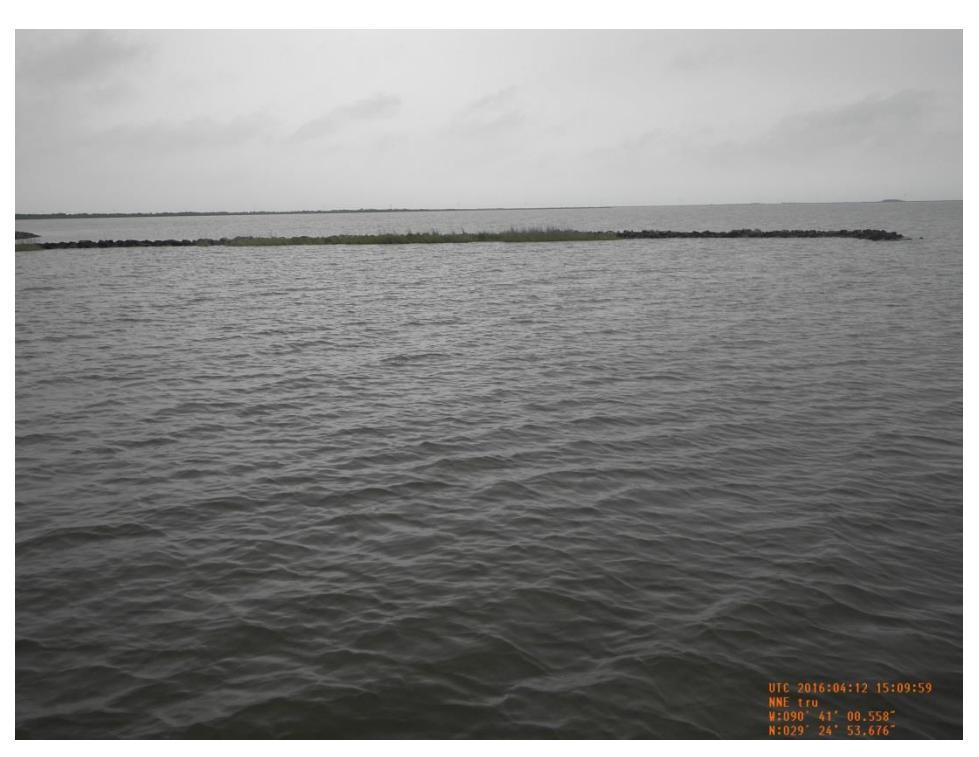
The central segment of the foreshore rock dike also appeared to be in good condition. There are no signs of settlement along the rock dike; the elevation is consistent throughout the entire length of the structure. There are no recommendations for maintenance at this time. (See Appendix B, Photo 10)

Photo 10: View of the south end of the central section foreshore rock dike, looking north

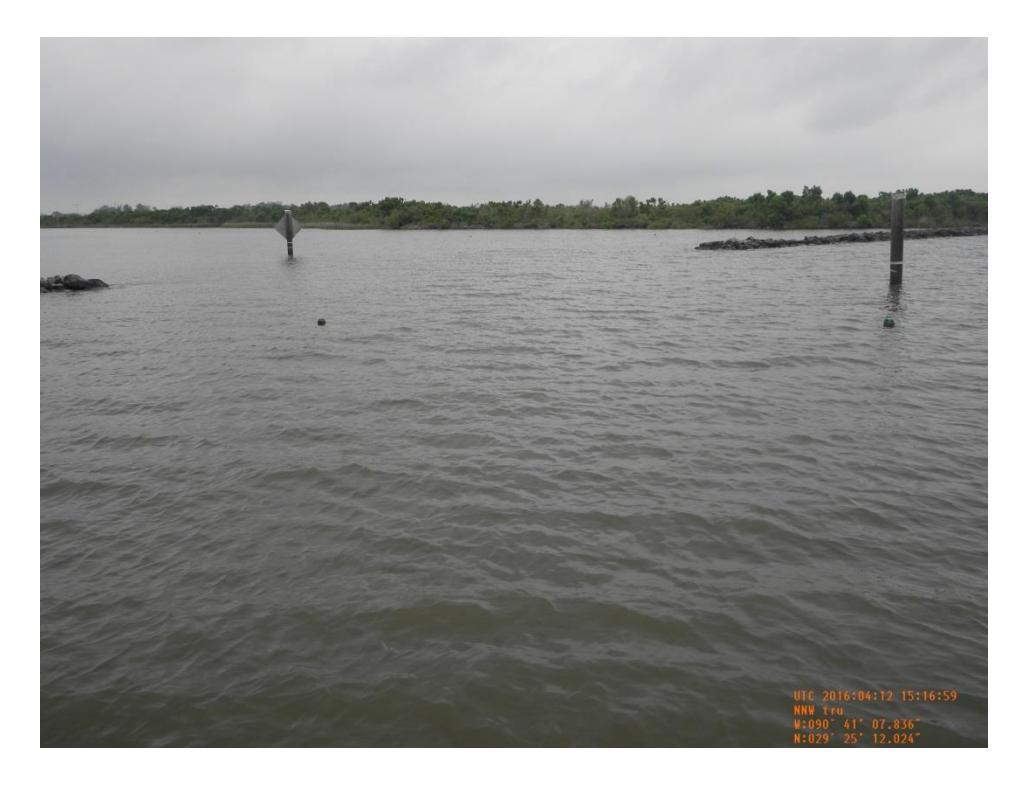
The choke down section of the foreshore rock dike could not be observed during the annual inspection as it is submerged under the waterline. The warning sign on the Lake Boudreaux side of the choke down section is still missing, as noted in the previous reports. The timber piling support is still in its location and in good condition, but the sign itself is no longer there. It is recommended that this sign be replaced to notify boaters coming from the lake of the navigational hazard posed by the choke down section. (See Appendix B, Photos 11 through 12)

Photo 11: View of the choke down section in the foreshore rock dike, looking west

All of the structures to be maintained in the TE-46 West Lake Boudreaux Shoreline Protection and Marsh Creation Project are in good condition. The foreshore rock dike segments remain at a consistent elevation with no evidence of settlement or displacement of the rock. From a visual inspection, these structures appear to have fared well since the end of construction. There was some erosion noticed on the northernmost and southernmost ends of the foreshore rock dike. The erosion in these areas do not seem to have increased significantly previous reports, not to the magnitude that would prevent the structure from operating as designed or require corrective actions. The earthen plug on the north side of the project area continues to be well vegetated with no observed settlement or erosion of the plug. The subaquatic choke down section appears to be in good shape from what was visible from above the waterline. The only deficiency found during this year's annual inspection was the fore mentioned warning sign on the lake side of the choke down section. As noted in previous inspections, it is recommended that this sign be replaced as it is the only indicator of the submerged structure for vessels traveling in that direction. There are no other recommendations for maintenance at this time.

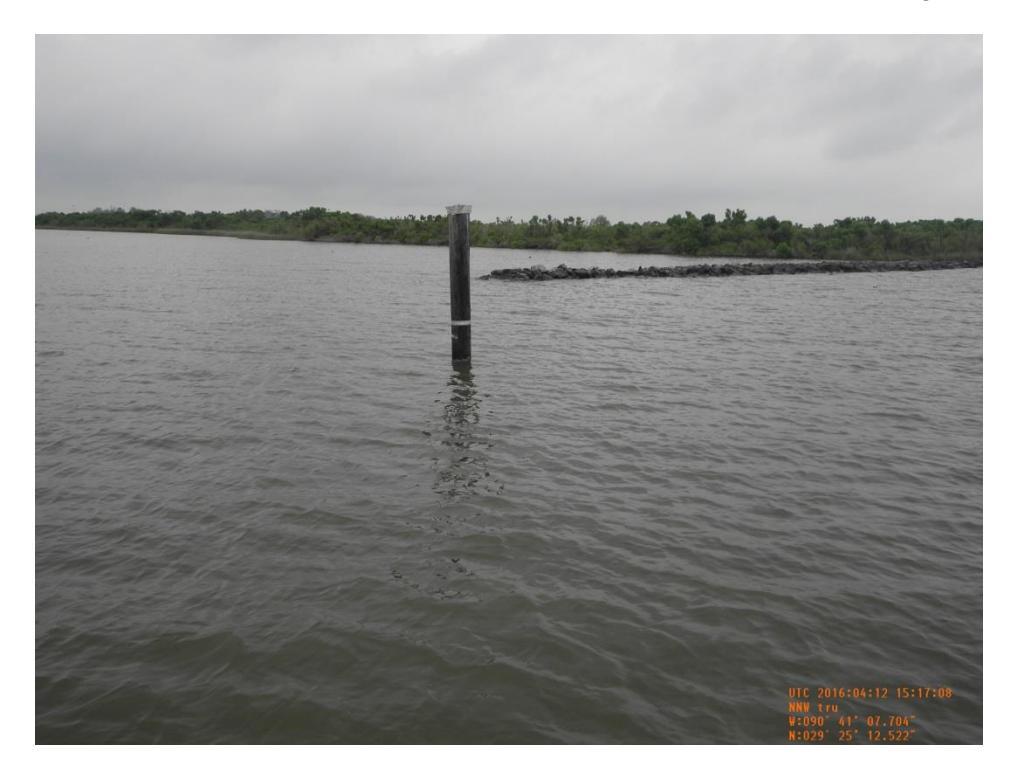
Photo 12: The warning sign on the lake side of the choke down section is missing form its support.

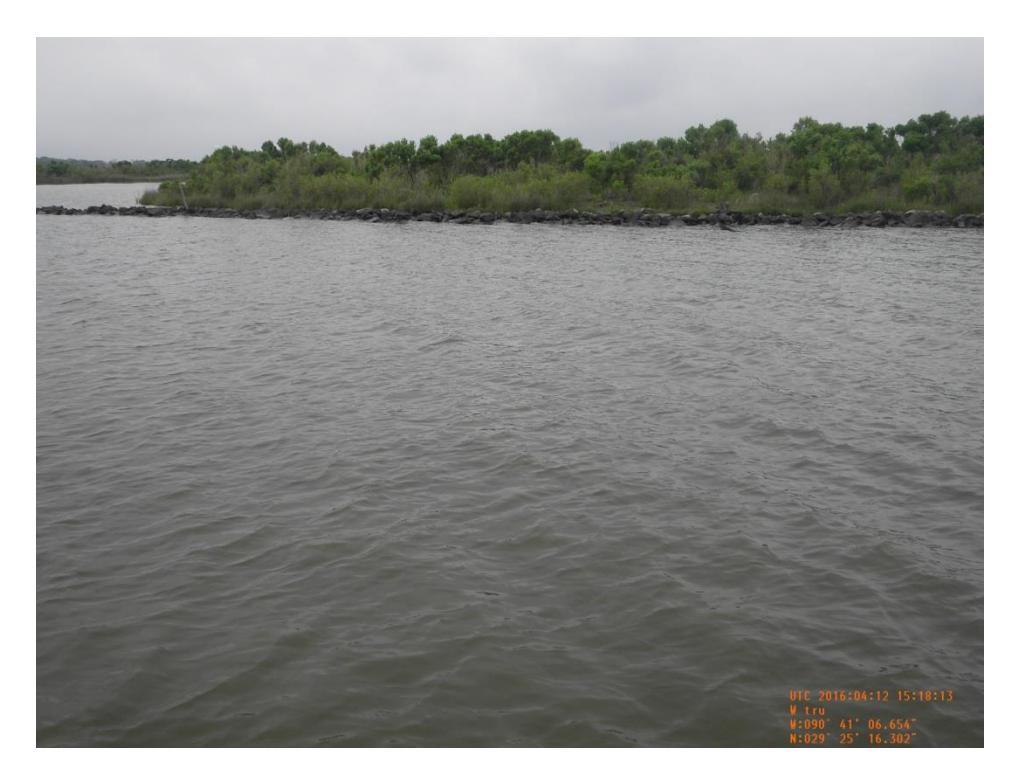
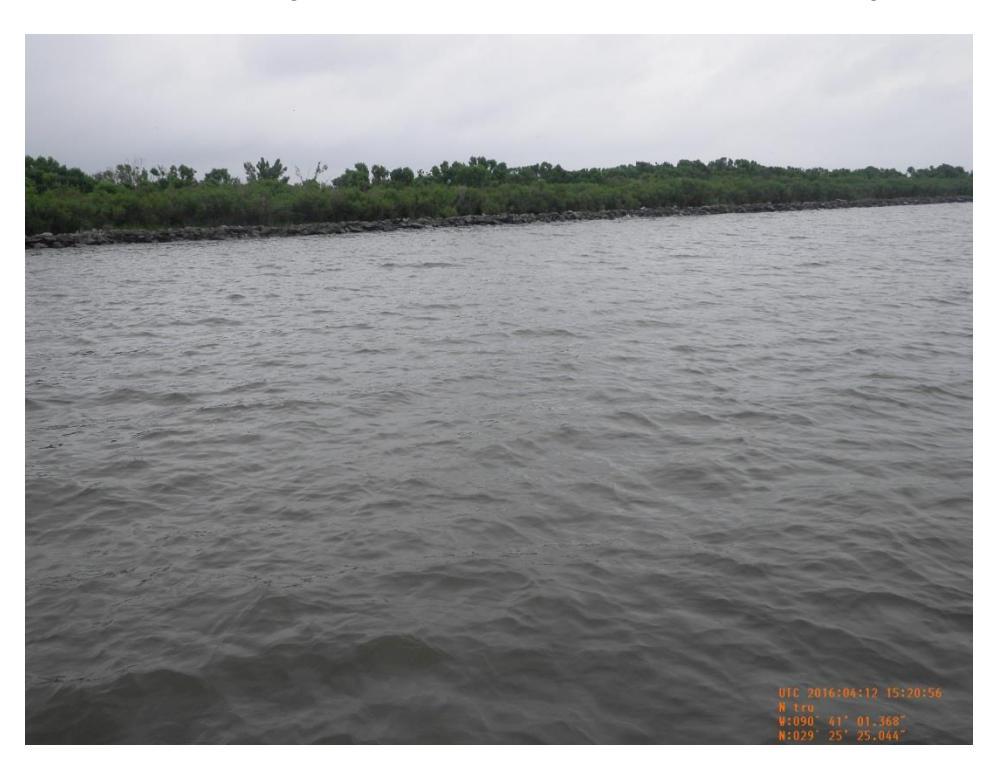
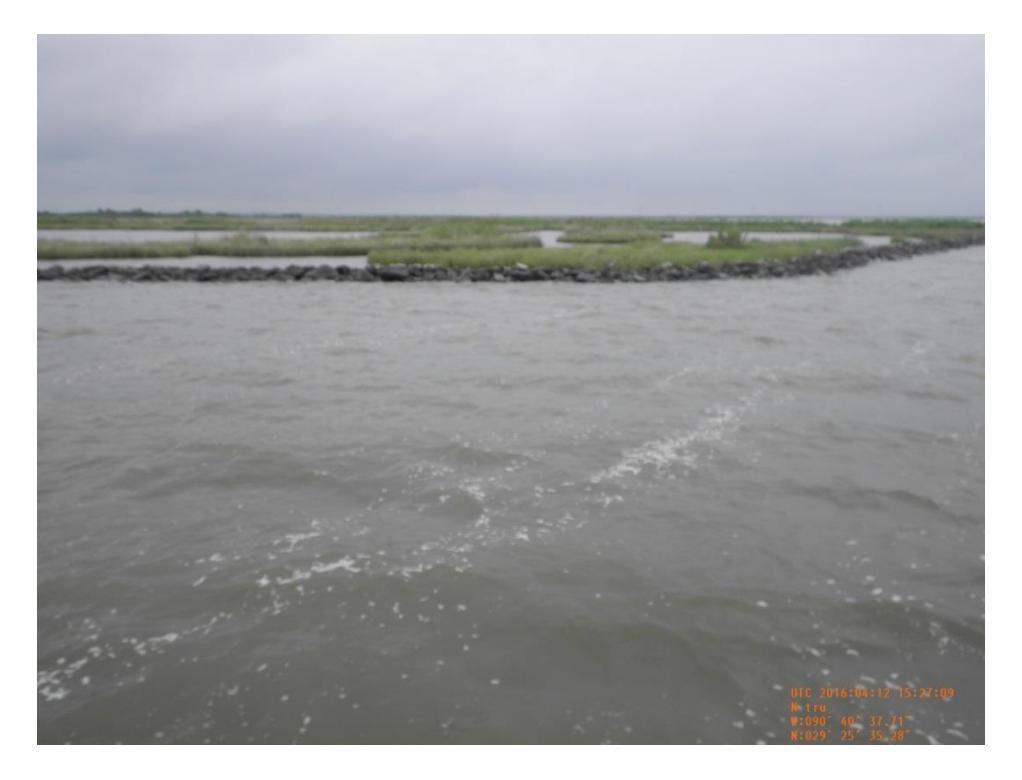
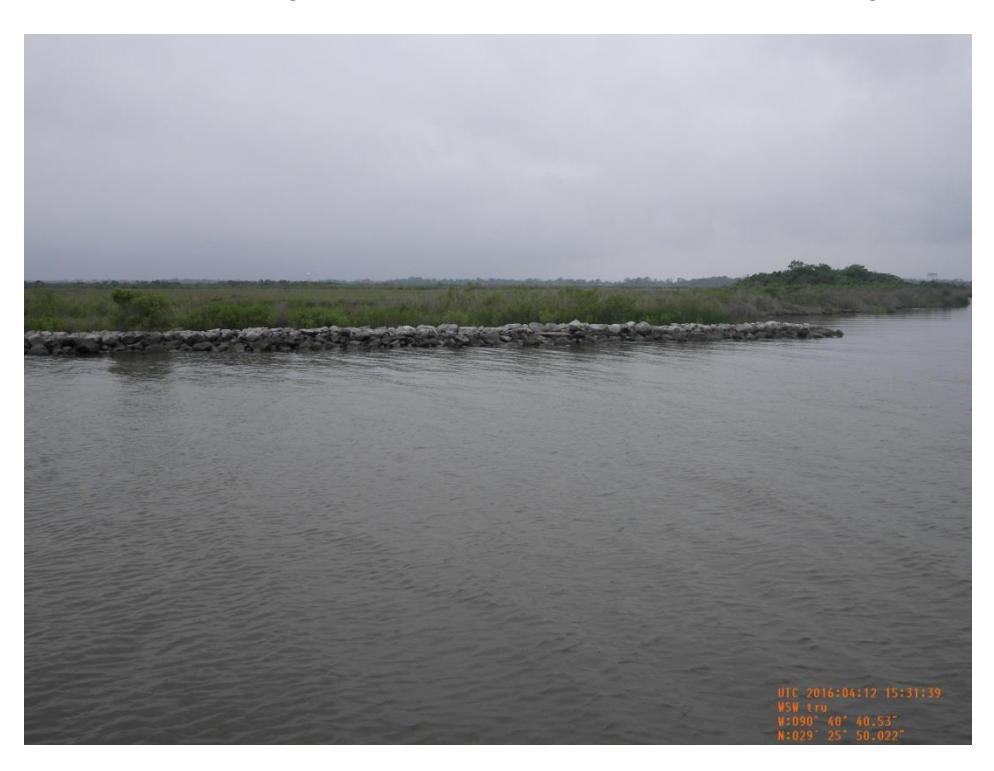
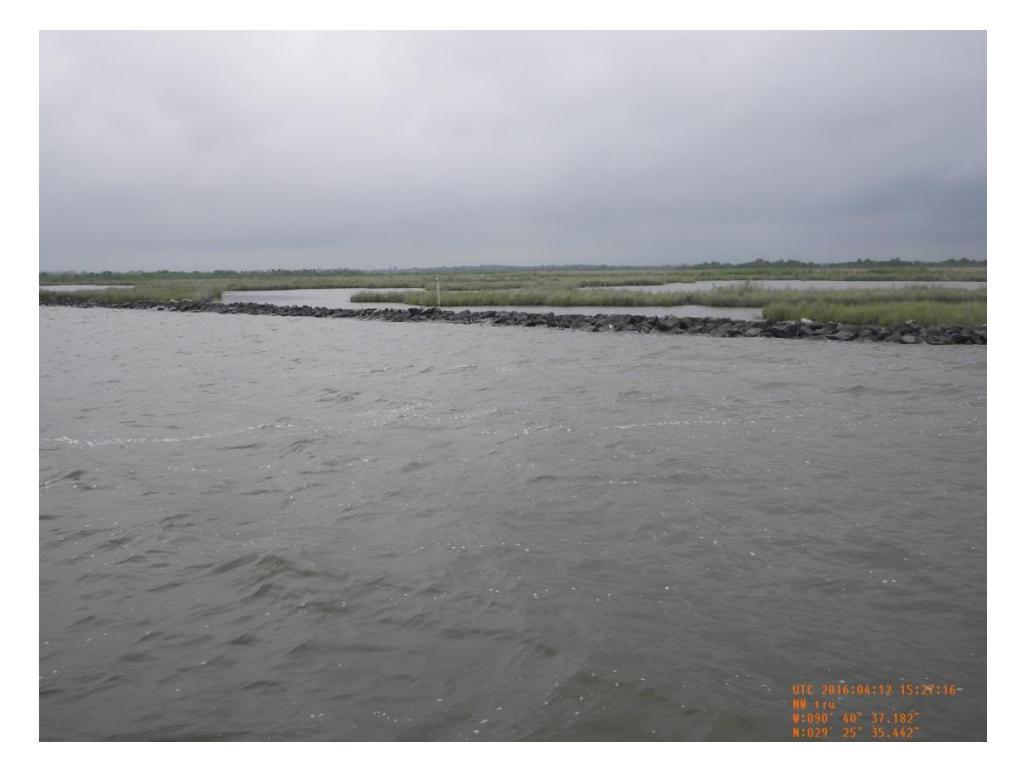
The northern segment of the rock dike appeared to be in good condition. There are no signs of settlement along the rock dike; the elevation is consistent throughout the entire length of the structure. There is still some evidence of erosional shadowing on the north end of this segment, measuring approximately 70 feet wide and 20 feet deep, as noted in the previous reports. This erosion may impede structure functionality, however this area has been identified and will continue to be monitored on future inspections. There are no recommendations for maintenance at this time. (See Appendix B, Photos 13 through 17)

Photo 13: View along the foreshore rock dike northern section, looking north

Photo 14: View along the foreshore rock dike northern section, looking north

Photo 15: View along the foreshore rock dike northern section, looking north

Photo 16: View along the foreshore rock dike northern section, looking west

Photo 17: View of the northernmost end of the foreshore rock dike, looking south
