**Coastal Protection and Restoration Authority (CPRA)**

# **2018 Operations, Maintenance, and Monitoring Report**

# **East Marsh Island Marsh Creation**

State Project Number TV-21 Priority Project List 14

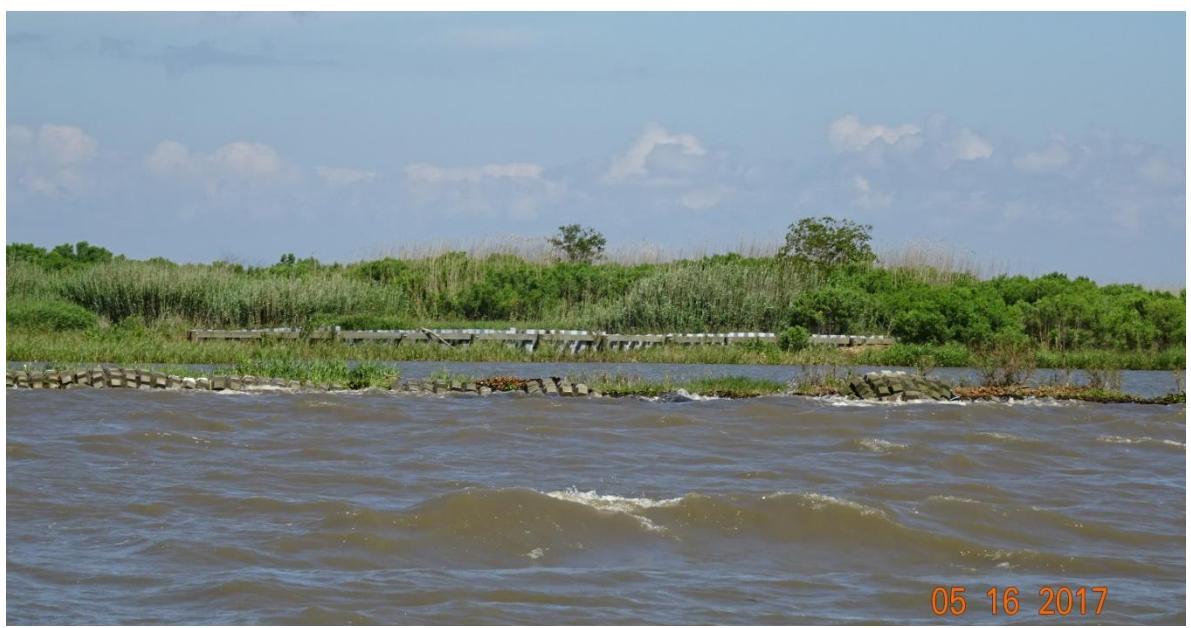
The concrete articulated mats placed in March 2015 on the Northeast corner of the island in Marsh Creation Containment Area No. 1 at the East-West Pipeline Canal has settled significantly at the original breach location. However, it continues to break the wave action approaching the shoreline. In addition, from topographic survey information the borrow channel on the interior of the containment dike which was excavated to repair the breach has infilled to -2.5ft NAVD88.

Photo No. 1, MC Cell No. 1 - Articulated Concrete Mat (2015 Maintenance Event)

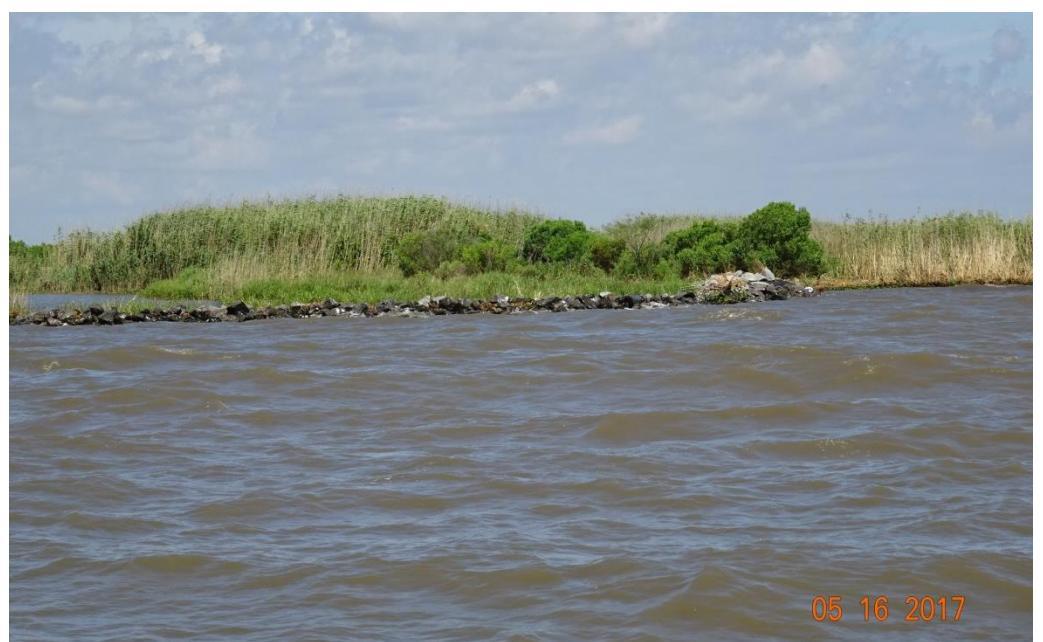
Only Nourished Areas No. 3 & 4 were visible during the site visit. Located on the Northeast tip of the island, shoreline erosion continues to degrade the point. The vegetation is thriving since the nutria population is under control.

Nourished Areas No. 3 & 4 experienced relatively minor net change. Despite one location with a 10 in. decrease, each other location observed in Nourished Area No. 3 had a 1.2 in. elevation increase. Nourished Area No. 4 had an elevation change ranging from -2.4 in. to +2.4in.

Photo No. 2, MC Cell No.1 & Nourished Area No. 4, Breach Repair (NE Corner of Island at East End of E-W Pipeline Canal (2015 Maintenance Event)

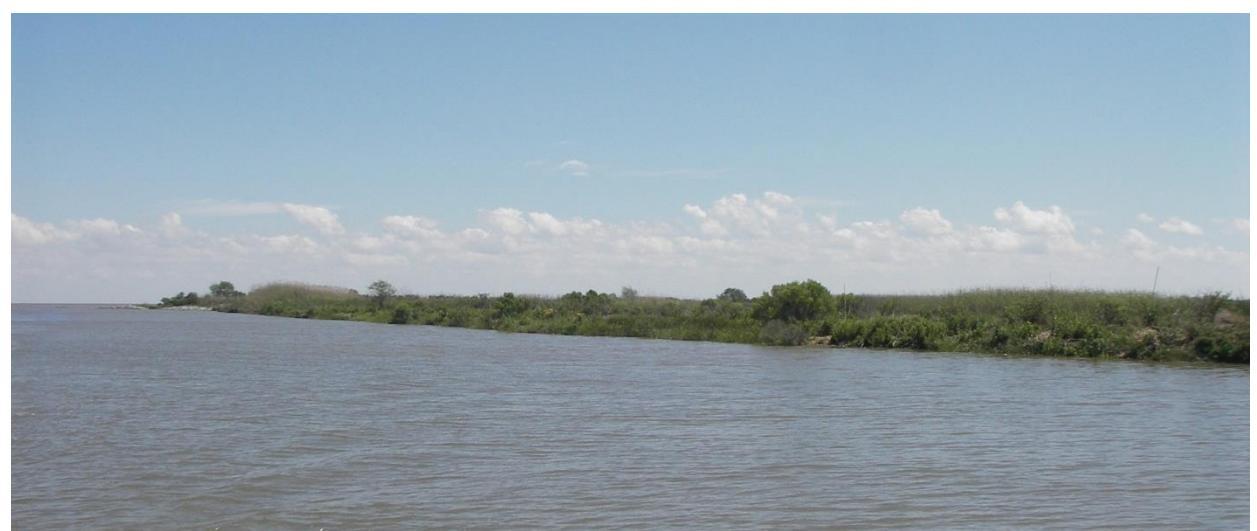
Photo No. 3, MC Cell No. 1, North South Canal Looking North

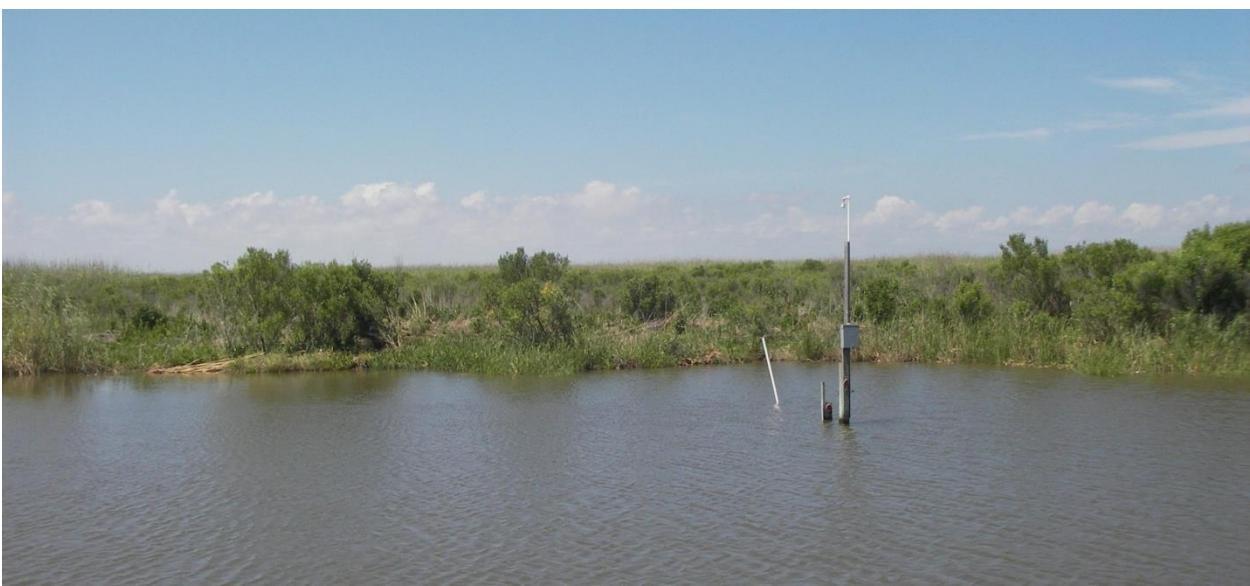
The earthen plug at the end of the North-South Pipeline Canal was intact. (Photos: Appendix B, Photo No. 4)

Photo No. 4, MC Cell No. 2, Plug at End of North-South Canal (Looking North)

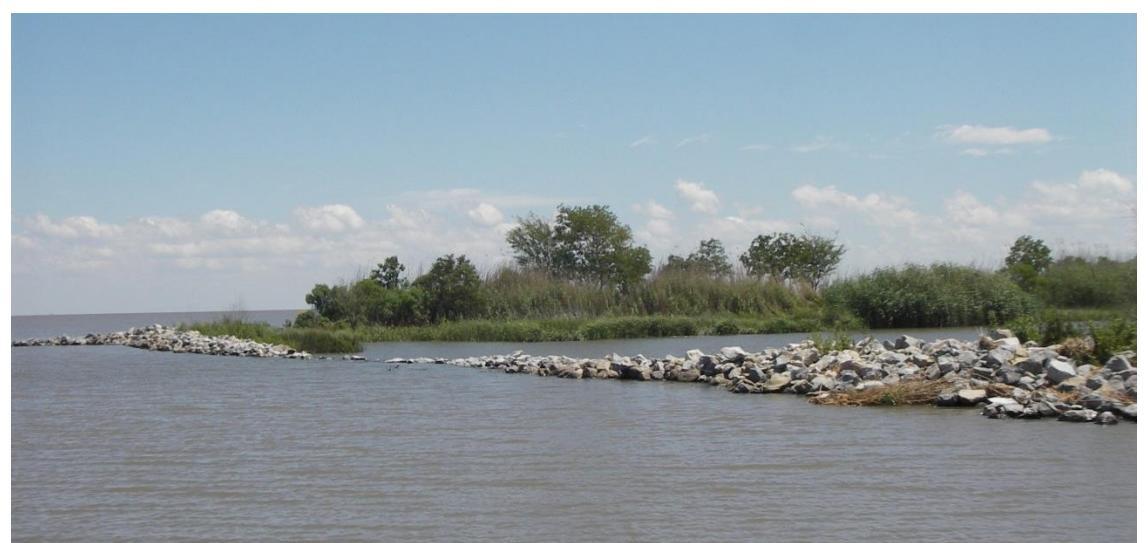
**Photo No. 5**, Nourished Area No. 4, Plug (TV-14 Project- End of East West Canal Looking North)

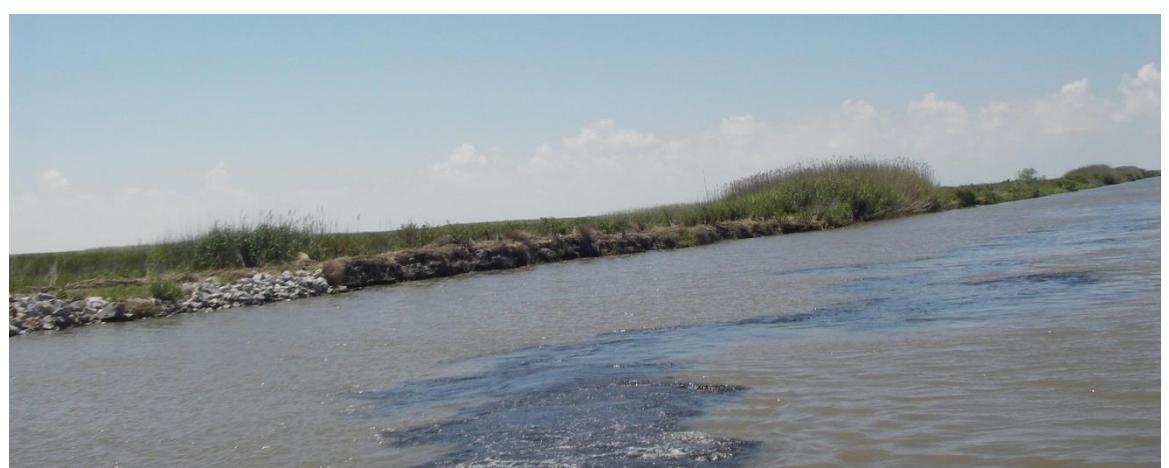
**Photo No. 6**, MC Cell No. 1, Plug Tie-In (TV-14 Project- End of East West Canal - Looking Southeast)
