Bayou St. John Urban Marsh Monitoring Report 2014 – 2019

**Pontchartrain Conservancy
Eva Hillmann, David Baker, John Lopez
July 27, 2020**

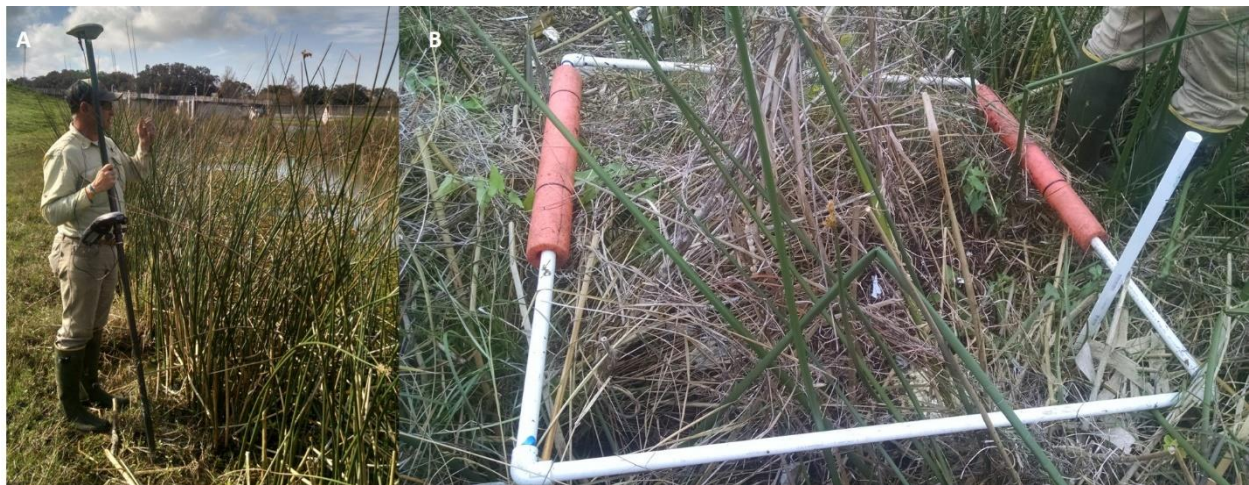
Elevation measurements were taken at all forty-two plots using a Trimble Geo Explorer 6000 GeoXR GPS attached to a Zephyr Model 2 GNSS receiver (**Figure 2-A**). Capable of real time kinematic (RTK) data collection, this survey grade GPS system provided latitude, longitude, and elevation with a horizontal precision of less than two inches and vertical precision of less than three inches.

Herbaceous vegetation was measured at all forty-two plots using a 1-m² PVC quadrat (Wikum and Shanholtzer 1978) (**Figure 2-B**). In each plot, total percent cover, percent cover by species and species richness was assessed. Only live plants were considered. The Floristic Quality Index (FQI) (Cretini et al. 2011, Cretini et al. 2012) were calculated using the vegetation data collected in August of each year. FQI assessments incorporate abundance and quality of species. FQI are scored from 0 – 100. In general, the FQI is an indication of native vegetative quality for an area: generally, 1-19 indicates low vegetative quality; 20-35 indicates high vegetative quality and above 35 indicates “Natural Area” quality (Herman et al. 2017; Wilhelm and Rerich 2017). FQI analyses was adjusted for Louisiana by Cretini et al (2017), whereas, and FQI score of 0-38 indicates a poor-quality site, 38-71 indicates a fair quality site, and an FQI score > 71 indicates a high-quality site.

Figure 2 Elevation measurements were taken using a Geo Explorer 6000 GeoXR GPS attached to a Zephyr Model 2 GNSS receiver (A); vegetation was surveyed using a modified Braun-Blanquet 1-meter squared method (B)

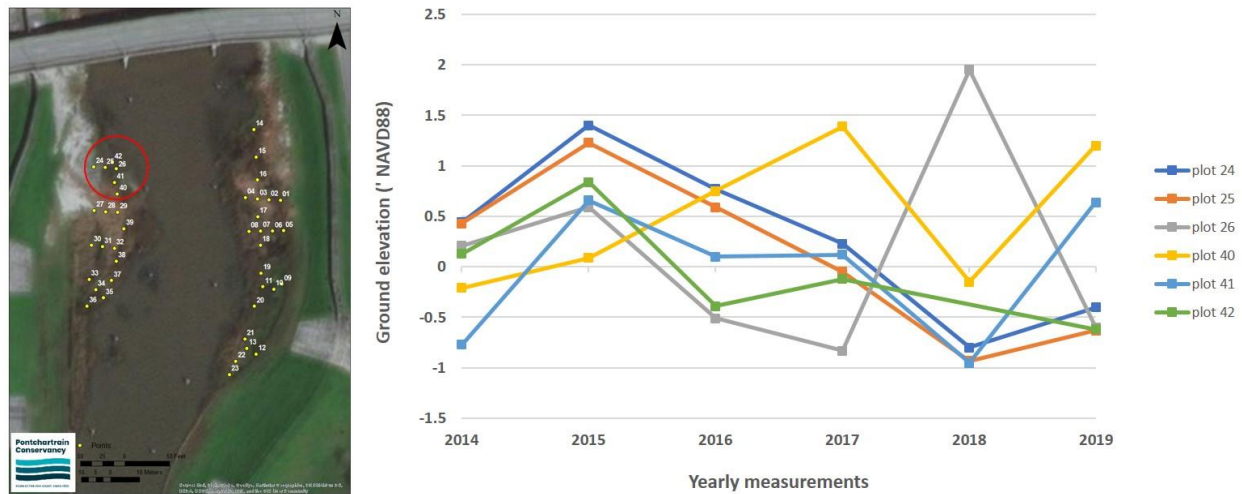
Figure 4 Ground elevation at select sites (red circle on left) on the west side of the Bayou St. John Urban Marsh from 2014-2019

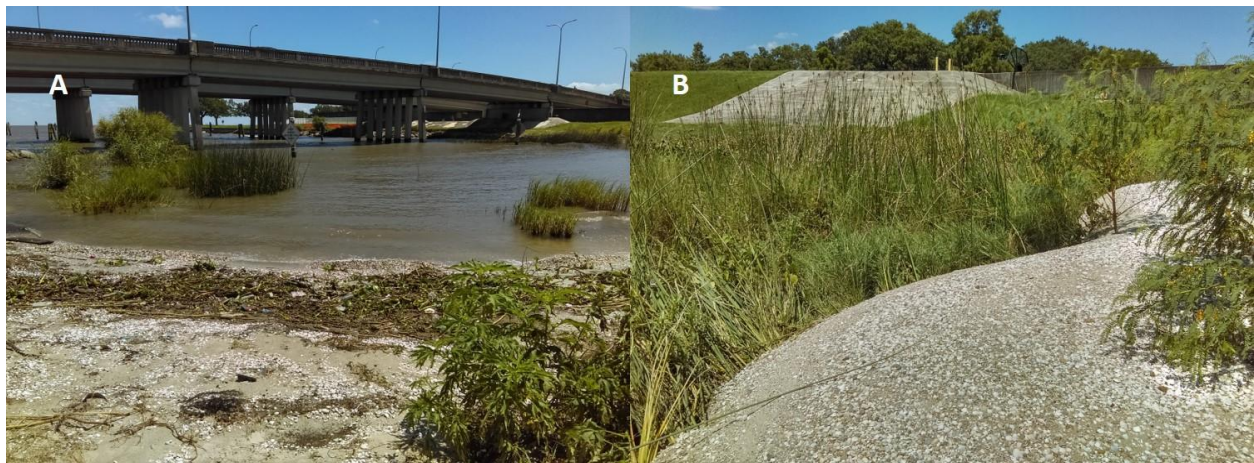
Figure 5 The photos depict areas of erosion (A) and deposition (B) of sediment and shells on the west side of the Bayou St. John Urban Marsh

Ponded areas on the east side and sediment deposition on the west side appear to explain these differences. In the beginning, we actually noticed a lot of scouring on the west side, and tried to “fix” this by fortifying the retaining wall there and replanting that area of the marsh. On May 20, 2017, using volunteers and equipment donated by Entergy, the PC tried to repair the retaining wall using Flex MSE Bags (formerly Deltalok Bags), moving some sediment back into place and then re-planting. This was done to prevent further erosion of the northwest side of the marsh to stabilize the area. Although *some* plants became established, overall this effort was not successful. The retaining wall breached, again. We are still not completely clear why this particular area simultaneously has sites that erode, and also has others that are sites of intense sediment deposition.

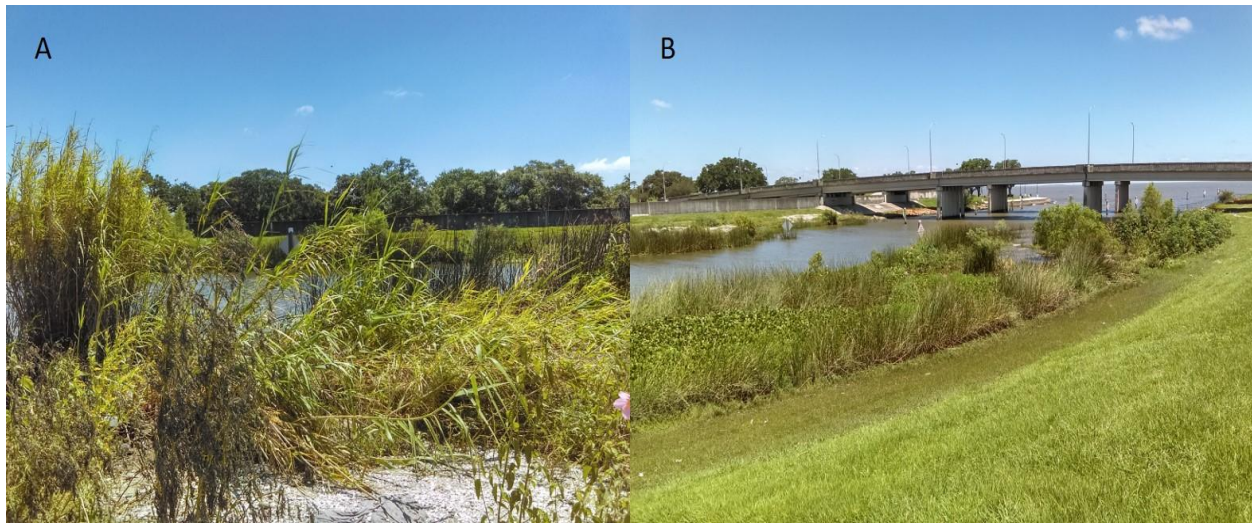
Figure 7 Pictures depict vegetative cover at Bayou St. John on the west side (A) and east side (B) of the bayou.

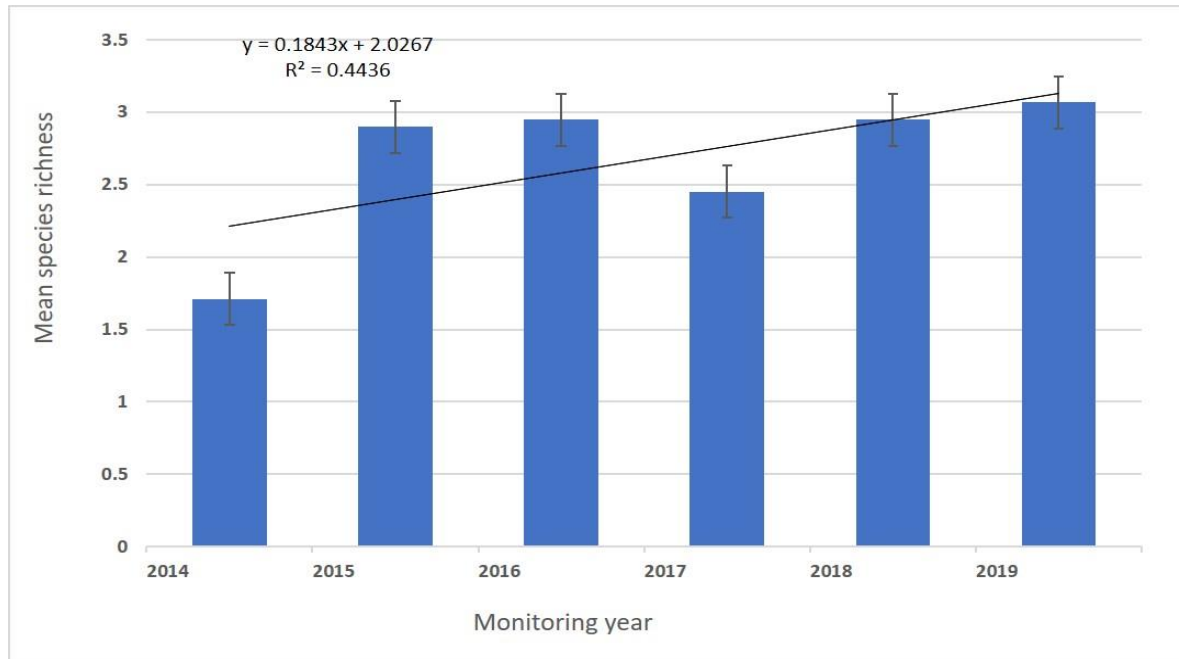
3.1 (± 0.27 SE; 2019). Species richness in 2014 was significantly different and lower compared to all other years. Despite some variability, the trend indicates that mean species richness across the marsh is increasing ($R^2 = 0.44$; **Figure 9**).

Figure 9 Mean species richness across the Bayou St. John Urban Marsh

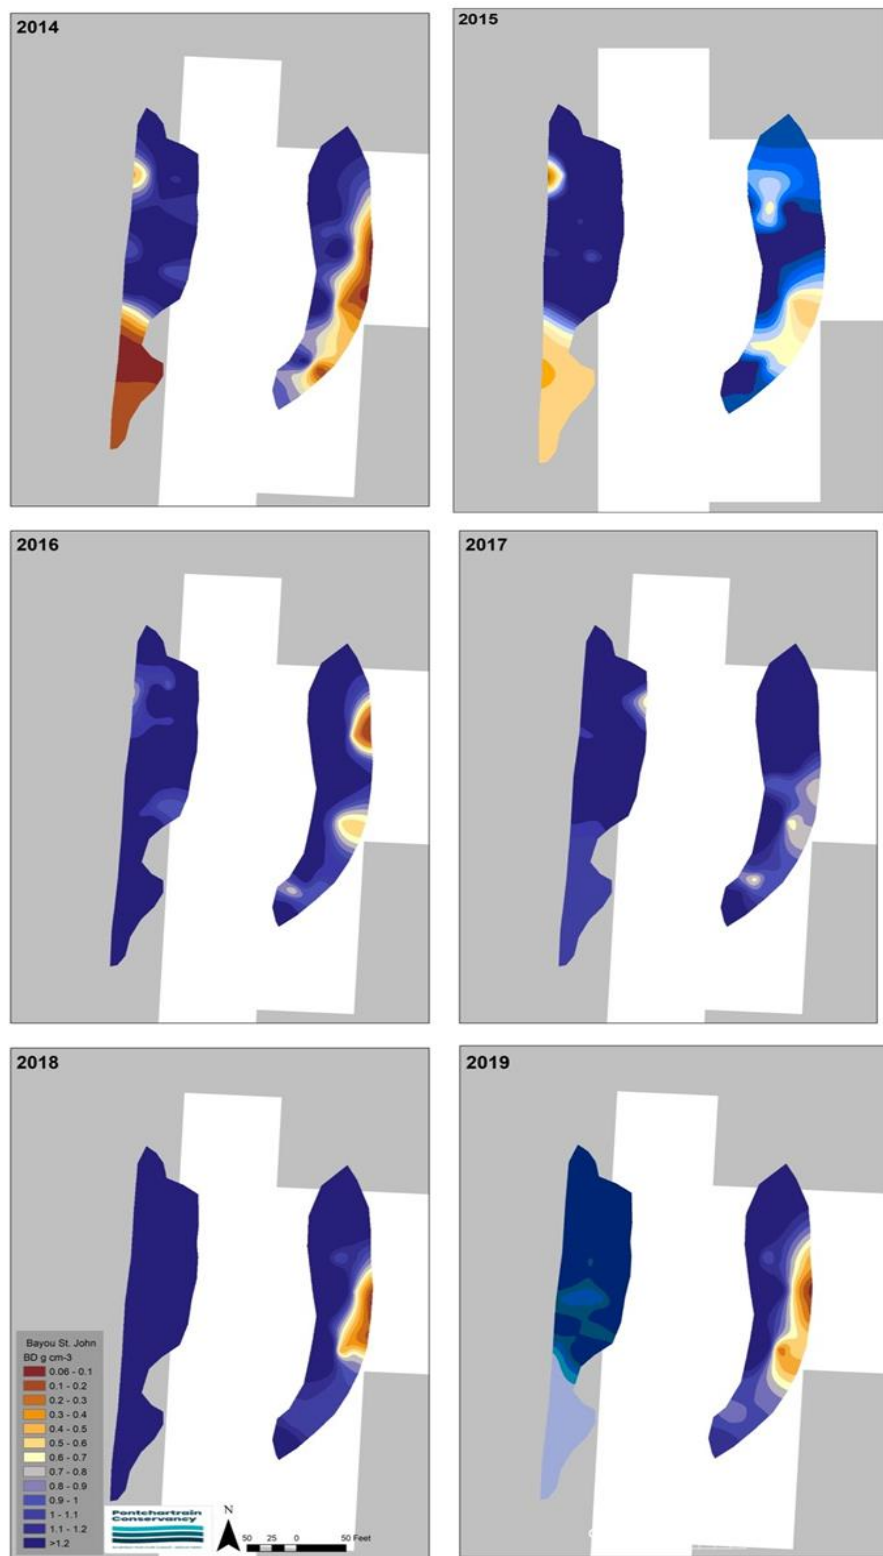
Figure 13 Interpolation of soil bulk density (g cm^{-3}) across the Bayou St. John Urban Marsh from 2014-2019

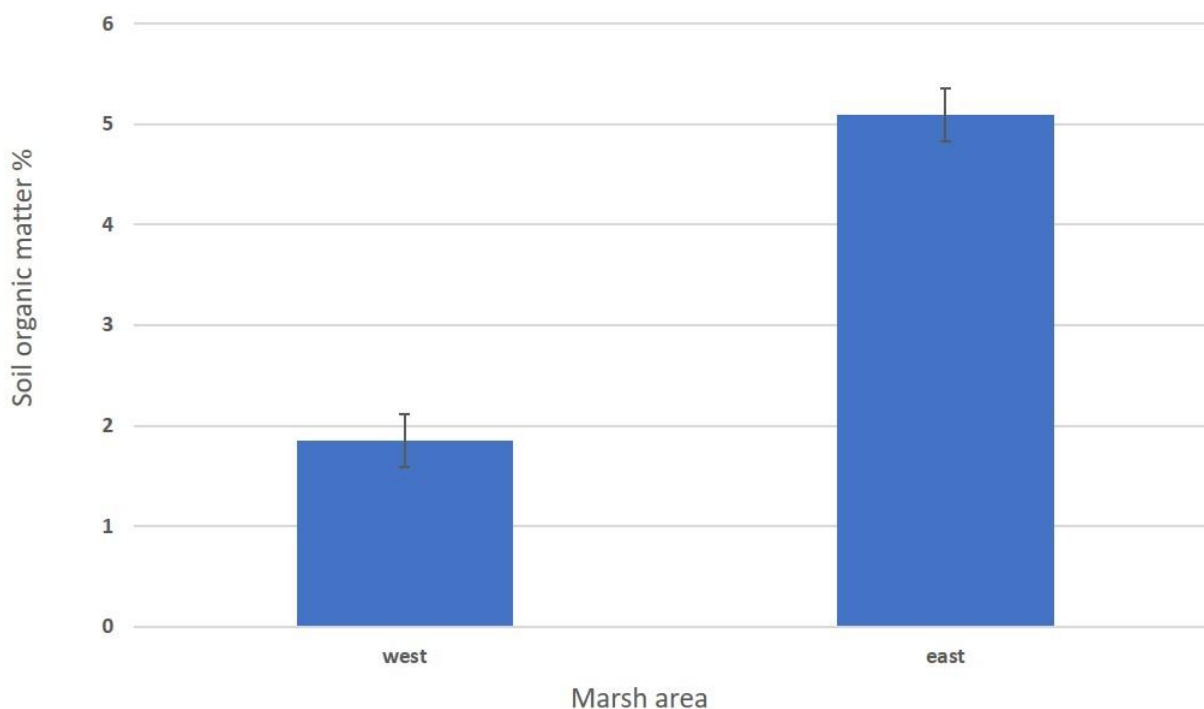
There was no significant percent soil OM interaction by area and year. There was also no significant difference in mean percent soil OM across the main effect of years only. Mean percent soil OM from 2014 - 2019 ranged between a low of 2.85 to 4.80 %, and percent soil OM at individual sites ranged from 0.17 % to 21.96 %. However, there was a statistical difference in percent soil OM across marsh areas ($F_{1, 249} = 46.25$; $p < 0.0001$) at the BSJ Urban Marsh (**Figure 14**). Soil OM across the western marsh ($1.81 \% \pm 0.03$ SE) was lower and statistically different from soil OM on the eastern marsh side ($5.01 \% \pm 0.42$ SE). On the eastern side soil OM ranged between a low of 0.40 % to a high of 21.96 %. On the western side OM ranged between a low of 0.17 % and a high of 7.84 %. The interpolation of soil OM data across the BSJ Urban Marsh showed where and possibly why the eastern marsh had generally higher OM than the western marsh (**Figure 15**). In short, the same ponded area on the eastern side of the marsh with lower elevation and lower soil BD, had higher soil OM. In contrast, the western marsh's most lake facing sites, which tend to retain highly mineral lake sediments, likely contribute to the overall lower soil OM on the western side.

Figure 14 Soil organic matter (%) across the Bayou St. John Urban Marsh by area

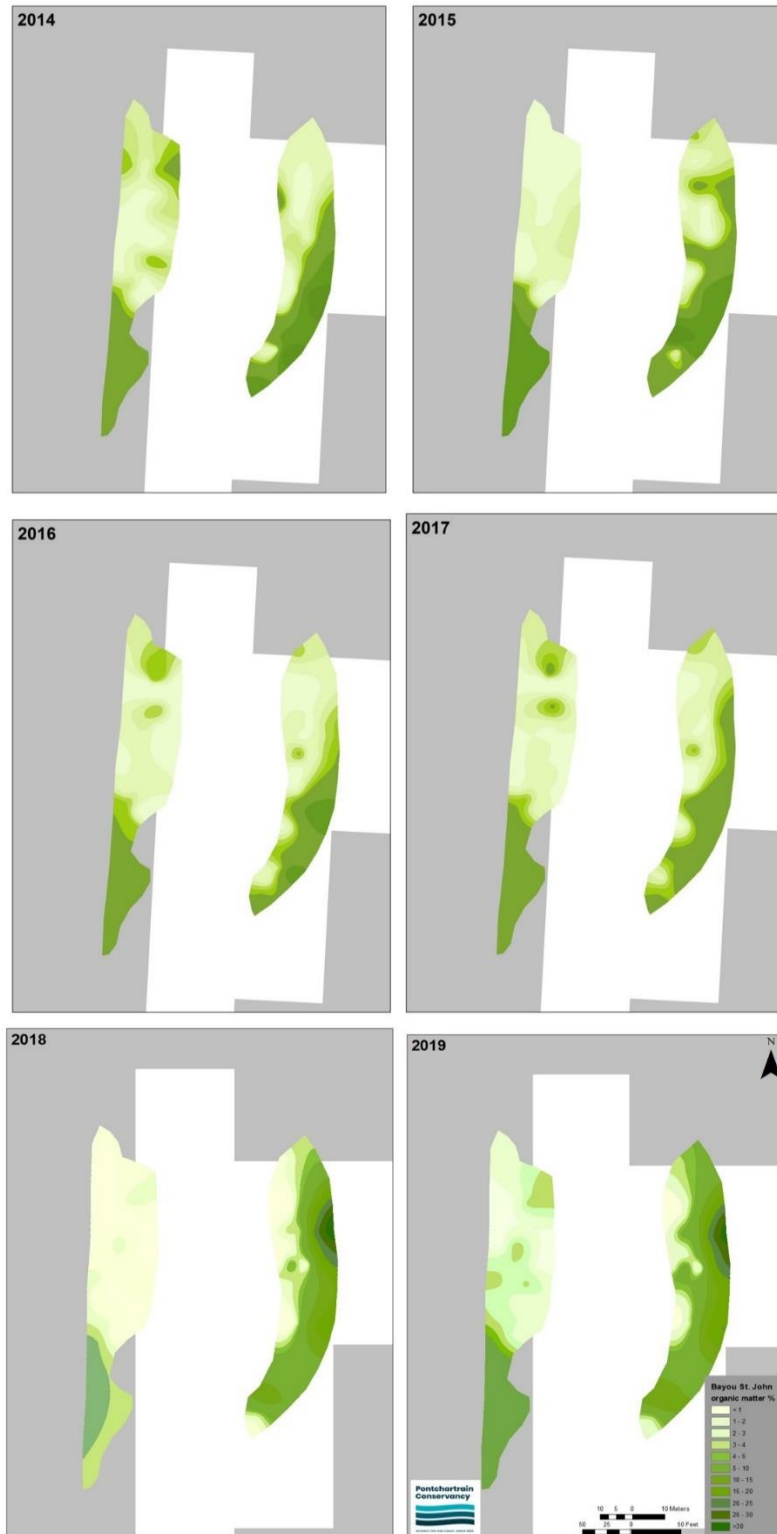
Figure 15 Interpolation of soil organic matter (%) across the Bayou St. John Urban Marsh from 2014-2019

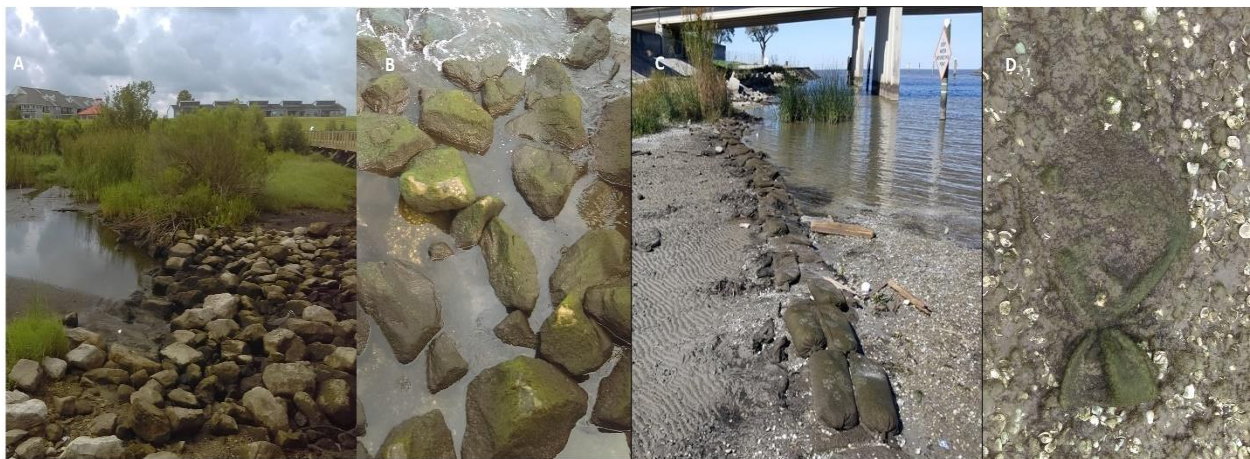
Concomitant to the plant community changes described above, mean total vegetation cover values have also never surpassed 50% at the BSJ Urban Marsh. This is unlike mean cover values at the Bucktown Mitigation Marsh (75%) and PO-17 LaBranche (65%) at the 5-year mark. Some of this may be attributed to the “wrack deposition event” at the BSJ Urban Marsh, but it’s also likely that low mean cover at BSJ is partially due to direct impacts from Lake Pontchartrain and flooding on the marsh, which result due to the specific location, elevation, construction materials, and dimensions of retaining wall at the BSJ Urban Marsh. For instance, the retaining wall at the Bucktown Mitigation Marsh was constructed with rip-rap, and extends 5-10 meters wide (**Figure 16-A & 16-B**), compared to the retaining wall at the BSJ Urban Marsh, which was constructed with sand-filled burlap bags and extends 2-5’ wide (**Figure 16-C & 16-D**), or the BSJ marsh may just be more exposed to direct impacts from the lake. We can see these differences when comparing Bucktown and BSJ marshes; both marshes are resilient, but there is an area on the western side of BSJ that is continually eroded, then built up with shells and lake sediments. This cycle suppresses vegetation from establishing and reduces overall mean vegetative cover. There is no such area at the Bucktown Mitigation Marsh that gets similarly disturbed.

Figure 16 Comparison and close-ups of the retaining walls used at the Bucktown Marsh (~10' wide border of rock, A & B) and at Bayou St. John Urban Marsh (~2' wide border of sand filled bags, C & D)

- Using the sand bag system (i.e. DeltaLok bags) for building marsh retaining walls is sufficient, but not as resilient as rip-rap. Some erosion will occur.

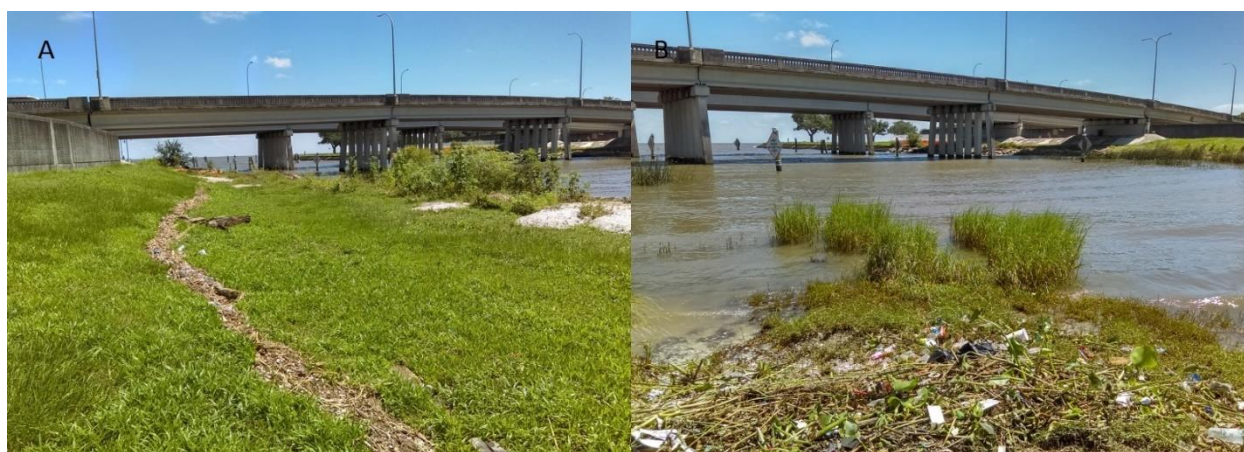
We've already discussed that the BSJ Urban Marsh is flooded for a large percentage of time throughout the year, and how this flooding likely impacts overall plant productivity in the marsh. Flooding also brings wrack, and marine debris (**Figure 19**); the amount of which depends on marsh location and body of water. Lake Pontchartrain is part of a dynamic, shallow-water estuary surrounded by a highly urbanized environment, especially on the south shore of the lake. The amount of marine debris can be voluminous. Community involvement was necessary to construct the marsh, and is also necessary to maintain it, at least to the degree that the marsh remains accessible and not dangerous because of debris.

Figure 19 Pictures depict the high-water line from a recent water event (A) and debris deposited in the marsh (B)

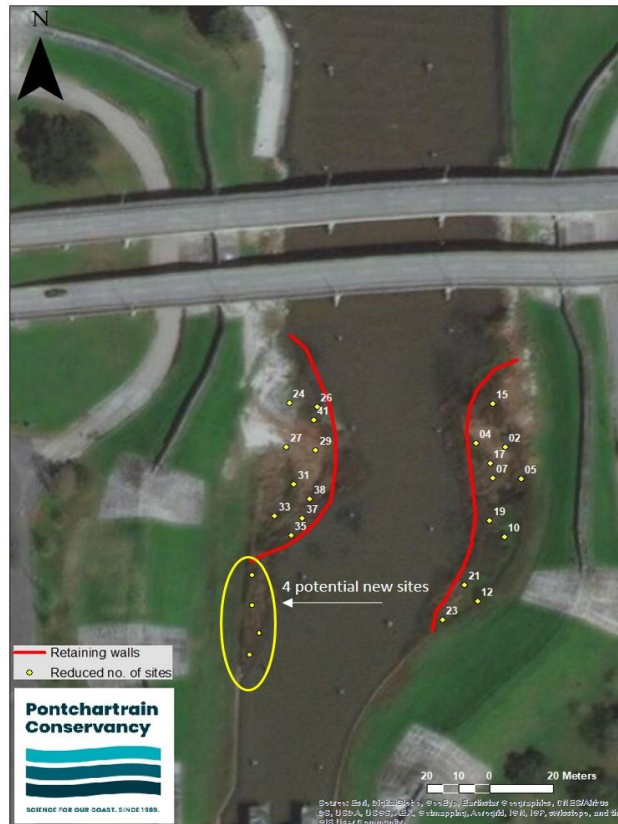
Figure 23 The map depicts a reduced sampling scheme, plus four new sampling sites at Bayou St. John Urban Marsh
