VEGETATIVE DELINEATION REPORT

**NAOMI FRESHWATER DIVERSION
SIPHON OUTFALL AREA (BA-3)**

**Delineation Date: July 22, 1992
Report Completion Date: May 20, 1993**

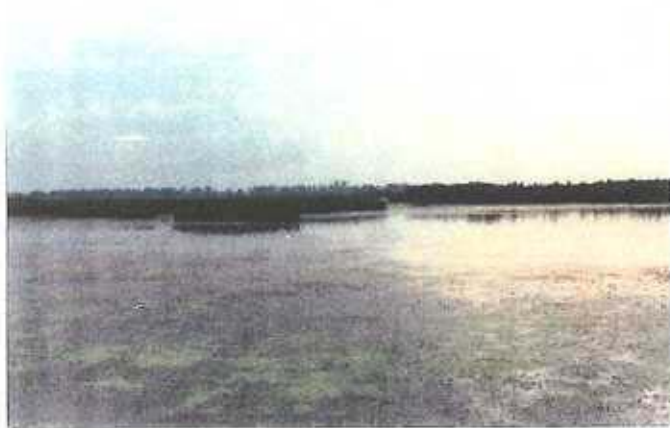
Figure 3

1.	Naomi Siphon project area and vegetative delineation station locations . .	2
2.	Naomi Siphon project area showing vegetative zone locations	6
3.	Station 1 is located in a freshwater pond east of a pipeline canal. Large openings have developed through the spoil bank of the canal. Photo direction is to the east	15

Station 1 is in a pond near the northeastern corner of the study area and is approximately ½ mi west of the active eagle nest. A large pipeline canal was constructed by Southern Natural Gas Company several years ago and converges with other pipeline canals at the back levee system. Openings through the pipeline canal spoil bank allow water interchange with the marsh

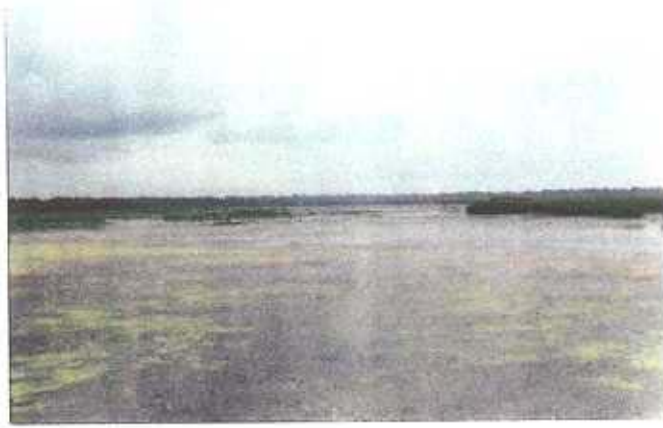
Figure 4

4.	At Station 1 aquatic vegetation was made up of coontail and southern naiad and was well established in the ponds. Photo direction is to the north	15

Salinity in the pond was .5 part per thousand (ppt) at the time of the field survey. The dominate emergent plants in the area were bulltongue (75 %), cattail (15 %), and bullwhip (10%). Aquatic vegetation was composed of southern naiad (*Najas quadalupensis*), coontail (*Ceratophyllum demersum*), duckweed (*Lemna minor*), and water hyacinth (*Eichhornia crassipes*). The submerged aquatics were occupying approximately 80% of the pond area (figures 3, 4, and 5).

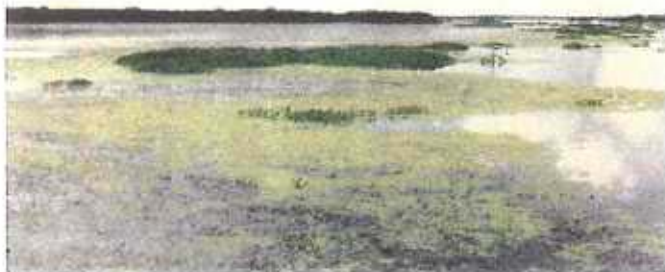
Figure 5

5.	Large stands of bullwhip are located within the pond areas. Photo direction is to the south	15
6.	Clumps of three-cornered grass are mixed with bulltongue at Station 2. Photo direction is to the north	15

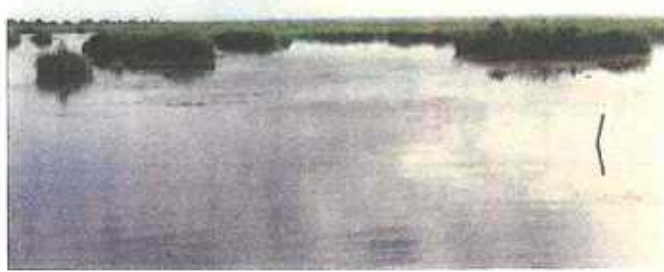
Figure 6

Station 2 is located at an opening in an oil and gas canal spoil bank. Salinity was 2 ppt and vegetation was three-cornered grass (85 %), bulltongue (10 %), and a 5 % combination of a belle dame (*Acnida cusidata*), deerpea (*Vigna luteola*), smartweed (*Polygonum spp.*), and

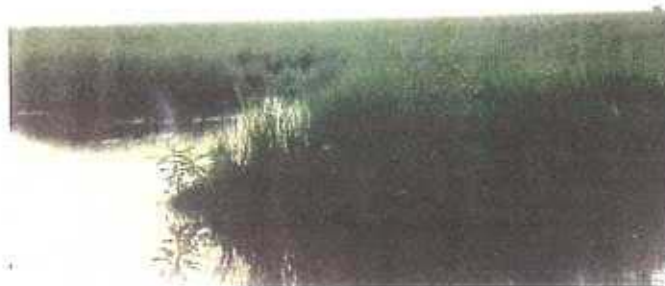
Figure 7

7.	The opening through an oil and gas access canal at Station 2 will serve as a distributary channel for introduced freshwater. Photo direction is to the southeast

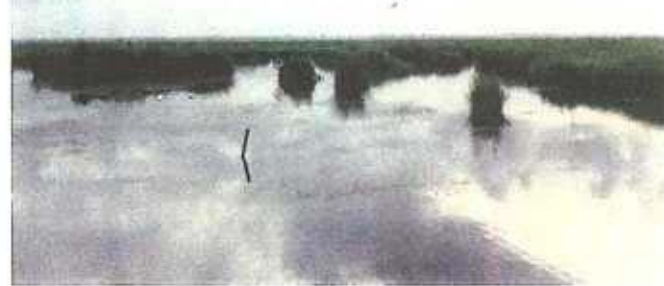
Figure 8

8.	Several large ponds are located near Station 2. Aquatic vegetation was growing in all of the ponds. Photo direction is to the east	15
9.	A small stand of smooth cordgrass is established in the marsh at Station 2. Photo direction is to the west	16

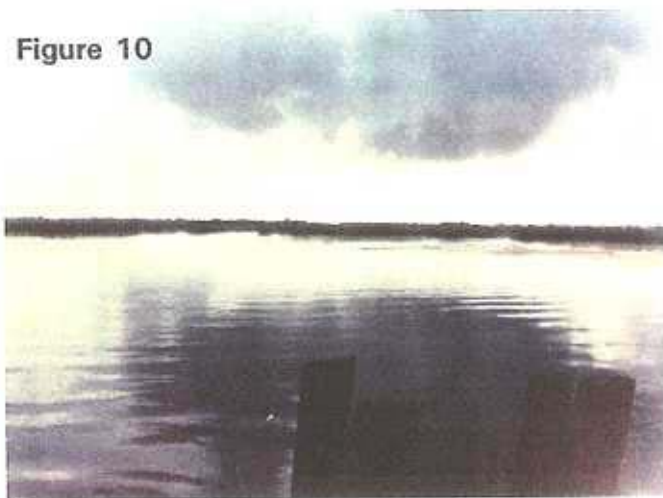
Figure 10

10.	Station 3 is near the back levee of Citrus Lands of Louisiana. The marsh has large ponds which were growing aquatic vegetation. Photo direction is to the north	16

Station 3 is near the corner of the Citrus Land of Louisiana back levee system. A pond area is located in the marsh next to a break in the canal system levee. Small boats can access the marsh interior. Marsh vegetation was bulltongue (80%), cattail clumps (10%) and three-cornered grass (10%). Though many other plants were observed, the combined amount of these species did not constitute a large enough portion of the entire plant community to rate a percentage designation. Some of the other plants observed in this area were pennywort (*Hydrocotyle umbellata*), waterhyssop (*Bacopa monnieri*), spikerush (*Eleocharis parvula*), alligatorweed (*Alternanthera philoxeroides*), Walter's millet (*Echinochloa walteri*), marsh morningglory (*Ipomoea sagittata*), and traces of smooth cordgrass and marshhay cordgrass. An attempt had been made to close the opening in the spoil bank and some of the timbers are still present (figures 10, 11, 12, and 13). Water salinity at this station was 2 ppt. A remote sensing station is located near this station in one of the mineral access canals (figure 14).

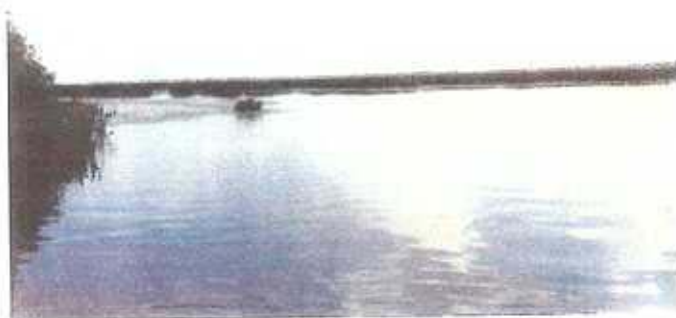
Figure 11

11.	There is an opening through the oil and gas access canal levee near Station 3. This opening will allow a flow of freshwater from the siphon to enter the canal system. Photo direction is to the west	16

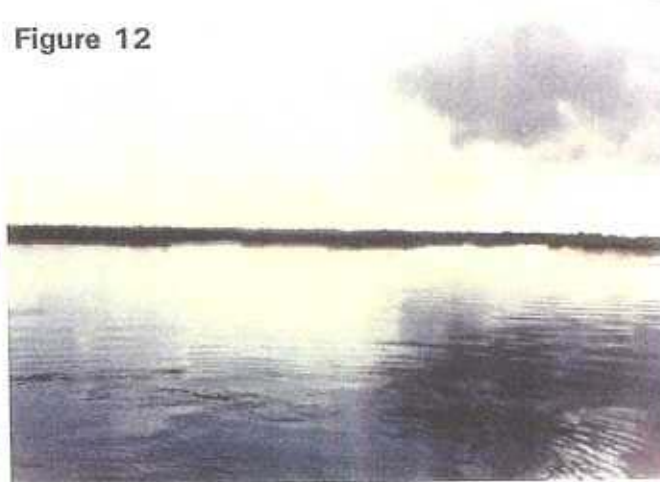
Figure 12

12.	The marsh at Station 3 is dominated by bulltongue. Large clumps of cattail are located to the northwest of the station. Photo direction is to the northwest	16

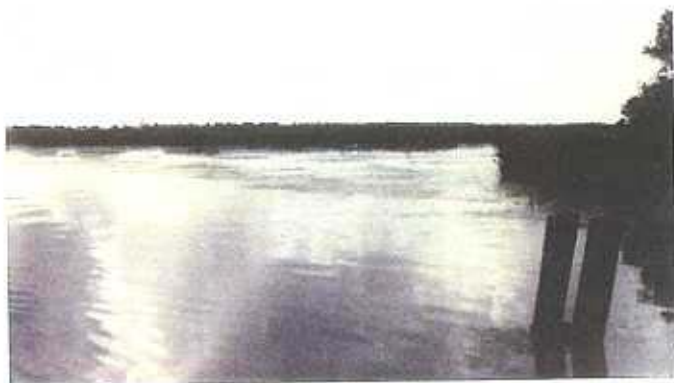
Figure 13

13.	An old water control structure exists in the levee opening. Repairs to the structure may be required to regulate the amount of water flow through this site. Photo direction is to the northeast	16

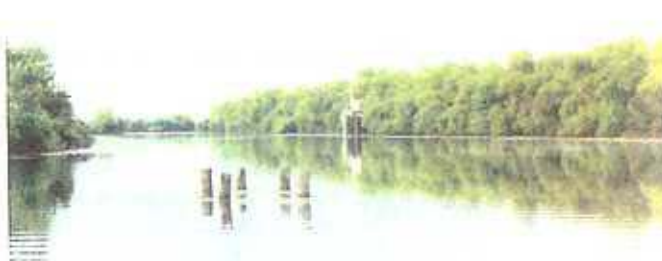
Figure 14

14.	A remote data collection platform is located in a canal near Station 3. Photo direction is to the northeast	16
15.	Station 4 is along a small ditch off the Brady Canal. This ditch will assist in directing freshwater flow into the marsh south of the canal system. Photo direction is to the southeast	17

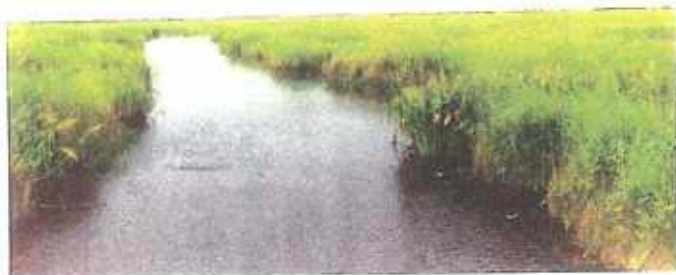
Figure 15

Station 4 is in the entrance to a small ditch leading southeast from the main mineral access canal system. Water salinity was 2 ppt. This station is near a demarcation between intermediate and brackish marsh. Area plants were marshhay cordgrass (25%), bulltongue (20%), three-cornered grass (20%), camphorweed (*Pluchea camphorata*) (10%), millet (5%), spikerush (5%), sedge (*Carex spp.*) (5%), belle dame (5%), and deerpea (5%). This marsh is a good, broken marsh with approximately 10% open ponds with aquatic vegetation. Small

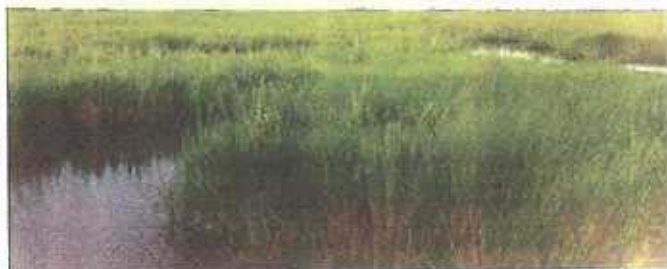
Figure 16

16.	The marsh vegetation at Station 4 is made up of bulltongue, marshhay cordgrass and three-cornered grass. Marsh plant communities are in good healthy condition. Photo direction is to the south	17

clumps of wax myrtle are visible in the marsh interior from this station and are good indicators of a slight surface elevation (figures 15 and 16).

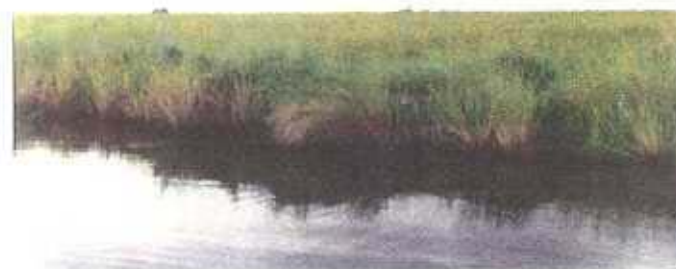
Figure 17

17.	Station 5 is in a broken, brackish marsh north of Bayou Du Pont. The dominate vegetation is marshhay cordgrass. Photo direction is to the northeast	17

Station 5 is in a small bayou on the north side of Bayou Du Pont. Water salinity was 4 ppt. The marsh is brackish and the vegetation was marshhay cordgrass (90%) and three-cornered grass (10%). Minor amounts of other plants were observed at this site and consisted of the same mixture as at Station 4. Aquatic vegetation in this area was Eurasian watermilfoil (*Myriophyllum spicatum*). There was a total lack of duckweed, a good indicator of the increased amount of saltwater that enters this section on occasion (figures 17, 18, and 19).

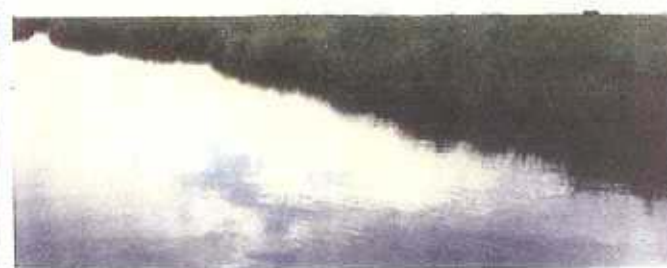
Figure 18

18.	At Station 6, there are several small ponds and interior waterways that will serve as distributary openings for freshwater. Photo direction is to the northeast	17

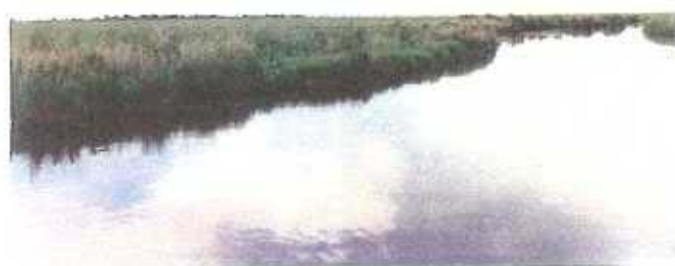
Figure 19

19.	Spoil banks along a pipeline canal near Station 5 may help to direct sheet flow of freshwater across the marsh. Photo direction is to the west	17
	Station 6 is located in a small interior marsh that is broken. The area has been disturbed by pipeline construction. Photo direction is to the north	17

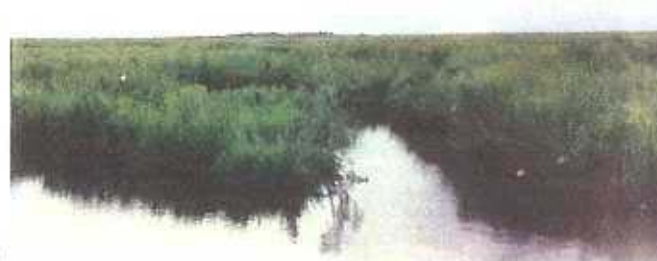
Figure 20

Station 6 is in an interior ditch north of Bayou Du Pont in a brackish marsh. The water salinity was 4 ppt. Marshhay cordgrass is the major vegetation (95%) with a mixture of other minor plants as listed at the other stations. This site had been disturbed by pipeline construction in the past, which had created some open ponds growing watermilfoil and coontail (figures 18, 20, 21, 22 and 23).

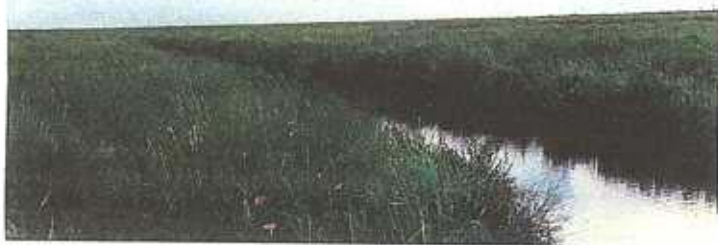
Figure 21

21.	Interior waterways will aid in distribution of freshwater near Station 6. Photo direction is to the northwest	18
22.	Several stands of wax myrtle trees are located in the interior marsh north of Station 6. Photo direction is to the west-northwest	18

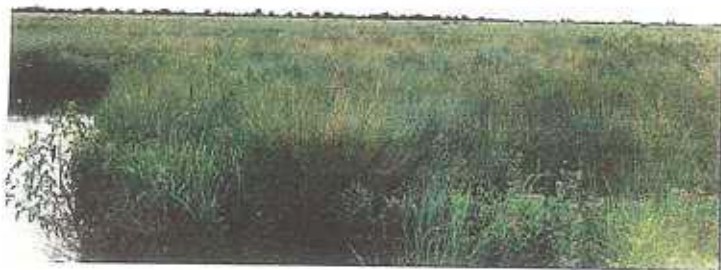
Figure 23

23.	Some sheet flow of freshwater may possibly be obtained by maintenance of spoil banks along pipeline canals in the area. Photo direction is to the southwest	18
	Large open water area south of Cheniere Traverse Bayou ridge system showing gaps in the spoil banks. Photo direction is to the southwest	18

The major obstacle will be transporting large amounts of freshwater to the southern end of the system beyond the Cheniere Traverse Bayou natural ridge system. The Brady Canal system is still servicing oil and gas facilities and cannot be closed. Restoring bulkheads and spoil banks along pipeline canal levees will be possible because these canals are only navigated by recreational fishermen and hunters.

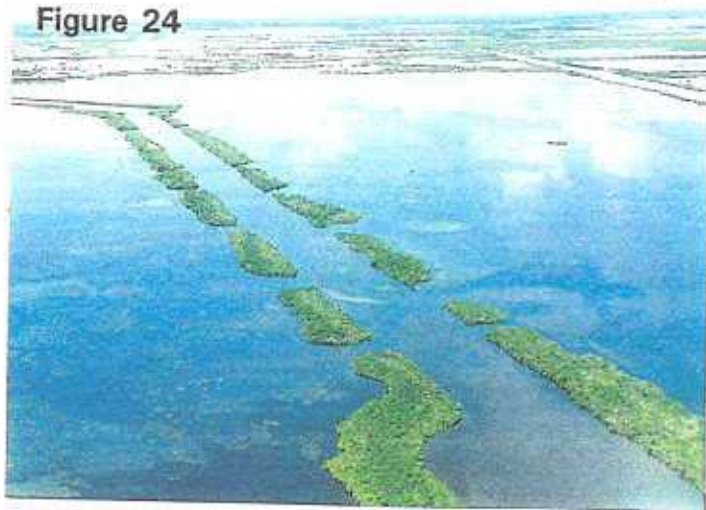
Figure 24

The Pen's east shoreline must be restored by dredging to prevent freshwater loss into the Barataria Navigation Canal. Several miles of levee will be required along Bayou Du Pont to contain any freshwater directed across the Cheniere Traverse Bayou ridge system. The large, open water area south of the ridge has developed from excessive tidal interchange through gaps in oil and gas access canals (figure 24). These openings should be plugged where unused canals depart from navigable waterways.
