VEGETATIVE DELINEATION REPORT

**WEST POINT A LA HACHE
FRESHWATER DIVERSION (BA-4)**

Delineation date: June 23, 1992
Report completion date: March 30, 1993

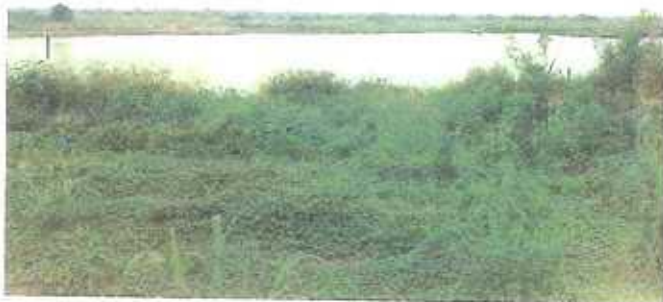
Figure 1

<u>Figure</u>	<u>Page</u>
1 The outfall pond of the West Pointe a la Hache Freshwater Diversion facility. Photo direction to the southeast	19
2. Small distributary canals have been installed Photo direction to the southeast	19

Station 1 is near the end of the northern-most distribution ditch of the structure's outfall pond (figure 1). Several small ditches were cut using a suction dredge and the material excavated was discharged into the marsh. Vegetation is growing on these spoil sites and is mainly smooth cordgrass (figure 2). The discharge ditches terminated in the marsh interior but did not connect to adjacent existing waterways (figures 3 and 4). Salinity at Station 1 was 11

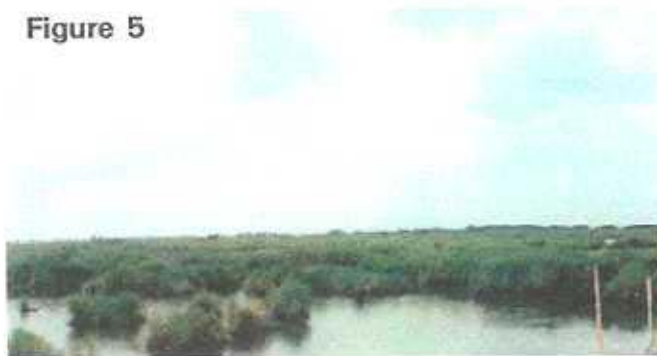
Figure 5

3. Smooth cordgrass has become established on the spoil from the distributary canals. Photo direction to the south 19
4. An existing small drainage canal adjacent to the outfall pond. Photo direction to the southwest	19
5 Station 1 is a smooth cordgrass marsh at the end of one of the distributary canals. Photo direction to the southeast	19

ppt and vegetation was smooth cordgrass (60%), salt grass (35%), and marshhay cordgrass (5%). The general area is composed of approximately 50% open water (figure 5).

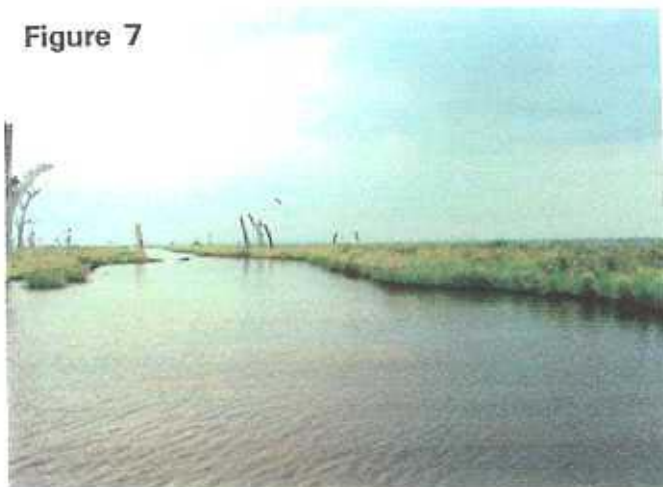
Figure 7

6. Station 2 is in a small marsh on the north of the Jefferson Lake Sulphur Company canal. Photo direction to the north 19
7. Dead trees are common along the Bayou Grande Chenier natural bayou bank at the Jefferson Lake Sulphur Company Canal crossing, Station 3. Photo direction to the northwest 20

Station 3 is located where the Jefferson Lake Sulphur Company Canal crosses Bayou Grande Chenier. Salinity at this site was 10.5 ppt. All of the original large tree species on the old bayou banks have been killed by subsidence and saltwater intrusion (figure 7). Marsh plants are dominantly marshhay cordgrass (60%) and smooth cordgrass (35%) with some salt grass (5%).

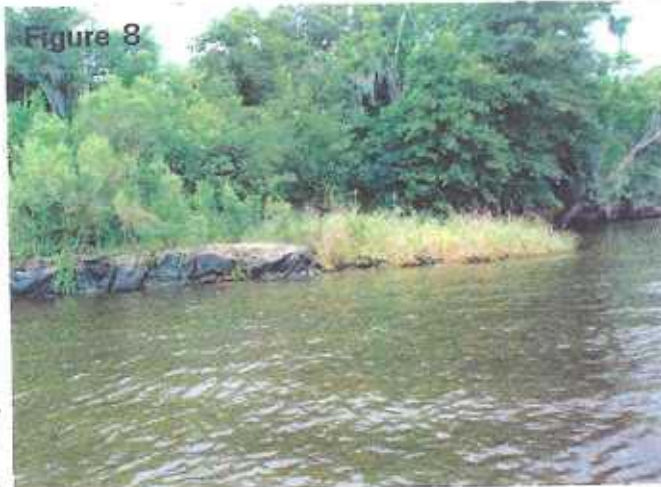
Figure 8

8. An earthen plug had been installed across the United Gas Pipeline canal at Bayou Grande Chenier, however the plug washed out. Photo of the east bank . .	20

Station 4 is located where United Gas Pipeline canal crosses Bayou Grande Chenier. Plant composition is marshhay cordgrass (60%) and smooth cordgrass (35%) with some salt grass (5%). Water salinity was 10.5 ppt. This canal has been plugged in the past, but is now open and provides an excessive amount of water interchange through the natural ridge system (figures 8 and 9).

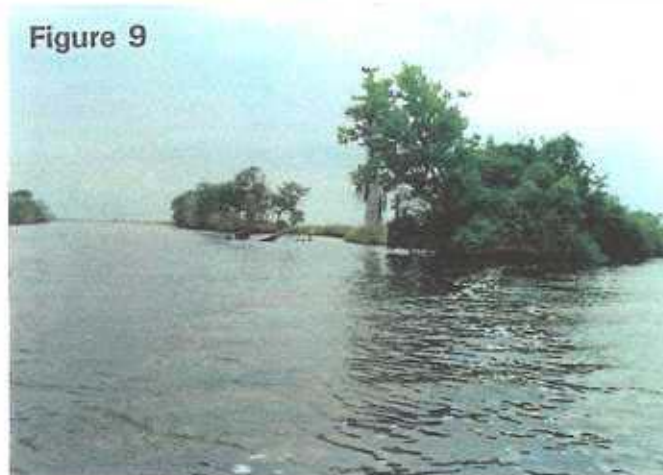
Figure 9

9. Station 4 is at the United Gas Pipeline crossing at Bayou Grande Chenier. Photo direction to the southwest	20
10. Station 5 is located at the earthen plug on a mineral access canal at Bayou Grande Chenier. Photo direction to the southeast 20

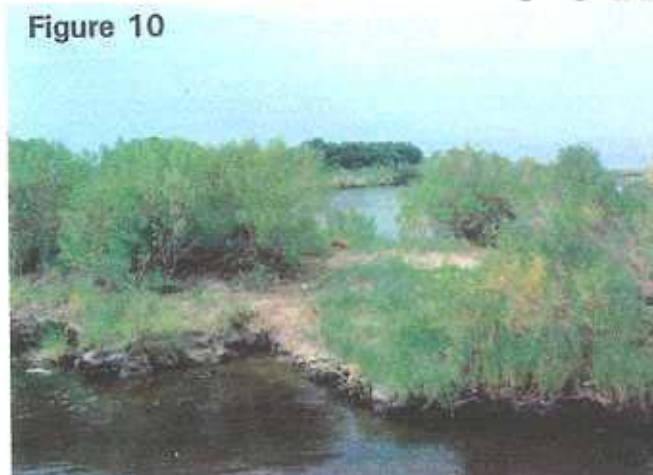
Figure 10

Station 5 is at a dead end mineral canal system that has been plugged on both sides of Bayou Grande Chenier. The plugs are constructed with soil and will need periodic maintenance to prevent wash out (figure 10). Marsh vegetation in this area is 60% marshhay cordgrass with approximately 30% smooth cordgrass and 10% salt grass.

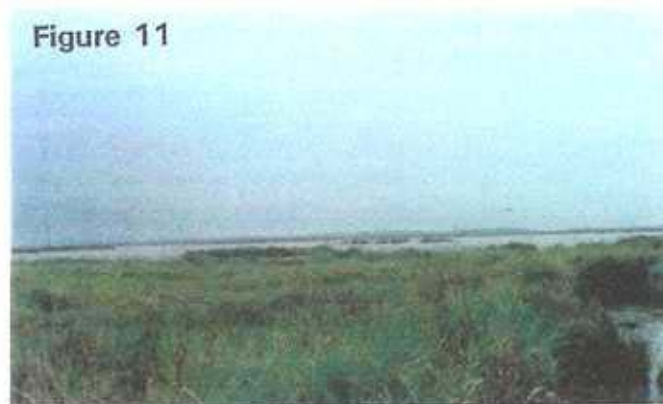
Figure 11

11. Station 6 is in an area of broken marsh that has converted into large open lakes. Photo direction to the southeast	20
12. Aquatic vegetation in the area was widgeongrass and was found in only a few sites, Station 7. Photo direction is to the north	20

Station 6 is near the outfall center in a section of intensive oil and gas operations. Several large ponds have developed (figure 11). Vegetation in this area has approximately 45% marshhay cordgrass and 45% smooth cordgrass with a good stand of salt grass (10%) along the edge of the levees.

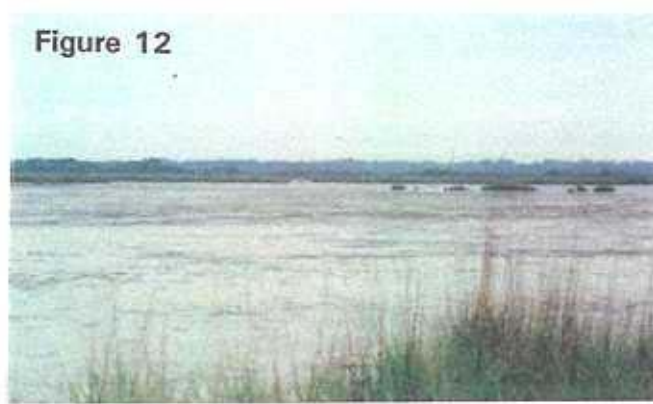
Figure 12

Station 7 is at an area where large ponds exist on the west side of Grand Bayou. Pond areas were supporting good stands of widgeongrass (*Ruppia maritima*) (100%) and approximately 80% of the ponds were covered (figure 12). Salinity in this area was 12.5 ppt. The spoil bank along the edge of the ponds was covered with 80% salt grass, 10% marshhay cordgrass, and 10% smooth cordgrass.

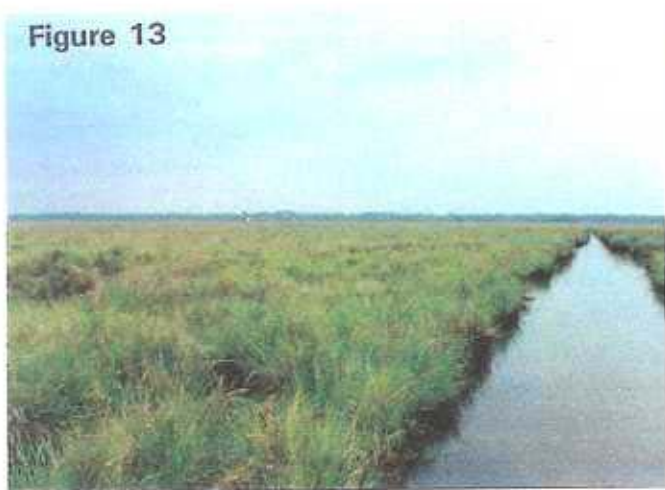
Figure 13

13. A large number of small ditches exist along the river side of Grand Bayou, Station 8. Photo direction is to the north 21

Station 8 is in the mouth of a small ditch off Grand Bayou which leads from the high ground near the back protection levee to Grand Bayou (figure 13). Vegetation in this area was 60% smooth cordgrass, 35% salt grass, and 5% marshhay cordgrass. Salinity was 12 ppt. Marshhay cordgrass was present but in minor amounts. A large pumping station discharges into the marsh in this area. There was no indication from the vegetation that enough freshwater was available to influence the brackish-saline marsh plant species composition.

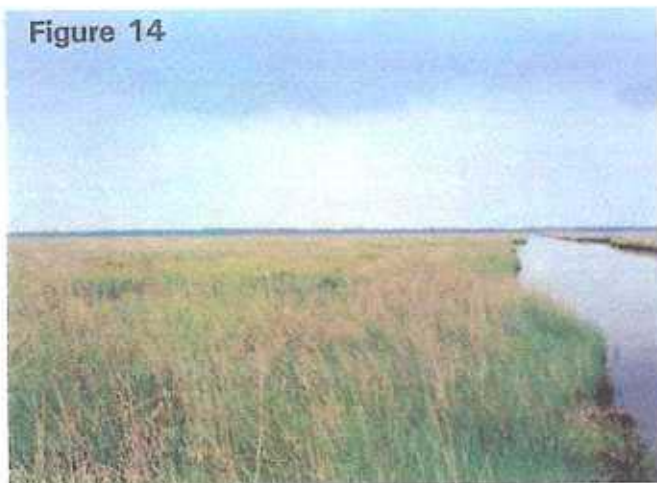
Figure 14

14.	Some of the ditches that empty into Grand Bayou from the river terrace are quite large and allow for extensive interchange of water, Station 9. Photo direction is to the north	21

Station 9 is in a small drainage canal on the lower side of Grand Bayou village and is between the bayou and the Mississippi River. Salinity in this canal was 15 ppt and the marsh vegetation was 70% smooth cordgrass, 20% salt grass, 5% marshhay cordgrass, and 5% saltmarsh bulrush (figure 14). Very little marshhay cordgrass was noted and some saltmarsh bulrush was observed. These species were in scattered sprigs in the smooth cordgrass.

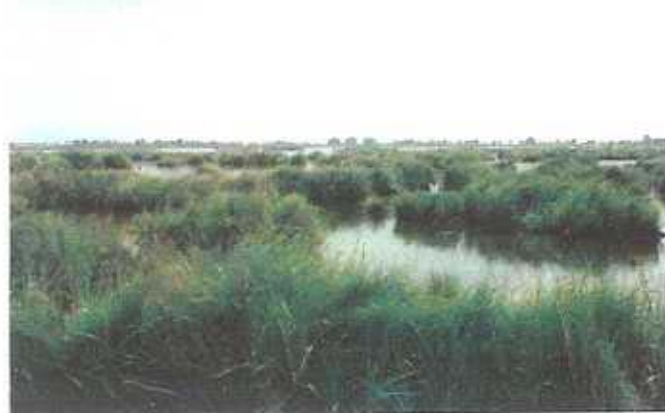
Figure 15

15.	Broken marsh at Station 10 looking toward Grand Bayou village from the river side. Photo direction is to the southeast	21
16.	The Grand Bayou remote sensing facility adjacent to the Jefferson Lake Sulphur Company canal. Photo direction is to the east	21
	Station 11 is near the Hermitage Ridge complex west of Lake Hermitage in marshhay cordgrass. Photo direction is to the northwest	21

ppt and the marsh was very broken. Approximately 70% of the area was open water and the plant communities were composed mainly of smooth cordgrass (70%) and salt grass (20%), with only 10% marshhay cordgrass (figure 15). Widgeongrass covered approximately 60% of the pond areas.

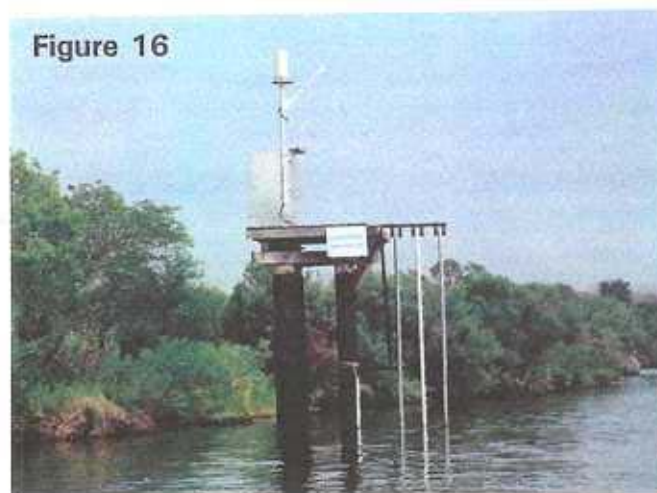
Figure 16

A remote sensing station is located in Grand Bayou near the point where the Jefferson Lake Sulphur Company Canal crosses (figure 16). This unit will provide excellent information that will be used to guide area management functions regarding water quality and levels.

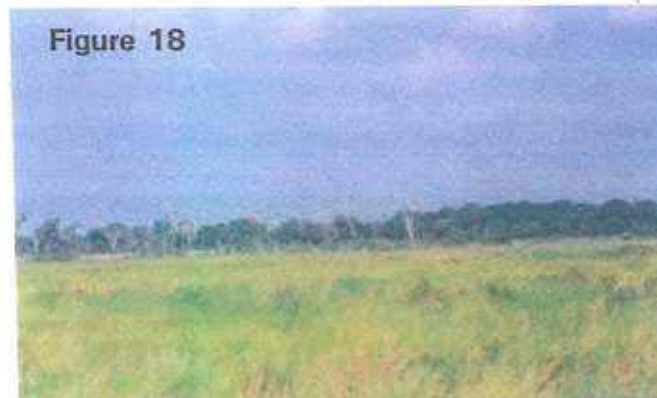
Figure 18

18.	From Station 12, dead trees along the Hermitage Ridge are visible. Photo direction is to the southwest	21
19.	Small patches of three-cornered grass are mixed with marshhay cordgrass at Station 13, north of Lake Hermitage. Photo direction is to the northwest	22
	A private drainage station on Citrus Lands of Louisiana empties into a bayou leading into Lake Hermitage, Station 14. Photo direction is to the northeast	22

killed along the ridge system from this point south because of subsidence and saltwater intrusion (figure 18).

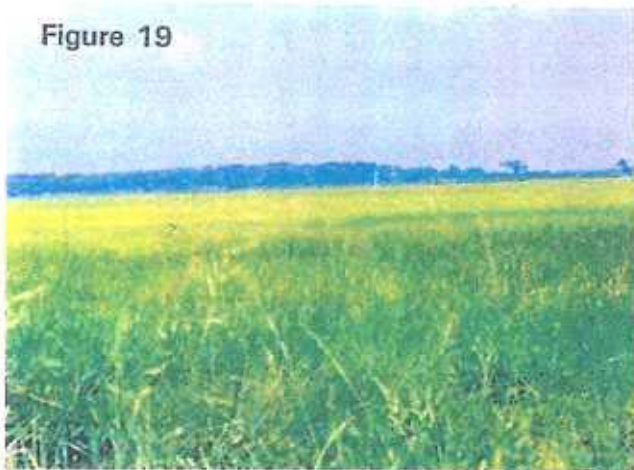
Figure 19

Station 13 is west of a small ditch out of the north end of Lake Hermitage. Salinity was 10 ppt and the marsh vegetation was 90% marshhay cordgrass with small patches of three-cornered grass (5%) and smooth cordgrass (5%) (figure 19). A few muskrat houses were observed in this area.

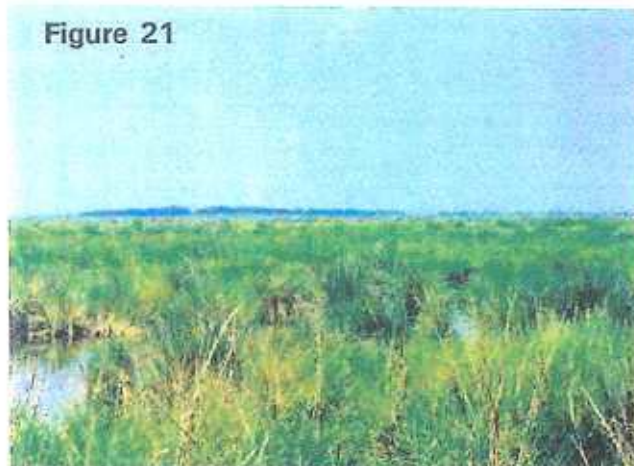
Figure 21

21.	Station 15 is located along the area where smooth cordgrass and marshhay cordgrass appear to be evenly distributed in the plant composition. Photo direction is to the southwest	22

Station 15 is in ponds east of Lake Hermitage and near the Citrus Lands of Louisiana levee system. This site is where marshhay cordgrass dominance (45%) gives way to smooth cordgrass (55%) (figure 21). The large trees visible in the background of this figure are where the Jefferson Lake Sulphur Company Canal crosses the Bayou Grande Chenier ridge system. Salinity in the area was 9 ppt.

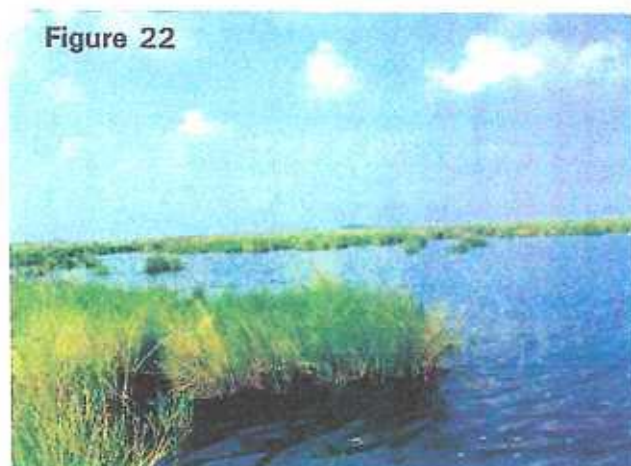
Figure 22

22.	Pond edges are broken in the area of Station 16. Photo direction is to the southwest	22
	Deep water is found at the break in the spoil banks of many oil and gas canals, and contribute to tidal exchange, Station 17. Photo direction is to the northwest	22
	At the site where the Southern Natural Gas pipeline crosses Bayou Grande Chenier. Photo direction is to the west	22

Station 16 is north of the Jefferson Lake Sulphur Company Canal. This site has broken marsh vegetation along the edge of natural ponds and the dominate vegetation is smooth cordgrass (60%) with a decreased percentage of marshhay cordgrass (40%) (figure 22). Salinity was 10.5 ppt this area. Tidal action in this area is excessive, and openings of water depth. Salt grass is established along pond and canal edges.

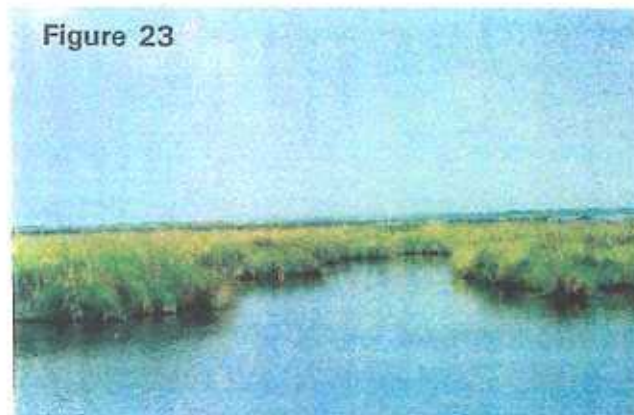
Figure 23

Station 17 is at the end of a mineral access canal where an existing Shell Pipeline crosses (figure 23). Salinity in this area was 12 ppt and some widgeongrass was noted in the edge of the ponds. Marsh vegetation was smooth cordgrass (80%) and marshhay cordgrass (20%). Salt grass was also present in minor amounts along the pond bank edges.

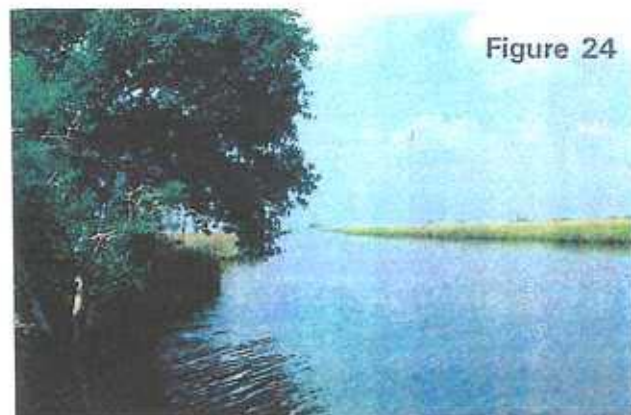
Figure 24

Station 18 is located where a Southern Natural Gas Pipeline crosses the Bayou Grande Chenier ridge system (figure 24). A bulkhead and rip-rap pipeline closure are approximately 1000 ft southeast of the natural ridge system. An opening has been created in the structure and is serving as a small weir (figure 25). Salinity in the area was 13.5 ppt and the marsh vegetation was dominated by 95% smooth cordgrass and 5% marshhay cordgrass. Tidal action was moving into the area during field observation on June 24, 1992.

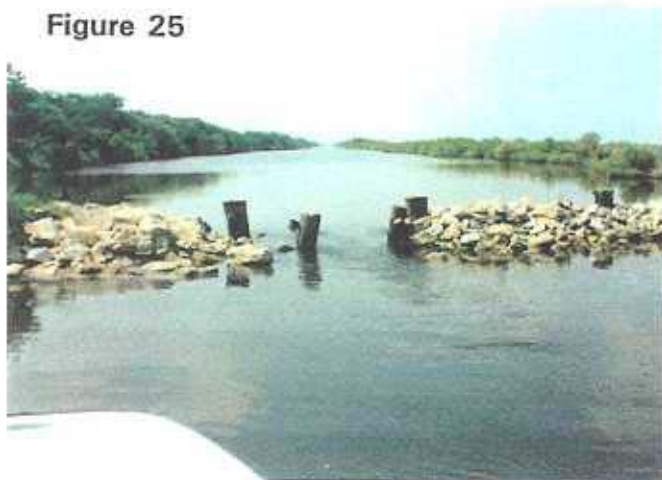
Figure 25

25.	Station 18 is near the S.N.G. rip rap weir and Bayou Grande Chenier. Photo direction is to the southeast	23
26.	Station 19 is at the intersection of Johnson Bayou and Bayou Grande Chenier. Photo direction is to the southwest	23

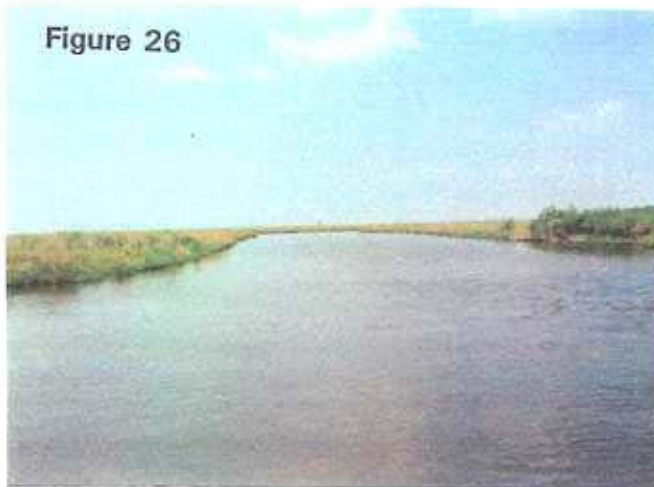
Figure 26

Station 19 is located where Johnson Bayou crosses Bayou Grande Chenier (figure 26). Some live oak, yaupon, toothache, hackberry, and wax myrtle trees are still alive on the natural bayou banks (figure 27). Such sites may reveal archeological middens. Marsh vegetation was dominated by smooth cordgrass (95%) with 5% marshhay cordgrass. The water salinity was 14 ppt. This site should be included in any outfall management plan calling for structural control of saltwater intrusion.

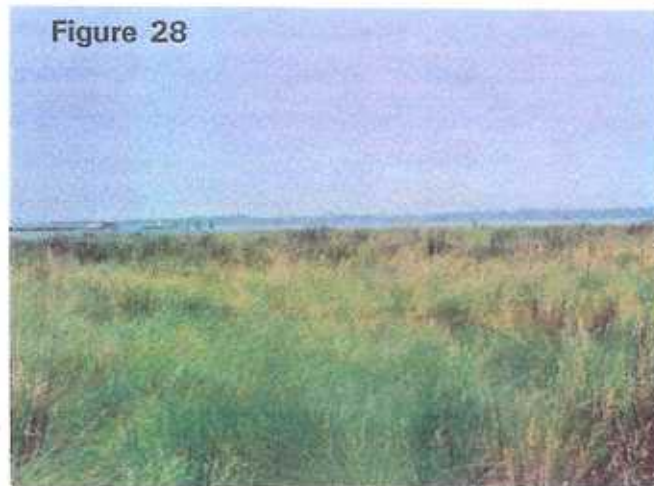
Figure 28

Station 21 is near where Willow Bayou empties into Lake Hermitage.

this portion of the Lake Hermitage watershed. The marsh is very broken and the natural waterway is no longer discernable from the ponds (figure 28). Vegetation in the area is 50% smooth cordgrass and 50% marshhay cordgrass. Salinity was 10 ppt and tidal action was very noticeable.
