Sabine National Wildlife Refuge Erosion Protection (CS-18)

Project Status

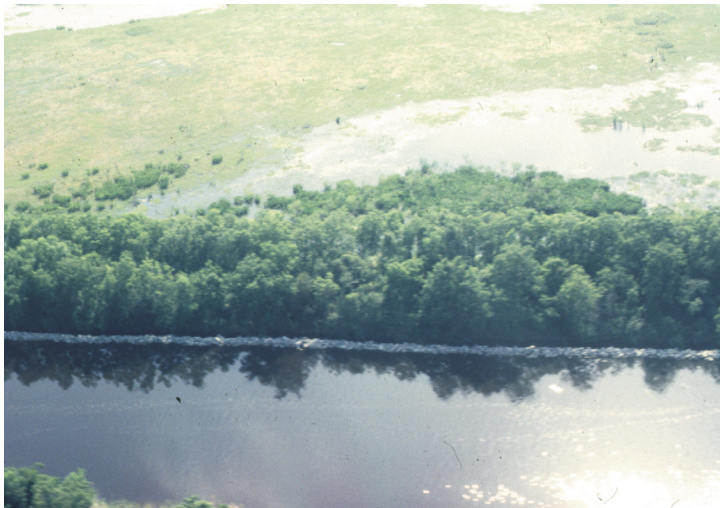
Sabine National Wildlife Refuge Erosion Protection looking eastward across the Burton-Sutton Canal into Pool 3. The continuous rock breakwater is seen along the shoreline in the lower third of the photo.

A 5.5 mile-long, continuous, free-standing rock dike was built along the east bank of the Burton-Sutton Canal and forms the western boundary of Pool 3.

The levee appears to be stable, and the rock dike seems to be in good condition at this time. Future inspections of the project area will be conducted at regular intervals to document the condition of the rock breakwater and any required maintenance.

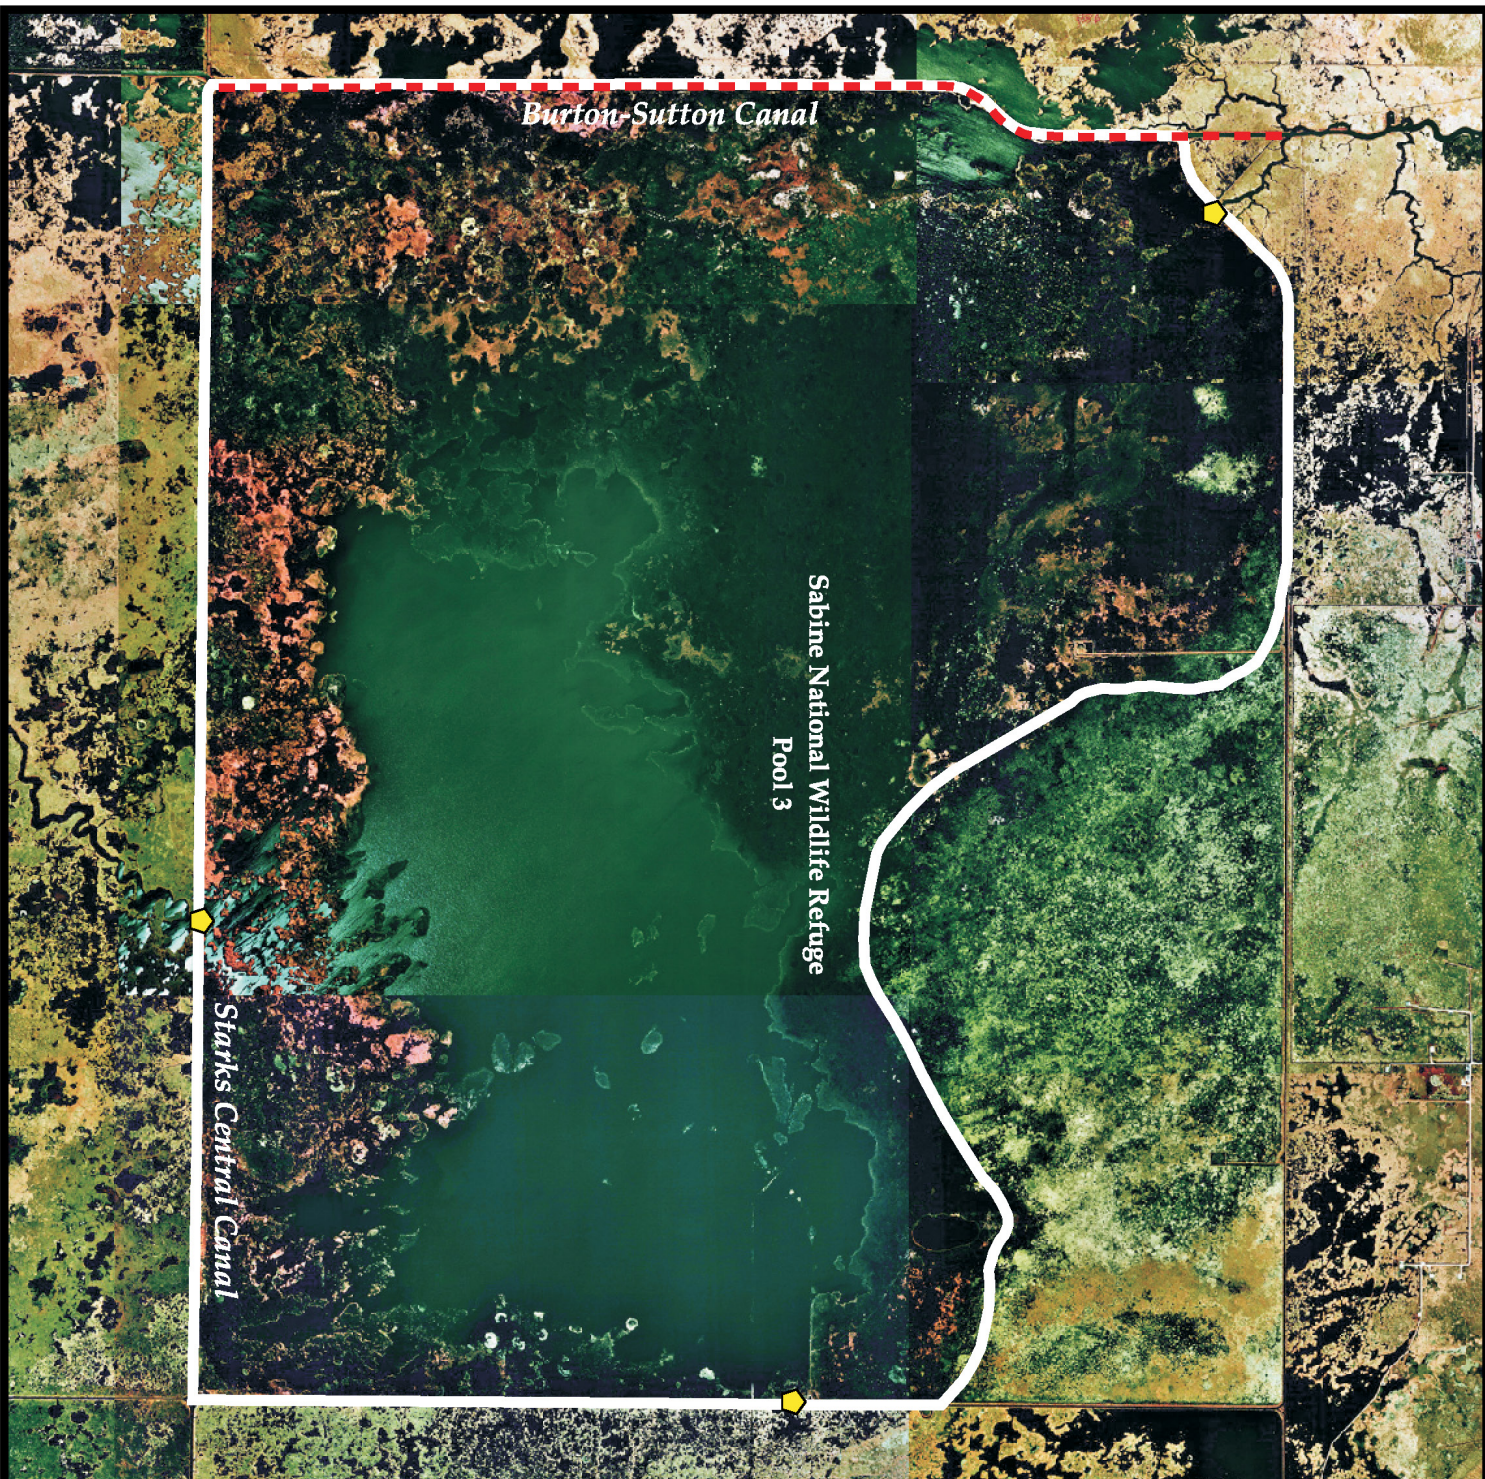
Sabine National Wildlife Refuge Refuge Erosion Protection (CS-18)

Weir

Shoreline Protection

Project Boundary
