Sabine National Wildlife Refuge Erosion Protection (CS-18)

Project Status

Approved Date: 1991 **Project Area:** 13,000 acres
Approved Funds: \$1 M **Total Est. Cost:** \$1 M
Net Benefit After 20 Years: 5,542 acres
Status: Completed Marsh 1995
Project Type: Shoreline Protection
PPL #: 1

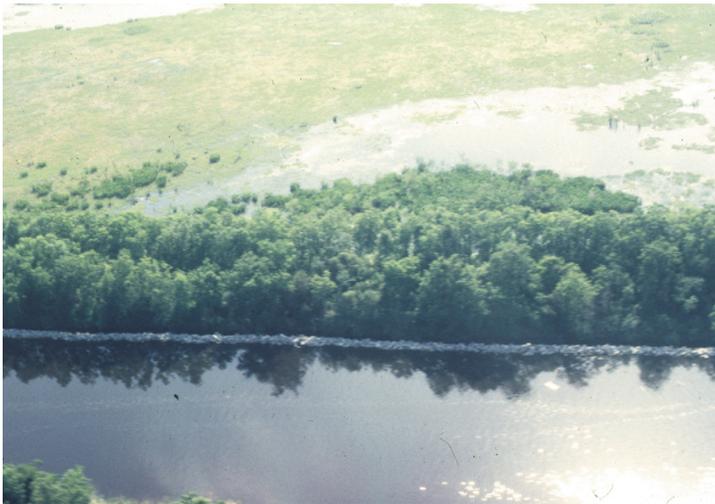
Sabine National Wildlife Refuge Erosion Protection looking eastward across the Burton-Sutton Canal into Pool 3. The continuous rock breakwater is seen along the shoreline in the lower third of the photo.

A 5.5 mile-long, continuous, free-standing rock dike was built along the east bank of the Burton-Sutton Canal and forms the western boundary of Pool 3.

The levee appears to be stable, and the rock dike seems to be in good condition at this time. Future inspections of the project area will be conducted at regular intervals to document the condition of the rock breakwater and any required maintenance.
