Sabine National Wildlife Refuge Erosion Protection (CS-18)

Project Status

Project Type: Shoreline Protection

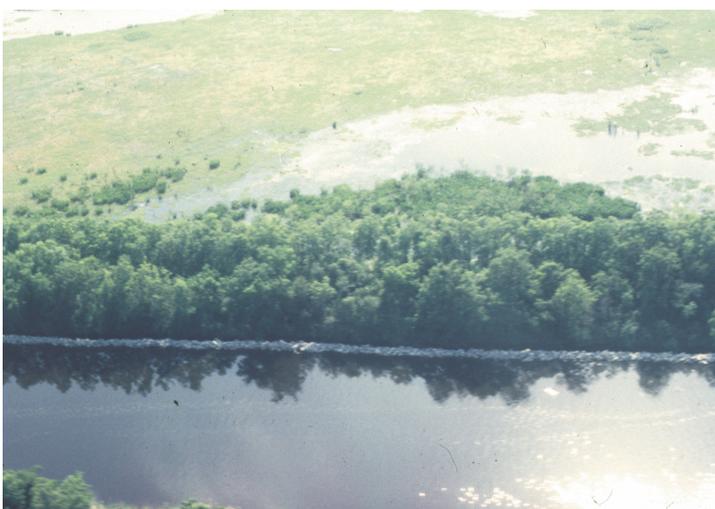
Sabine National Wildlife Refuge Erosion Protection looking eastward across the Burton-Sutton Canal into Pool 3. The continuous rock breakwater is seen along the shoreline in the lower third of the photo.

A 5.5 mile-long, continuous, free-standing rock dike was built along the east bank of the Burton-Sutton Canal and forms the western boundary of Pool 3.

The levee appears to be stable, and the rock dike seems to be in good condition at this time. Future inspections of the project area will be conducted at regular intervals to document the condition of the rock breakwater and any required maintenance.

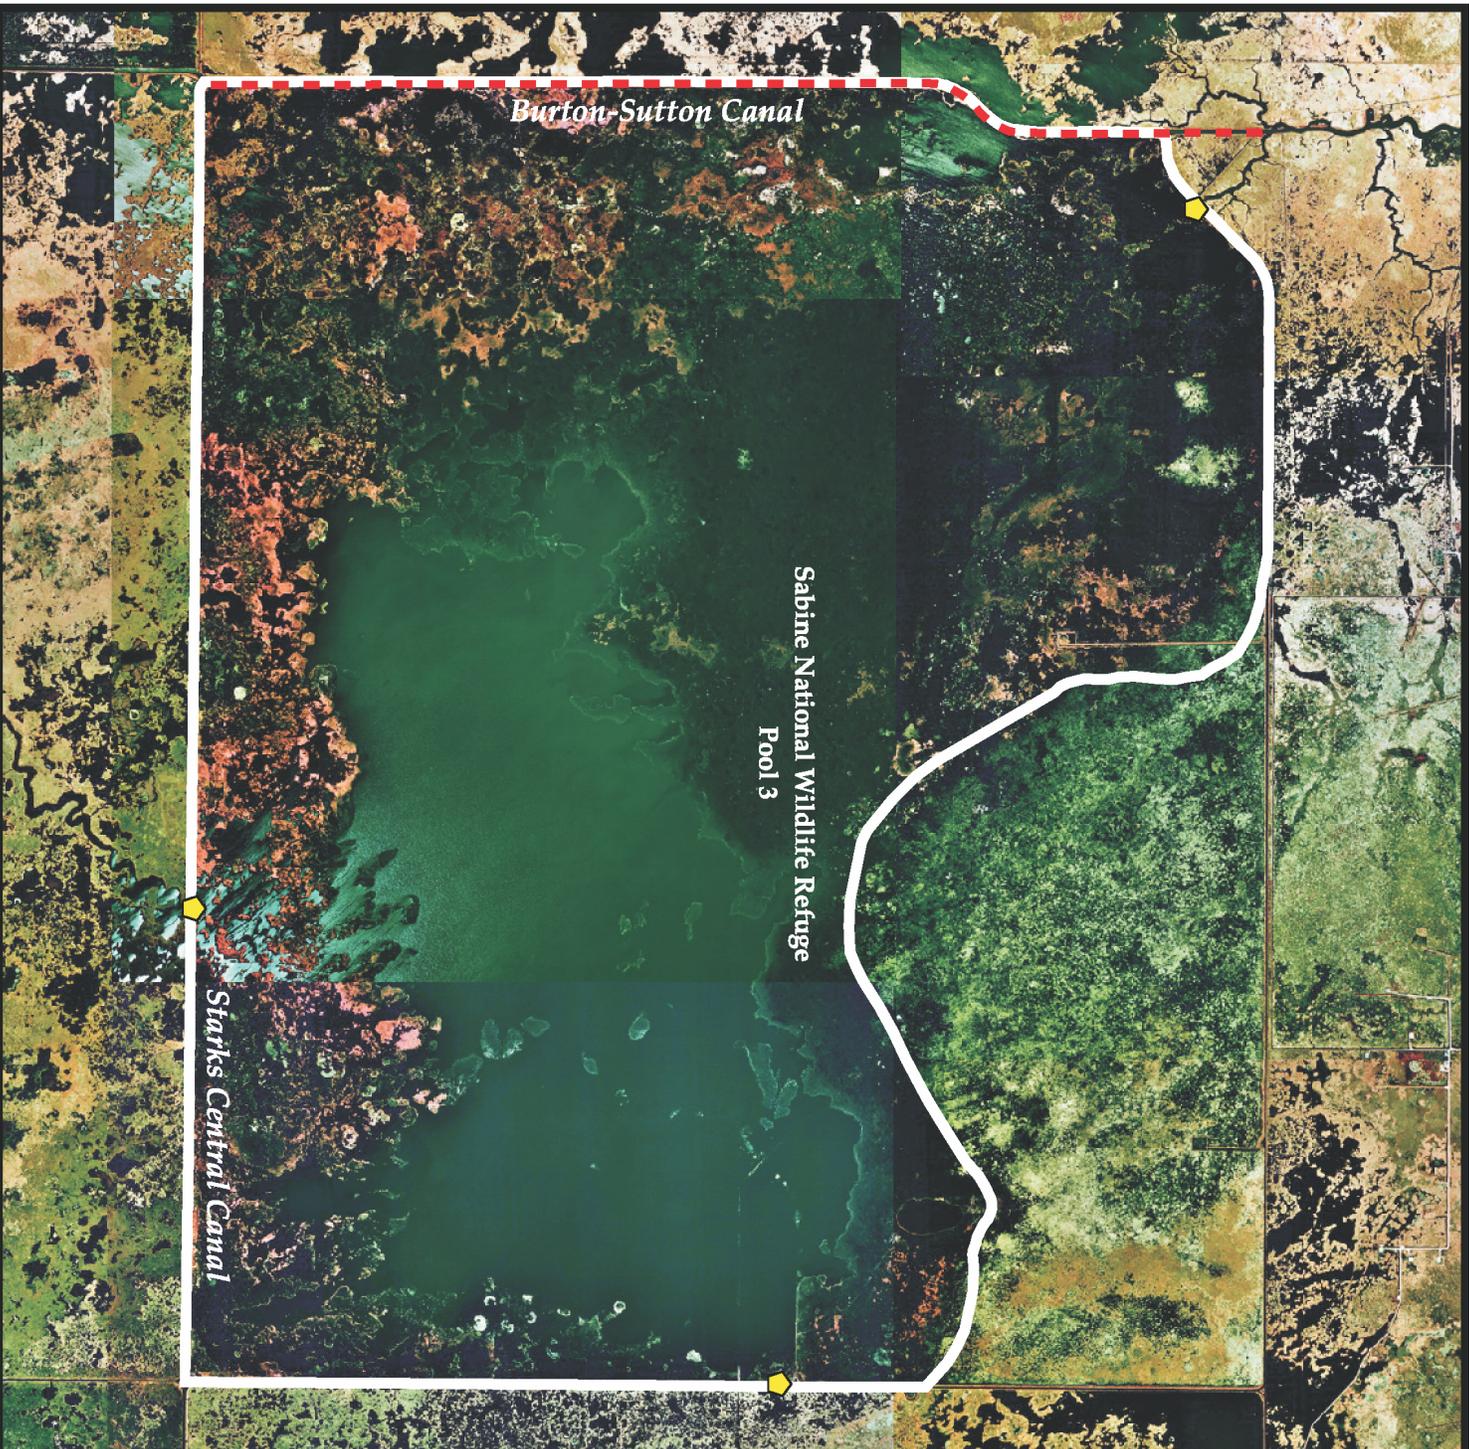
Refuge Erosion Protection (CS-18)

Weir

Shoreline Protection

Project Boundary
