East Mud Lake Marsh Management (CS-20)

Project Status

Project Type: Marsh Management

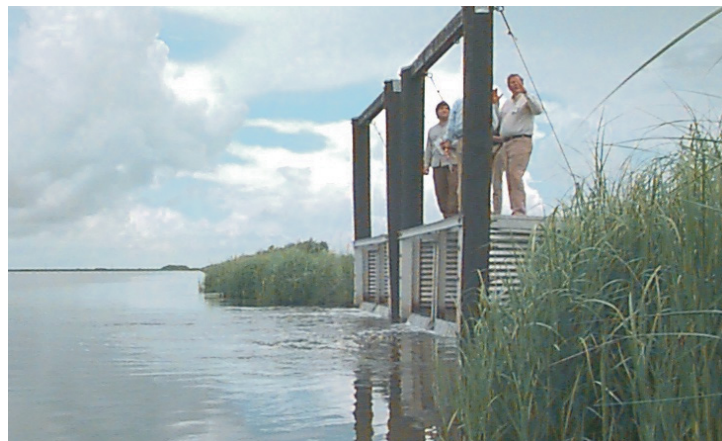
A gate in operation. A healthy stand of cordgrass protects the gate's flanks.

The project was designed to stabilize salinity and water levels while ensuring the movement of commercial fish species into and out of the project area. Earthen plugs, flapgated culverts, variable crest culverts, and gated culverts were constructed and can be used to manage the flow of water into and out of the project area. In treatment unit 1, the structures have slots allowing ingress and egress of commercial fish species. Treatment unit 2 structures have drawdown capabilities, encouraging shallow water areas to revert to emergent vegetation. In both treatment units, the structures are closed when salinities exceed 15 parts per thousand (ppt).
