# East Mud Lake Marsh Management (CS-20)

## Project Status

**Project Type:** Marsh Management

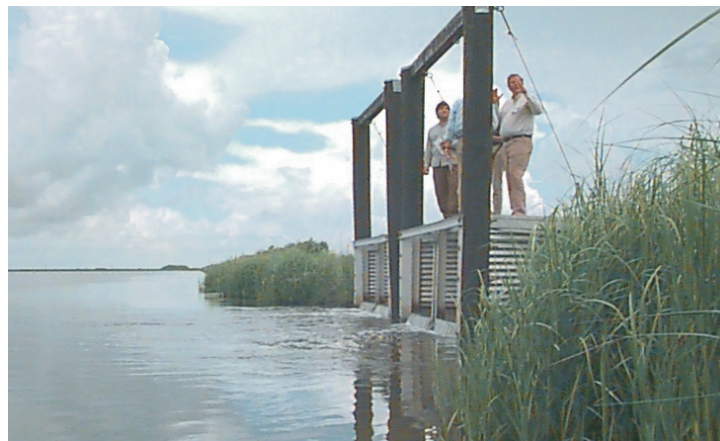
A gate in operation. A healthy stand of cordgrass protects the gate's flanks.

The project was designed to stabilize salinity and water levels while ensuring the movement of commercial fish species into and out of the project area. Earthen plugs, flapgated culverts, variable crest culverts, and gated culverts were constructed and can be used to manage the flow of water into and out of the project area. In treatment unit 1, the structures have slots allowing ingress and egress of commercial fish species. Treatment unit 2 structures have drawdown capabilities, encouraging shallow water areas to revert to emergent vegetation. In both treatment units, the structures are closed when salinities exceed 15 parts per thousand (ppt).

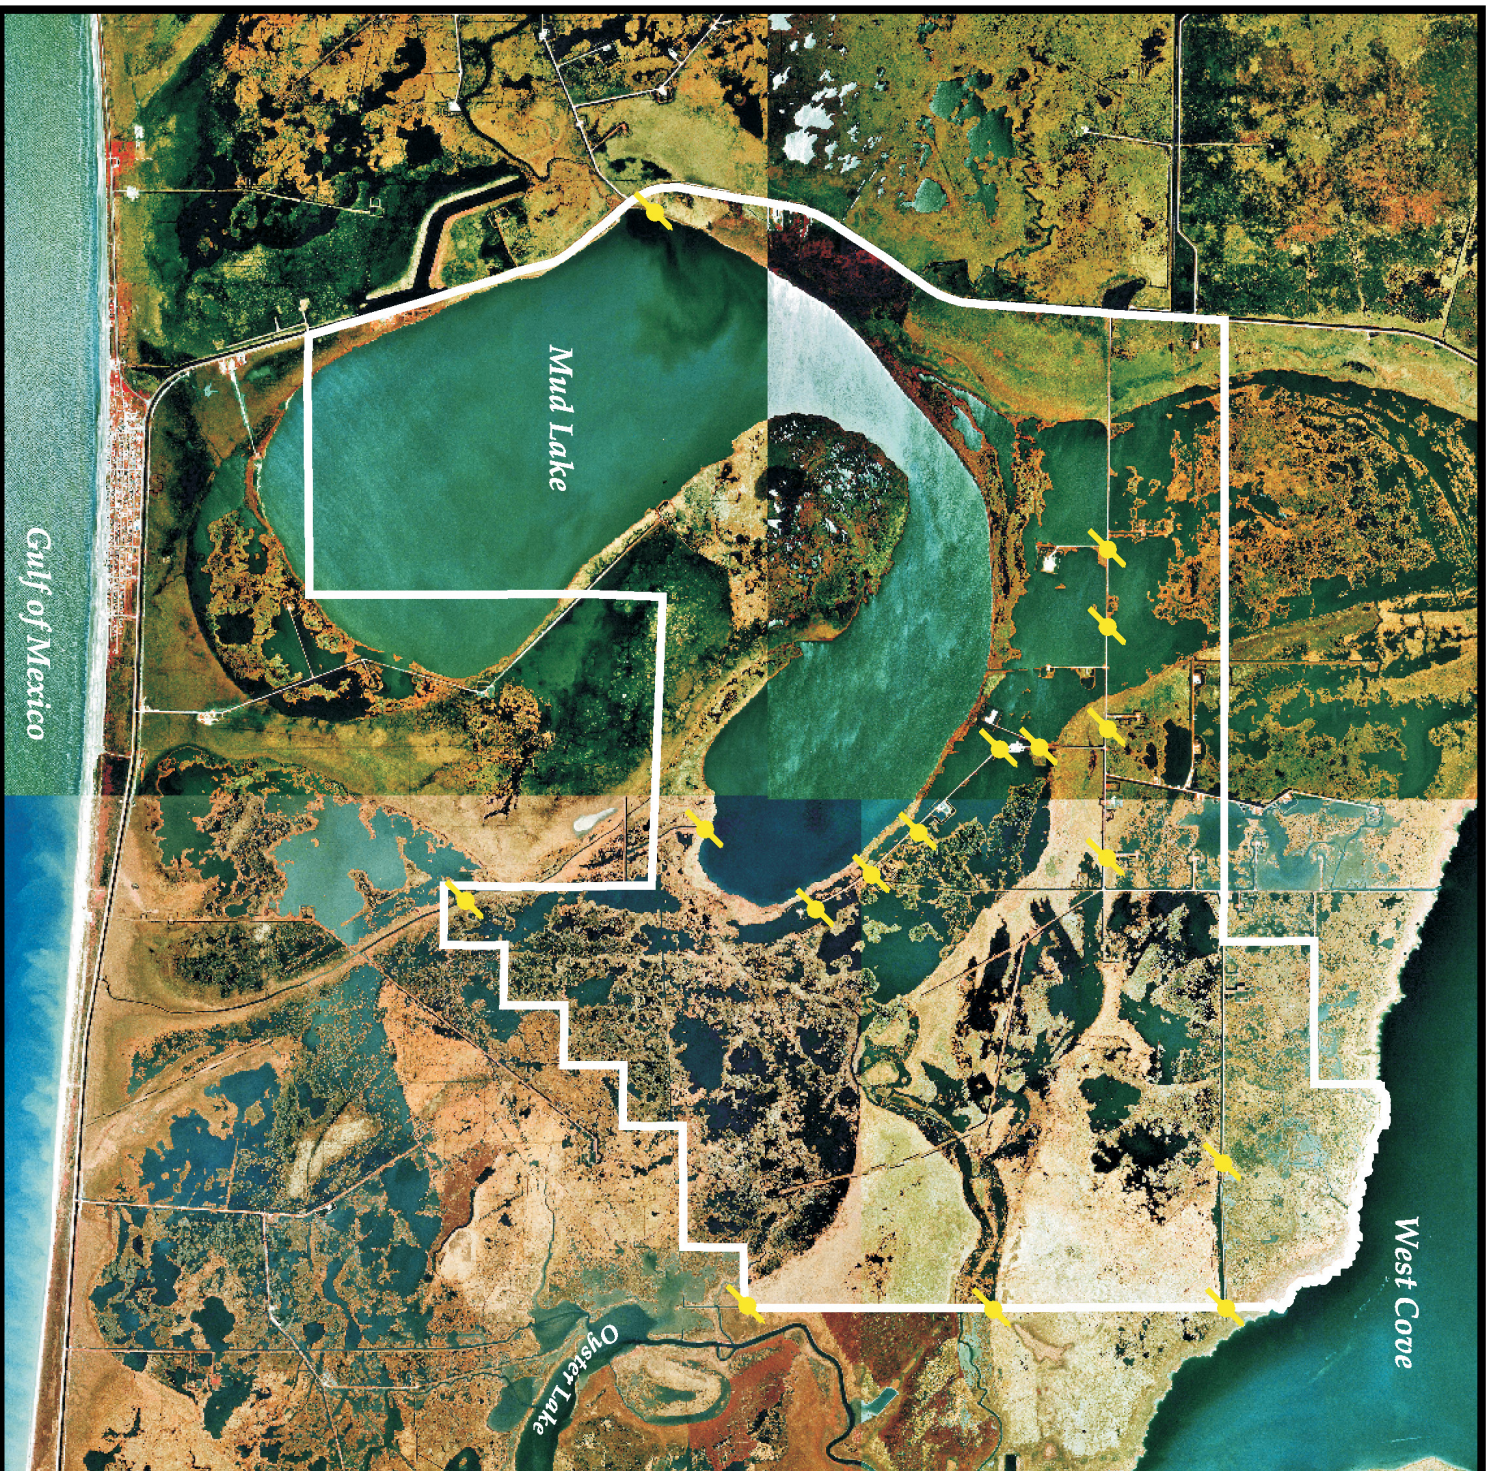
# **East Mud Lake Marsh Management (CS-20)**

Water Control Structure
-

Project Boundary
