Freshwater Introduction South of Highway 82 (ME-16)

Project Status

Approved Date: 2000 **Project Area:** 19,988 acres
Approved Funds: \$6 M **Total Est. Cost:** \$6 M
Net Benefit After 20 Years: 296 acres
Status: Completed 2006
Project Type: Hydrologic Restoration
PPL #: 9

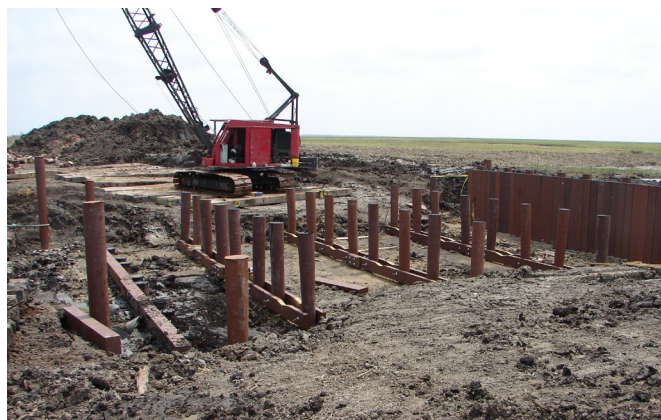
Early stages of the construction of a water control structure to move freshwater to brackish marshes to the south.

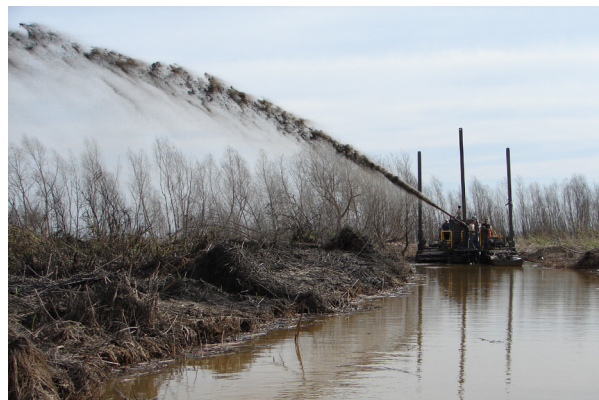
Small spray dredge enlarging the Grand Volle Ditch and spraying the spoil over existing marsh.

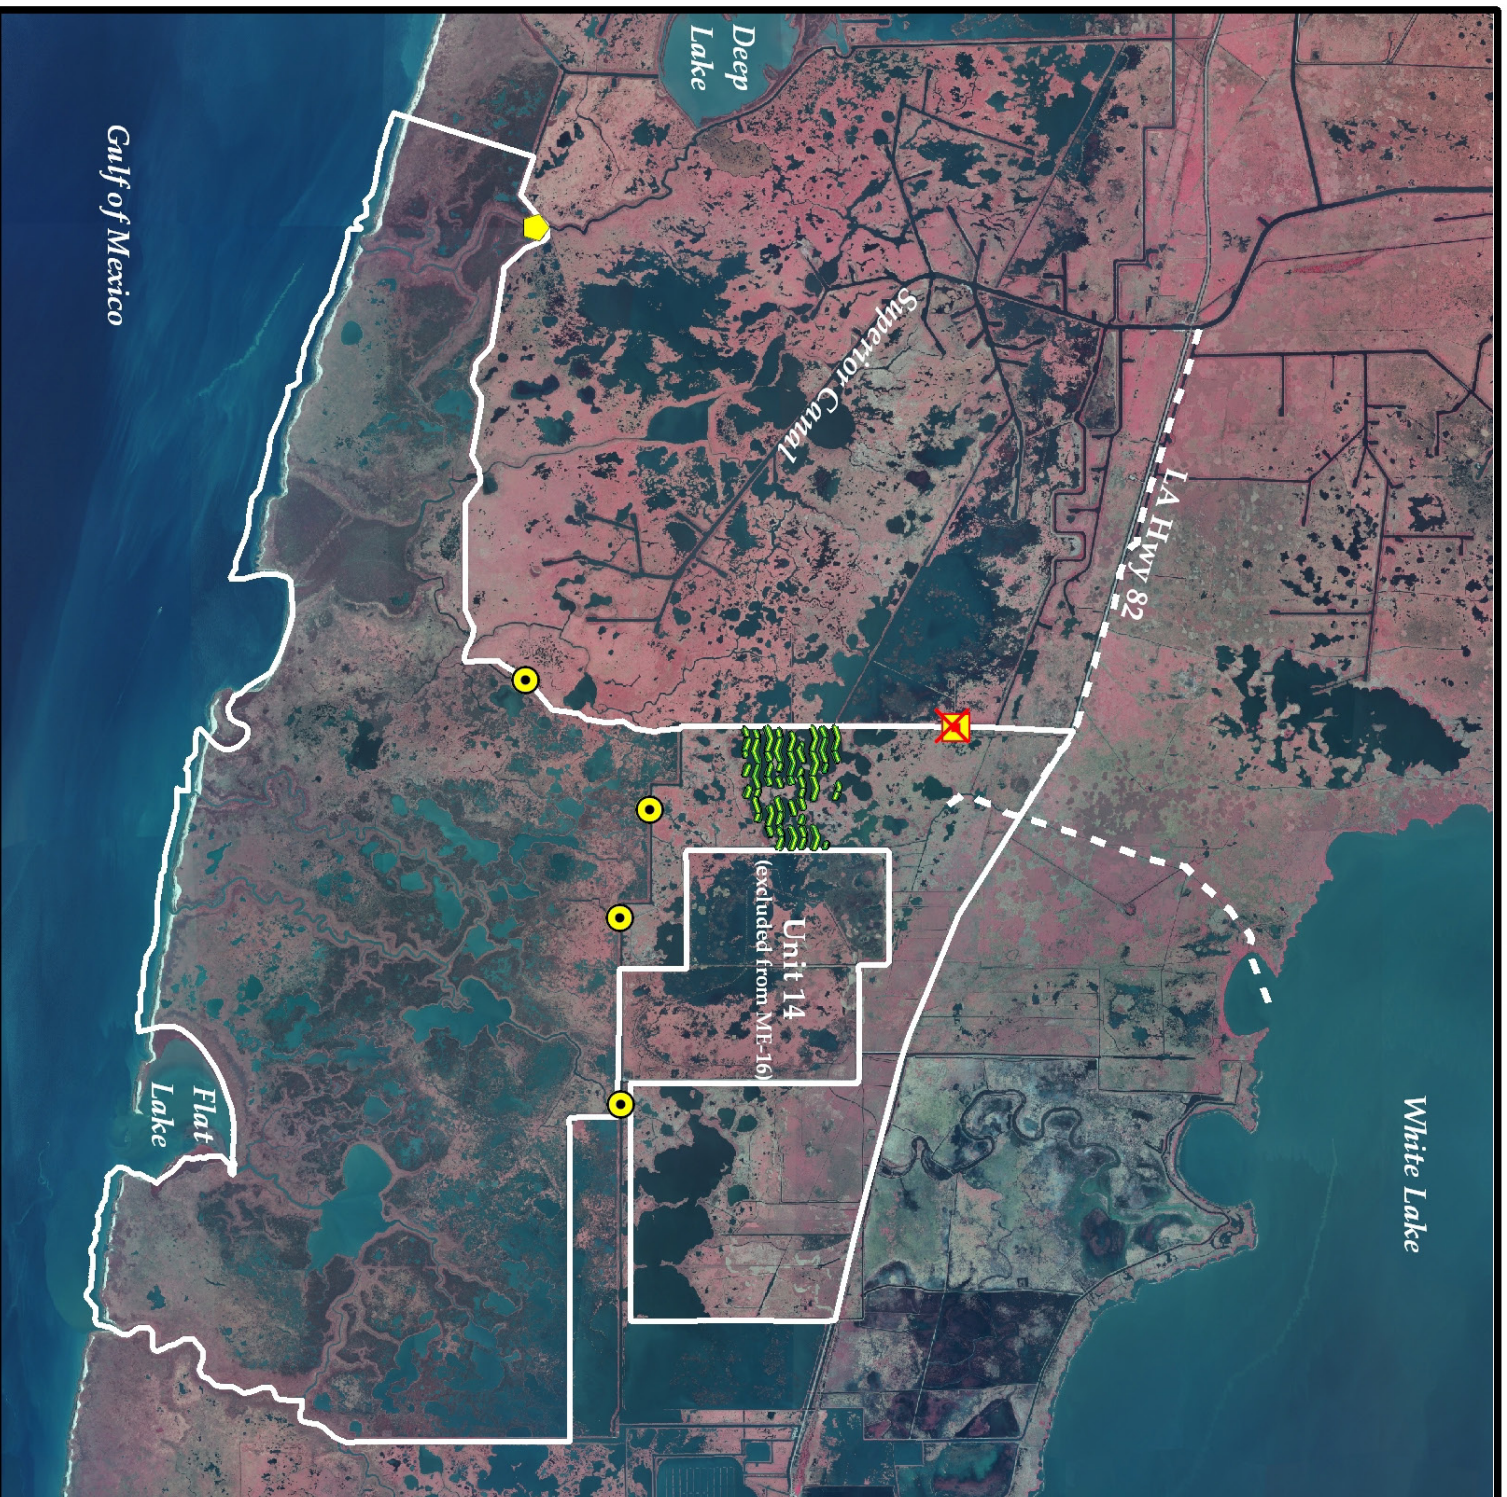
Freshwater Intrusion South of Highway 82 (ME-16)

Culvert
-

Remove Existing Plug
-

Weir
-

Dredge Channels
-

Terrace
-

Project Boundary

The project components included: installation of four freshwater introduction water control structures; plug removal; modification of the Little Constance structure; and canal enlargement north and south of Louisiana Highway 82 to allow water flow under the highway from the Lakes Subbasin south into the Chenier Subbasin. A small "spray dredge" was used to enlarge the freshwater introduction channels that spread the dredged sediment in a thin layer over the existing marsh eliminating spoil banks and impacts to adjacent marsh. Higher water levels in the Lakes Subbasin afford the opportunity to divert water into the Chenier Subbasin. 26,000 linear feet of "duck-wing" earthen terraces were also constructed west of Rockefeller's Unit 14 impoundment.
