Rockefeller Refuge Gulf Shoreline Stabilization (ME-18)

Project Status

Project Type: Shoreline Protection

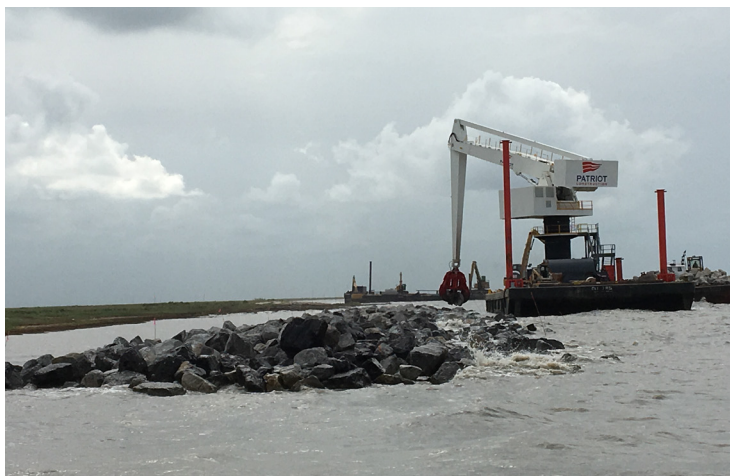
Constructing shoreline protection along the gulf shoreline of Rockefeller Wildlife Refuge.

The project constructed a shoreline protection breakwater along the Rockefeller Wildlife Refuge gulf shoreline. A lightweight aggregate core rock breakwater was constructed due to soft soils in the area. The original 3-mile long project was expanded during construction to build an additional 6,000 linear feet of breakwater. The Louisiana Department of Wildlife and Fisheries (LDWF) contributed funding for the expansion. The breakwater consists of encapsulated lightweight aggregate, bedding stone, and large armor stone and has a 65- to 70-foot bottom width and a 18-foot crown width. The project is designed to reduce shoreline retreat, and promote shallowing and natural vegetative colonization of the overwash material landward of the structure. Gaps in the breakwater facilitate movement of organisms and allow sediment-laden water behind the breakwater.

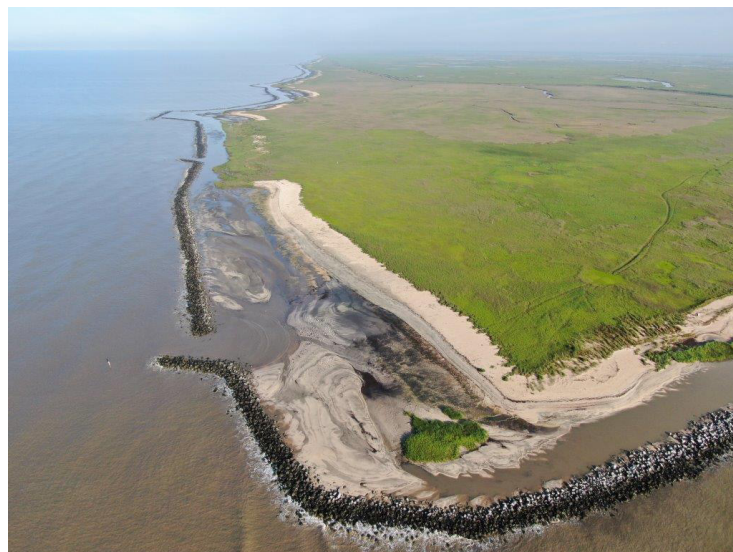
Shoreline protection breakwater constructed along the Rockefeller Wildlife Refuge gulf shoreline (LDWF aerial photo).

The project was approved for Phase 2 construction funding in January 2016. The construction contract was awarded to LeBlanc Marine, LLC. Construction on the project began in July 2018 and was completed in May 2020. A total of 20,352 linear feet of breakwater were installed along the Gulf of Mexico shoreline of Rockefeller Wildlife Refuge. Accretion of sediments and oysters have been observed behind the structure.

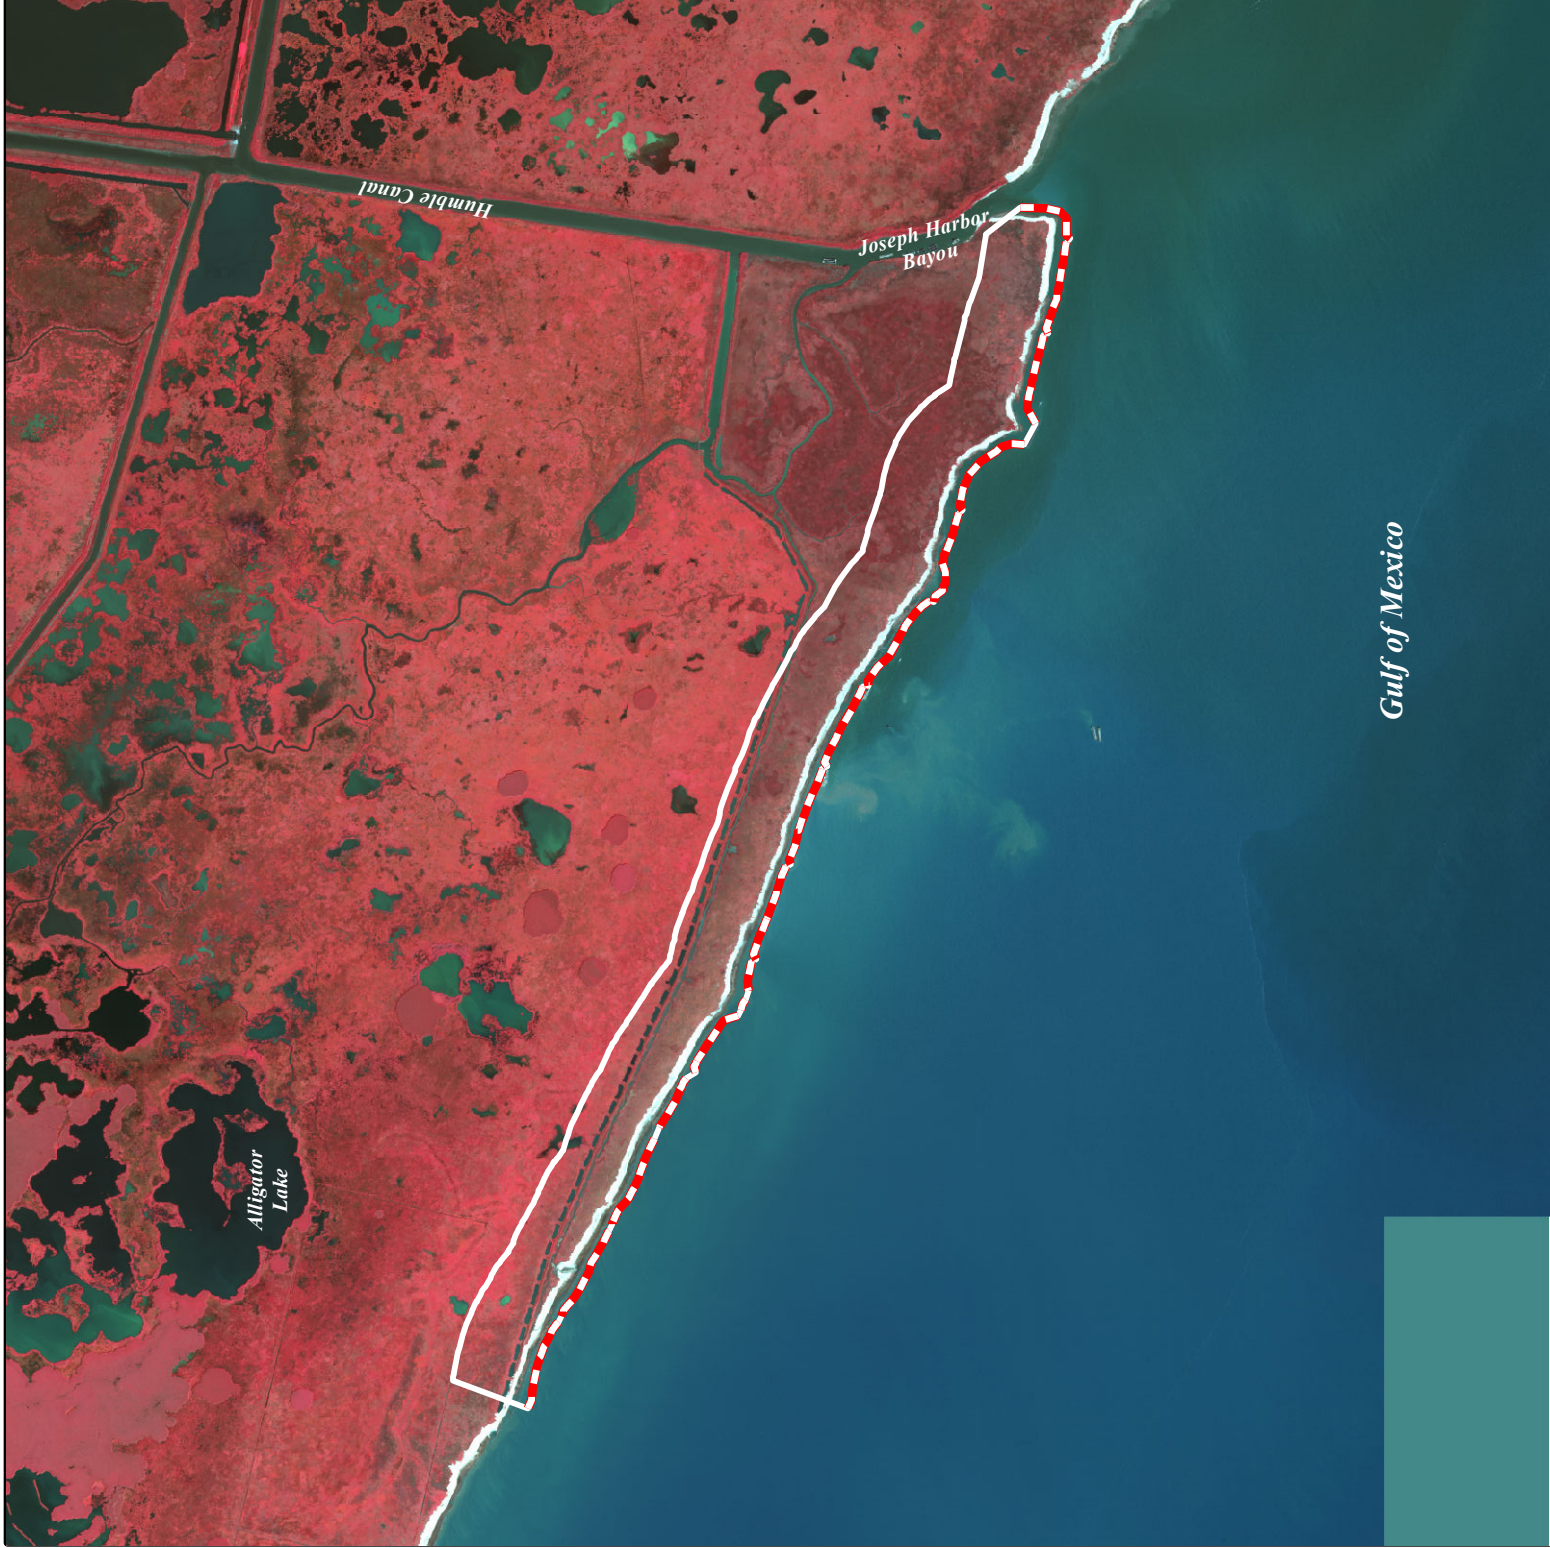
Rockefeller Refuge Gulf Shoreline Stabilization (ME-18)

- Shoreline Protection *
- Project Boundary
- *denotes proposed features
