Rockefeller Refuge Gulf Shoreline Stabilization (ME-18)

Project Status

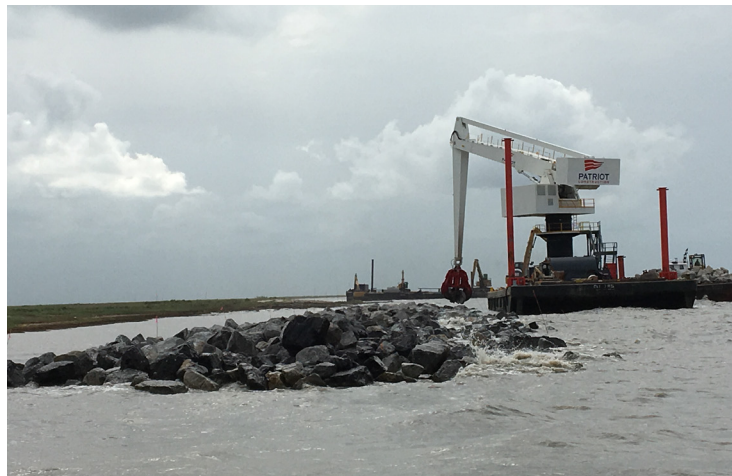
Constructing shoreline protection along the gulf shoreline of Rockefeller Wildlife Refuge.

The project constructed a shoreline protection breakwater along the Rockefeller Wildlife Refuge gulf shoreline. A lightweight aggregate core rock breakwater was constructed due to soft soils in the area. The original 3-mile long project was expanded during construction to build an additional 6,000 linear feet of breakwater. The Louisiana Department of Wildlife and Fisheries (LDWF) contributed funding for the expansion. The breakwater consists of encapsulated lightweight aggregate, bedding stone, and large armor stone and has a 65- to 70-foot bottom width and a 18-foot crown width. The project is designed to reduce shoreline retreat, and promote shallowing and natural vegetative colonization of the overwash material landward of the structure. Gaps in the breakwater facilitate movement of organisms and allow sediment-laden water behind the breakwater.

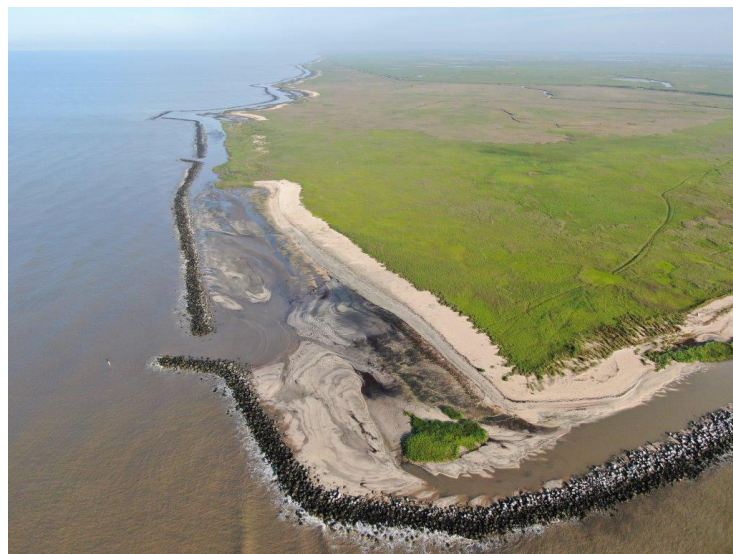
Shoreline protection breakwater constructed along the Rockefeller Wildlife Refuge gulf shoreline (LDWF aerial photo).

The project was approved for Phase 2 construction funding in January 2016. The construction contract was awarded to LeBlanc Marine, LLC. Construction on the project began in July 2018 and was completed in May 2020. A total of 20,352 linear feet of breakwater were installed along the Gulf of Mexico shoreline of Rockefeller Wildlife Refuge. Accretion of sediments and oysters have been observed behind the structure.
