East Mud Lake Marsh Management

- Selected on PPL 2
- Construction completed June 1996
- Location: Cameron Parish, north of Holly Beach

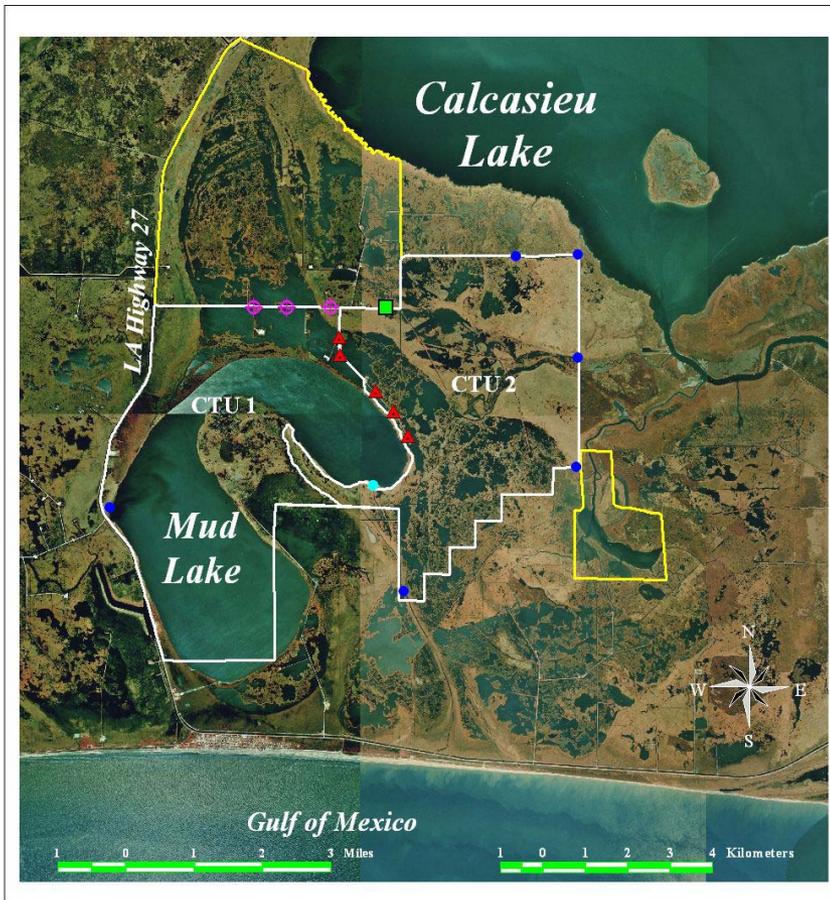
● Project Features

- ▲ – Culvert with flapgate
- – Gated culvert
- – Variable crest culvert with flapgate
- ⊕ – Variable crest culvert with slots
- – Variable crest box structure with boat bay
- Vegetative plantings (7,200 CTU 2, 480 Mud Lake)

- Four 36” corrugated aluminum pipes w/ 10ft variable crested weir inlets and 4” vertical slots
- Six 36” corrugated aluminum pipes w/ 10ft variable crested weir inlets and flap gates *(changes structure 1 and 13)
- One (1) 48” corrugated aluminum pipe w/ flap gate and screw gate
- Five (5) 24” corrugated aluminum pipes and flap gates
- Two (2) sheet pile variable crested weirs
- Three (3) earthen plugs
- 1,500 lf of levee construction
- 40,500 lf of levee rehabilitation *(added more lf due to levee degradation)
- Vegetative plantings *(reduced # planted for project and changed location of plantings)

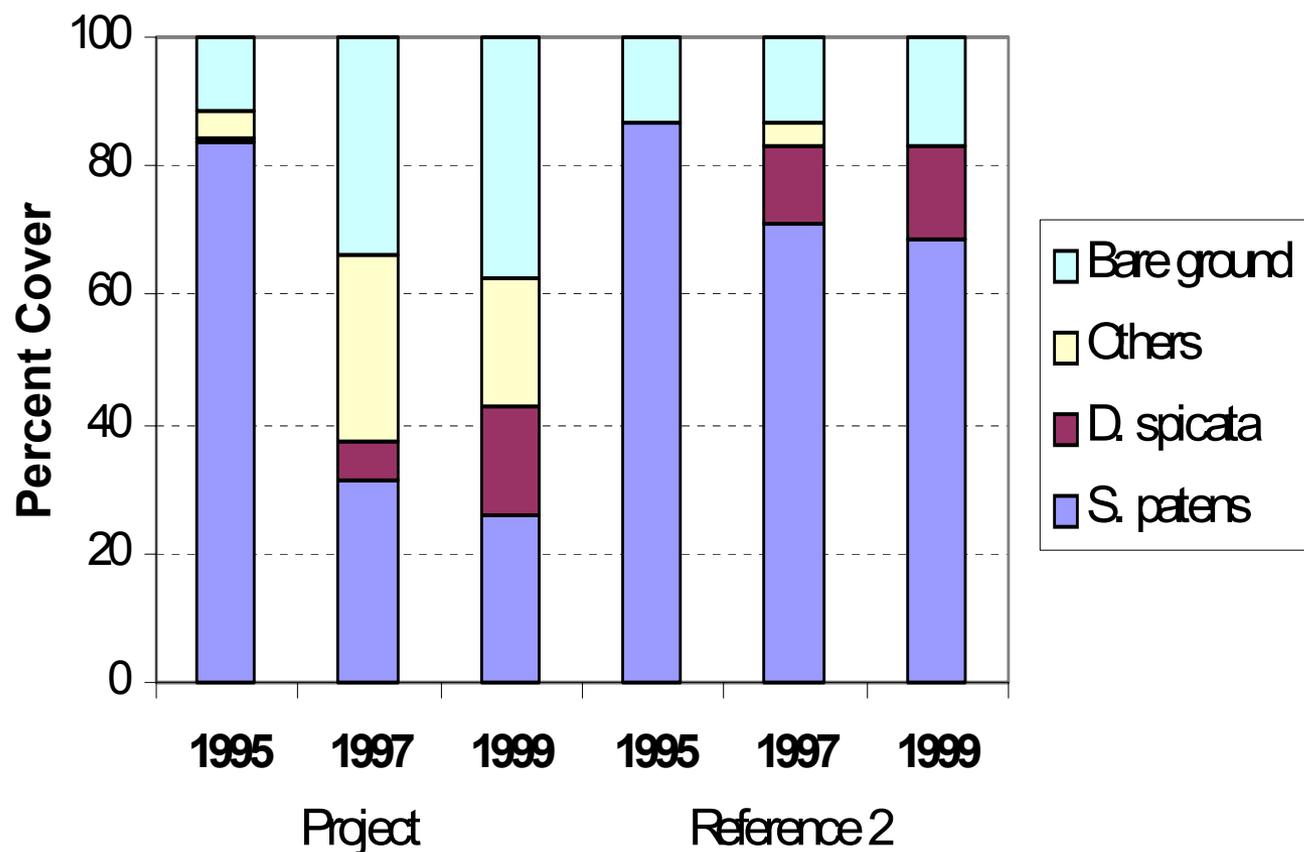
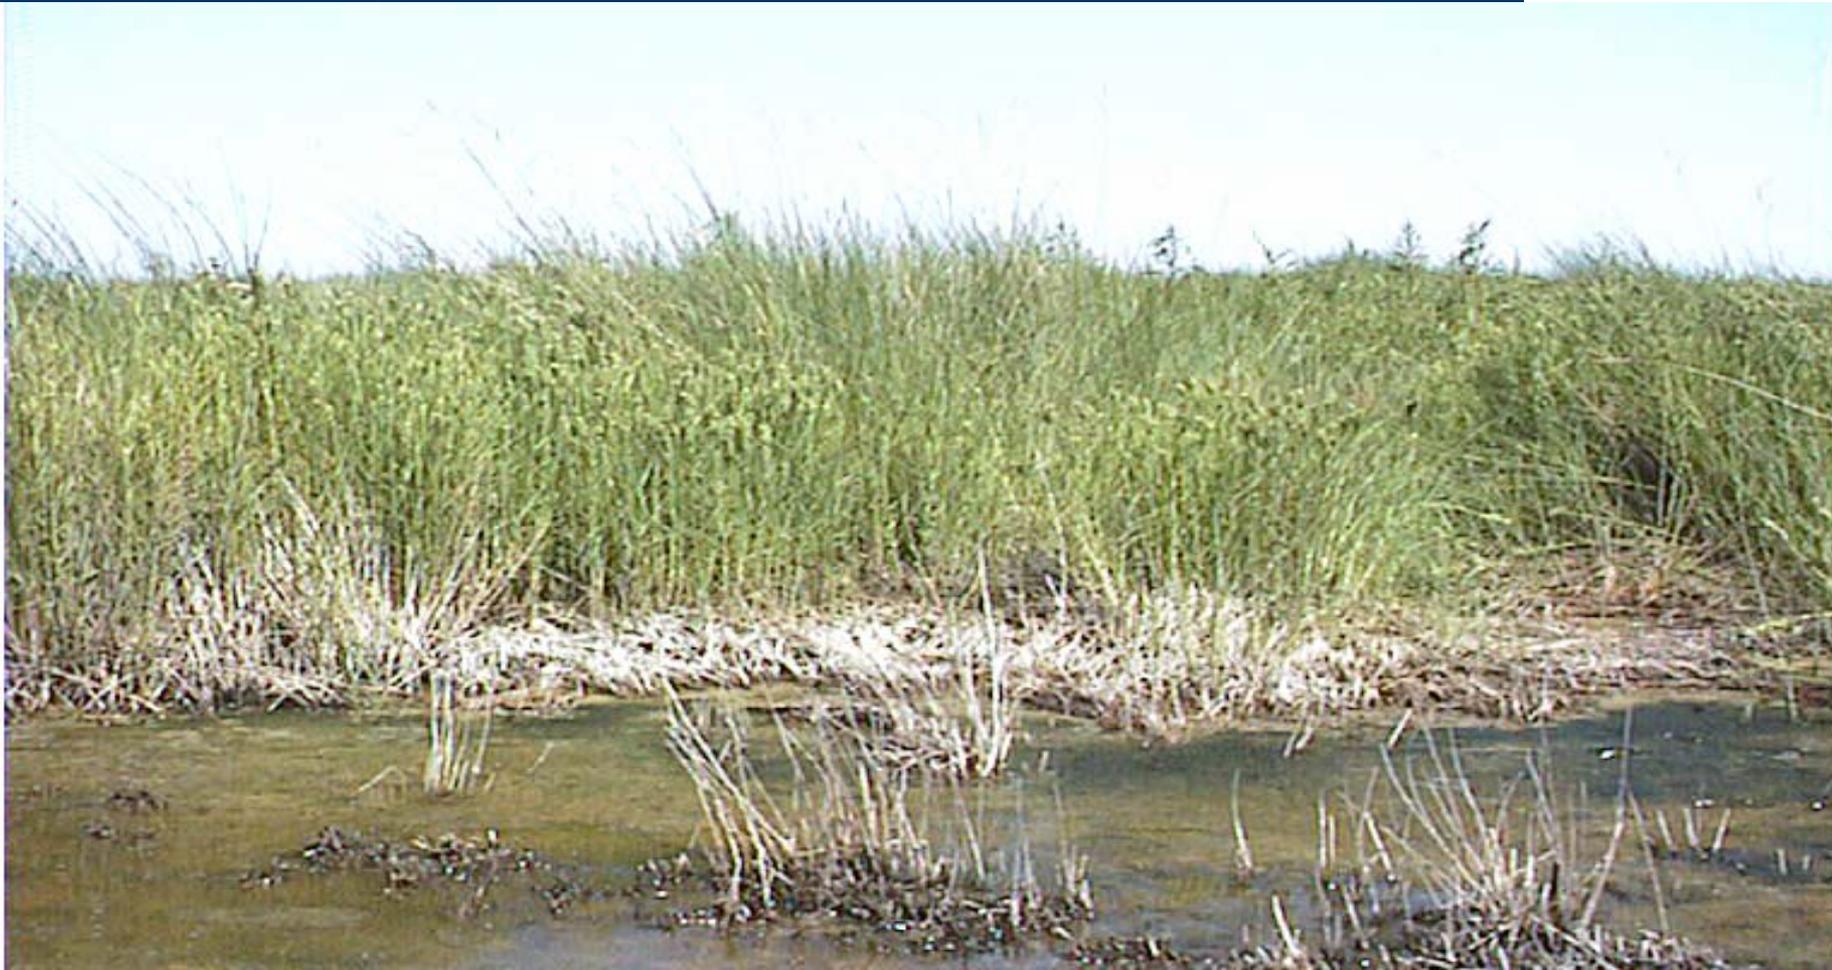
Biological Response

- *Spartina patens* decreased in the project area
- *Distichlis spicata* increased
- Species diversity is higher in the project area
- *Paspalum vaginatum* increased along pond edges
