Lake Chapeau Hydrologic Restoration and Marsh Creation (TE-26)

- Selected on PPL 3 (1993)
- Construction finished May, 2000
- Location:

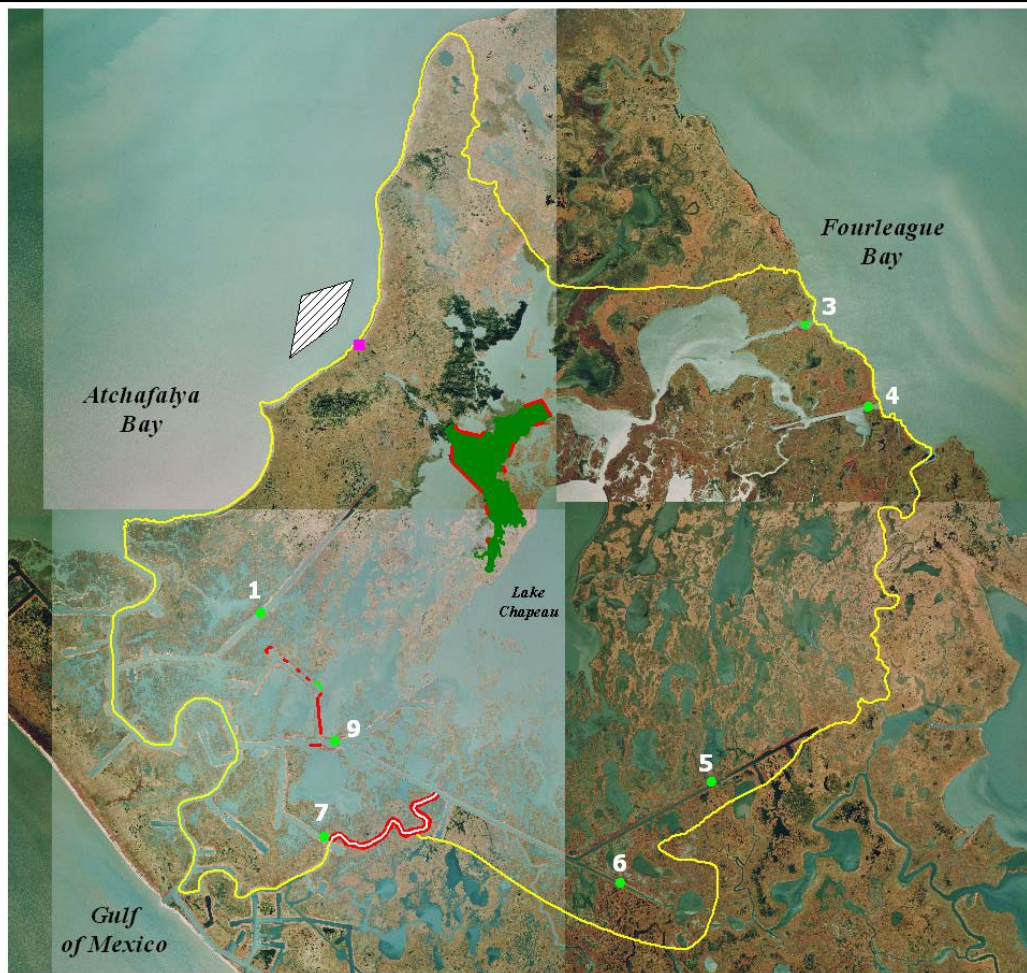
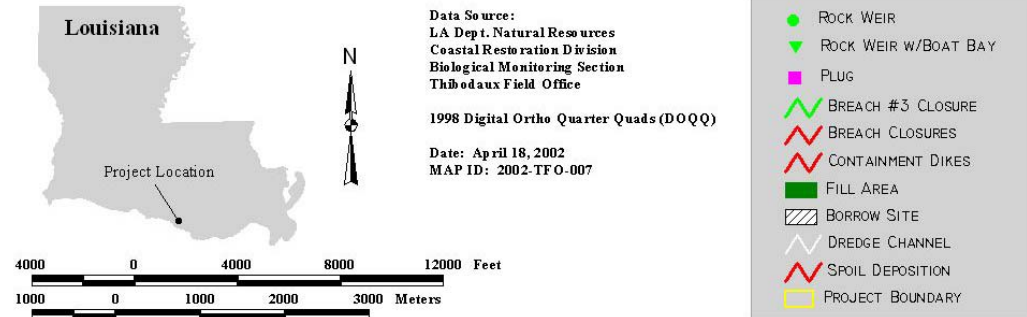
● Project Features

- 7 rock weirs
- 1 rock weir w/boat bay
- 1 rock plug
- dredge channel w/spoil deposition
- spoil bank maintenance
- 193.5 acres dedicated dredge fill
- dredge containment dikes
- 46,980 *Spartina alterniflora* plantings

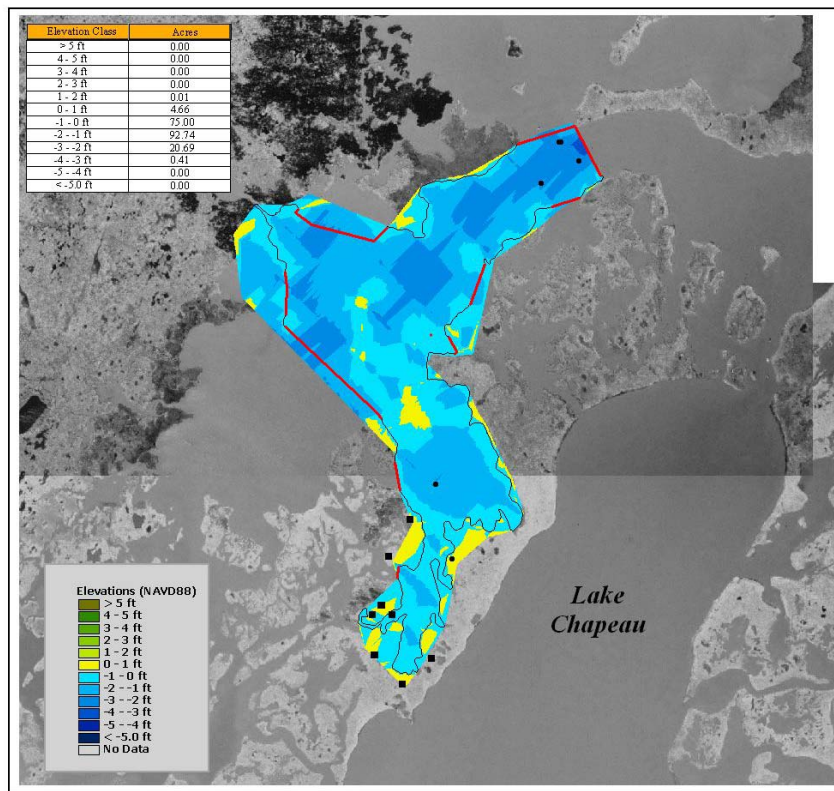
PRE

Physical Response - Elevation

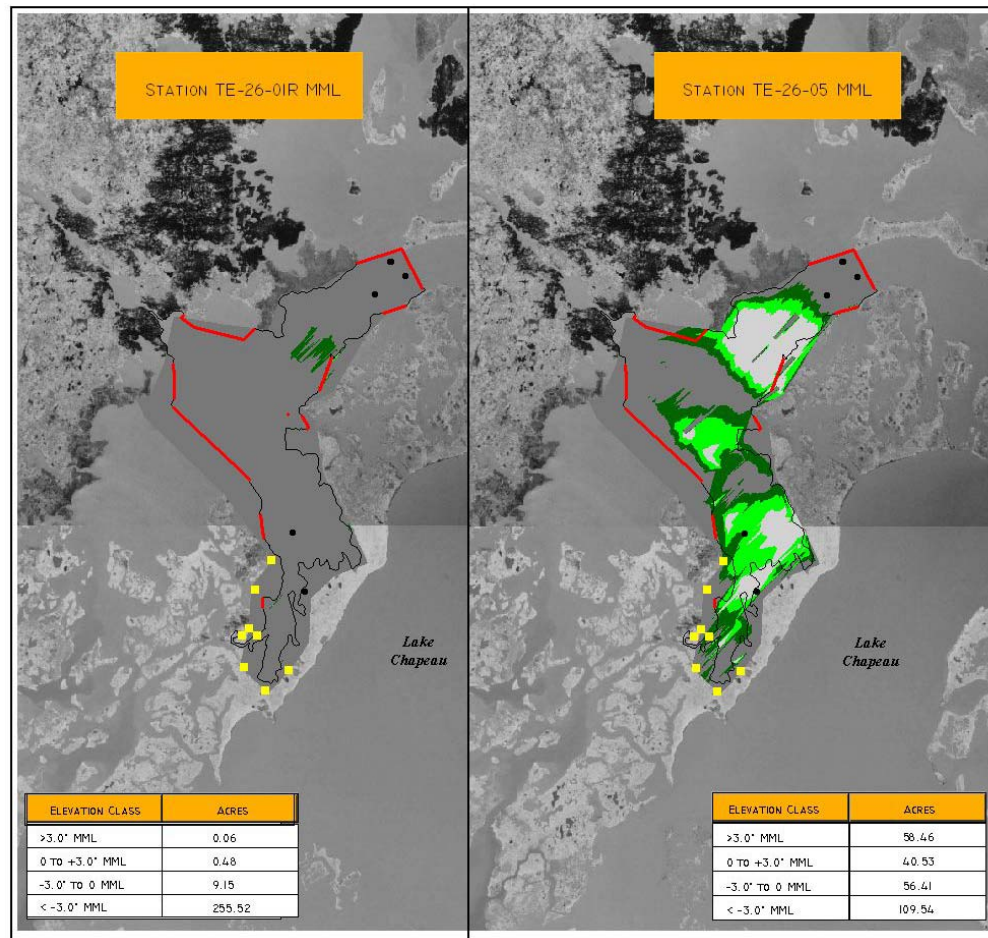
Physical Response – Elevation 2

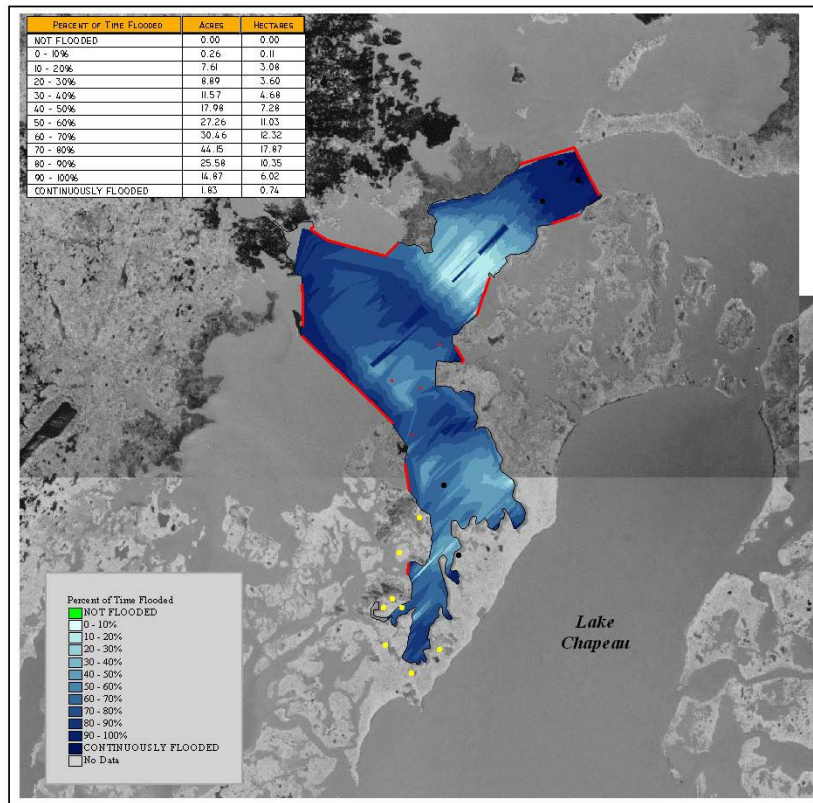
TE26-01R

Physical Response – Hydrology

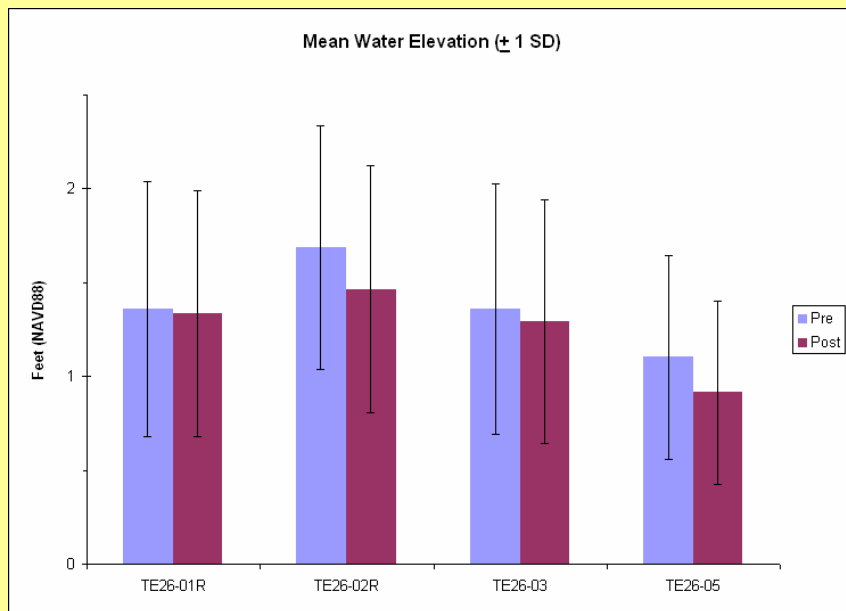
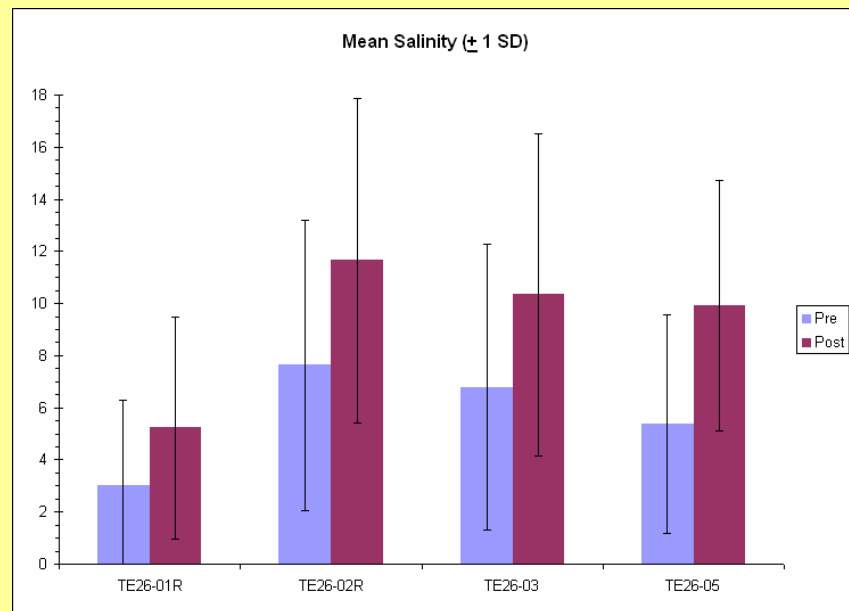
Physical Response - Hydrology 2

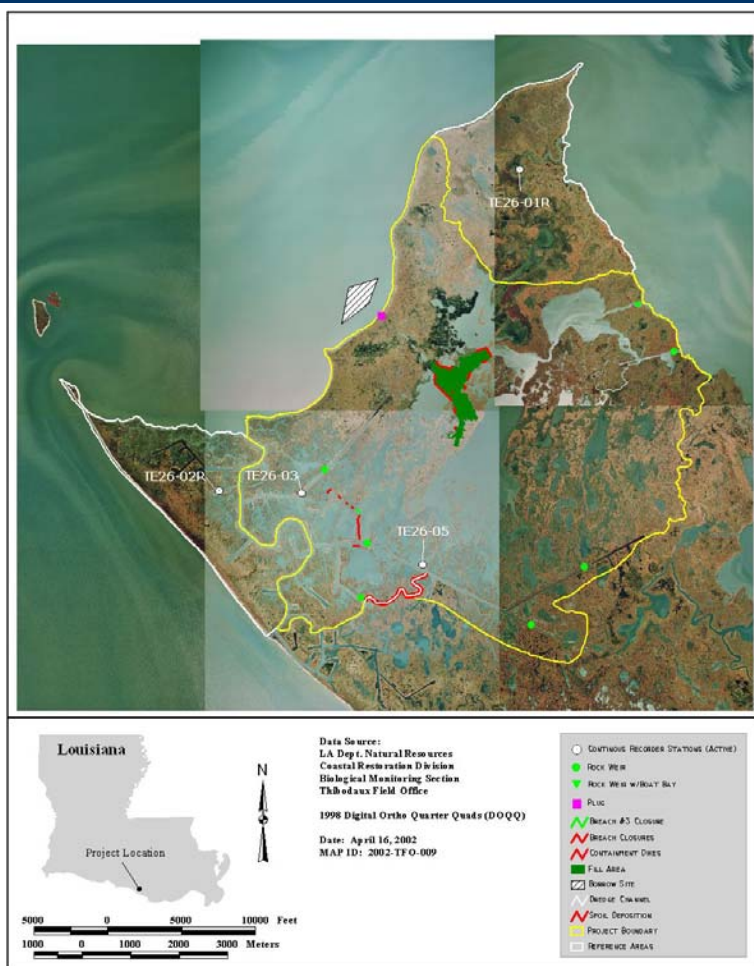
Physical Response - Hydrology 3

Salinity Station Differences	Variability ttests					
	Mean		Std.Dev.		Pr > t	
	Pre	Post	Pre	Post	Pre	Post
Diff1 (01r - 02r)	-0.005	-0.039	0.5387	1.0548	0.3369	<.0001
Diff2 (01r - 03)	-0.047	-0.007	1.0138	0.8591	<.0001	0.2548
Diff3 (01r - 05)	0.0006	0.0036	0.5749	0.7067	0.9246	0.4229
Diff4 (02r - 03)	-0.043	0.0287	1.0287	1.1492	<.0001	0.001
Diff5 (02r - 05)	0.0047	0.0389	0.6359	1.0728	0.5201	<.0001
Diff6 (03 - 05)	0.0676	0.0096	1.1562	0.9177	<.0001	0.127
Water Level Station Differences						
Diff1 (01r - 02r)	-0.000098	-0.005	0.124	0.1553	0.9333	<.0001
Diff2 (01r - 03)	-0.009	-0.002	0.1618	0.1225	<.0001	0.0042
Diff3 (01r - 05)	0.001	-0.00087	0.1521	0.1588	0.5575	0.4215
Diff4 (02r - 03)	-0.009	0.0022	0.1556	0.1214	<.0001	0.0122
Diff5 (02r - 05)	0.0014	0.0052	0.1766	0.2073	0.4908	0.0006
Diff6 (03 - 05)	0.0135	0.0013	0.2071	0.175	<.0001	0.3034

Note: For test results, if 0.05 or less, variability is significantly different

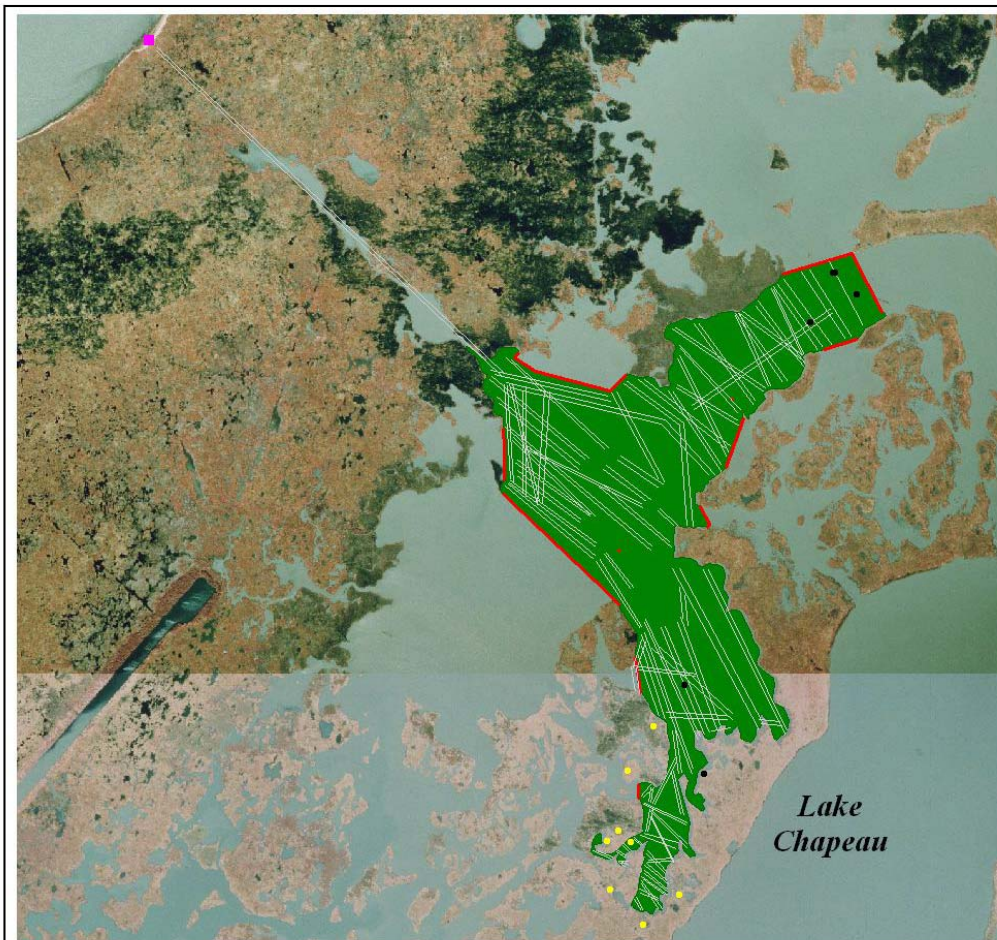
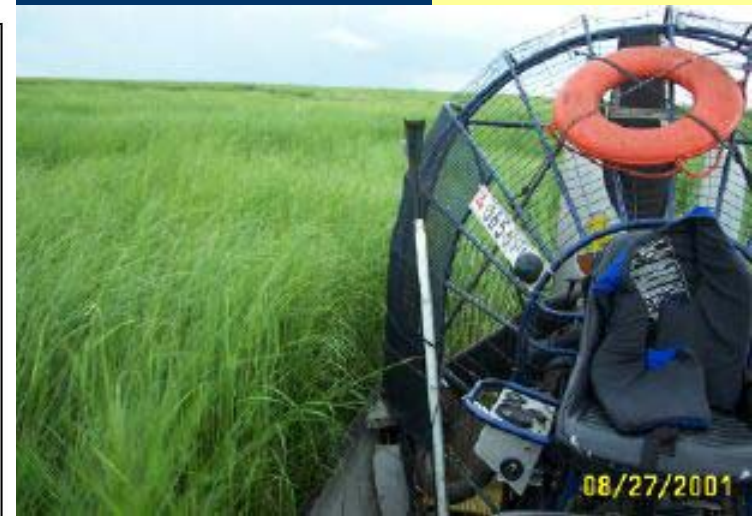
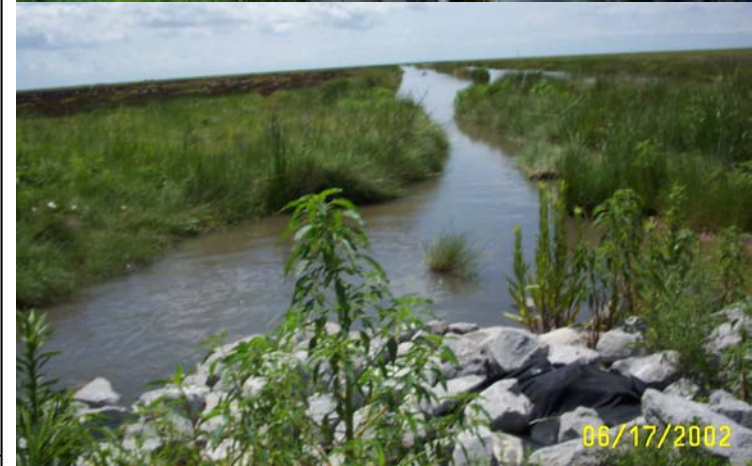
Biological Response - Plantings

- Implemented Changes
 - Plantings added once natural colonization of fill area did not occur

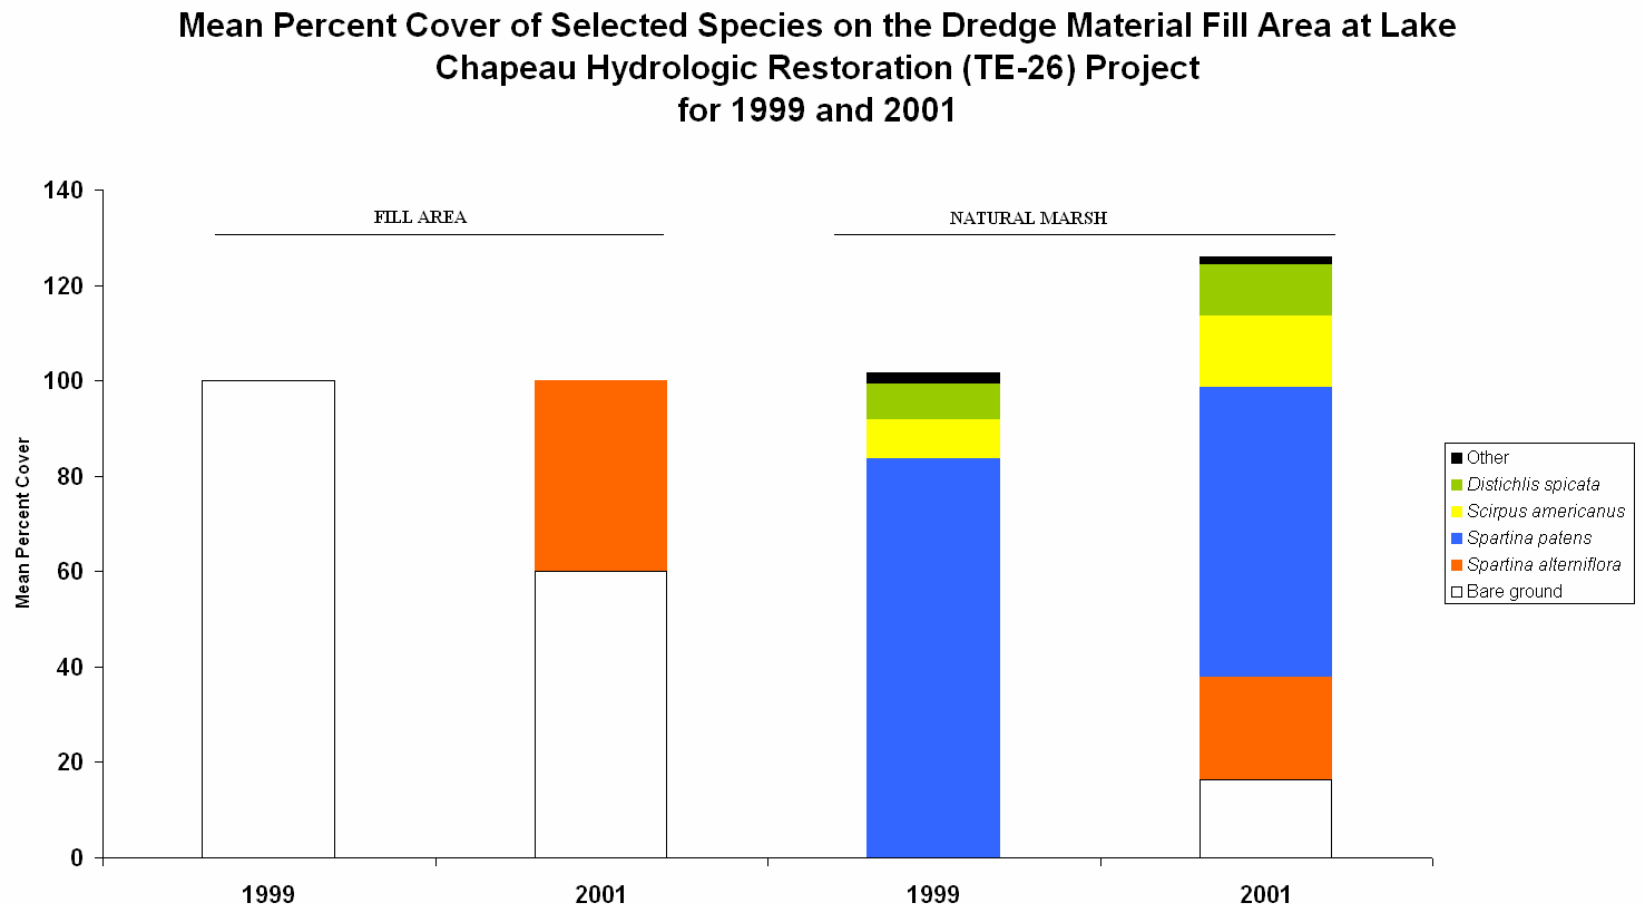
Biological Response – Vegetation

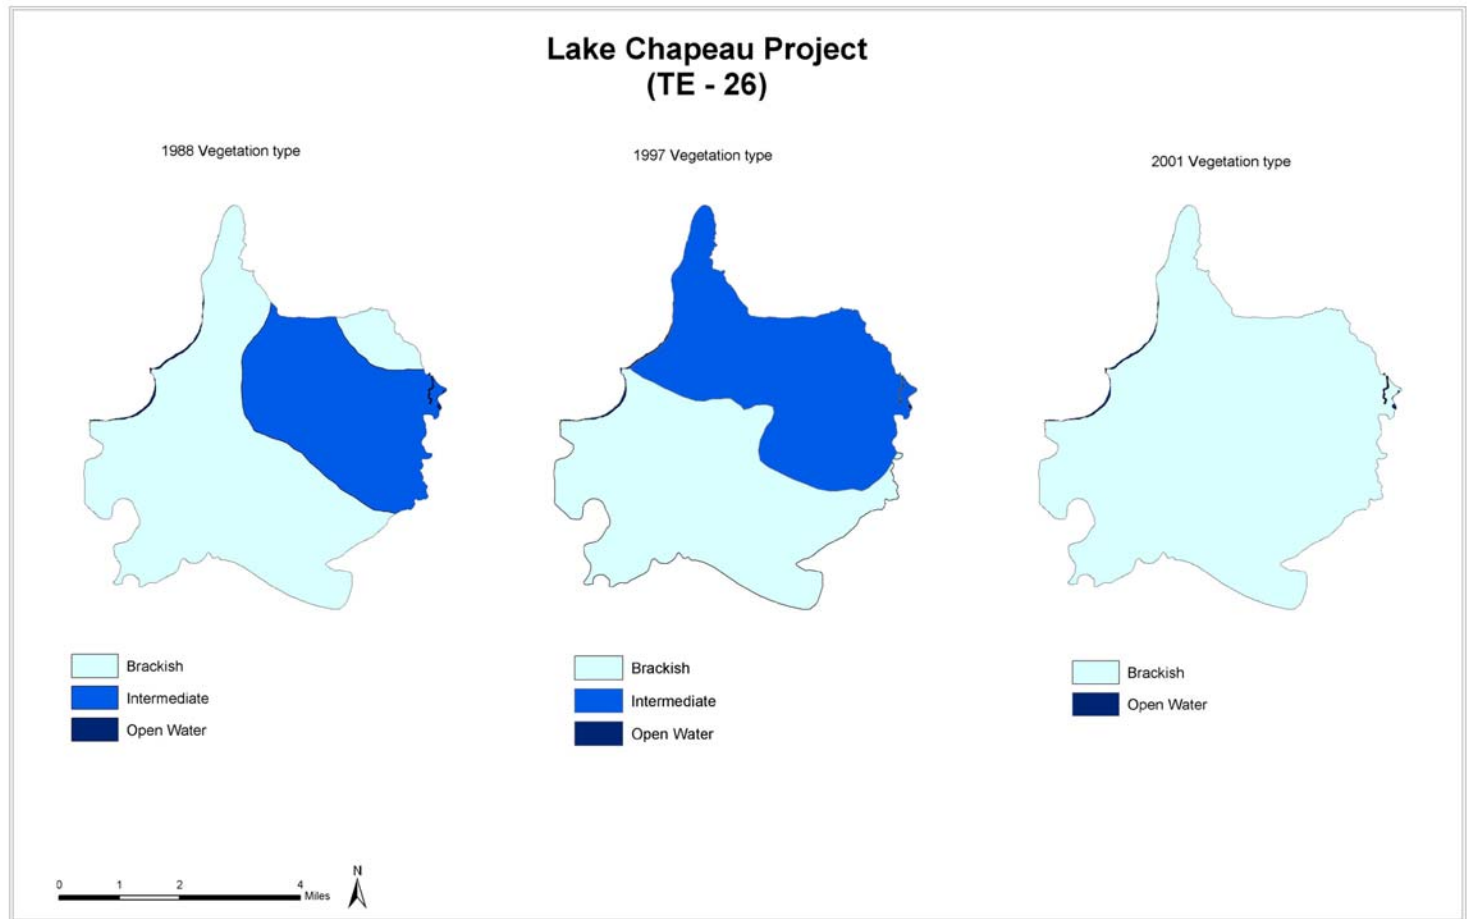
Landscape Response
