Vermilion River Cutoff (TV-03)

- Selected on the 1st Priority Project List
- Construction finished February 1996
- Location: East bank of the Vermilion River Cutoff in Vermilion Parish in the vicinity of Onion Lake and Onion Bayou

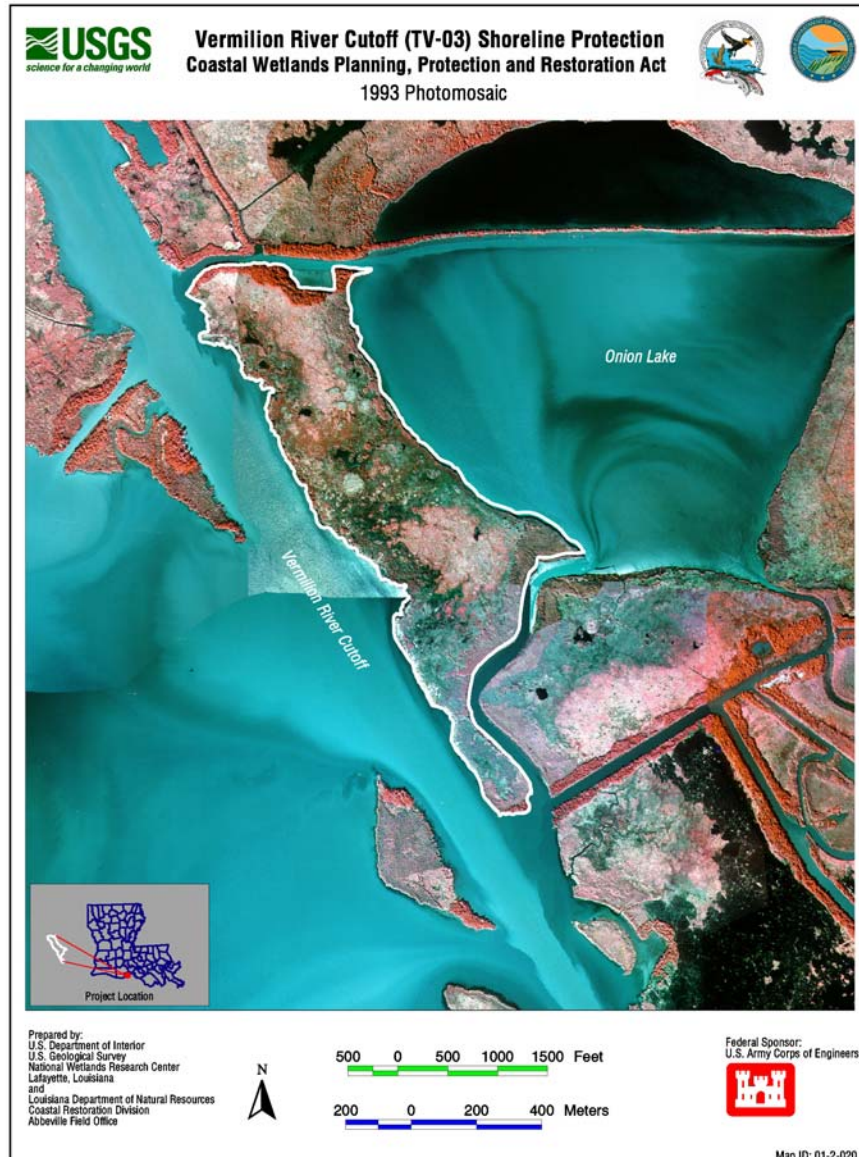
Project Features

- A continuous foreshore rock dike along 6,269 feet of the east bank of the Vermilion River Cutoff

- A rock dike was used to address shoreline erosion from vessel waves and from wind-blown waves
- A dike with a +3.5 foot (+1.1 meter) NGVD elevation, a 7-foot (2.1 meter) berm on the channel side, and crown width of 4 feet (1.2 meters) was built, although a larger dike was planned
