Post Hurricane Monitoring Report

Rockefeller Refuge Gulf Shoreline
Stabilization Project

HDR Engineering, Inc.
State Project Number ME-0018
HDR Project Number 10270651

Cameron Parish, Louisiana
August 18, 2021

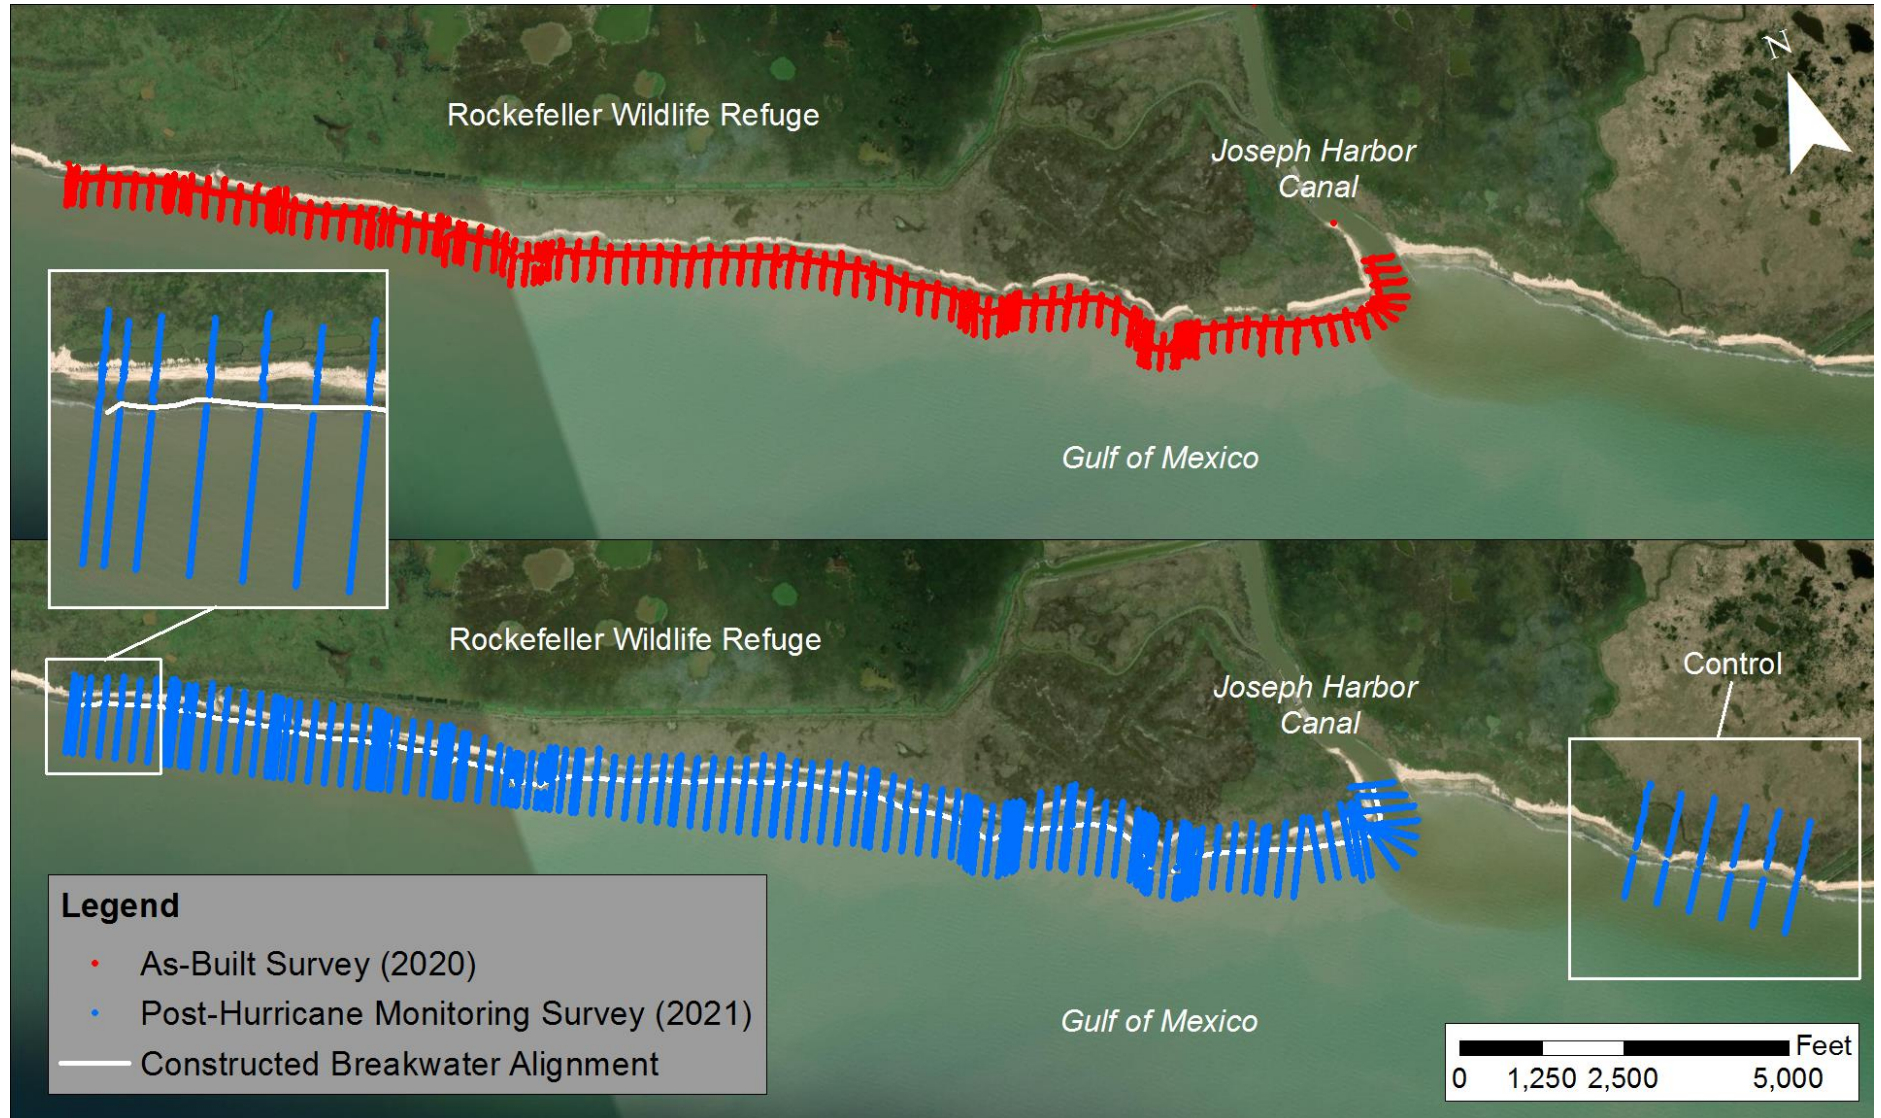
Figure 2-1. As-Built and Post-Hurricane Monitoring Survey Locations

Monitoring topographic and bathymetric elevation surveys of the ME-0018 project site were conducted by HydroTerra Technologies, LLC (HydroTerra) from January 26, 2021 through March 30, 2021. The survey consisted of 113 transects intersecting the LWAC breakwater and adjacent shoreline, with maximum 250-ft spacing between transects. As-Built survey data collected in June 2020 by Patriot Construction and Industrial (Patriot), the construction contractor, was available for 87% of the Monitoring transects. The Monitoring survey also included 10 topographic and bathymetric transects at an unprotected shoreline control site east of Joseph Harbor with similar transect spacing. The Monitoring survey limits were extended further inshore than the As-Built survey to more adequately capture the transition elevations into vegetated marsh. Figure 2-1 shows the As-Built and Monitoring survey locations.

The Monitoring survey transects extended approximately 350 ft seaward of the toe of the breakwater to approximately 200 ft inland to survey into the marsh and at least 25 ft beyond

the sand over wash from hurricane deposition. A closer view of the landward and seaward transect extents is shown in Figure 2-1. Seaward of the breakwater, survey shots were taken along the transects at all significant grade breaks and at contours (i.e. -4-ft contour, -5-ft contour), with a maximum horizontal spacing of 25 ft. Survey shots of certain topographic features were also taken along the transects, including the end of continuous vegetation from the marsh, top of berm, Mean High Water (MHW) elevation, and breakwater toe. Shots were also taken at the locations of all significant grade breaks of the water bottom and structure features (toes and crest). All shots of the breakwater and landward were taken at a maximum horizontal spacing of 10 ft along transects.

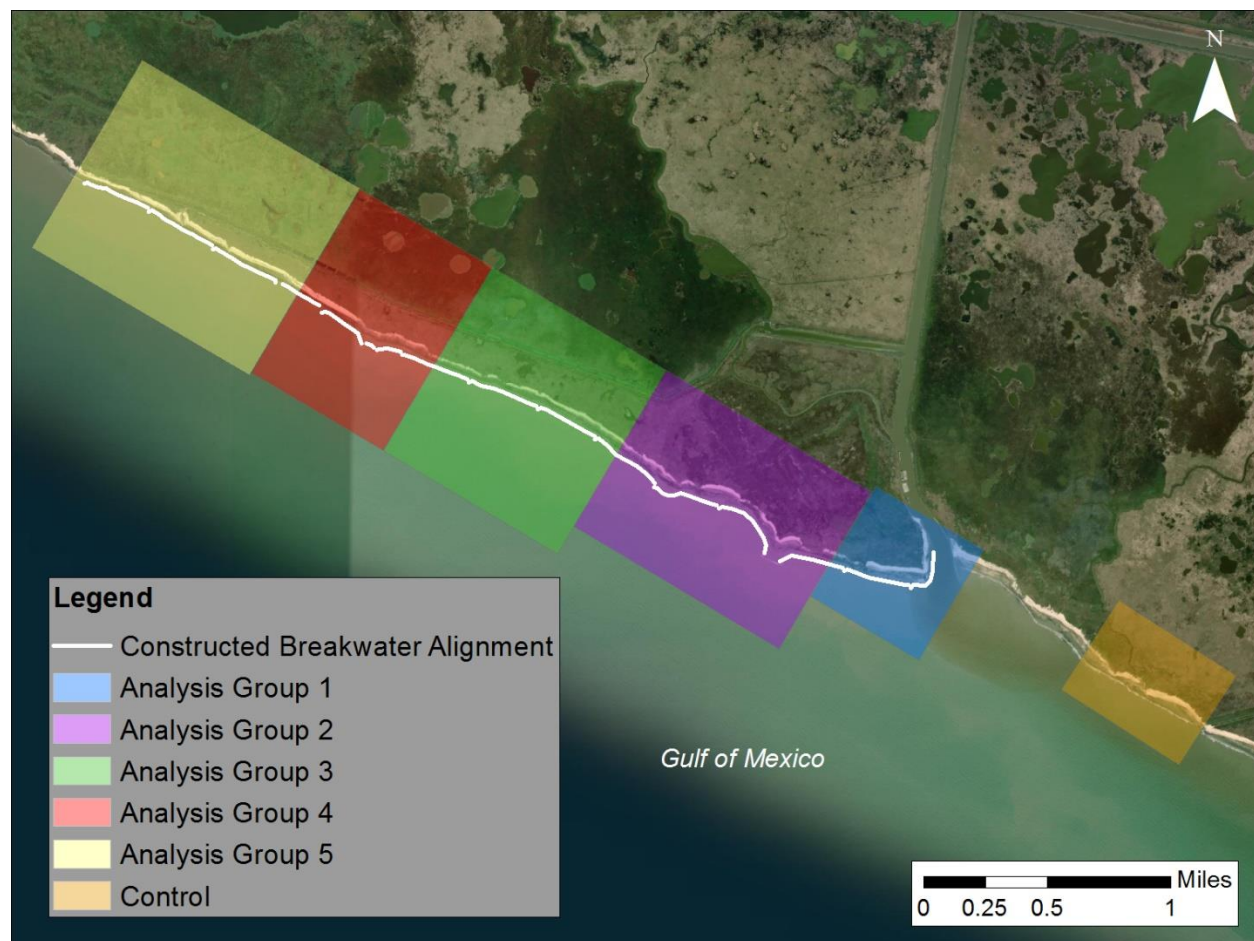
Figure 3-1. Analysis Groups

The project area was divided into 5 Analysis Groups as shown in Figure 3-1.

Group 1 (Mouth of Joseph Harbor Bayou) is the easternmost portion of the study area. It is located west of the mouth of Joseph Harbor Bayou (Joseph Harbor) and includes 2,700 ft of shoreline. This area was selected to capture the influence of Joseph Harbor on shoreline movement within the project area. This analysis group also includes 350 ft of shoreline north of the breakwater structures with open exposure to Joseph Harbor.

Group 2 (ME-0018 Demonstration Sections) spans 5,700 ft of shoreline which includes the area of the two demonstration sections completed in December 2009 and the more recently constructed breakwater structures in the vicinity. The demonstration areas differ from other construction locations in the study area in two ways: 1) the pre-construction shoreline extended into the Gulf relative to the remainder of the study area that had a relatively flat or linear shoreline geomorphology and 2) the breakwater alignment was updated during construction to accommodate the change in shoreline and bathymetry due to the demonstration features and to incorporate the demonstration features into the overall system.

Group 3 (Middle Typical) is the center-most analysis group and includes 4,400 ft of shoreline. This analysis group is generally characterized by the typical linear shoreline geomorphology and breakwater construction technique.

Group 4 (LA-0008) spans 3,500 ft of shoreline and includes the LA-08 demonstration project which was constructed in April 2012. This analysis group is functionally similar to Group 2 in that the shoreline had been influenced by another structure before construction of ME-0018.

Group 5 (Western Typical) is the westernmost analysis group and includes 5,300 ft of shoreline. Like Group 3, this analysis group is generally characterized by the typical linear shoreline geomorphology and breakwater construction technique.

The Control Group was established 3,650 east of Joseph Harbor along 2,950 ft of shoreline without a breakwater system. This shoreline is directly exposed to waves and currents from the open Gulf of Mexico including high tides, storms, and hurricane events. Longshore transport in this region of the Gulf of Mexico generally moves from east to west, meaning that the Control Group is generally considered to be outside the area of influence from the constructed structures to the west, including the jetty at the mouth of Joseph Harbor. The Control Group area has a similar pre-construction shoreline geomorphology as the typical shoreline segments. The beaches are composed of similar soft marine clays and crushed shell and are both backed by similarly vegetated marshland. Although the Control Group was not included in the As-Built survey, it will be compared to Analysis Groups 1 through 5 to quantify future sedimentation behind the breakwater and to measure project performance over its 20-year design life.

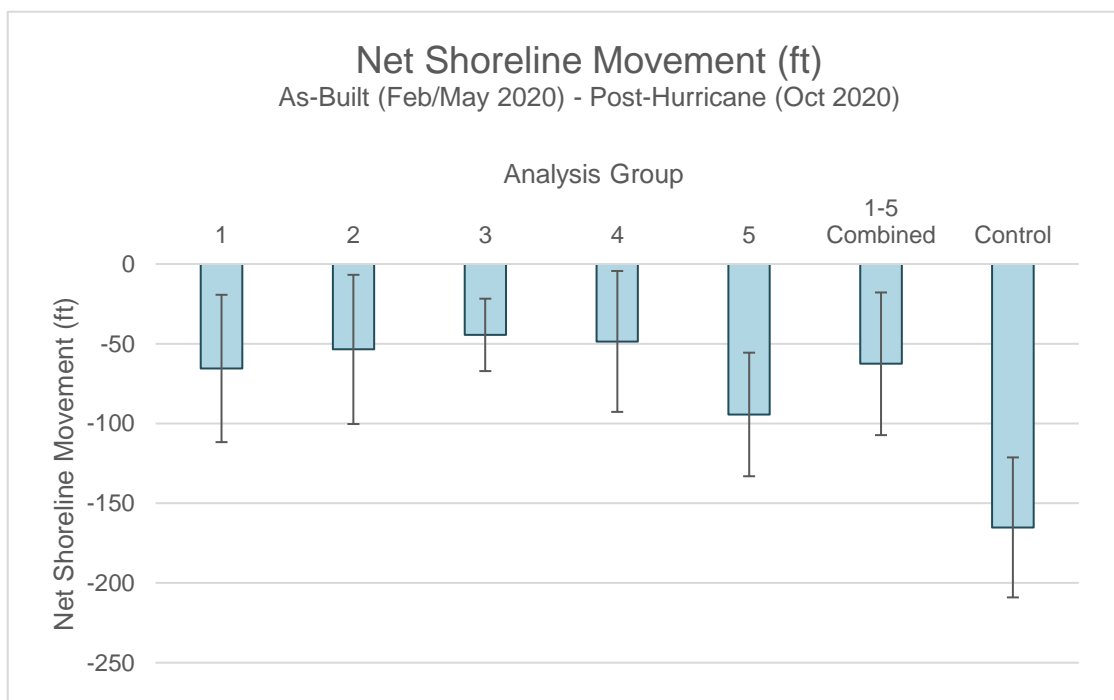
Figure 3-2. Net Shoreline Movement for Each Analysis Group

Aerial imagery from NOAA's Emergency Response Imagery program was used to create a post-hurricane shoreline location for October 10, 2020. This imagery is collected by the remote sensing division of NOAA as part of homeland security and emergency response requirements. The substrate classification data from the field topographic survey were used to check the shoreline location derived from post-hurricane imagery (Appendix A, Figures 1-1 through 1-6). The spatial distribution of shoreline movement by Analysis Group is illustrated in Appendix B, Figures 1-1 through 1-6. A summary of the change by Analysis Group is shown in Table 3-1 and Figure 3-2.

All transects in Analysis Group 1 experienced a net negative shoreline movement. Because of a lack of data from the As-Built survey, it is not clear what the sediment dynamics are at the mouth of Joseph Harbor (Analysis Group 1), but future samplings of the expanded survey area would allow for further investigation. While Analysis Groups 2-4 all experienced negative shoreline movement, Analysis Group 4 had the highest number of transects (10) and the highest percentage of transects (2.5%) with a positive shoreline movement of any analysis group in the study area. Even so, the positive shoreline movement values in Groups 2-4 were all near 0 ft, the highest value being 0.16 ft, which denotes no significant positive shoreline movement. Analysis Group 5 had the greatest shoreline movement variability of all analysis groups and had the greatest negative value for average shoreline movement. Since shoreline data reflect vegetated shoreline and did not include sand/shell hash (unvegetated) area, it is possible that areas of recent sand/shell deposition (as seen in Analysis Group 5) may experience positive shoreline movement in the future as these areas are recolonized by marsh vegetation. The Control Group experienced significantly higher values of negative shoreline movement than any of the analysis groups and did not contain any transects with a positive shoreline movement value.

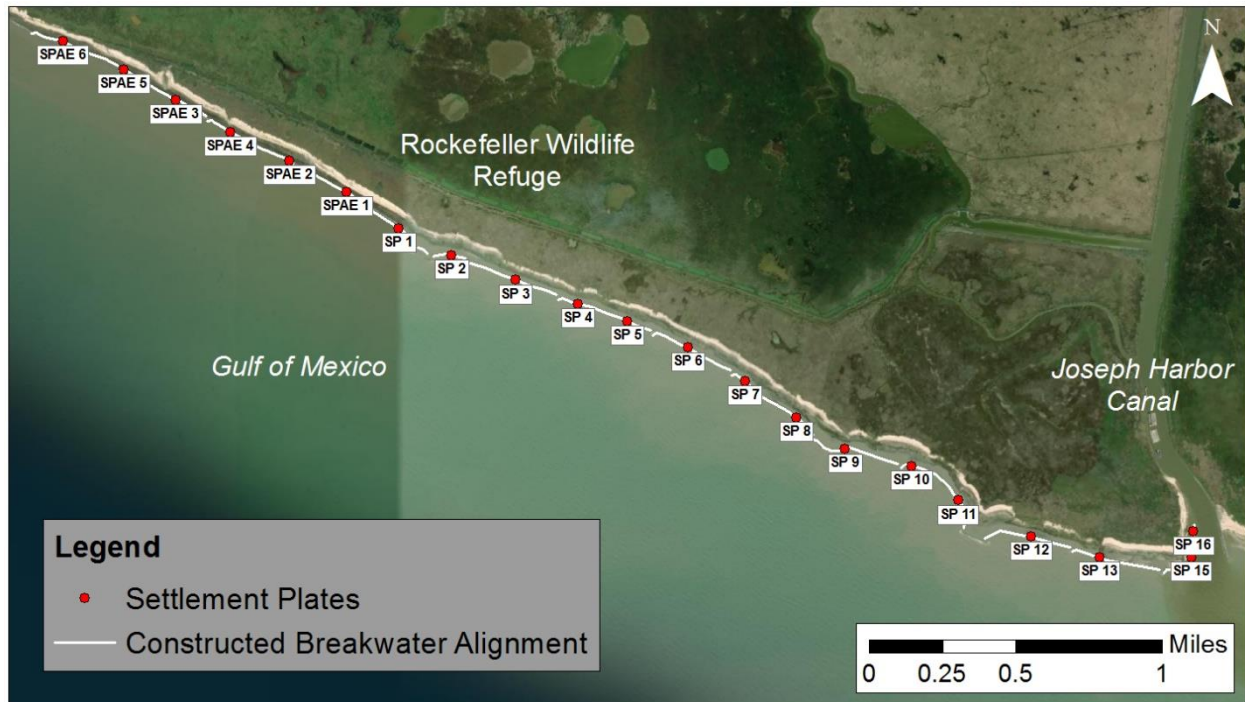
Figure 3-3. Settlement Plate Locations

Settlement plates were installed at 21 locations along the breakwater during construction. Elevations were collected at the top of the pipes and at the grade elevation of the rocks at these locations.

Settlement plate elevation data obtained during the construction surveys, As-Built surveys, and Monitoring surveys were compared. Construction surveys conducted by Patriot captured the settlement plate elevation at the time of installation, periodically throughout construction, and for the As-Built survey. Two settlement values were calculated at each settlement plate location: 1) Settlement between the As-Built survey (May 2020) and Monitoring survey (January 2021); and 2) Settlement between installation (varies between July 2018 and May 2020) and the Monitoring survey (January 2021). The locations of the settlement plates along the constructed breakwater alignment are shown in Figure 3-3, and the computed settlement quantities are listed in Table 3-5. The calculated settlement at the breakwater transects between the As-Built and Monitoring surveys is summarized in Table 3-6.

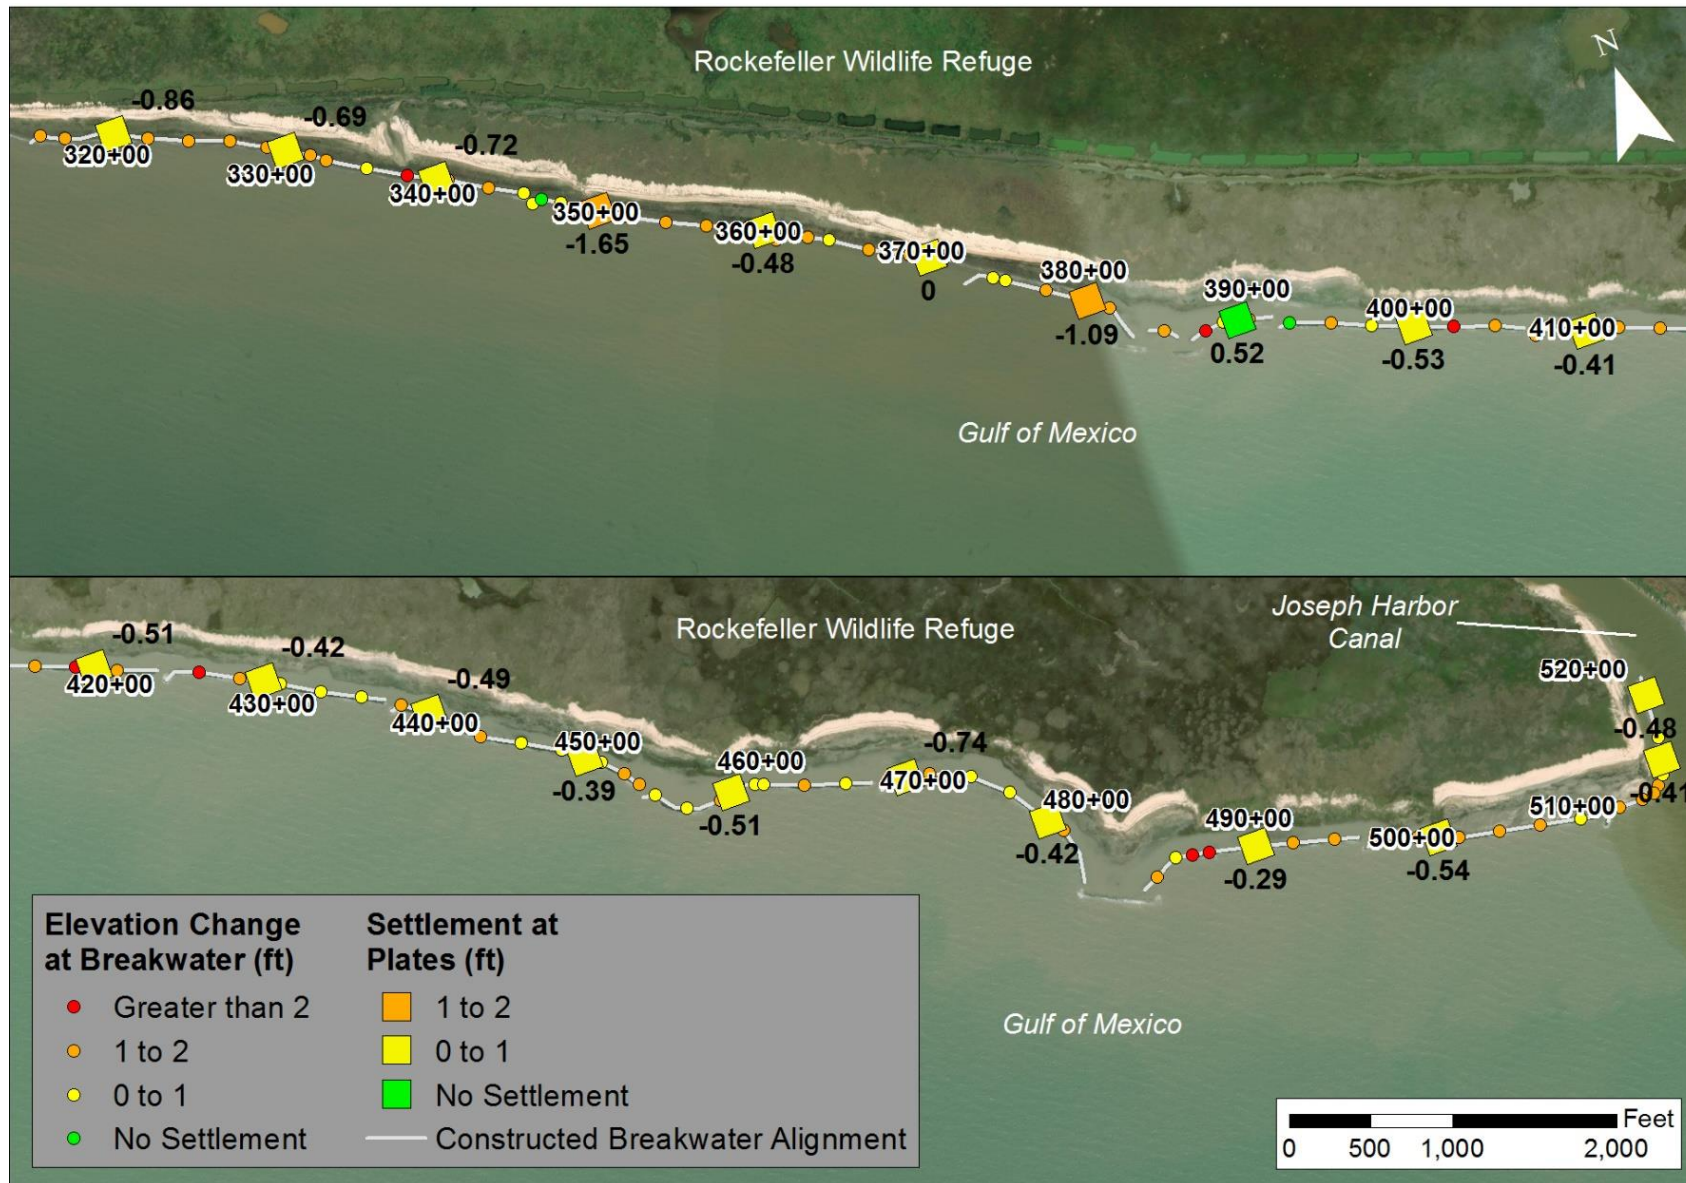
Figure 3-4. Elevation Change at Breakwater vs. Settlement at Settlement Plates (ft)

Figure 3-4 shows the settlement between the As-Built and Monitoring surveys at each settlement plate and the corresponding breakwater elevation changes. One settlement plate showed no settlement, 18 settlement plates showed settlement between 0 and 1 ft, and two settlement plates showed settlement between 1 and 2 ft. The greatest amount of settlement experienced between the As-Built and Monitoring surveys was 1.09 ft at SP1.

In addition to using settlement plate data, the average elevation change along the breakwater extents of each transect was calculated. If the average breakwater elevation change is similar to nearby settlement values, the amount of riprap displaced from the breakwater is likely minimal.

Ninety-eight breakwater transects were surveyed. Of this total, 34 transects showed elevation change between 0 and -1 ft, 57 transects showed elevation change between -1 and -2 ft, and 6 transects showed elevation change exceeding -2 ft. One transect showed no elevation change. The maximum elevation change observed between the As-Built and Monitoring surveys was -2.64 ft at Station 415+01. The elevation change of the breakwater is generally higher than the settlement plate elevation change which indicates there may have been some

minimal movement of riprap. Since the majority of the structure appears to be intact, no corrective actions are recommended at this time. Future monitoring should continue to assess the structure integrity.

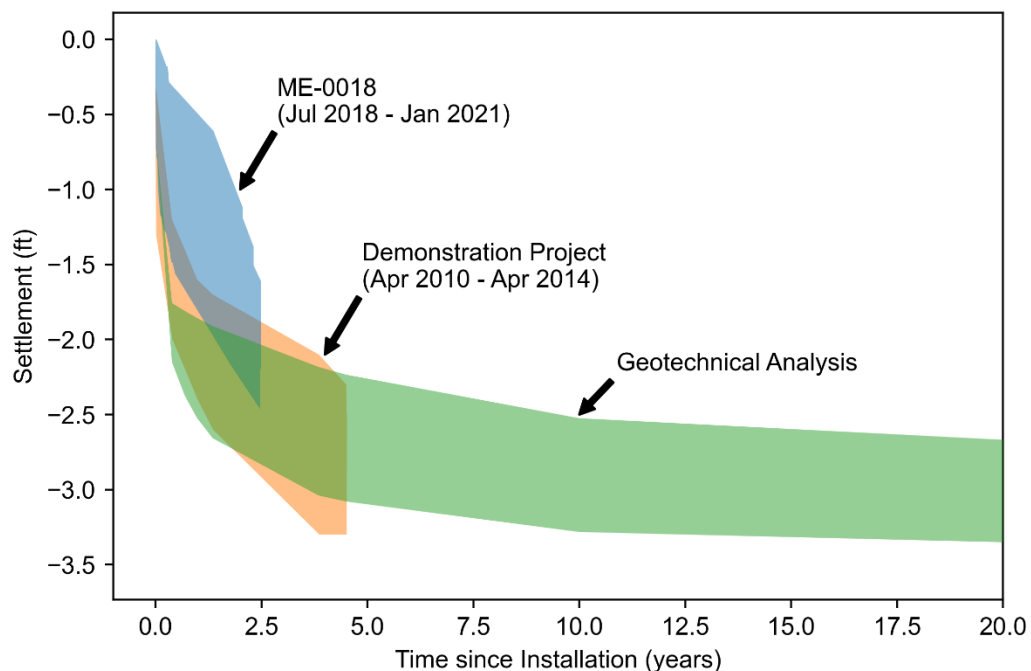
Figure 3-5. Settlement at ME-0018 compared to the LWAC demonstration project and geotechnical analysis.

A demonstration project which included a LWAC breakwater was constructed at the site in April 2010 before the full ME-0018 project was constructed. HDR performed geotechnical analyses on the demonstration project settlement plate data in October 2011 and April 2014. The results indicated an average settlement of 2.7 ft at the demonstration project over the 4 years from installation to the 2014 analysis. The full ME-0018 project was constructed between July 2018 and January 2020 with settlement plates installed throughout that timeframe as the breakwater was constructed. Each of the settlement plates from the full ME-0018 project were surveyed again in January 2021 as part of the current monitoring providing a range of settlement data from 12 to 30 months, depending on installation time. Figure 3-5 shows the maximum and minimum measured settlement values as shades for both the demonstration project and the full ME-0018 project relative to time since settlement plate installation. Also included is the predicted settlement curve used during design over the project's 20-yr design life. All settlement plates installed during the full ME-0018 construction project and all breakwater transects compared between the As-Built and Monitoring surveys show less settlement than what was estimated during design. This indicates that the breakwater is settling as anticipated, or better than anticipated.

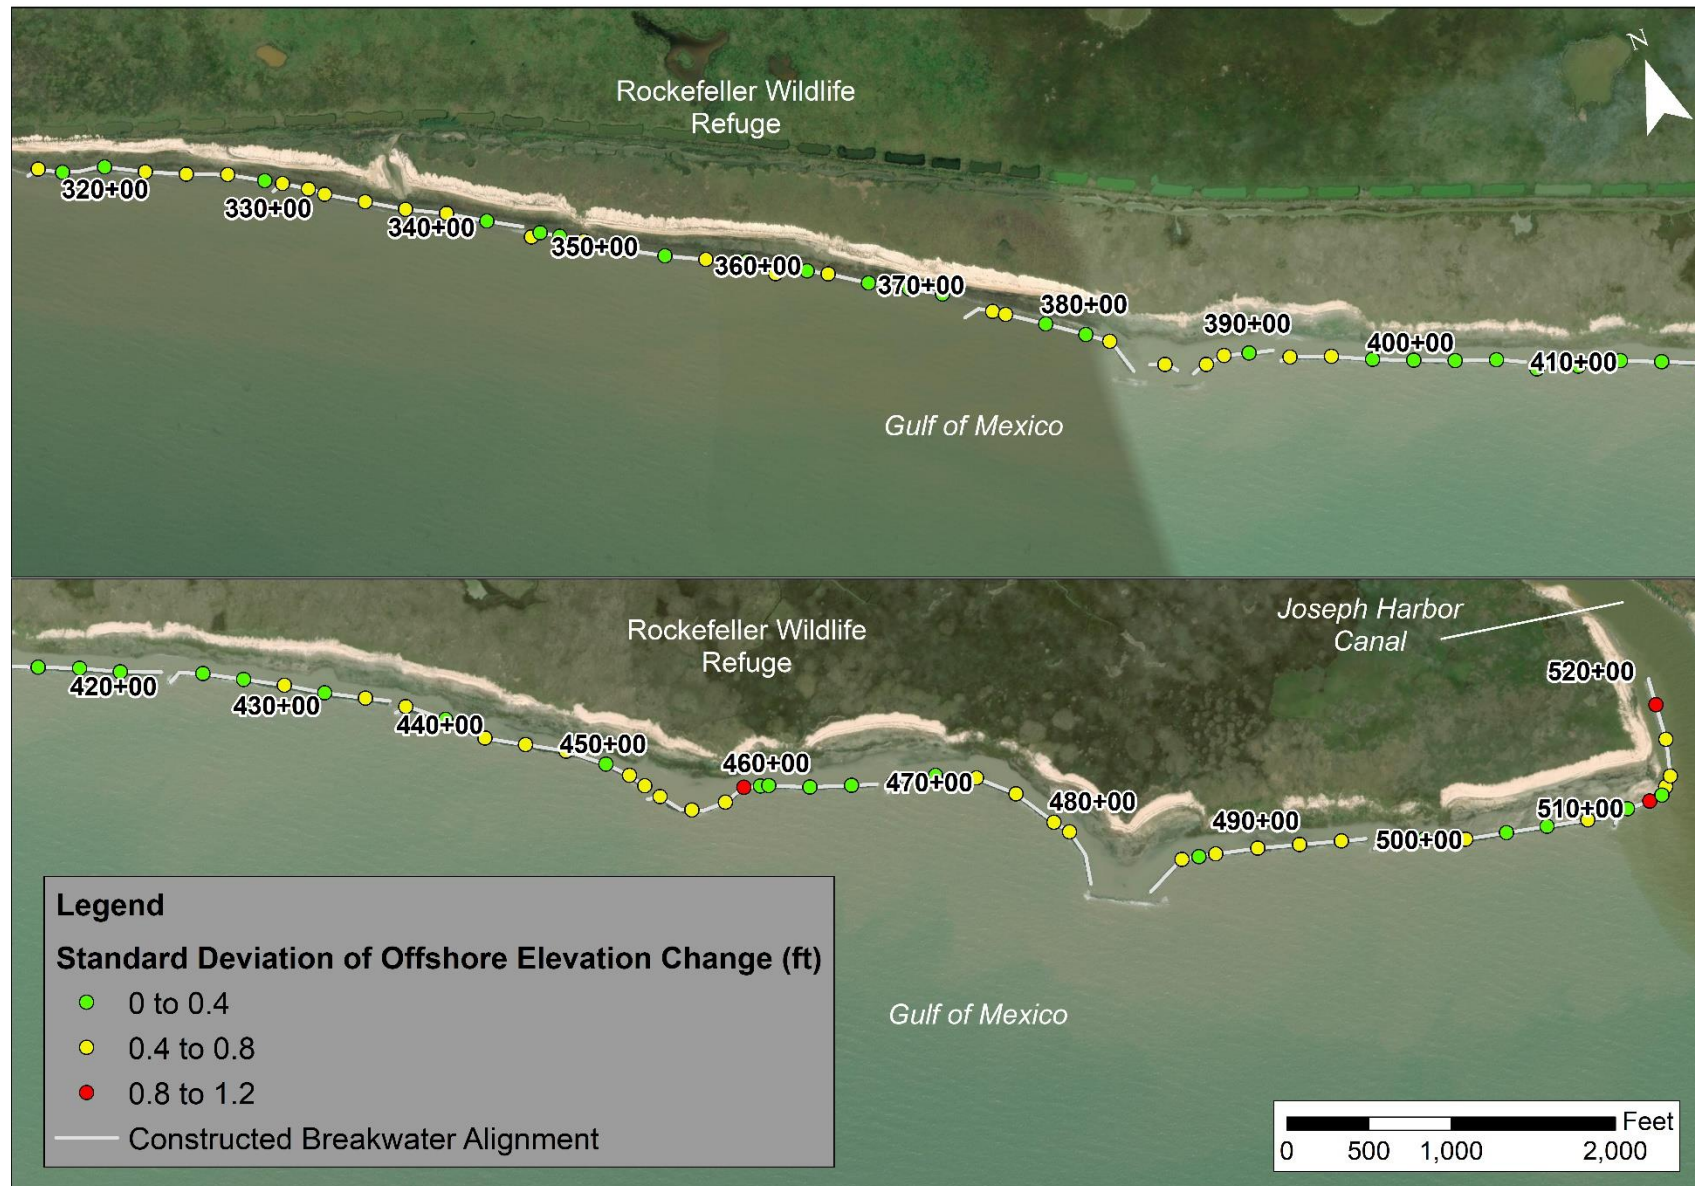
Figure 3-6. Standard Deviation of Offshore Scour (ft)

A toe scour assessment was performed. The offshore As-Built and Monitoring survey lines at each transect were sampled at 1 ft horizontal spacings and the elevation change was calculated at each sampled point. The standard deviation of the offshore elevation change values at each transect was then computed. A high standard deviation indicates that the elevation change values along a transect are spread out over a wider range, suggesting the presence of noticeable erosion or deposition relative to the mean offshore elevation change.

Figure 3-6 shows the standard deviation of each transect. The transects with the highest standard deviations (i.e., greater than 0.8 ft) mostly lie at the mouth of Joseph Harbor Canal where offshore erosion (away from breakwater toe within the canal) has been observed. Transects toward the center of the breakwater segments typically showed lower standard deviation values due to the greater protection from erosion with values ranging from 0 to 0.8 ft. Review of the transects did not indicate any significant toe scour near the breakwater. See Appendix C for As-Built and Monitoring Transect Plots.

Based on the results of the Post-Hurricane Monitoring analysis, no major structural defects (i.e., excessive settlement, detrimental erosion, and noticeable movement of riprap) has been observed. Therefore, no structural corrective action is currently recommended. The breakwater performed as intended despite being impacted by two major hurricanes within two months. The Control Group experienced considerable shoreline and soil volume loss relative to the project location. This result indicates that the coastline would have experienced a much higher amount of erosion without the ME-0018 project. It is recommended that the lighted daybeacons that were damaged during Hurricanes Laura and Delta be repaired or replaced as needed. Monitoring of the condition of the breakwater, warning signs, and lighted daybeacons after all major storm events is recommended.
