**State of Louisiana
Department of Natural Resources
Coastal Restoration Division**

**2004 Operations, Maintenance,
and Monitoring Report**

**Bayou Chevee Shoreline
Protection**

State Project Number PO-22
Priority Project List 5

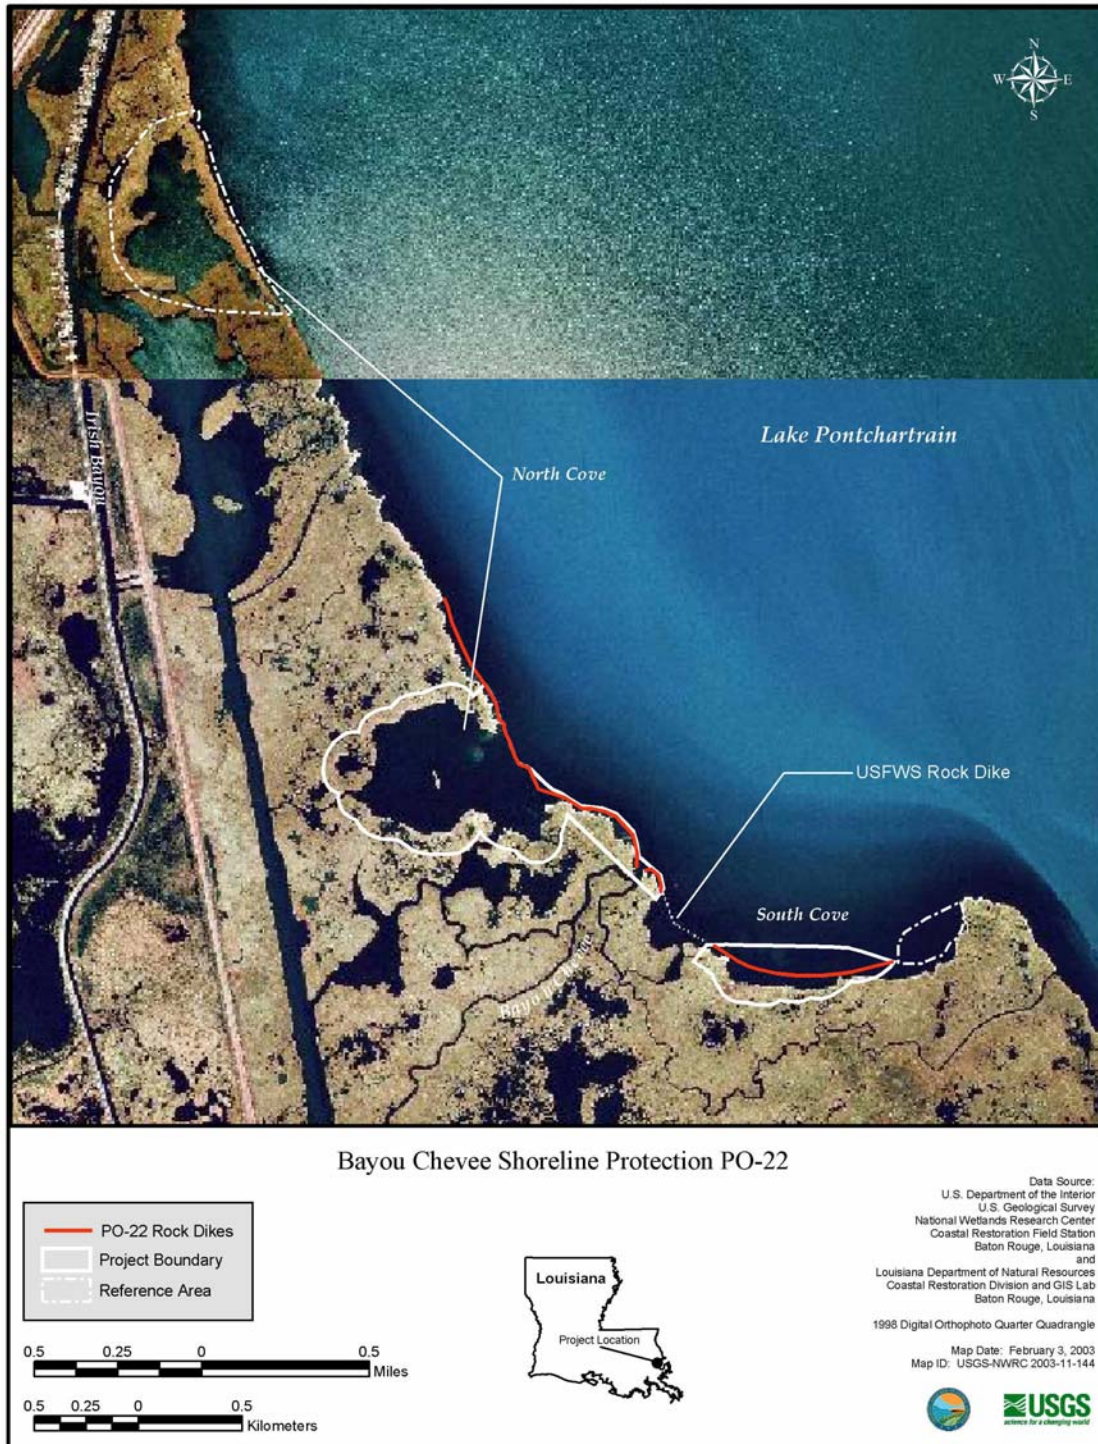
Figure 1. Location of Bayou Chevee Shoreline Protection (PO-22) project boundaries, features and reference area.

The Bayou Chevee Shoreline Protection project is located within the northern section of the Bayou Sauvage National Wildlife Refuge, approximately 10 miles northeast of New Orleans, Louisiana (figure 1). The project area is located on the southern shoreline of Lake Pontchartrain and is divided into two areas, the north cove area and the south cove area. The north cove project area, comprising 164 acres, is located just north and west of Bayou Chevee. It extends 300 ft into the marsh from the existing shoreline of an 110 acre pond of open-water and includes 54 acres of brackish marsh. The south cove area, consisting of 48 acres, is located southeast of Bayou Chevee and northwest of Chef Menteur Pass. It extends 300 ft into the marsh from the existing shoreline around a 27 acre cove and includes 21 acres of brackish marsh. Project and reference area marshes are dominated by *Spartina patens* (marshhay cordgrass) with *Pluchea spp.* and *Cyperus spp.* present.

The PO-22 project consists of approximately 8,875 linear feet of rock bankline protection along the shoreline of Lake Pontchartrain, extending north and south from Bayou Chevee. Construction was completed on December 12, 2001. The shore protection will allow for the enclosed shallow water areas to be colonized by a greater abundance of submerged aquatic vegetation (SAV).

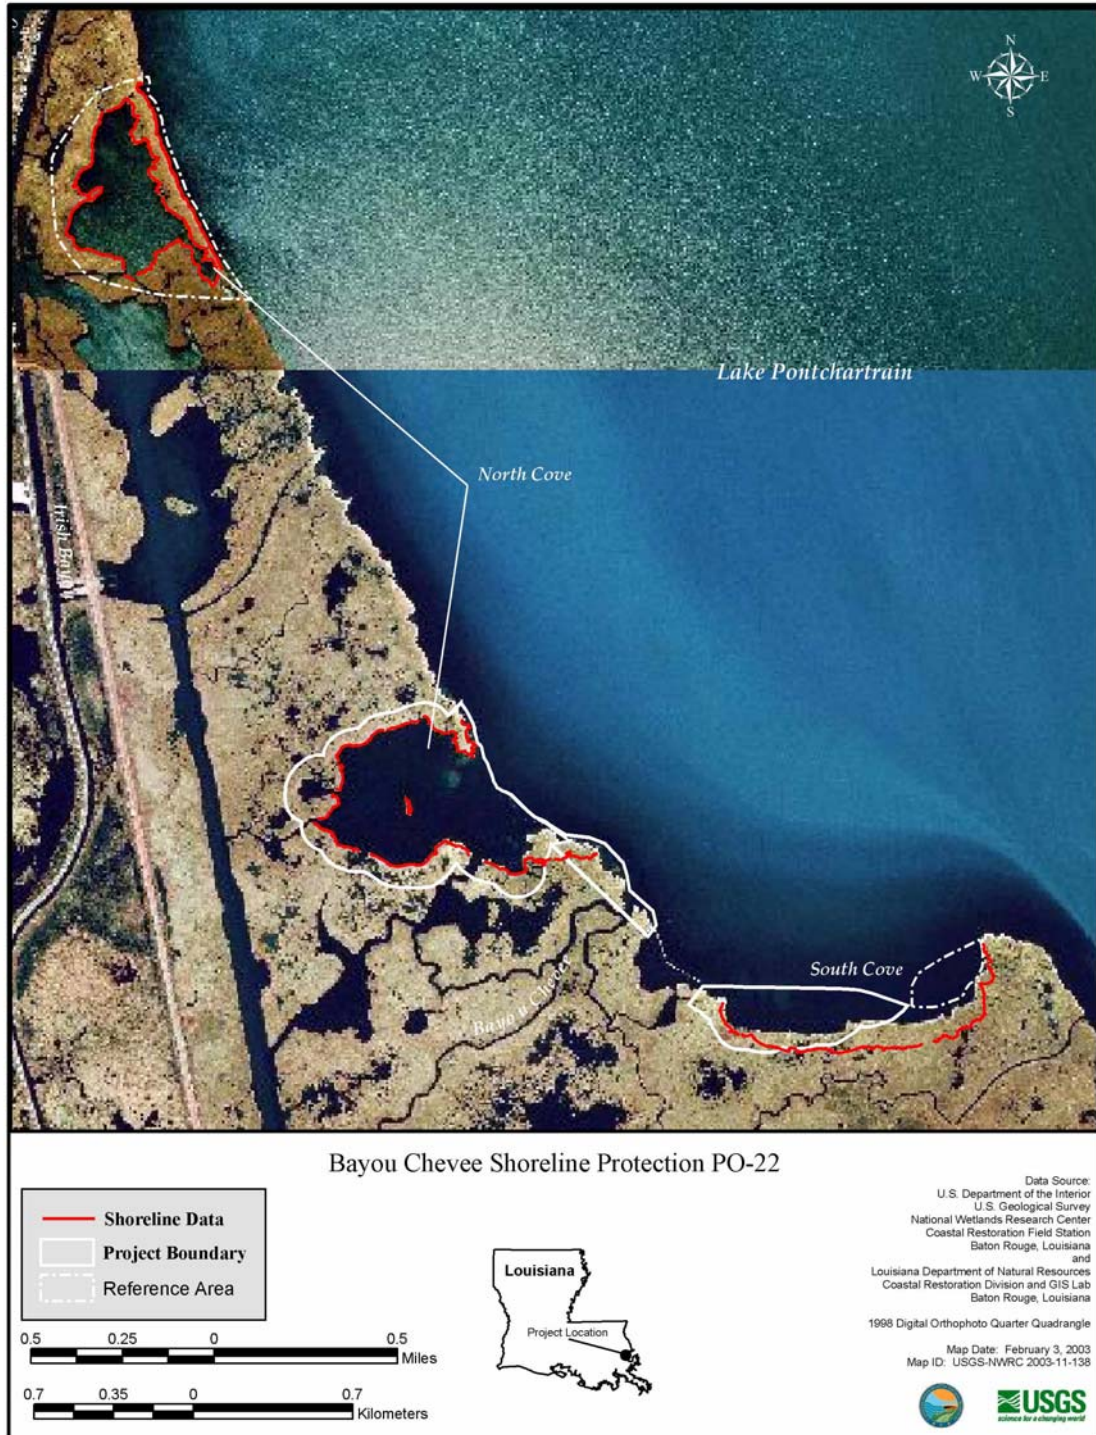
To date, only an as-built survey has been completed. After shoreline position is documented in 2004, the data will be analyzed and the shoreline change quantified. However, as determined by overlay of 2001 shoreline data over the 1998 DOQQ image, shoreline position has retreated considerably since 1998 (figure 3). In the South cove project area, shoreline position has retreated past the original project boundary.

Figure 3. 2001 Shoreline position overlaid on 1998 DOQQ image of the Bayou Chevee Shoreline Protection (PO-22) project.

The north cove project area showed a similar decline between 1998 and 2001, with only algae and a small amount of *R. maritima* (6.19%) recorded during 2001 sampling compared to a high abundance and diversity of SAV in 1998 (table 2). The north cove reference area showed a high occurrence of algae (81%) and *R. maritima* (61%) in 2001, but had lost the diversity and overall abundance of SAV species recorded during the 1998 sampling (table 2). Overall, a significant decline in SAV frequency and occurrence was realized across all areas between the 1998 and 2001 SAV surveys (figures 4 and 5). This loss was most likely due to drought conditions that prevailed during the 2000 growing season. During the drought salinities at the Fritchie Marsh monitoring station (PO06-06) in Salt Bayou, located northeast of the project area on the north shore of Lake Pontchartratin, averaged 10ppt, which is more than twice the normal average of 4 ppt and exceeds the tolerance levels of *C. demersum*, *M. spicatum*, *N. guadalupensis*, and *V. americana*. *Ruppia maritima*, which can withstand a broad range of salinity levels, was the only plant species observed during the 2001 sampling. However, the total loss of SAV noted in the south cove area was probably a result of both increased salinity levels and unabated wave action. The south cove shoreline retreated considerably between 1998 and 2002 (figure3), and the high wave energies which caused this retreat likely contributed to the demise of the SAV.

Although no post-construction DGPS shoreline data have yet been collected, it is evident from the combination of the 2001 shoreline data with the 1998 DOQQ photography that substantial areas along the shoreline were lost during the three years that construction of this project was delayed. During this time, we also saw a dramatic reduction in SAV abundance in both the project and reference areas mostly due to drought conditions.

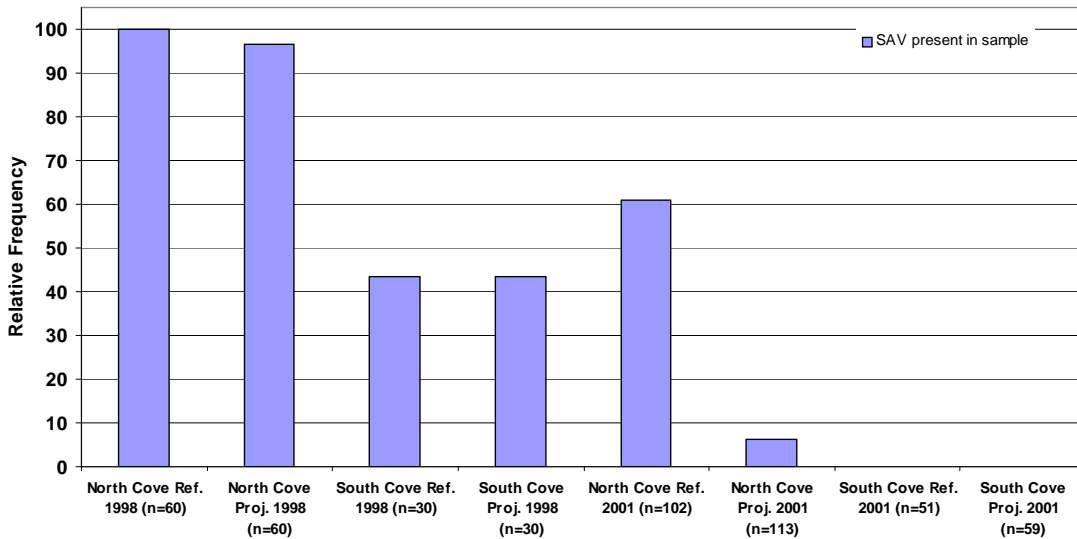
Figure 4. Frequency of occurrence of submerged aquatic vegetation in samples for North and South cove project and reference areas 1998 and 2001 for the Bayou Chevee Shoreline Protection (PO-22) project.

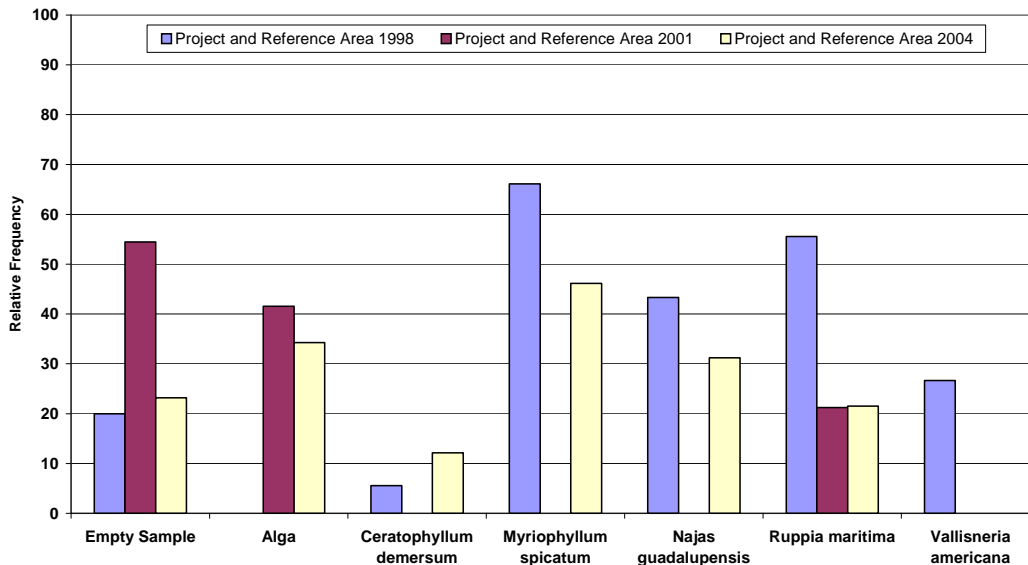
Figure 5. Relative frequency of submerged aquatic vegetation species for project and reference area July 1998 and April 2001 for the Bayou Chevee Shoreline Protection (PO-22) project.
