**2004 Operations, Maintenance  
and Monitoring Report**

**North Lake Mechant Landbridge  
Restoration**

State Project Number TE-44  
Priority Project List 9

May 2004  
Terrebonne Parish

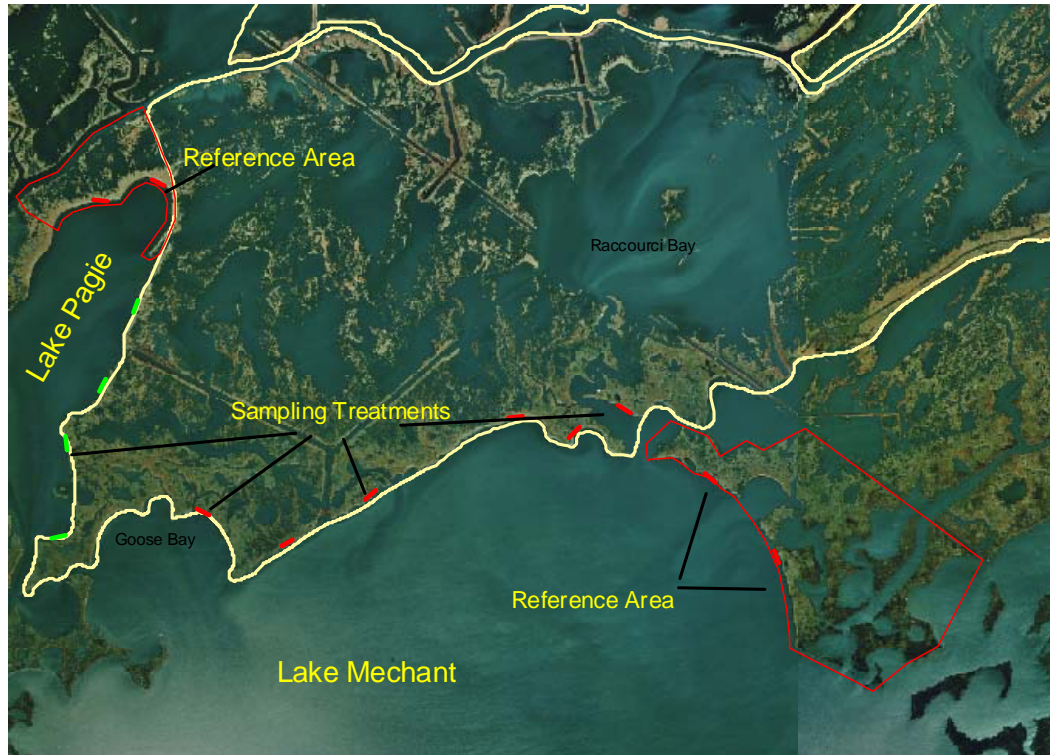
## North Lake Mechant Landbridge Project (TE-44) Vegetation Sampling Plots

**Figure 3.** Vegetation sampling plots and project boundary.

Species composition and relative abundance will be evaluated using techniques described in Steyer et al. (1995). A modified Braun-Blanquet method (Mueller-Dombois and Ellenberg 1974) will be utilized. Vegetation will be sampled in ten randomly selected plots within each of the ten randomly selected 400 foot (122 m) segments referenced in the previous section (figure 3).

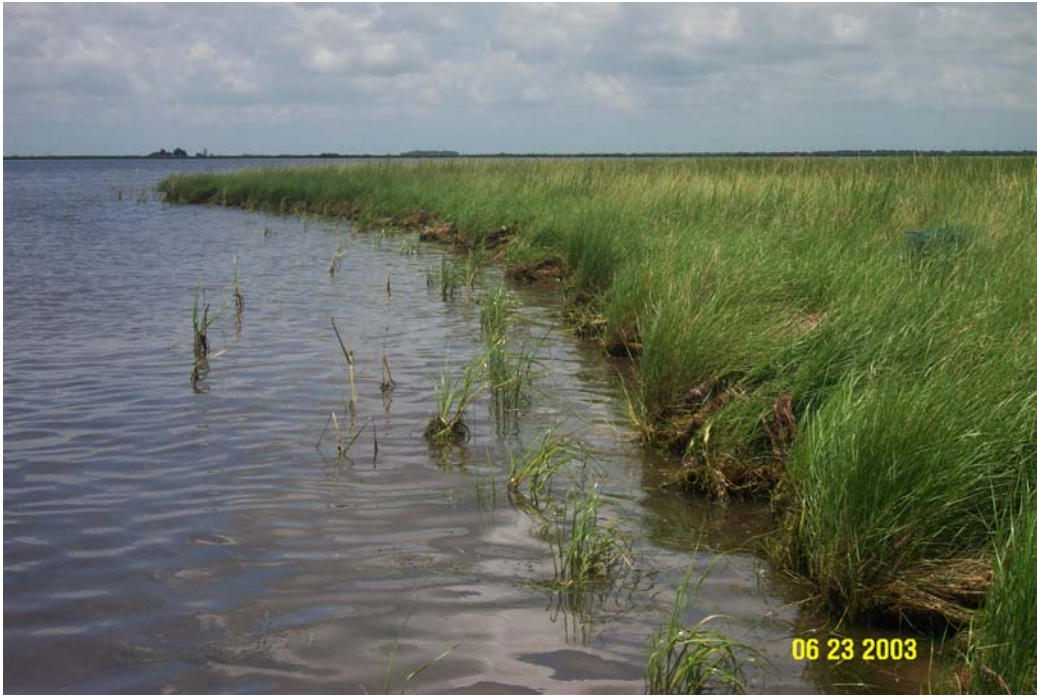
**Figure 6.** Planted rows of *Spartina alterniflora* along the eastern shore of Lake Pagie.

It is recommended that supplemental planting be done in the future since the initial planting experienced only 65% survival immediately following planting. The project design calls for supplemental planting after CU2 construction is completed to replace vegetation damaged by dredge material placement on the interior marsh. This should also be considered as regular maintenance when periods of high mortality reduce the planted vegetation. In our opinion, the significant mortality was due to unusually high water immediately after planting and poor soil conditions. High water occurs frequently after tropical storm events and during summer when southerly winds push water levels two feet and higher above normal tides. Plants tolerant to being submerged for long periods of times should be considered. It was also observed that the *Spartina alterniflora* (smooth cordgrass) did considerably better in the more compact soils along the shoreline of Lake Mechant. The soils of Lake Pagie have a much higher organic composition and are much more unconsolidated.

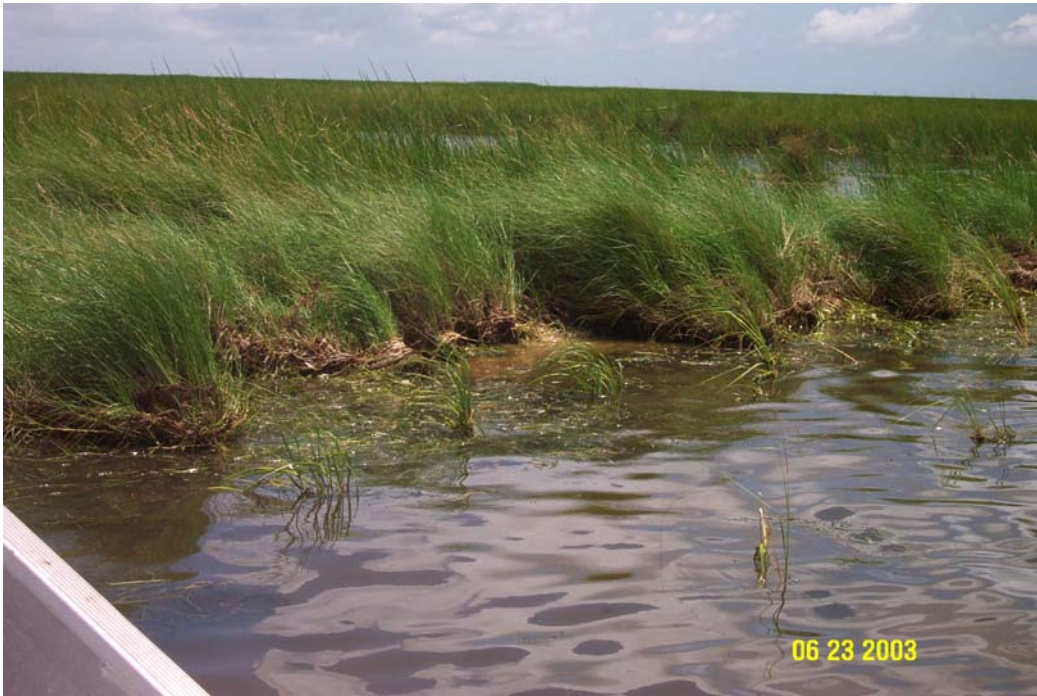
**Figure 7.** Marsh edge showing drop off and planted vegetation along Lake Pagie.

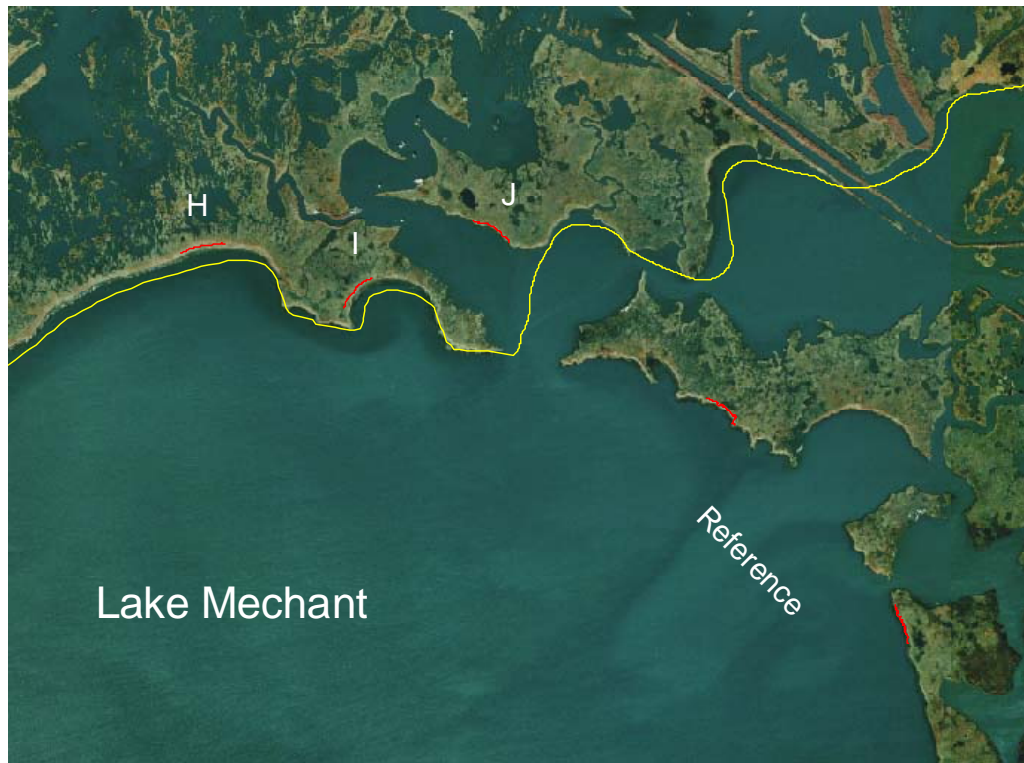
**North Lake Mechant Landbridge Restoration  
TE-44  
Sample of Shoreline Location Readings  
June, 2004**

Controlled GPS was used to document marsh edge position using techniques described in Steyer et al. (1995). The shoreline of Lake Pagie and Lake Mechant within the project area were divided into 400 foot (122 m) segments along the shoreline of Lake Mechant and Lake Pagie. GPS readings were taken within each of the ten randomly selected 400 foot (122 m) segments immediately post construction and coincided with the vegetation sampling segments (figure 8). Historical rates of erosion will be obtained and compared to erosion rates within the sample segments after project implementation. Reference sites adjacent to the project area will be monitored and compared to historical erosion rates.

No comparative analysis was done on this first set of data (Year 0). Year 1 data collected in 2004 will be compared to year 0 data and historical rates.

**Figure 8.** Shoreline segments measured with differential GPS in Year 0. This will serve as a baseline to measure shoreline changes over time.
