**2004 Operations, Maintenance,  
and Monitoring Report**

**Vermilion River Cutoff**

State Project Number TV-03  
Priority Project List 2

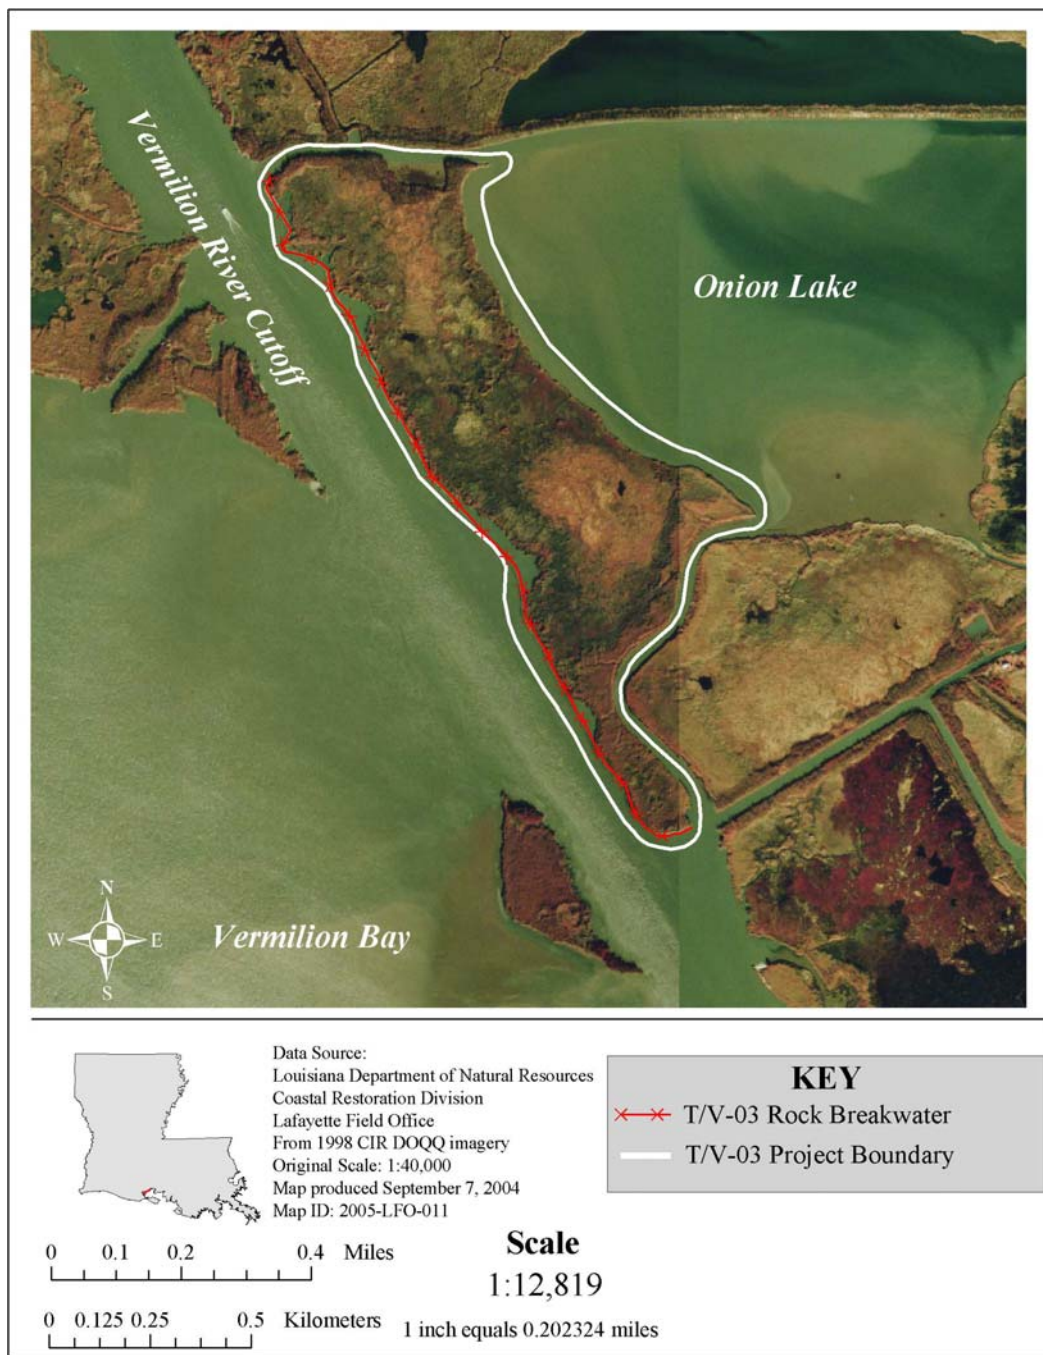
**Figure 1.** Vermilion River Cutoff (TV-03) project area map showing location of rock breakwater.

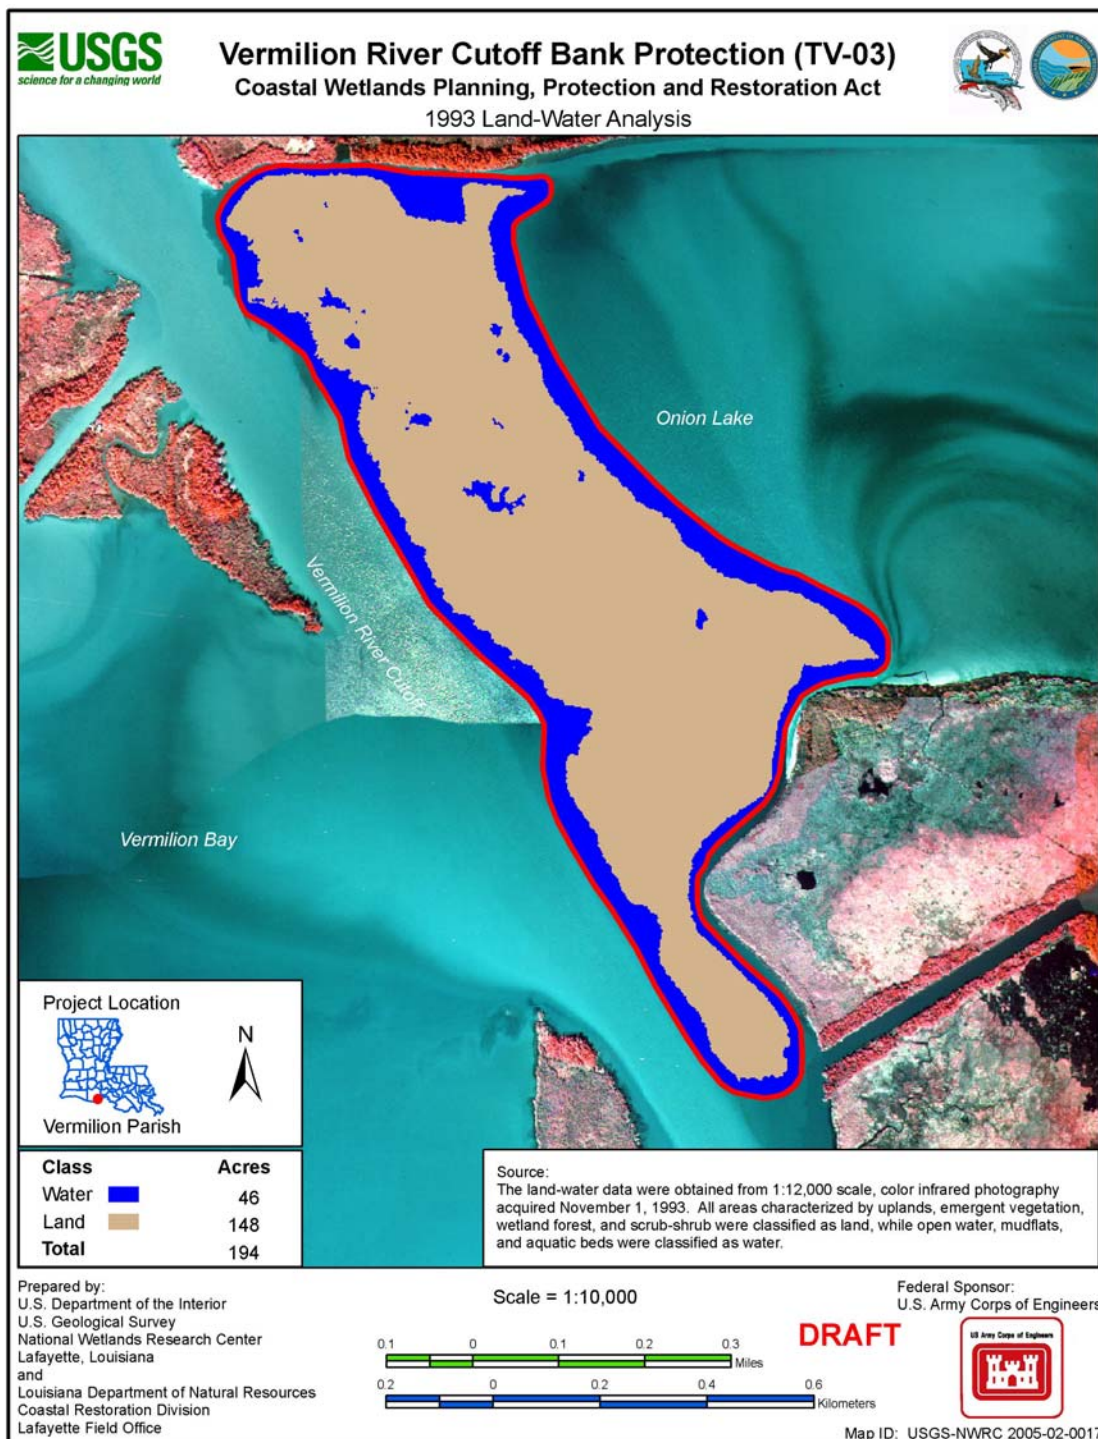
**Figure 2.** Pre-construction Land to Water analysis for Vermilion River Cutoff (TV-03) project area for 1993.

The original boundary for the project area in 1993 did not include the entire area where the shoreline structure was constructed. The official boundary for the project area was adjusted to encompass the rock dike to better evaluate the project area over time. Comparison of the 1993 land to water analysis to the analysis for 2002 shows an increase in land by one acre (figures 2 and 3). Part of this increase may be due to the terraces that were constructed by a private land owner in Onion Lake.

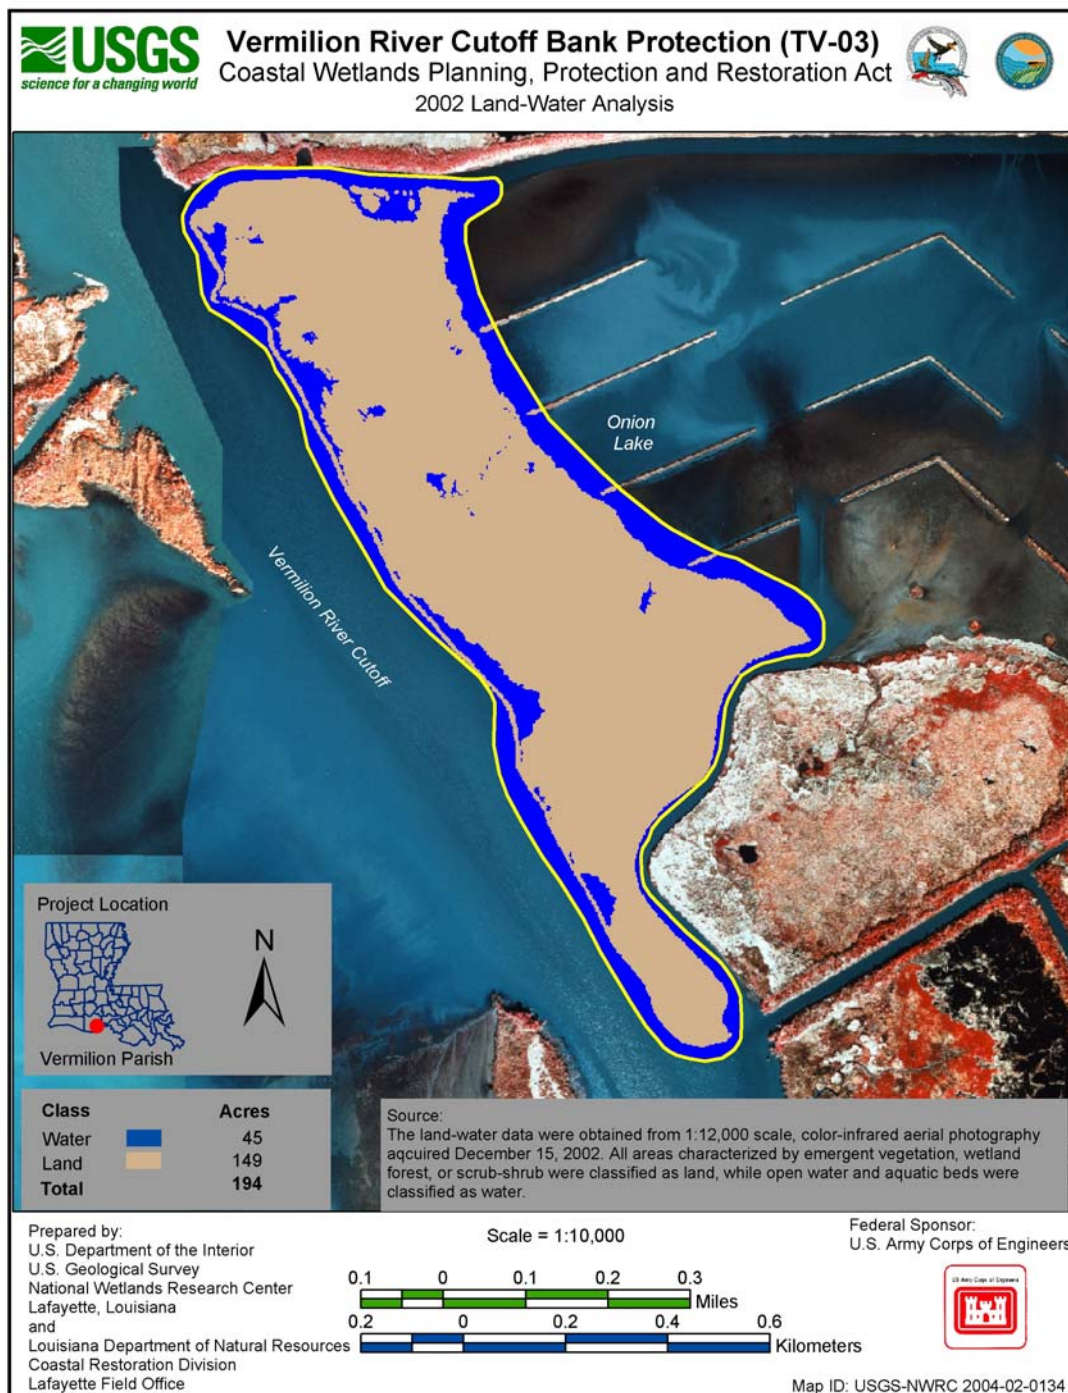
**Figure 3.** Land to water analysis for Vermilion River Cutoff (TV-03) project area in 2002.

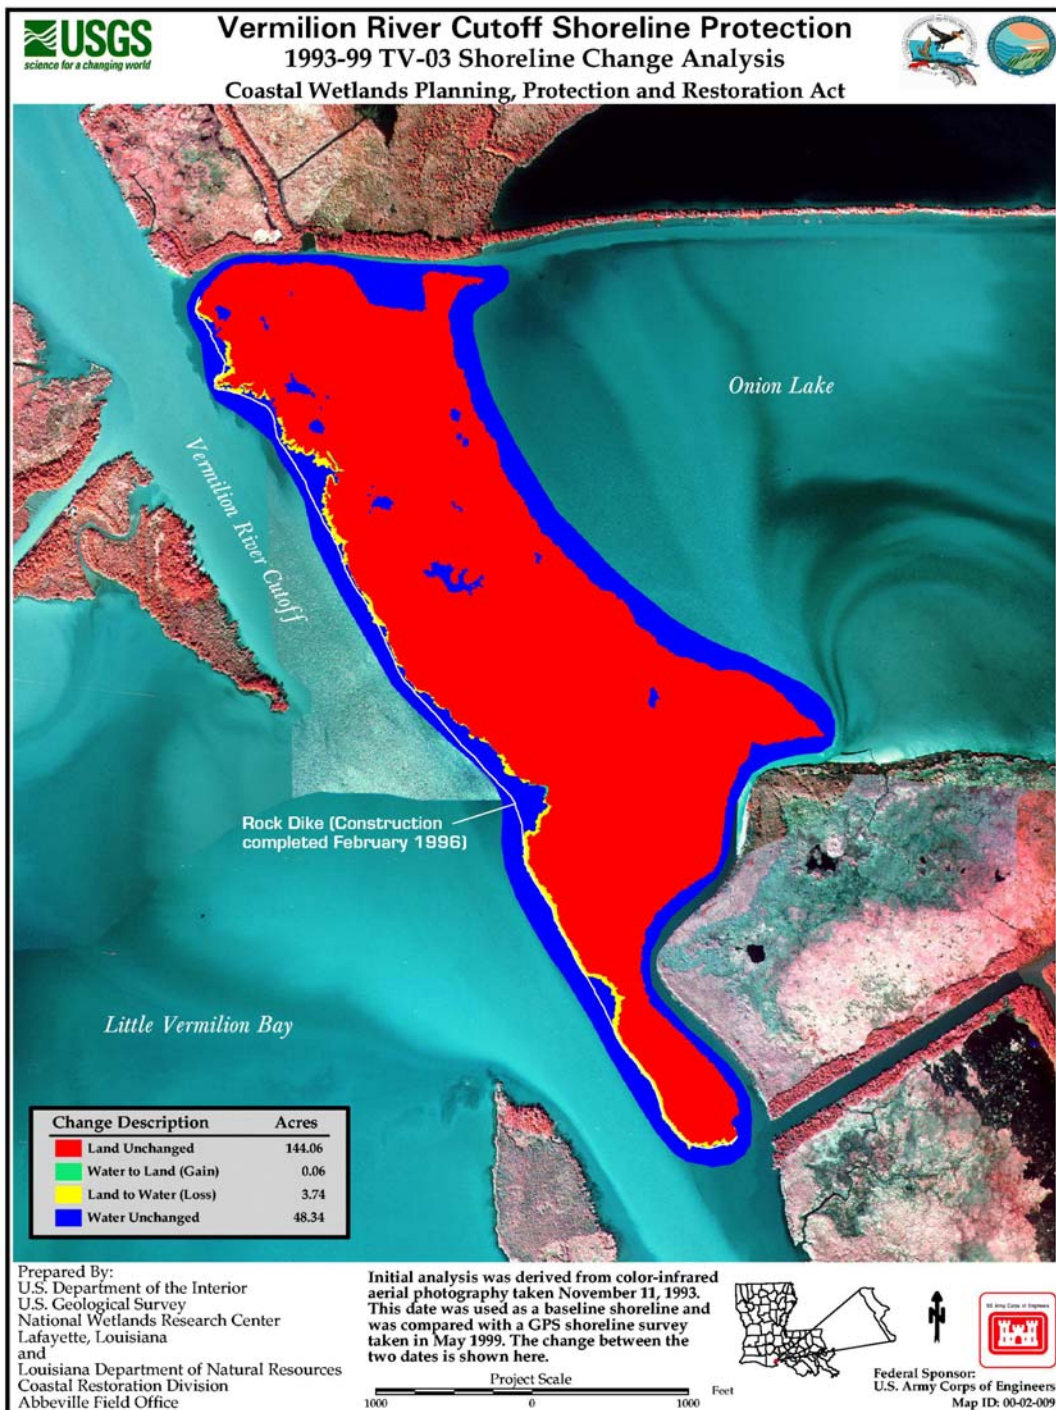
**Figure 4.** Shoreline change analysis for Vermilion River Cutoff (TV-03) project from 1993 to 1999.

Shoreline change analysis from 1993 to 1999 indicates an increase of open water in the project area. Aerial photography taken in 1993 was used as a baseline for shoreline position instead of the actual DGPS shoreline positions captured in 1995. This was three years prior to construction of the Vermilion River Cutoff (TV-03) project in February 1996, which increases the probability of error in interpreting when this loss actually occurred (figure 3). The data used for the 1999 shoreline position was from DGPS acquired by LDNR personnel. It is not known how much of the loss occurred from 1993 to the completion of project construction in February 1996. Analysis of baseline DGPS taken in 1995 and compared to 1999, and 2002 DGPS has not been completed (figures 4-5). There was some question of compatibility of the 1995 DGPS data set with the subsequent DGPS surveys that still needs to be addressed.

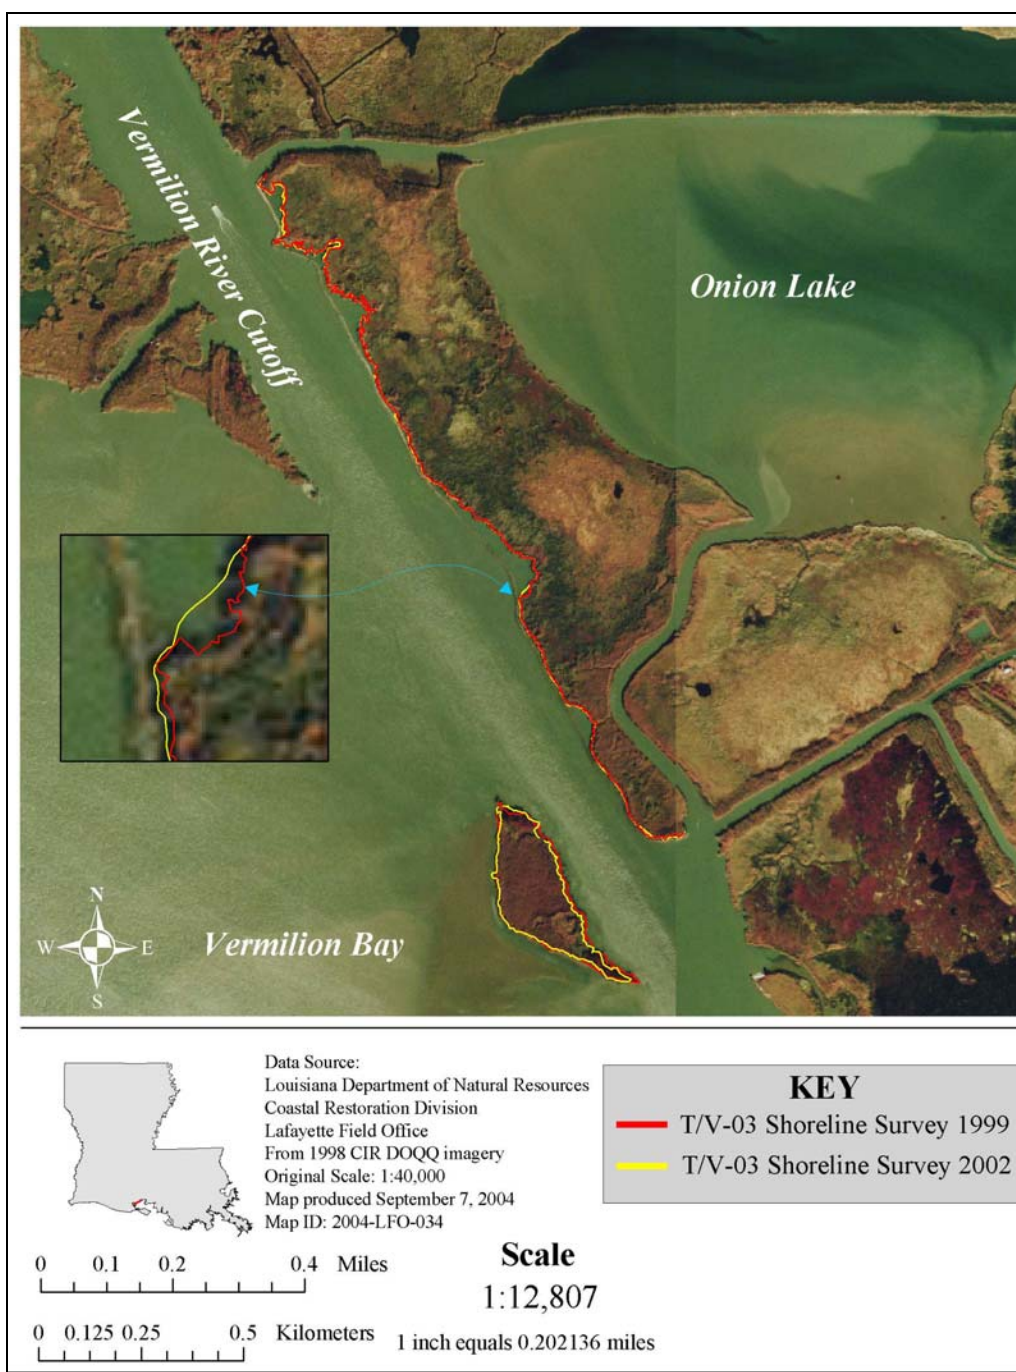
**Figure 5.** Location of shoreline surveys for 1999 and September 2001 of Vermilion River Cutoff (TV-03) project and surrounding shoreline.

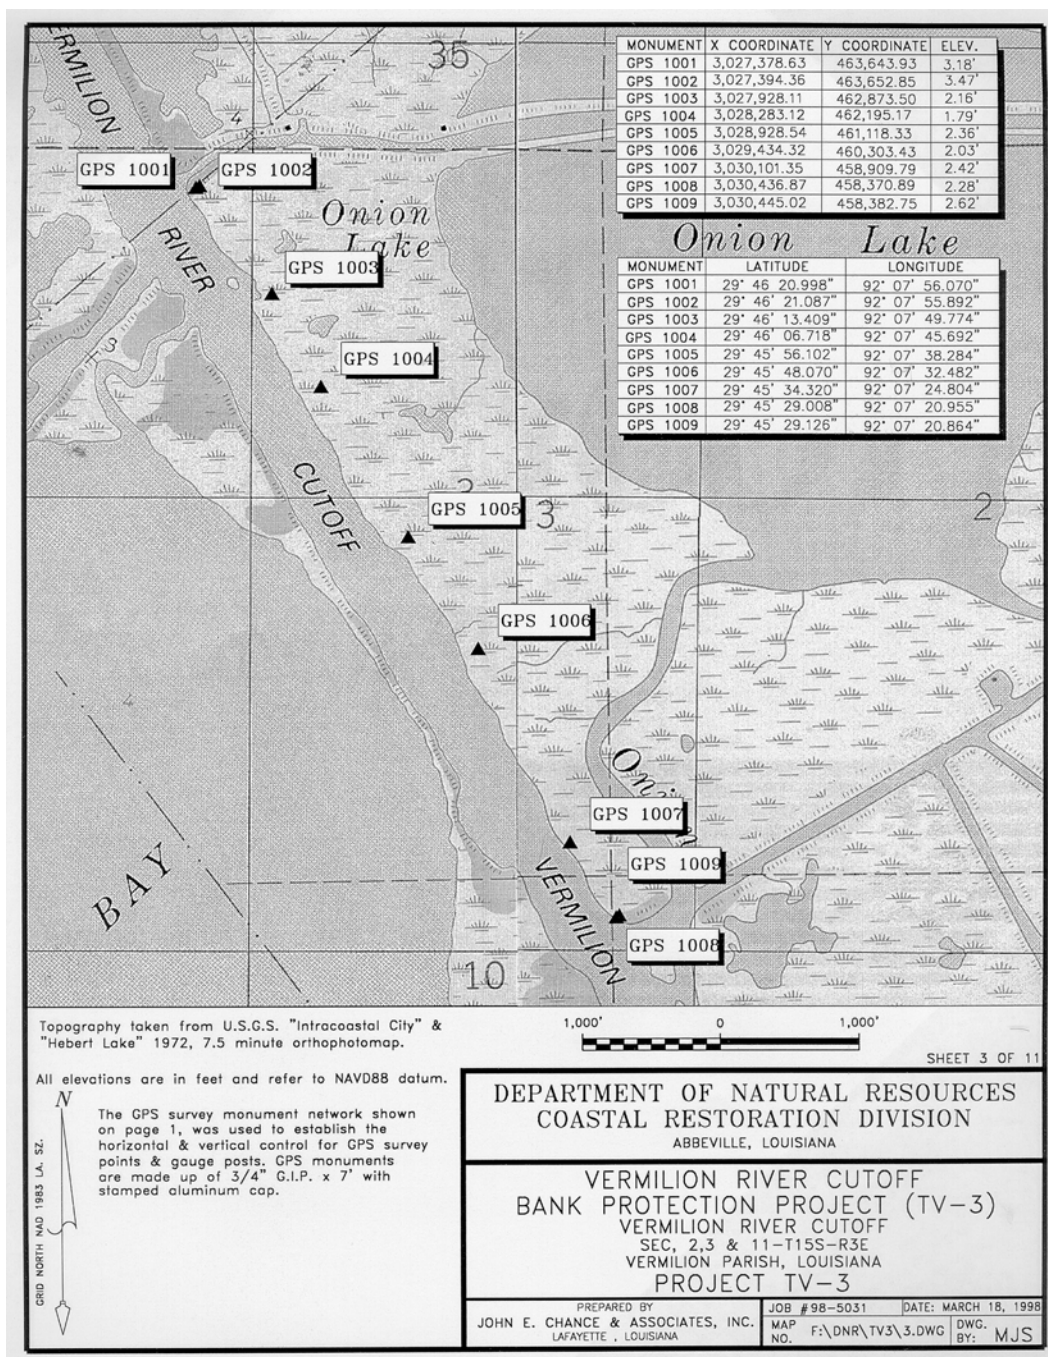
Direct shoreline measurements taken from each settlement plate (figure 6) to the vegetated edge of the marsh behind the rock breakwater in the project area indicate progradation at three of the five sites. Only one site, at settlement plate 1006, experienced a loss of approximately 0.77 ft/yr (0.23 m/yr). Settlement plate 1005 showed a gain of 2.56 ft/yr (0.78m/yr) and settlement plate 1007 remained unchanged (table 1, figure 7). The data from these measurements indicate the shoreline behind the rock breakwater on the three northern most settlement plates is prograding (figures 8-10). The loss of shoreline behind nearest settlement plate 1006 may be attributed to the sinking elevation of the rock breakwater at or below 2 ft NAVD88.

**Figure 6.** Cross section of Vermilion River Cutoff Shoreline Protection project showing settlement plate locations.

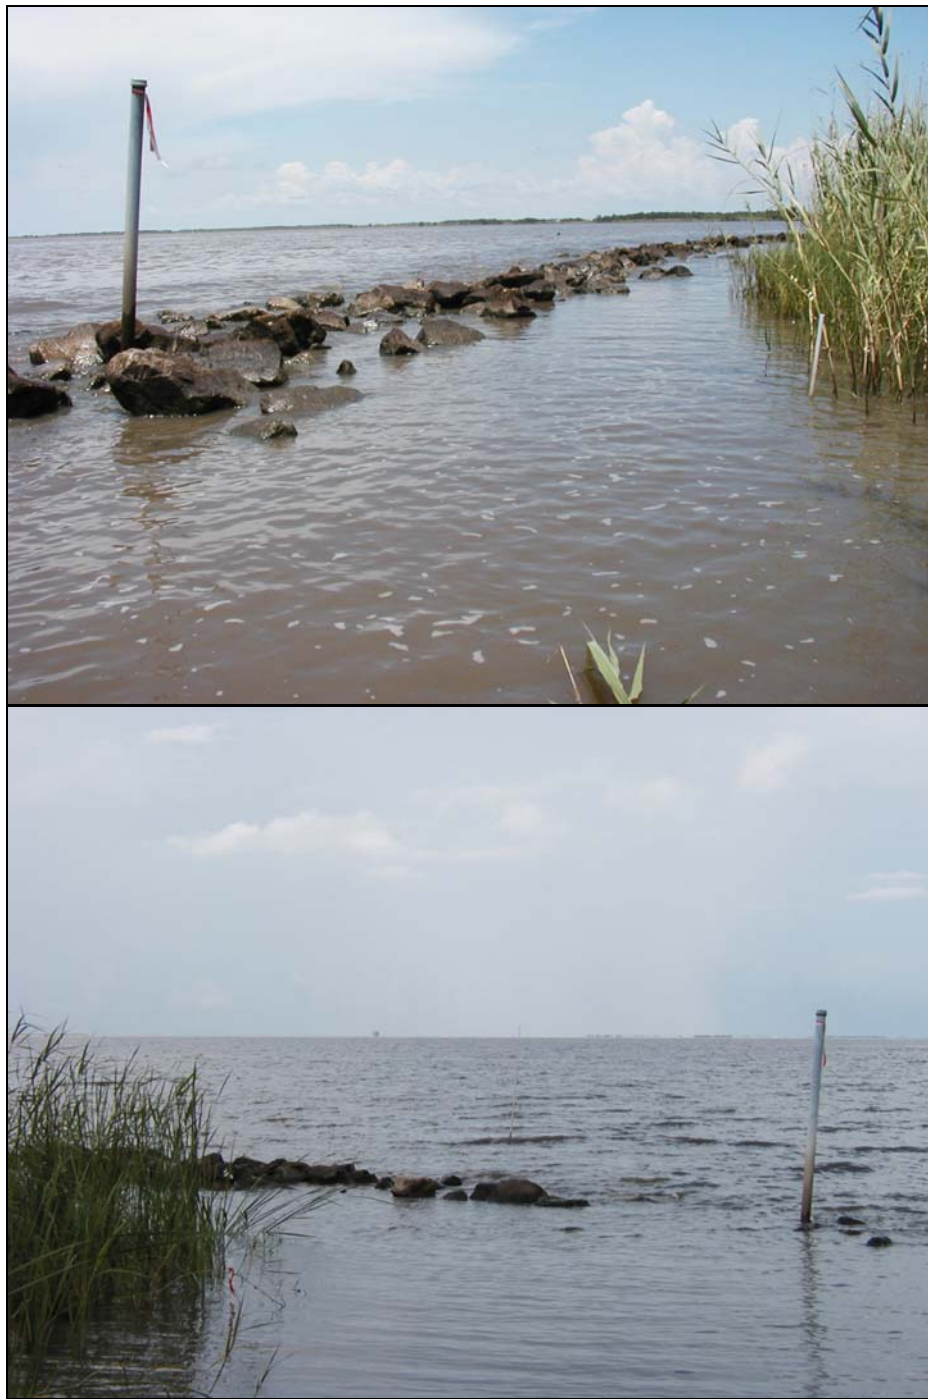
**Figure 7.** Photograph of rock breakwater and vegetation growth at settlement plate 1005 (upper) and water overtopping rock breakwater at settlement plate 1006, July 2002 (lower).

Construction to begin in Spring 2005 to raise dike back to approximate original construction elevation in areas as required.

A maintenance construction contract is currently being developed to address an area of the foreshore dike that has deteriorated below acceptable standards. Construction is scheduled for Spring 2005.

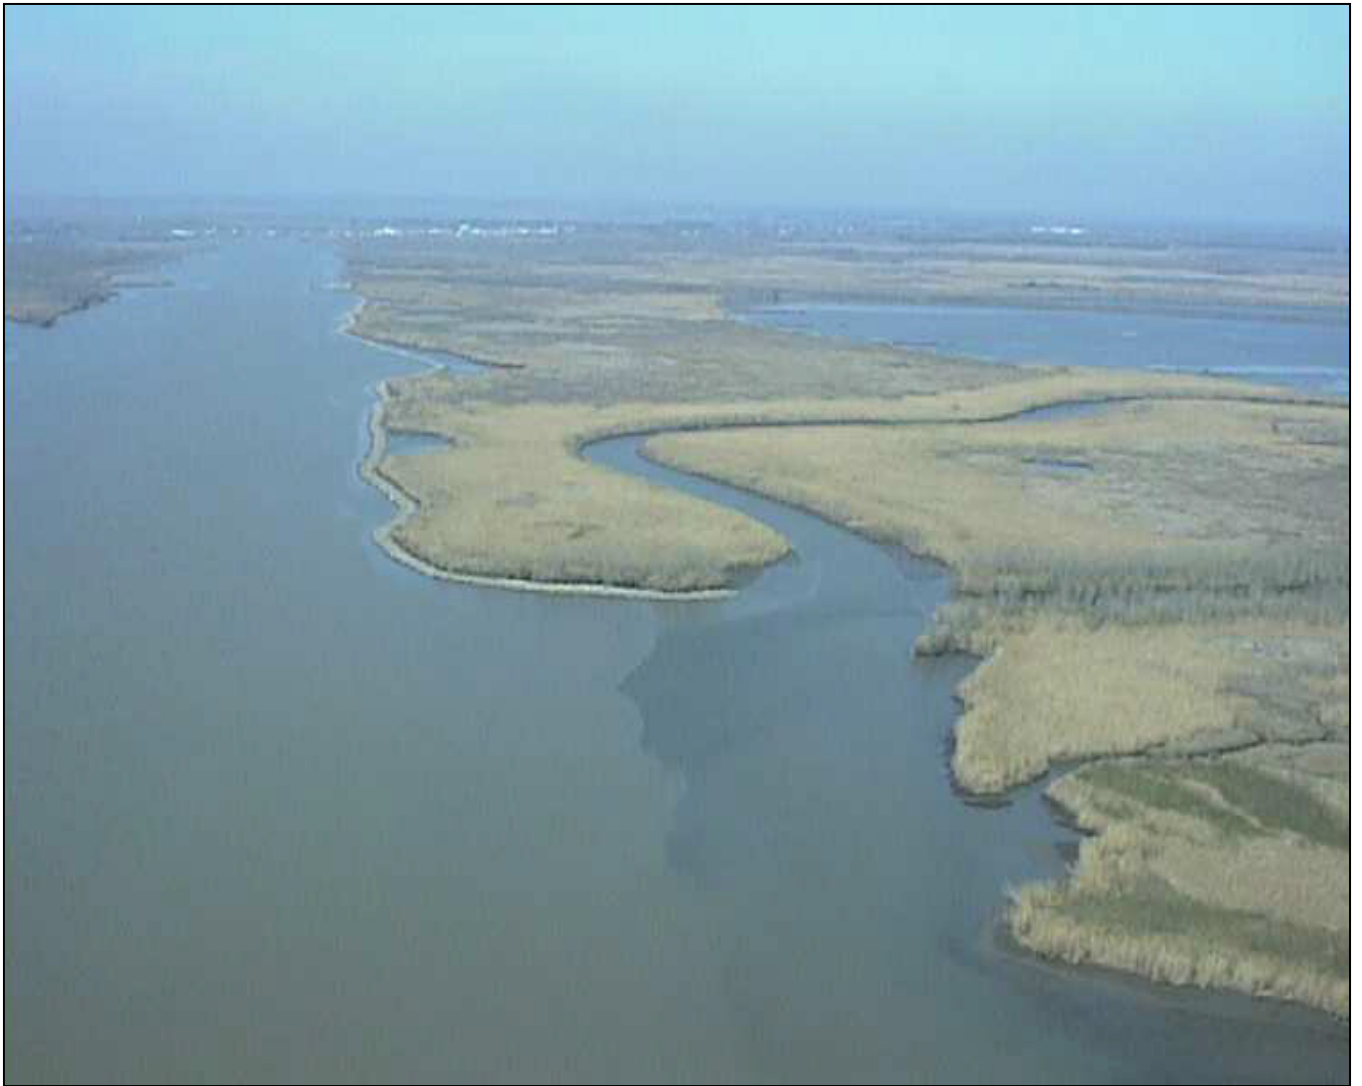
**Figure 8.** Aerial photograph of Vermilion River Cutoff (TV-03) shoreline protection project showing the Onion Lake complex on the right side of the rock breakwater, February 2000.

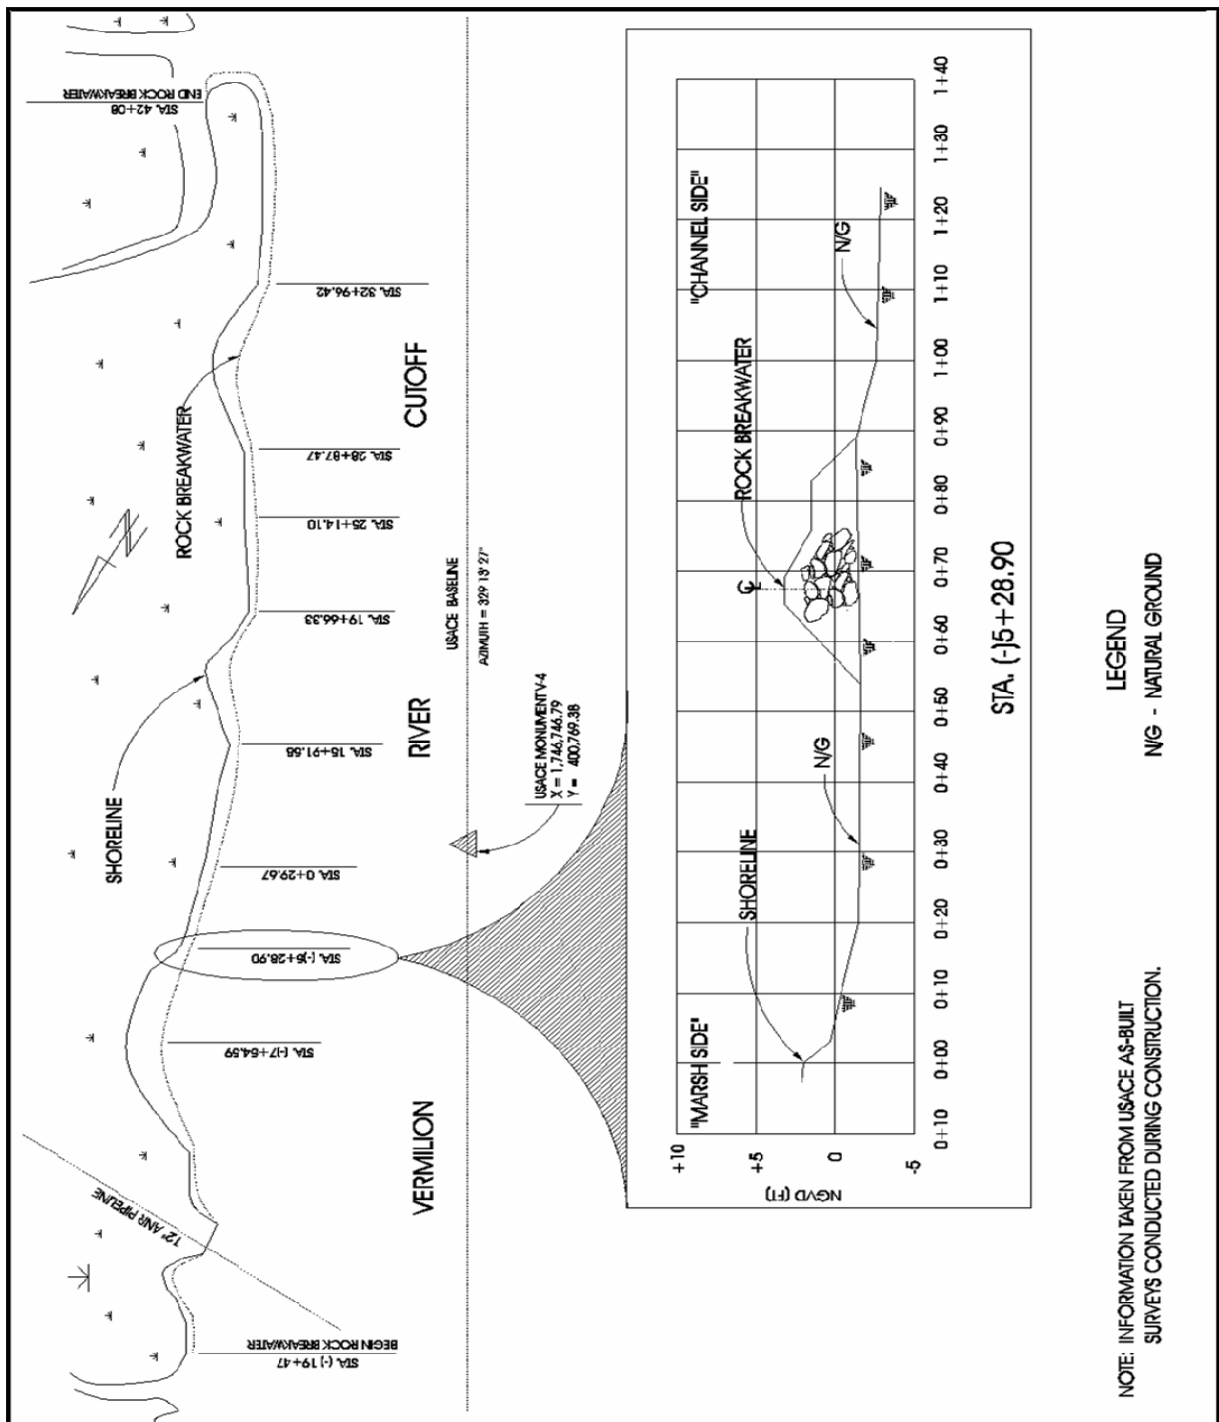
**Figure 9.** Plan and cross section showing location and elevation profile of station (-)5+28.90 in as-built survey (data from USACE 1996).
